UK P&I CLUB

# RISK FOCUS: PAINT

*Protecting your asset against the environment*

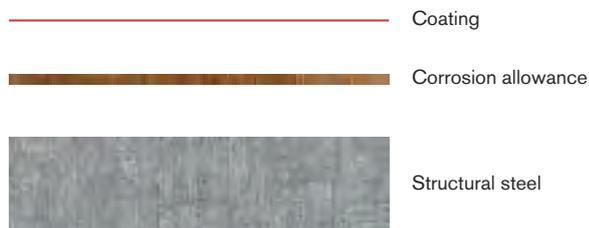
### Thickness of coating compared to that of the structural steel

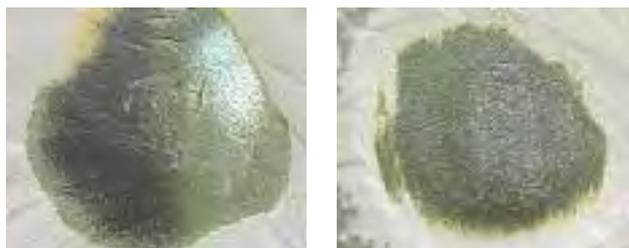
An example of the 'finish' obtained using a conventional hand held tool is shown below. Note the shine on the metal surface on the left compared to the profiled surface on the right.

Of particular concern when repair is carried out on board is the use of power tools and the tendency to polish the surface, removing the steel profile.

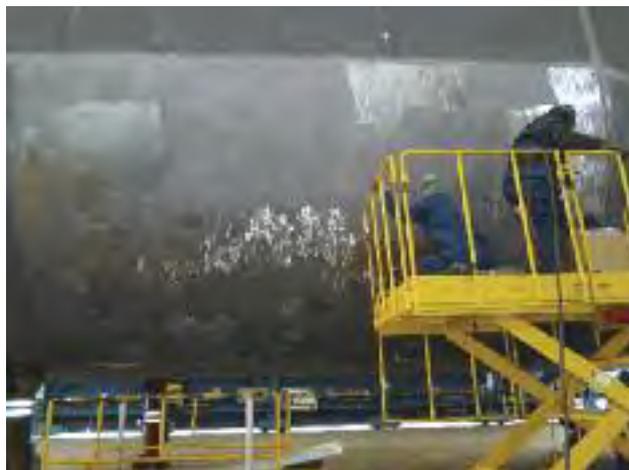
Polished mechanical tooling

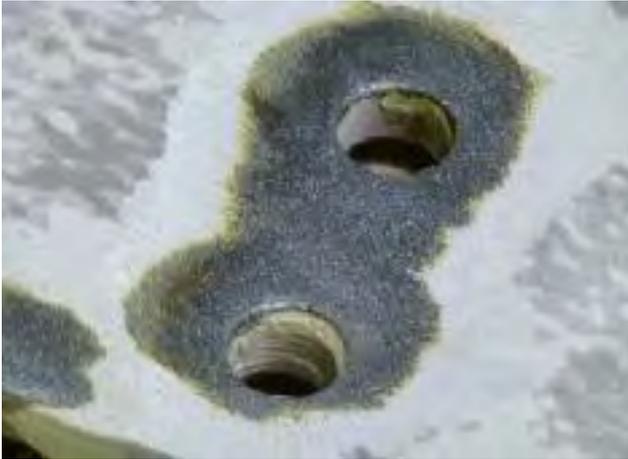
Repair area with profiled surface ready for painting

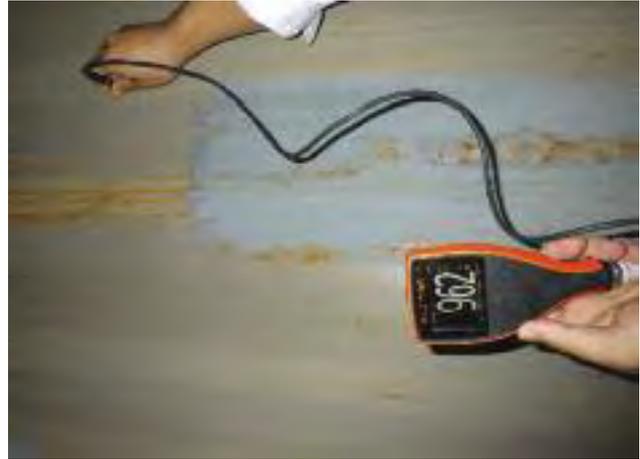
Measuring the dry film thickness (dft)

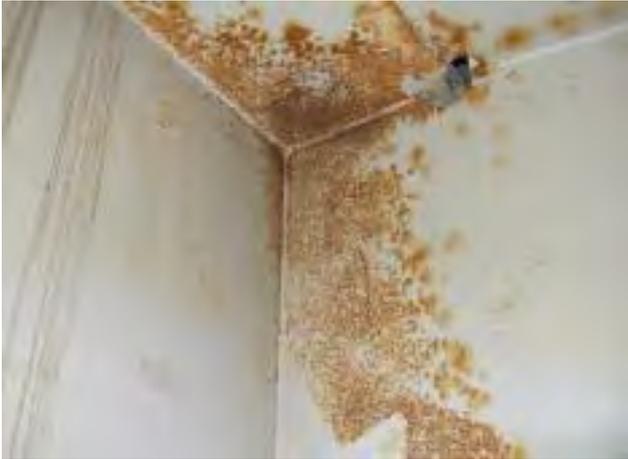
**Scattered corrosion**

**Under application** of the protective coating can, and does, lead to early coating failure with scattered corrosion in areas of under film thickness.

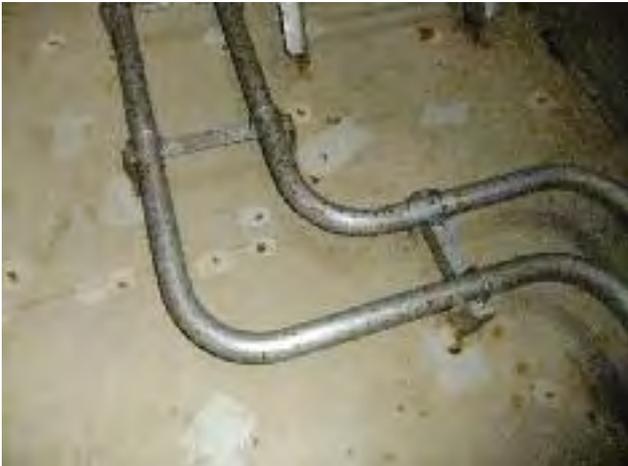
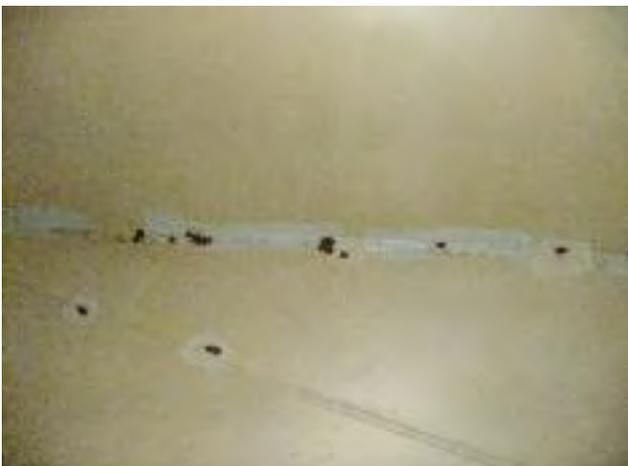
This under application means that the repair patch is not able to perform properly as a corrosion barrier. As a consequence, the repair can break down. Note that many of the repair patches shown below show corrosion.

It is very easy to under apply paint when using either of these tools as the tendency is to spread out the paint too thinly. Even though the required number of coats of paint may well have been applied (as per paint manufacturer's technical data sheet), the repair is likely to be under the recommended scheme film thickness.

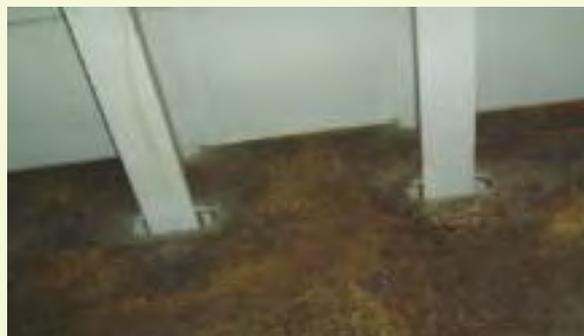
Safinah were asked to inspect and report on the level of rust present in the cargo tank of a one year old vessel. The photo supplied appeared to show a heavily corroded tank top:

On closer inspection, however, the rust was found to be a surface layer of corroded steel grit. Light abrasion removed the rust to reveal a sound coating underneath.

Corrosion was due to the grit, caught in the pipework during construction, which had subsequently fallen onto the tank top. Far from needing to recoat the cargo tanks, the recommendation was to remove the rust staining and apply a single coat of paint.

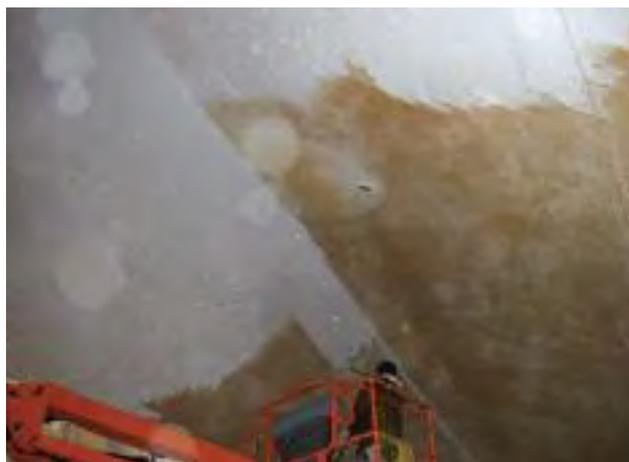
Slime fouling

The first fouling to occur is slime, which is then followed by weed fouling and finally, by hard shell fouling.

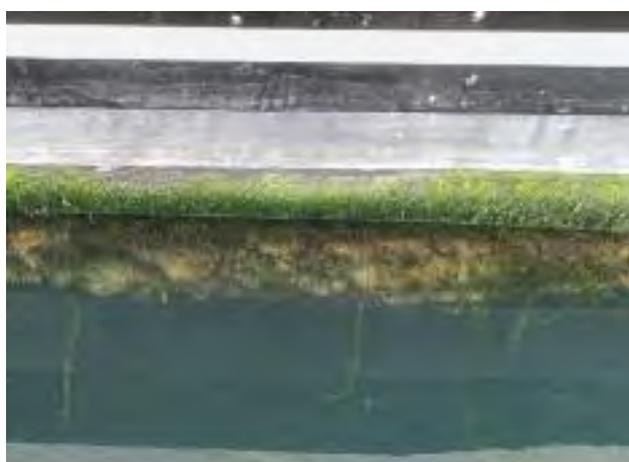
Weed fouling

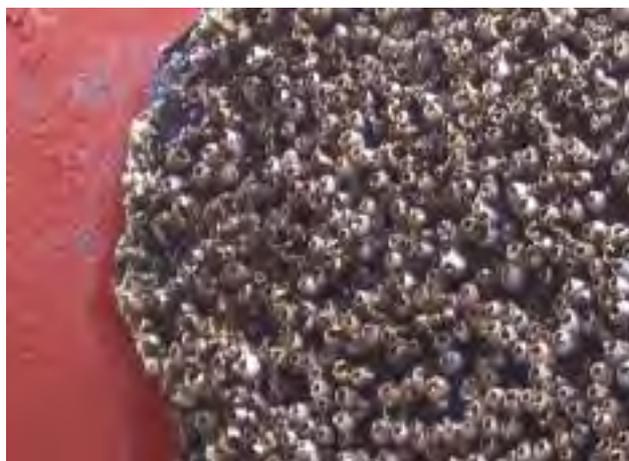
Hard calciferous fouling

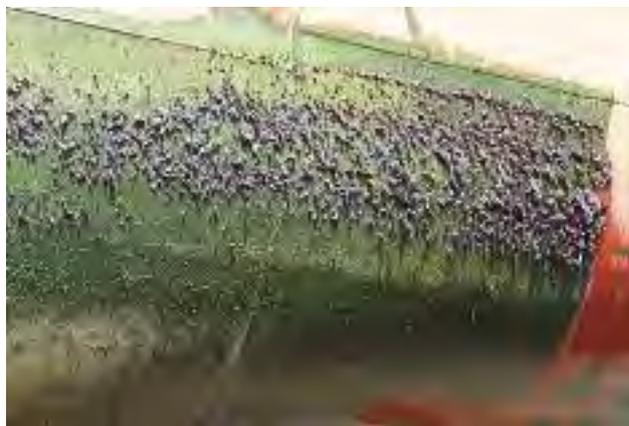
This coating will foul and regular cleaning is required. If regular cleaning is not possible, heavy fouling will occur, increasing the drag on the vessel. This is what your vessel could look like after only 2-3 months, with both weed and barnacle fouling.

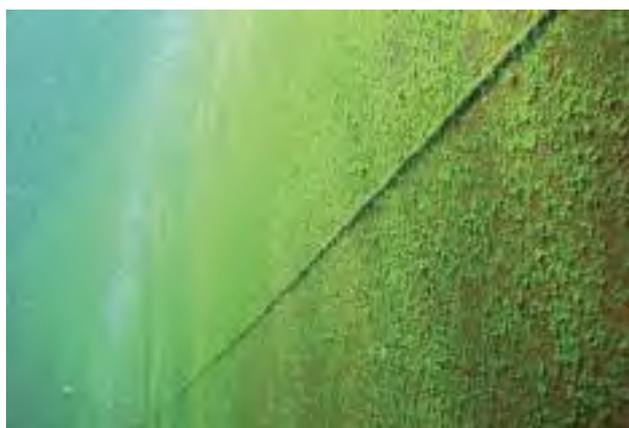
A large fleet owner chose to use market leading foul release technology on its vessels, but due to the presence of slime and the associated increased fuel penalty, the owner decided to remove the foul release coatings and return to biocidal antifouling. So if a vessel is slow moving, the biocide free version of this technology is probably not appropriate for use.
