# RISK FOCUS: HATCH COVERS

# Are the ships' hatch covers weathertight?

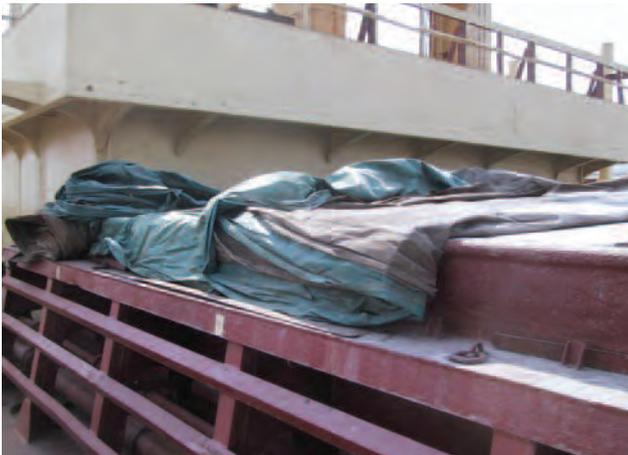
**Different plies of tarpaulins used for making hatch covers weathertight**

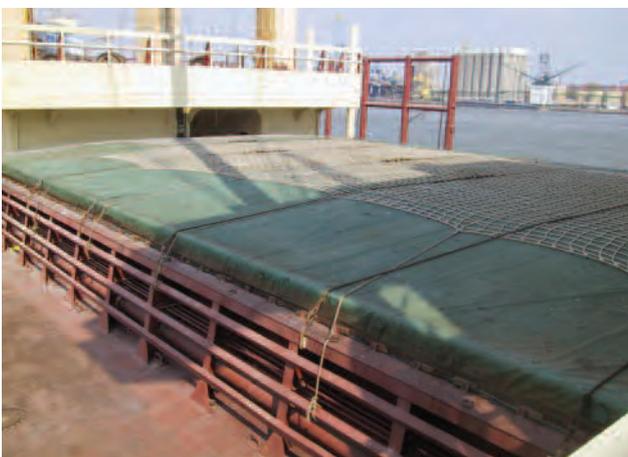
**Tarpaulin type hatch covers, properly battened down and ready for going to sea**

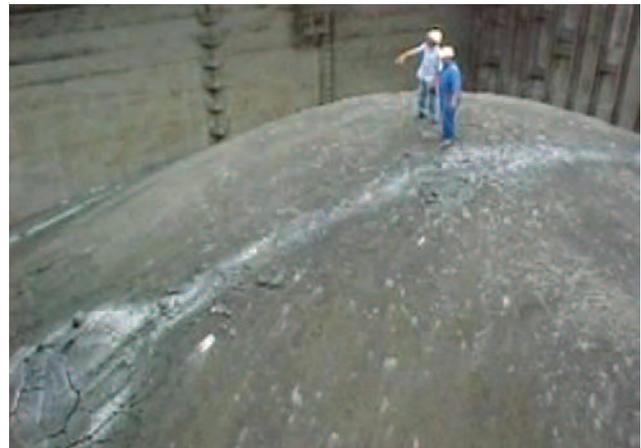
**Evidence of leakage in way of the hatch cover cross joints**

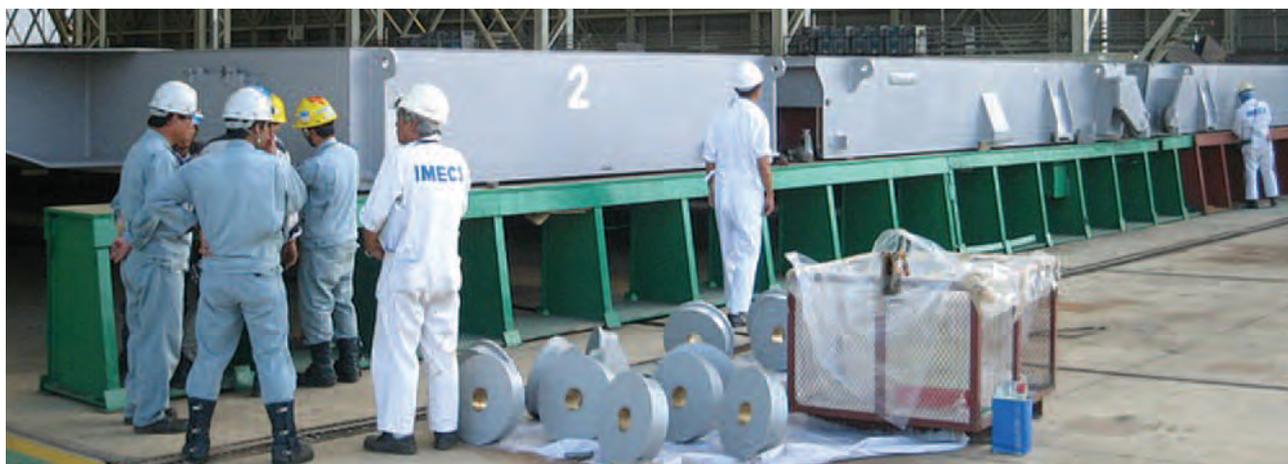
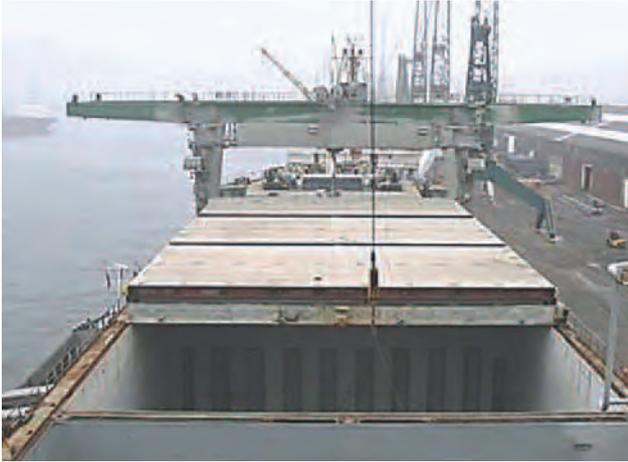
In the first place, one has to think of a ship as a steel box, and in this context, it is useful to compare a ship with a box of cookies. Such a box will be quite rigid as long as the lid (comparable to the deck of a ship) is on. However, once the lid is removed, the box becomes very flexible as it has lost part of its structural integrity. Whilst on a ship, the deck is not completely removed, big openings (hatch ways) are created, which in turn leads to the structure of the ship becoming more flexible. An extreme example of this is the open hatch-type ship, which has large hatch openings and therefore, less deck space than an ordinary design.

In order to maintain the vessels weathertightness, it is necessary to cover up these openings in the deck.

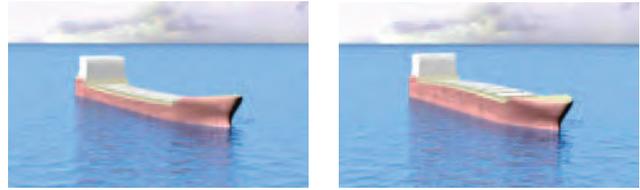
### Showing ship deflections

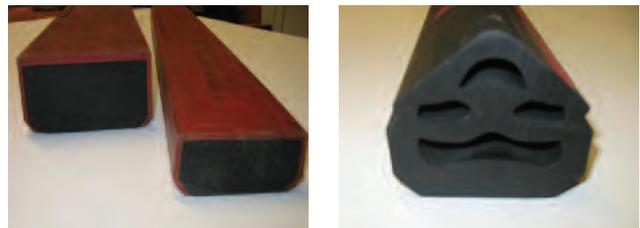
Different types of packing rubbers (from left to right: Sponge rubber, CAT or Sliding seal and Flex seal)

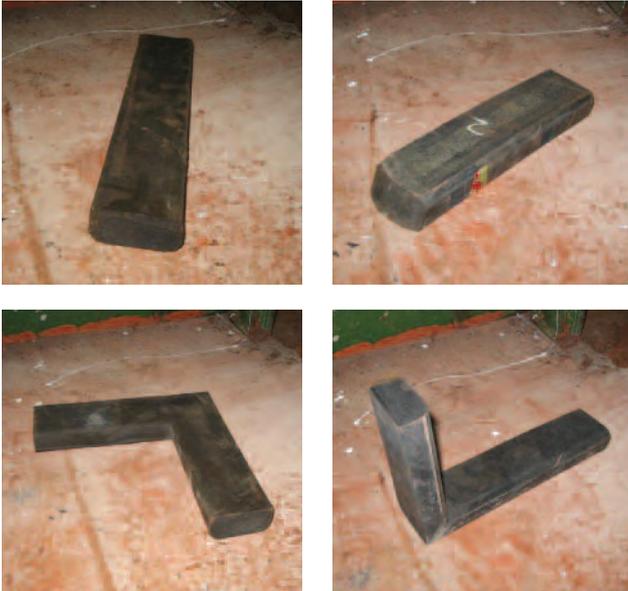
**Different shapes of packing rubbers (from left to right: linear rubber, end piece with solid nosing, flat corner and vertical corner)**

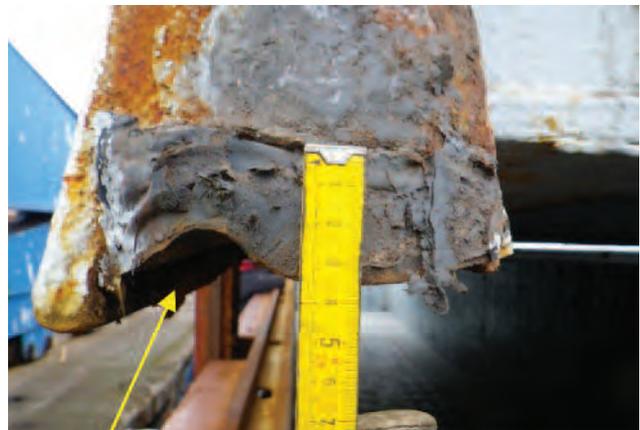
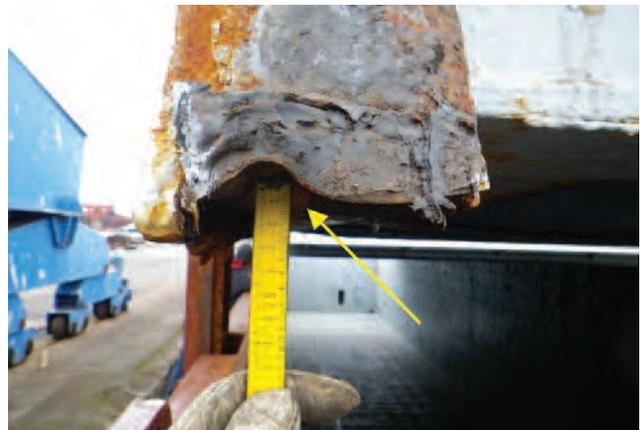
Overcompression of the packing rubber will result in permanent damage over time. This will become apparent in the form of a set groove in the impact area between the packing rubber and compression bar, as shown in the following images.

**Deep permanent groove in packing rubber as a result of overcompression. Also note the off-centre permanent imprint**

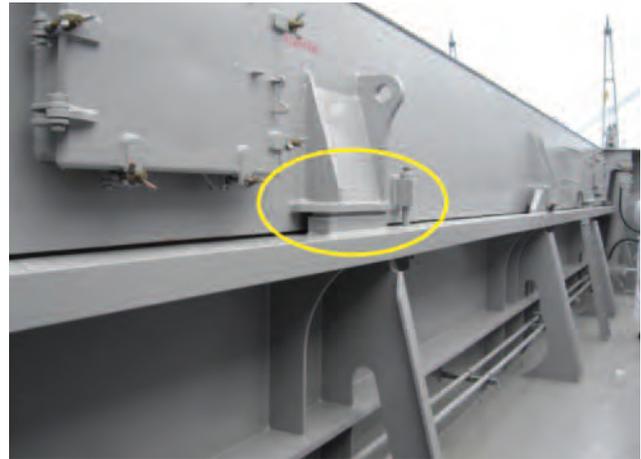
Bearing pads are supporting pads that comprise of two parts. One part is fixed on the panels and the other part is welded on the coaming. Bearing pads work in the vertical plane (Fz). They provide steel to steel contact between the panels and the coaming, and, as such, prevent the panels from sitting too low on the coaming, which would cause overcompression of the packing rubber, or panels from being pushed down under weather loads causing the cleats to be come disengaged.

They also prevent other structural parts like wheels and axles from taking up the load acting on the panels. Furthermore, bearing pads contribute to proper alignment/adjustment of the panels and transfer the load into the deck structure. Finally, in case of wear, they can relatively easily be repaired and restored to their original height.

Knowing that there is a relative movement between the hatch covers and the coaming, bearing pads should also allow for some movement between the mating halves of the bearing pad system. To prevent wear and corrosion that would prevent sliding action between the mating halves, compatible steel needs to be used. Bearing pads are available in different sizes and materials, and their wear will depend on their position and loads. This means that not all bearing pads will wear down to the same extent simultaneously, and require regular checking/inspection to determine if allowable wear limits have been exceeded and if repairs or replacement are necessary. The use of low-friction material is recommended to allow for smooth movement between panels and coaming, and to avoid the disturbing noise that is created by friction between ordinary steel to steel pads.

Bearing pads are fine pieces of engineering and replacing them with non-original spares or non-compatible steel could result in serious problems. Far too often bearing pads are replaced or repaired by the ship's crew with only one thing in mind, i.e. restoring the height of the bearing pads, whereby the correct size and use of appropriate material for the mating surfaces is overlooked. For bearing pad adjustment, it is

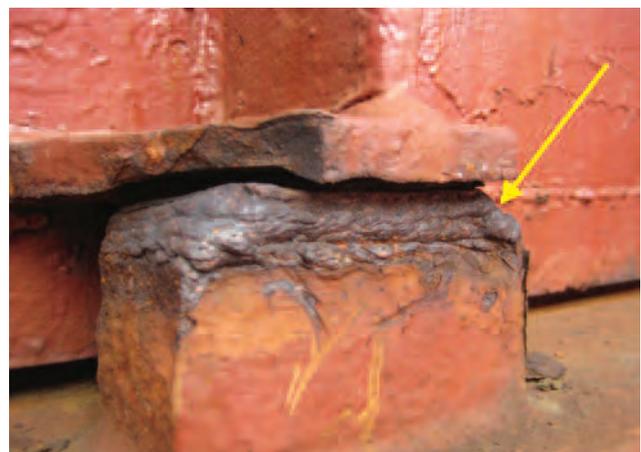
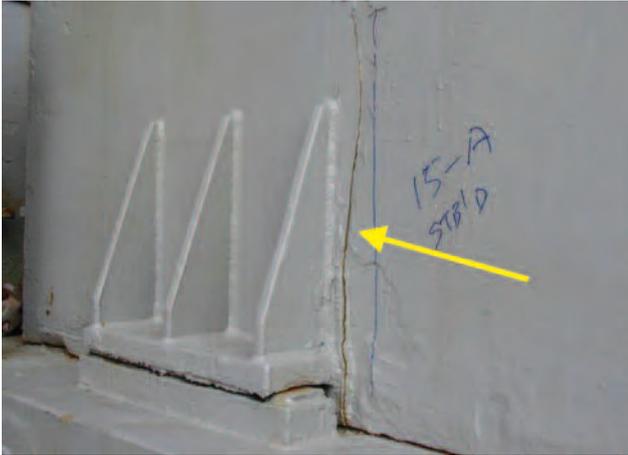
**Improper repairs to bearing pad and a crack developing in the hatch panel side plating due to advanced bearing pad wear**

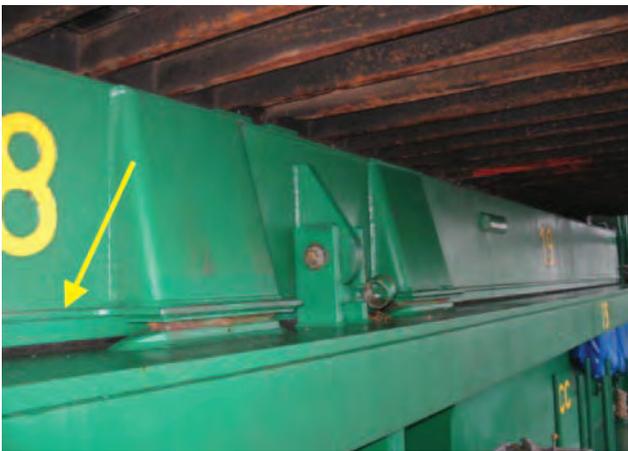
On hatch covers that are equipped with bearing pads, an operational clearance in range of 10-15 mm will generally be present between the panel side lower edge and coaming. The exact distance should be checked with the manual and clearly noted on inspection sheets as it is one of the first indicators of bearing pad wear down.

**Operational clearance between the lower edge of the panel side plating and the coaming table**

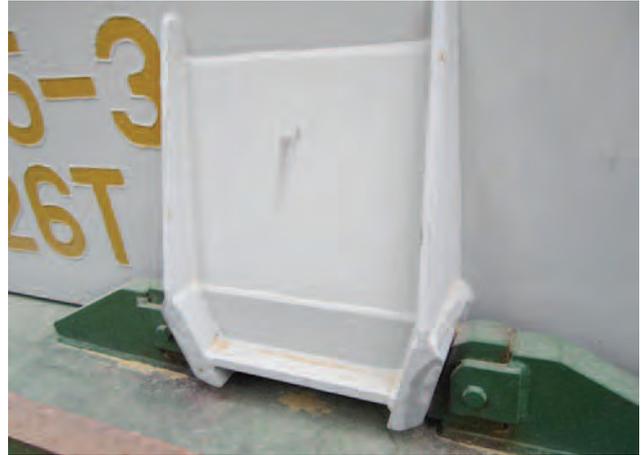
**Properly maintained and adjusted locator**

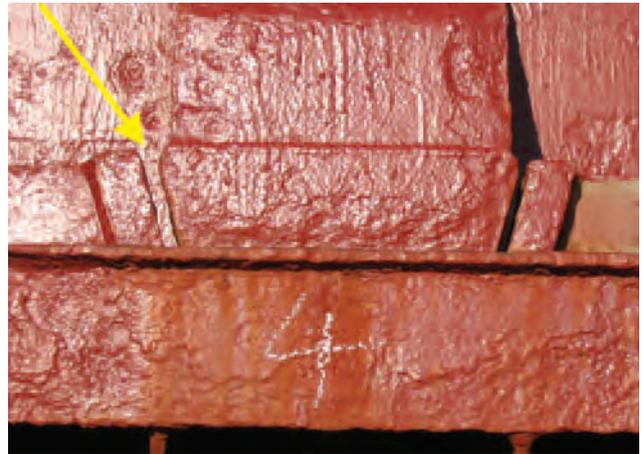
**Excessive wear on locator**

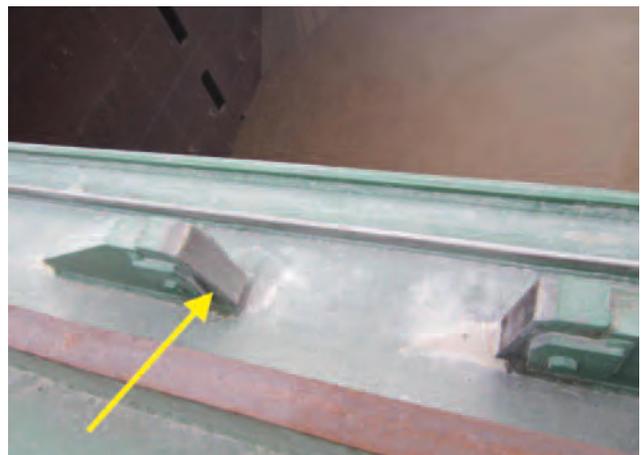
More recent designs of locators have replaceable mating surfaces and allow for the use of shim plates, which facilitates installation and adjustment in case of wear down.

**Replaceable locator pads**

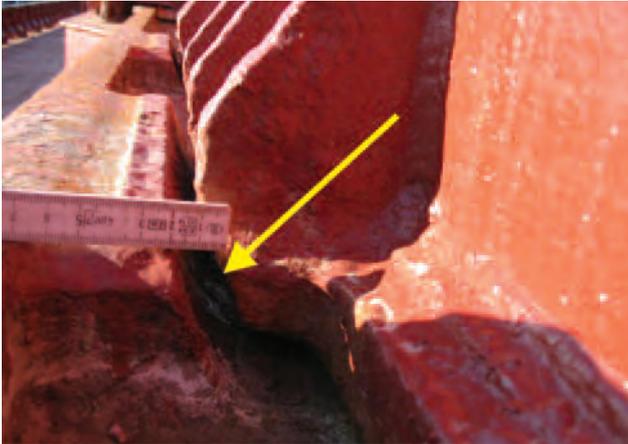
**Excessive clearance in way of stoppers**

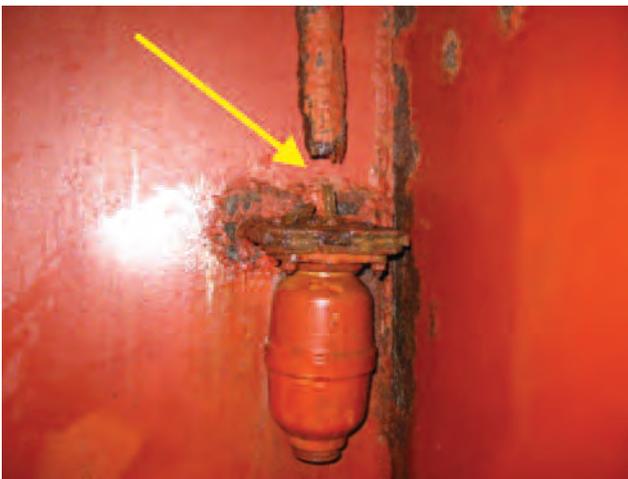
**Corrosion wasted drainpipe**

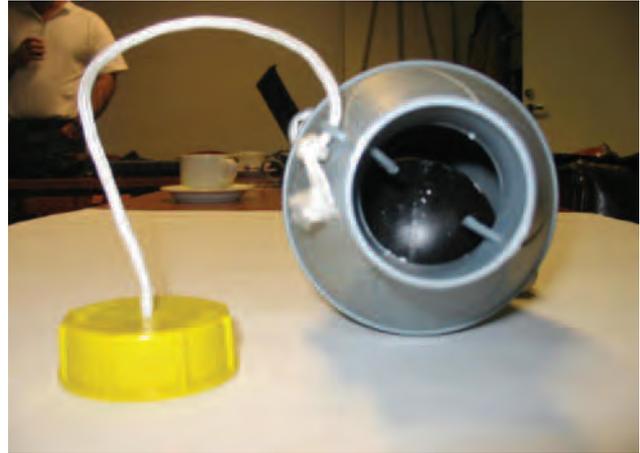
Also, in heavy weather, with waves crashing over the deck and hatches, there is a risk that water will be pushed into the drain pipe and infiltrate the hold, causing wetting damage to the cargo. To prevent this from happening, drain valves should be equipped with a non-return system that needs to be checked and maintained.

**Drain valve with ball inside acting as non-return system**

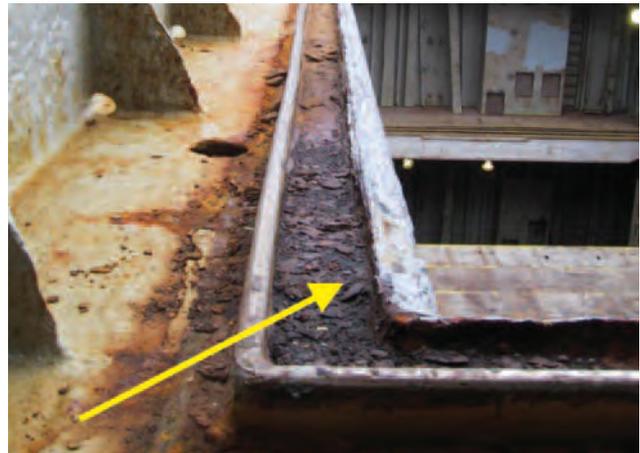
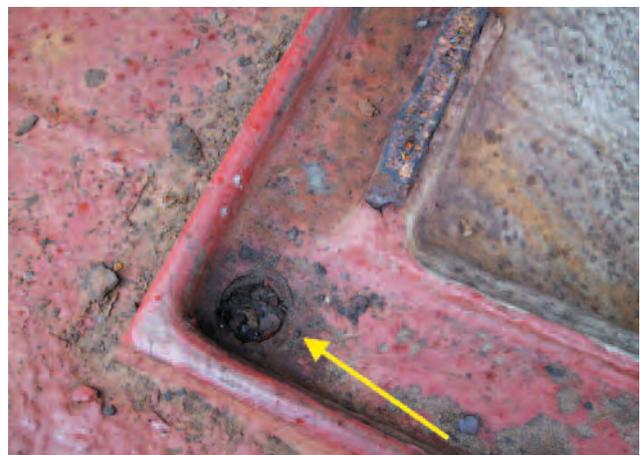
**Presence of rust and debris will eventually lead to the clogging of the drain hole/drain pipe**

Proper maintenance should include regular cleaning of the drain channels (as well as drain holes, drain pipes and drain valves), especially after completion of cargo operations when spilled cargo may have accumulated in the drain channels and drain pipes.

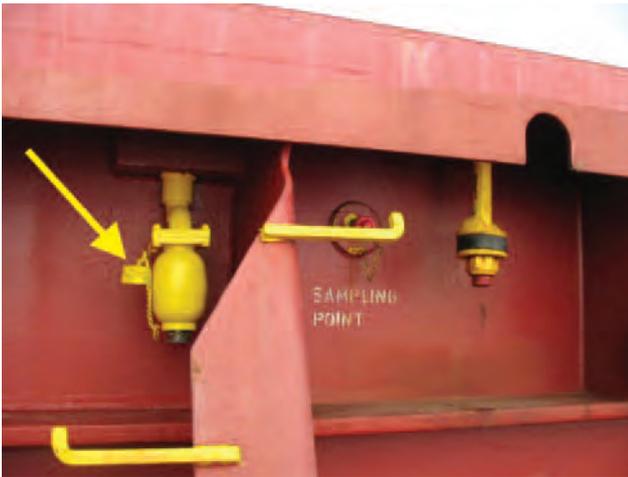
Finally, in order to keep extinguishing gas (CO<sub>2</sub>) in the hold and/or prevent outside air from entering in case of a cargo hold fire, drain valves should be fitted with so-called "fire caps", which allow the drains to be closed off. Also, in case of fumigation, these caps should be fitted in order to seal off the cargo compartments.

Drain valve (yellow) with threaded fire cap firmly connected by a lanyard

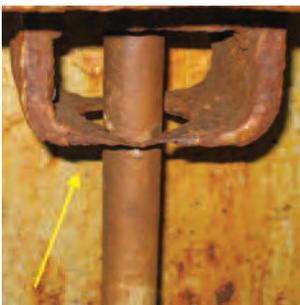
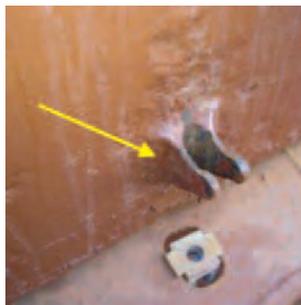
Corrosion and diminution of a quick acting cleat crutch and thinned down snugs

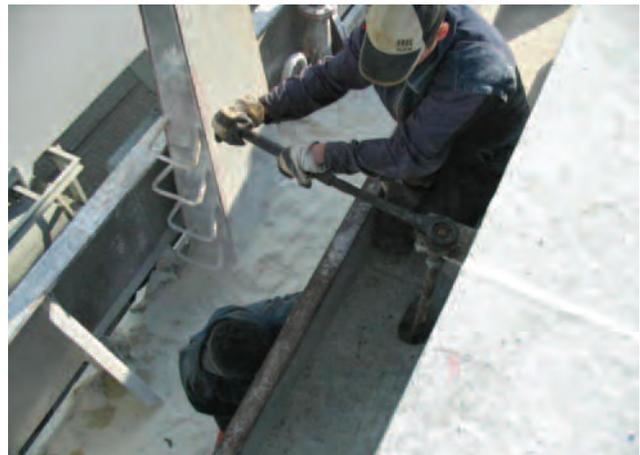
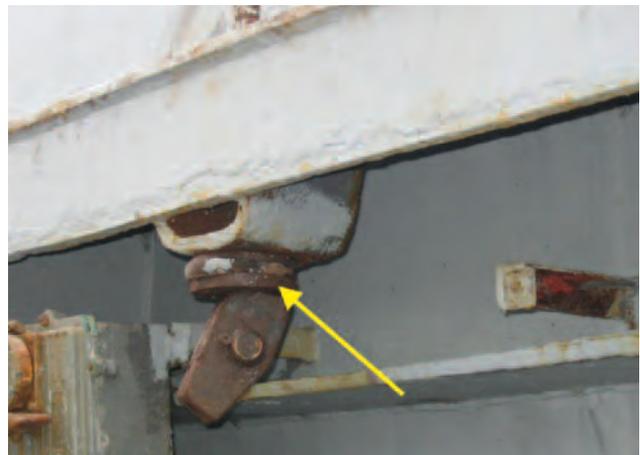
The primary function of the cleats is to hold the panels down when the ship is at sea. However, as there will be relative movement between the panels and coaming, cleats should also cater for some movement. In many cases where ships fail an ultrasonic or hose test, the crew is seen to tighten up the cleats with spanners, cheater bars, etc. However, it is important to know and understand that cleats should never be overtightened to obtain a tighter seal. Excessive tightening makes the system too rigid and eventually results in the cleats becoming damaged. In view of the steel to steel contact between panels and coaming, it would be impossible to compress the rubber packing further once steel to steel contact has been achieved.

Overtightening of securing arrangements and crew member overtightening cleat with a spanner and cheater bar (top) until the rubber washer is reduced to pancake size (bottom)

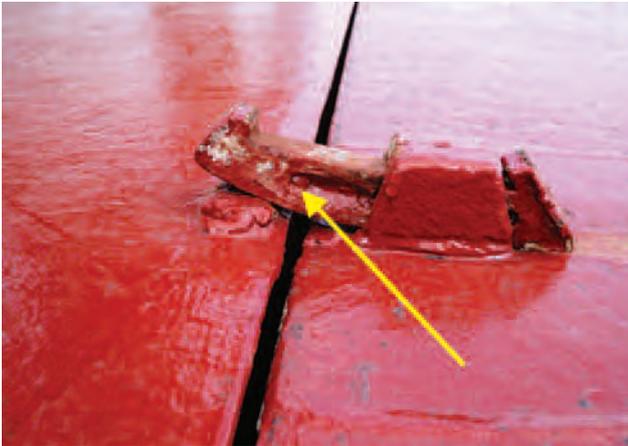
“Banana” shaped cross wedge

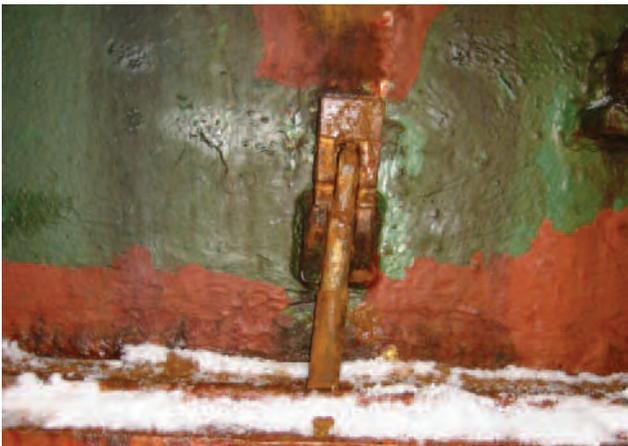
Crooked quick acting cleat (improper vertical alignment)

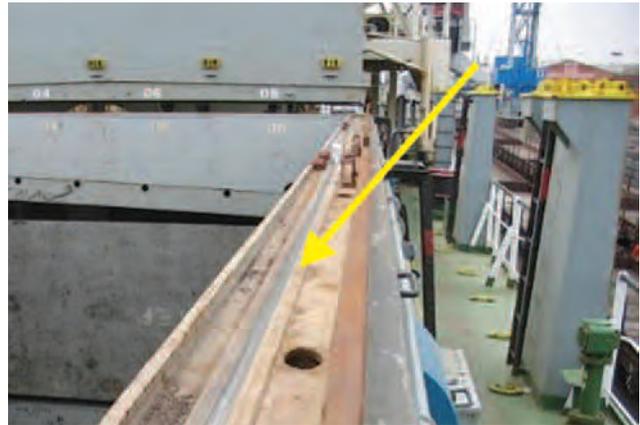
A variety on the traditional compression bars are the flat steel mating surfaces which are used in combination with “sliding” type seals. In many cases the steel coaming plating can act as the mating surface for sliding type seals, however, it is best to weld a stainless steel strip on the coaming table as the smooth surface will contribute to the longevity of the seal during its in-service life.

Stainless steel mating surface for sliding type packing rubber on coaming

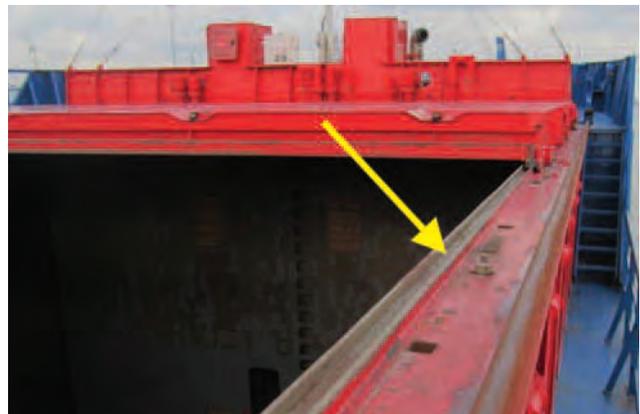
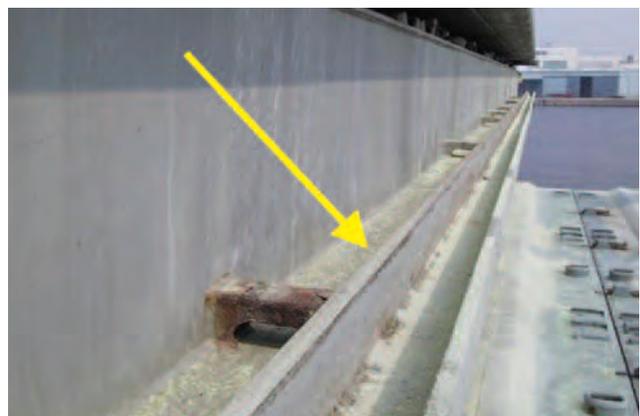
Taking into consideration the compression force that acts on the rubber packing, sharp edges can easily cause damage to the packing rubber. This is the reason why the sealing surface of the compression bars should be round shaped and not square. Replacing damaged sections of compression bars with ordinary steel flat bars (often seen in cases of stevedore damage) should be avoided.

Round shaped (top) and square shaped (bottom) compression bars

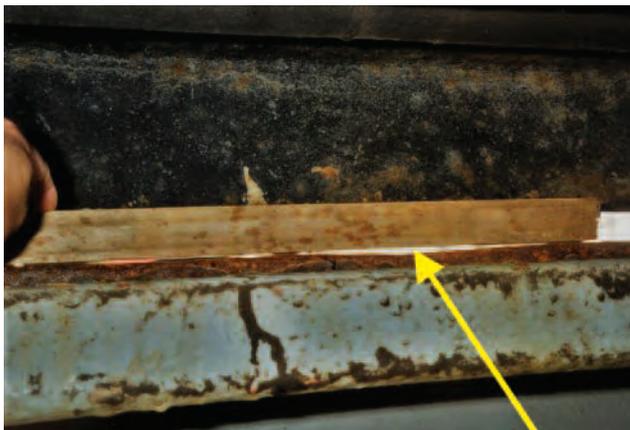
Whilst some limited tolerances are allowed with regards to straightness (these are generally stipulated in the maker's manual), waviness (either + or -) will lead to over or under compression of the seal, both of which should be avoided). Taking into consideration that design compression is a matter of millimetres (generally in the range of 10-12mm), even slight unevenness or waviness by a few millimetres represents a significant percentage of lack of compression or overcompression.

**Compression bar waviness will result in loss of compression**

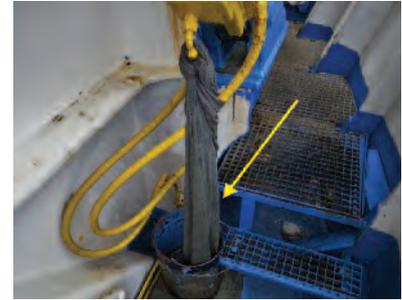
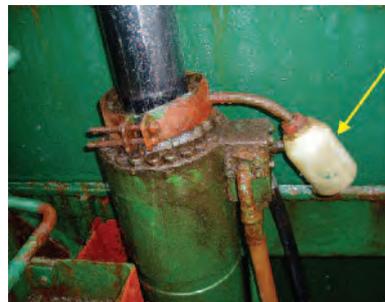
**Temporary repair (rubber patch and jubilee clip) and shipboard made systems to contain hydraulic oil leakage from hydraulic piping and cylinders**

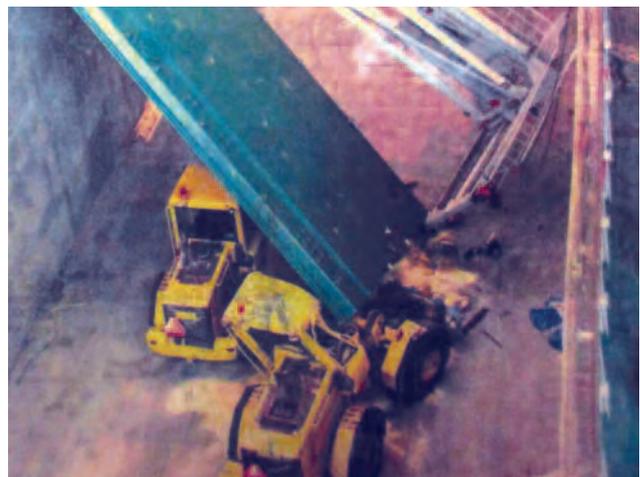
**Improperly maintained or wrongly operated hatch covers can result in serious damages or accidents**

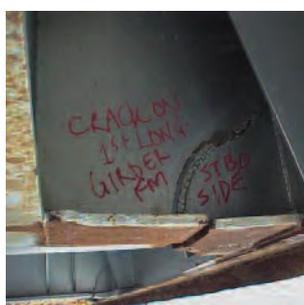
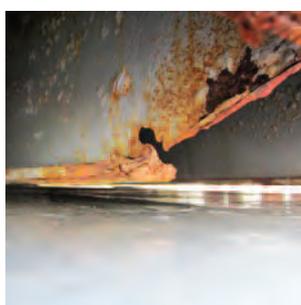
Both advanced corrosion and stress fractures (caused by improper maintenance, improper panel adjustment, bearing pad wear, overloading, heavy weather damage, etc) will affect the structural integrity of the panels. Therefore, the structural condition of the panels should be carefully monitored.

**Cracks and corrosion will affect the panel's structural integrity**

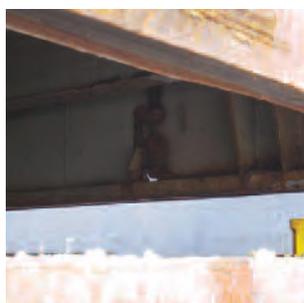
Sometimes panel damage like cracks or holes are repaired with doublers. Whilst doublers might, under certain circumstances, be acceptable as a temporary repair, they are never to be considered as a substitute to a proper insert repair. Doublers will actually cover up damage and prevent water ingress, but they will never restore the original strength or stop the corrosion process. Furthermore, welding work on hatch covers needs to be carried out by trained and qualified personnel as excessive heat during welding might cause distortion of the panel structure, which is very difficult to correct.

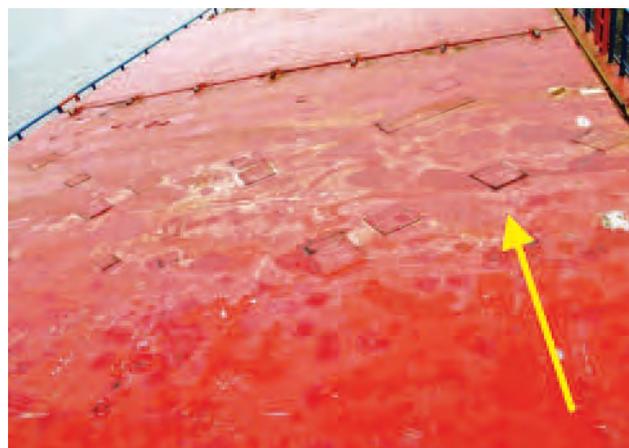
**Multiple doubler plates on the hatch top plating**

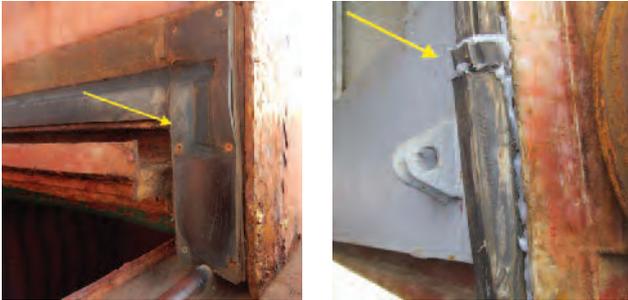
a hatch cover tightness test (which is generally carried out before loading water sensitive cargo). Short rubber packing inserts, applying backing strip on the packing rubber's sealing surface, use of silicon etc are frequently seen and considered as evidence of poor repairs.

**Backing strips (here nailed into the original packing rubber) and short insert repairs are frequently seen as evidence of improper repairs**

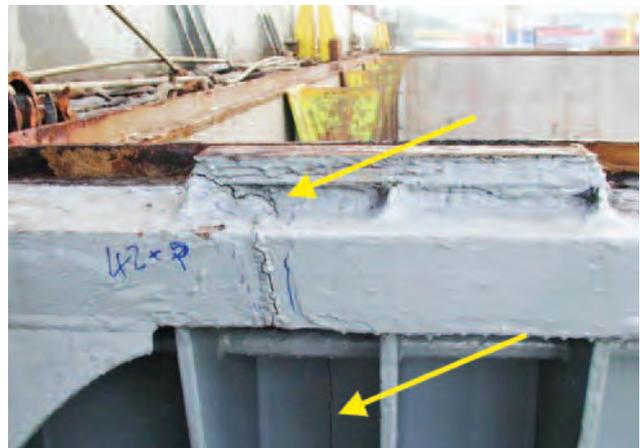
Another important maintenance and inspection related issue is that hatch covers are type approved equipment. Therefore, repairs involving modifications and changes made to the existing design can only be made with the approval of the respective class or flag state. Experience shows that on board repairs to coamings, brackets, panels and supporting structures are not always properly and promptly reported to the classification society or flag state. Apart from the fact that it is a class requirement to be informed of any repairs to structural items carried out on board, the involvement of class is also recommended in order to obtain the correct repair information in line with class rules. Quite often, repairs are made on board with the wrong materials, incompatible steel grades, incorrect spare parts, and this might actually give rise to more serious problems (a well-known problem here is bearing pad repairs with incompatible steel qualities between the stool and landing pads, with the development of cracks in panels and coamings as a result).

**Crack progressing from the landing pad into the coaming**

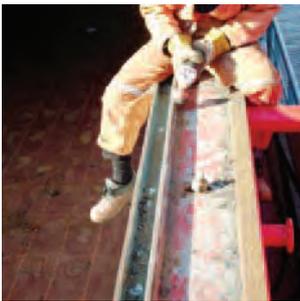
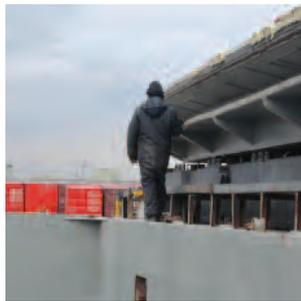
**Bad and dangerous practices (sitting/walking on coaming, putting hand on trackway). Crew should be familiarised with hatch covers, their operation and safety issues**

This is also recognised by the CSWP (2015 edition) where Ch. 16 addresses a wide variety of hatch cover related issues in Ch. 16.2.8 where it is stated that *"All personnel involved with the handling and/or operation of hatch covers should be properly instructed in their handling and operation. All stages of opening or closing hatches should be supervised by a responsible person"*. In practice, however, it is often seen that no proper familiarisation programme that covers hatch cover work is available on board.

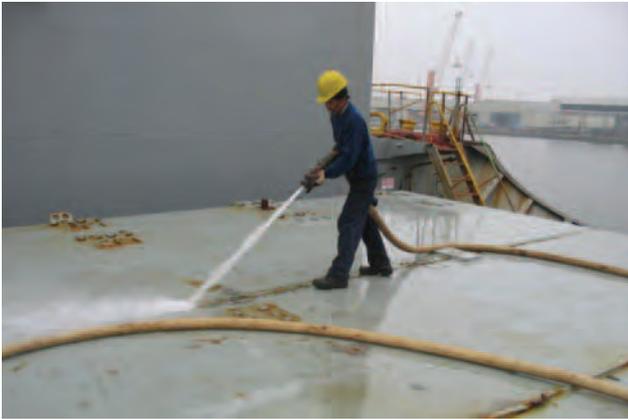
because the space between the top plating of adjacent hatch panels is very small and will cause the jet of water to break apart on top of the panels instead of entering the interpanel void space. In such a case, the absence of water in the hold would not be an indication that the sealing arrangements are in order, but merely the result of lack of water and hydrostatic pressure acting on the seal.

**Strong jet of water being applied to the cross joint**

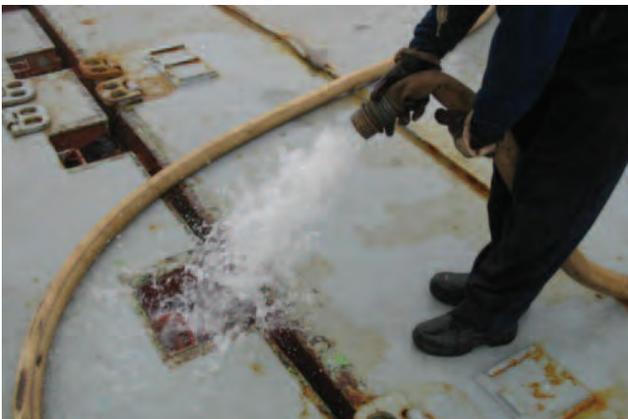
An improved testing method when carrying out hose tests with a view to assessing the integrity of a weathertight system (especially when delicate cargoes are to be loaded) would be to close the panel's side guttering and fill up the cross joint interpanel void spaces with water (with a fire hose without a nozzle, without applying a high pressure jet).

**Filling up of interpanel void space with water from a fire hose without a nozzle**

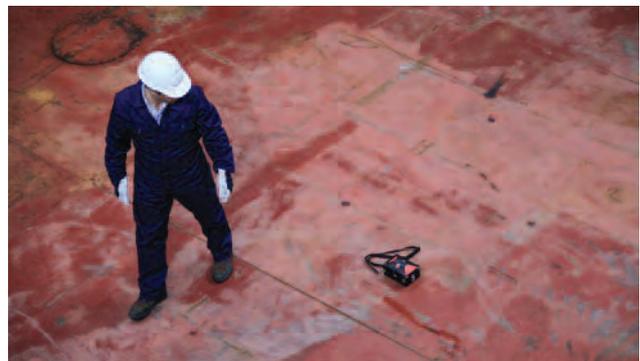
The ultrasound testing principle is quite simple. Ultrasound equipment for hatch cover tightness testing requires a transmitter and a receiver unit. The transmitter emits ultrasound and is placed in the ship's hold.

**Transmitter being placed in the ship's hold**

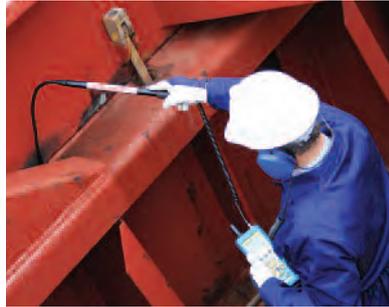
Once the hatch covers are closed, the operator scans the sealing areas of the closed hatch covers (cross joints and perimeter rubber/compression bar interface) with the receiver unit and will detect ultrasound signals that are passing through the seal with pin point accuracy, which allows for quick and easy detection of leaky areas.

Ultrasound testing is based on the characteristics of a piezo electrical crystal, which vibrates when subject to an electrical current and which, when squeezed, discharges an electrical current, which can easily be measured.

As such, we are able to measure the strength of an ultrasound signal, a signal that would not be heard by the human ear (if it was not heterodyned). Following the above logic, a small leak will only allow a small amount of ultrasound to escape and hit the receiver's sensor, which will result in a small electrical current being discharged, resulting in a low measurement, which is an indication of a small leak. In case of a big leak, a "cloud" or "beam" of ultrasound will hit the receiver's sensor and cause a significant electrical discharge, resulting in a high measurement that indicates a big leak.

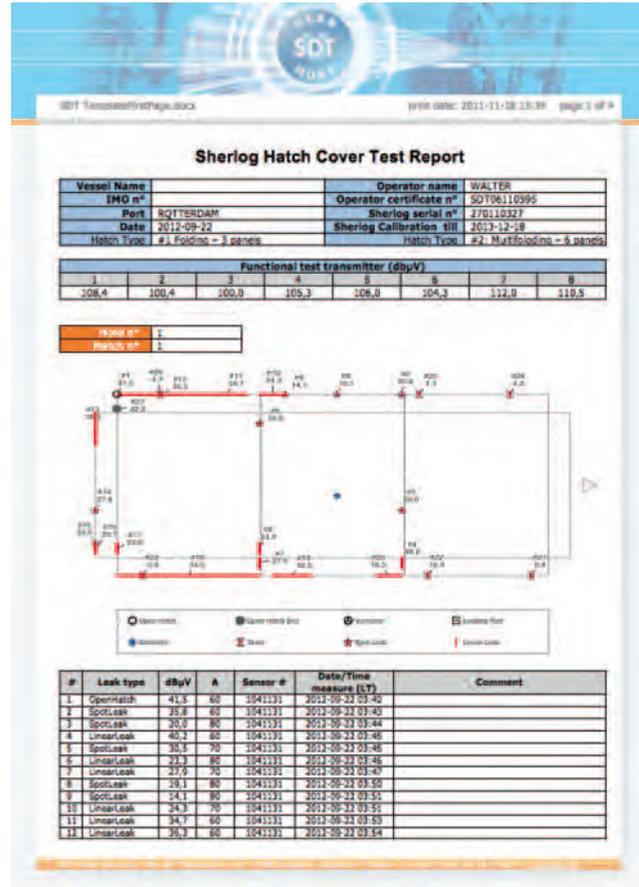
The biggest advantage of ultrasound testing is that the test results give an indication of not only the contact with the packing rubber, but also the compression of it. If compression is good, then we know that the packing rubber has sufficient compression force, which means that the rubber packing will be able to compensate for relative movements and, as such, provide a tight seal. The fact that we can find out whether the rubber will perform well at sea whilst the ship is still in port provides extra safety. Moreover, in hatch cover tightness, compression is the governing factor and not contact.

### Typical example of a hatch cover test report

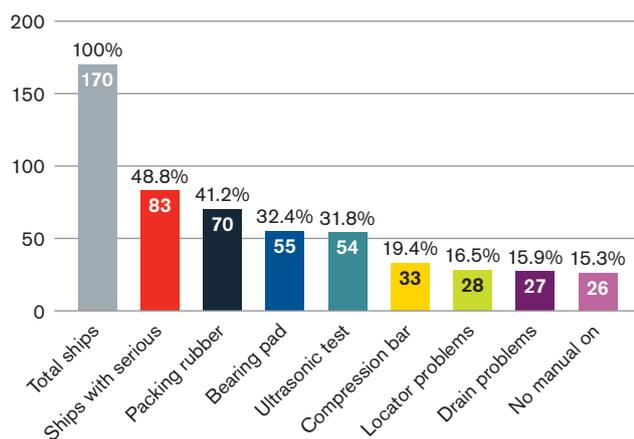
#### Main hatch cover problems in numbers and %
