2019 Best Practices for Operations of Ballast Water Management Systems Report

American Bureau of Shipping
Advisory Services

Date: 18 March 2019

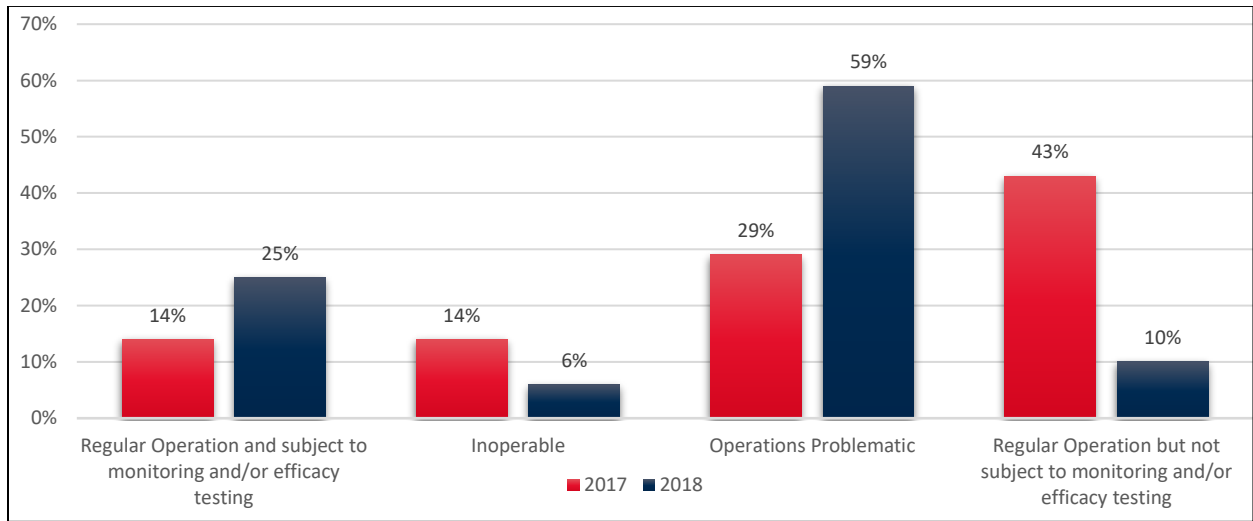
Figure 7 BWMS Operability (2017 vs 2018)

The survey findings represented in Figure 7 below show that the number of problematic BWMS in operation increased from 29% in 2017 to 59% in 2018. This implies that many vessel operators are trying to get their BWMS fully functional and into operation before the U.S. Coast Guard or IMO compliance deadlines.
