Pilot Ladder Safety

Part 1: Poor pilot ladder condition

GOOD CATCH from **The American Club**

Pilot Ladder Safety Part 2: Retrieval lines

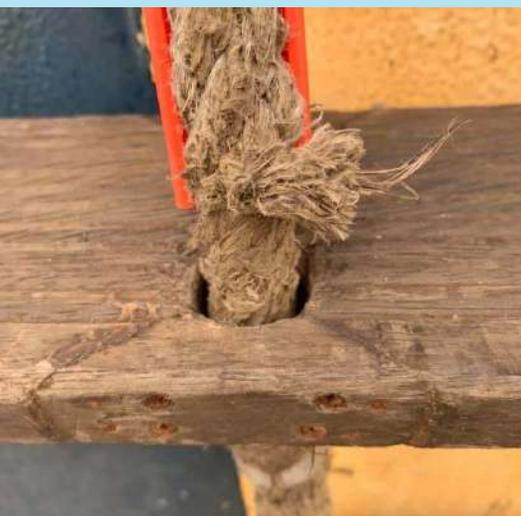
Worn and frayed side rope at pilot step.

Before every use, and before every rigging of a pilot ladder, attention is to be paid by the responsible officer to the overall condition of the pilot ladder. Due to the work pressure on ship's crews, the condition of the pilot ladder can be overlooked and loose or missing chocks, dirty ropes and steps, even damaged steps are found in some cases.

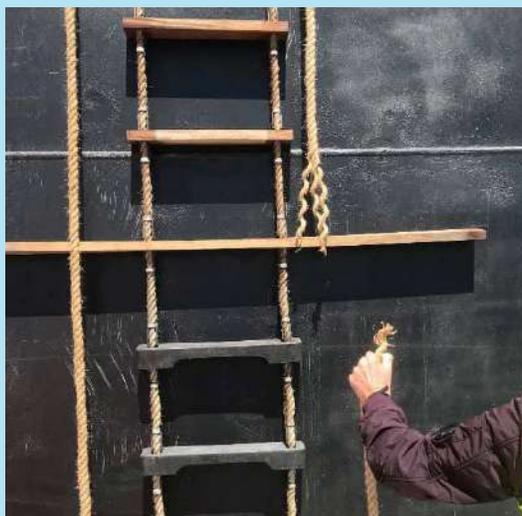
Frayed and broken man-rope.

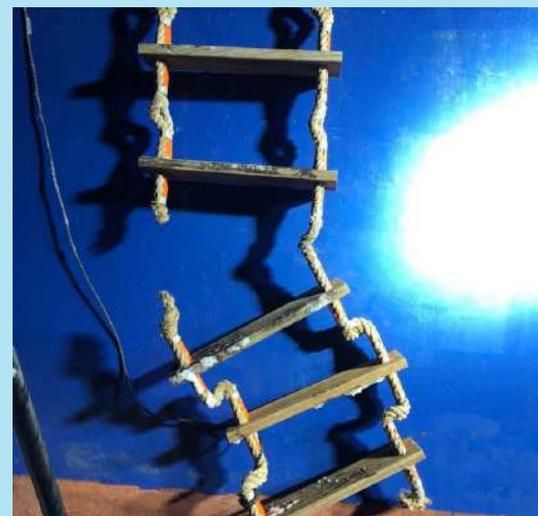
A broken side rope. Periodic visual inspection are imperative.

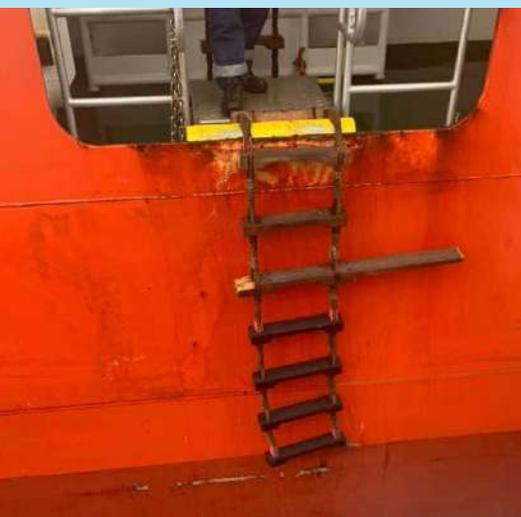
Exposure of pilot ladders to sea conditions and regular handling of the equipment lead to broken wooden spreaders.

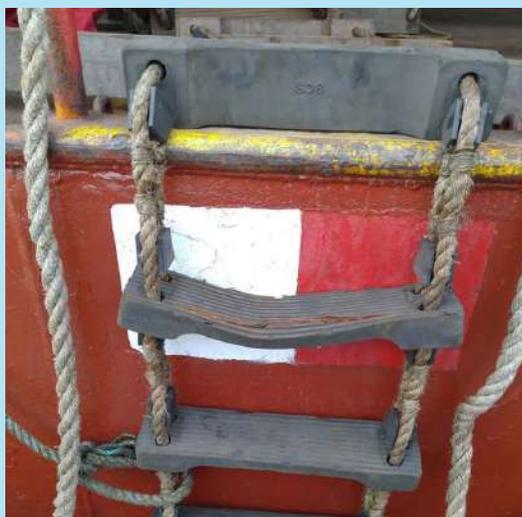
These pilot steps have seen many feet cross them and should be replaced.

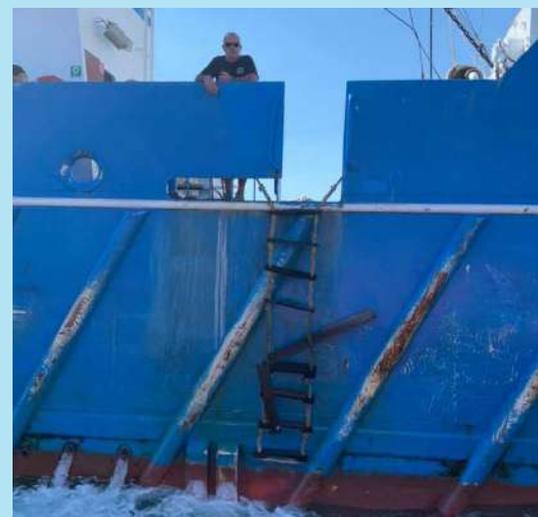
This is not exactly what a pilot is happy to see if they come to board your vessel.

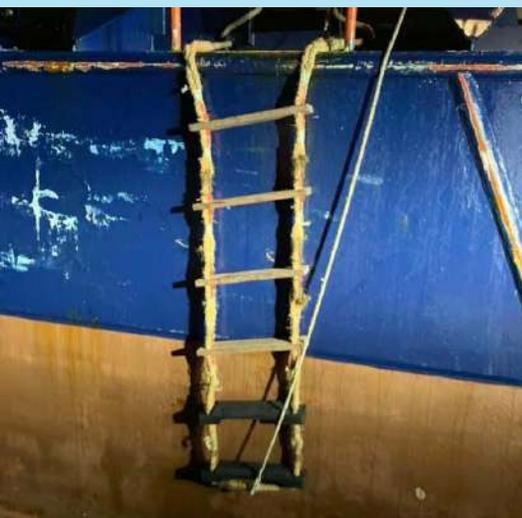
This ladder is not classified as a pilot ladder, since it has no spreaders and four rubber steps. The retrieval line is in the way of the steps.

International Maritime Organization Assembly Resolution A.1045(27), Recommendations on Pilot Transfer Arrangements, paragraph 2.1.5 recommends that when a retrieval line is considered necessary to ensure the safe rigging of a pilot ladder, the line should be fastened at or above the last spreader step and should lead forward. The retrieval line should not hinder the pilot nor obstruct the safe approach of the pilot boat.

The reason for this is very simple: A retrieval line suspended under the bottom spreader can easily get caught in the fenders or bollards of the pilot boat, or the pilot's leg can get entangled in it. Ensure the retrieval line is correctly rigged every time as the pilot's safety is dependent upon it.

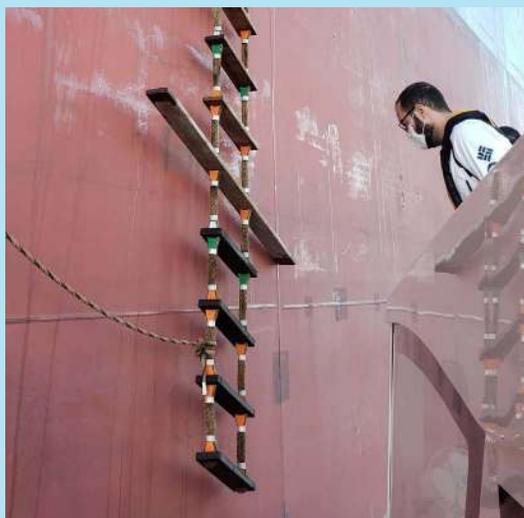
A pilot ladder in excellent condition, but the location of the retrieval line on this long pilot ladder does not seem fixed for ease of retrieval by the crew.

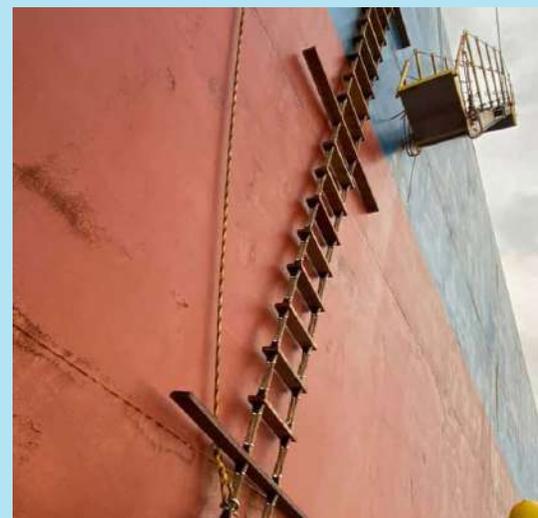
Although this retrieval line seems not be in a position that would increase risk of entanglement, it has been affixed at least two meters above where it should have been affixed.

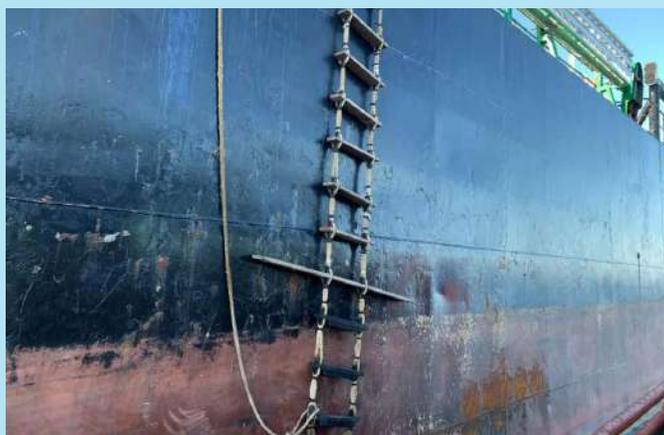
This slack retrieval line could be a source of trouble for a pilot in heavier seas.

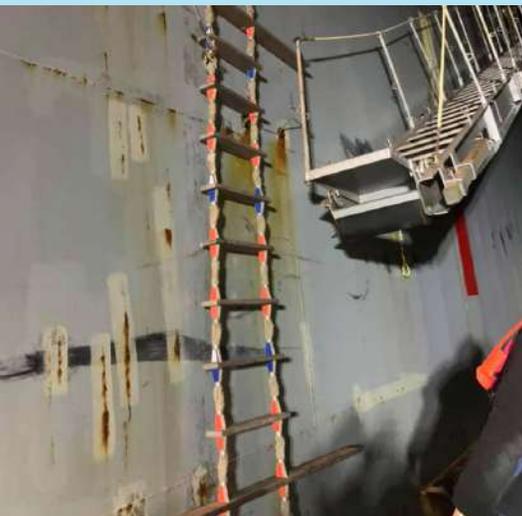
The lower platform of the accommodation ladder is less than 16 feet (5 meters) above the waterline.

When the vertical freeboard to the water level is more than 30 feet (9 meters), a combination ladder arrangement, consisting of a pilot ladder and an accommodation ladder at the same time, is normally used. The reason for this is that a fall from more than 30 feet (9 meters) into the water is considered mortal. There are many things to keep in mind when rigging a combination ladder, all of which can be found on the International Maritime Organization/ International Maritime Pilots' Association poster, [Required Boarding Arrangements for Pilots](#).

- a. the platform is less than 16 feet (5 meters) over the water;
- b. the platform is not horizontal;
- c. the pilot ladder is not secured to the vessel's side at 5 feet (1.5 meters) above the platform;
- d. the accommodation ladder is not secured to the vessel's side; and
- e. the inner stanchion of the combination ladder is missing.

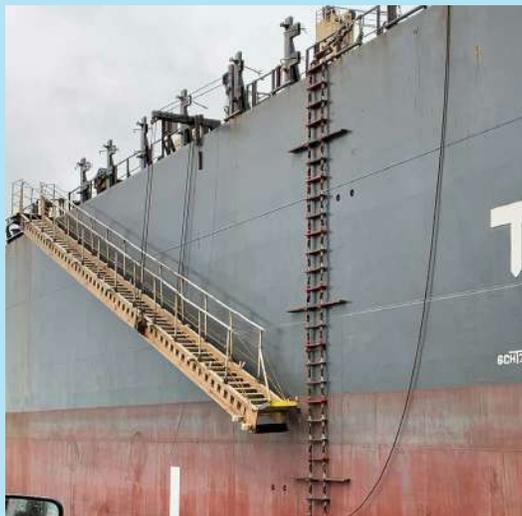
The pilot ladder has not been secured to the ship's side.

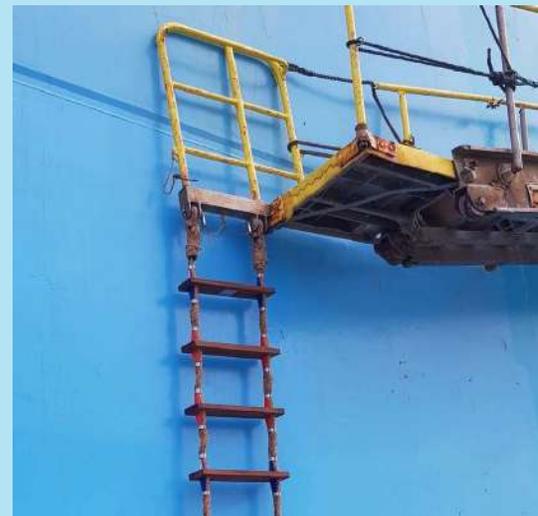
Pilot ladder is to be secured to the ship, not the accommodation ladder.

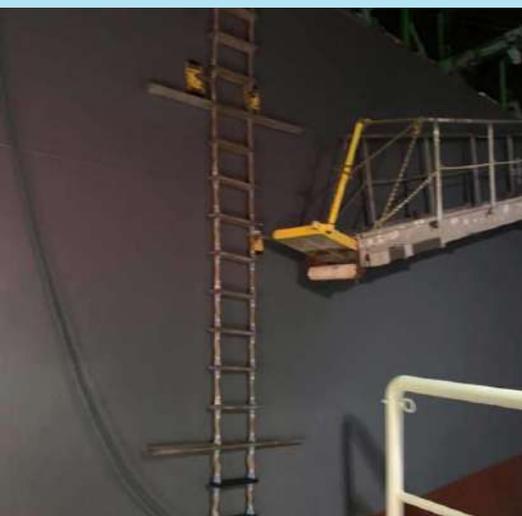
Accommodation ladder's lower platform is not horizontal with waterline.

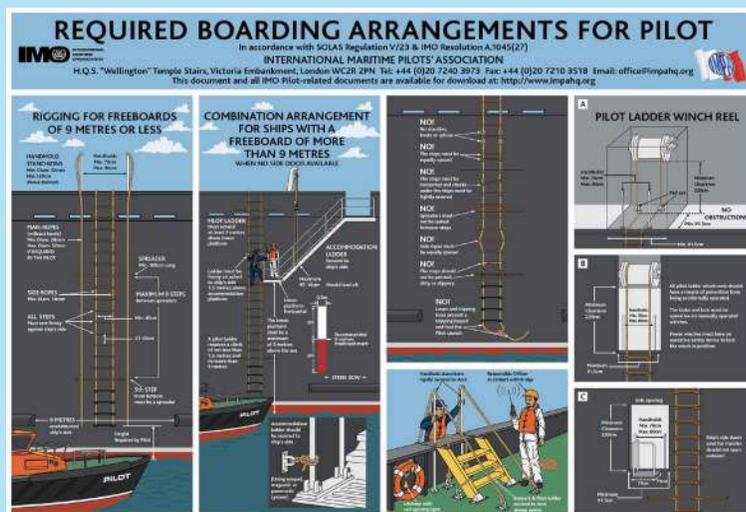
International Maritime Organization/International Maritime Pilots' Association poster, *Required Boarding Arrangements for Pilots*.

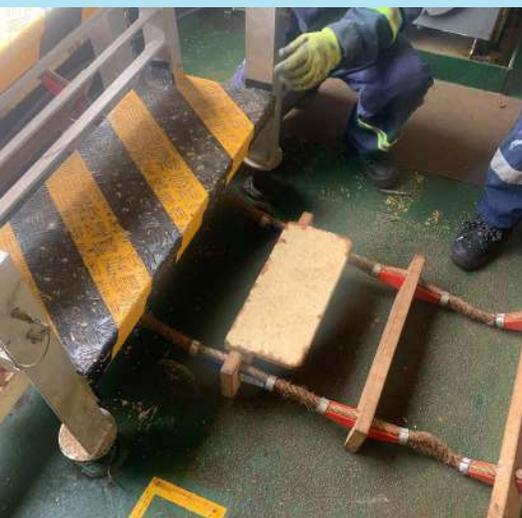
Affixing a deck tongue over a pilot ladder should be avoided as they are not designed to carry the load of the ladder.

To ensure that the pilot ladder is not damaged, no excessive weight should be put on the steps and spreaders as they are not designed to carry such loads. The weight of the ladder should be transferred to fixed strong points on deck by means of the pilot ladder's side ropes. It is recommended to use a rolling hitch knot using ropes of sufficient strength. The use of D shackles and deck tongues can damage pilot ladder's steps. Using steel bars should also be avoided. The use of pilot ladder chocks to secure the pilot ladder should also be avoided.

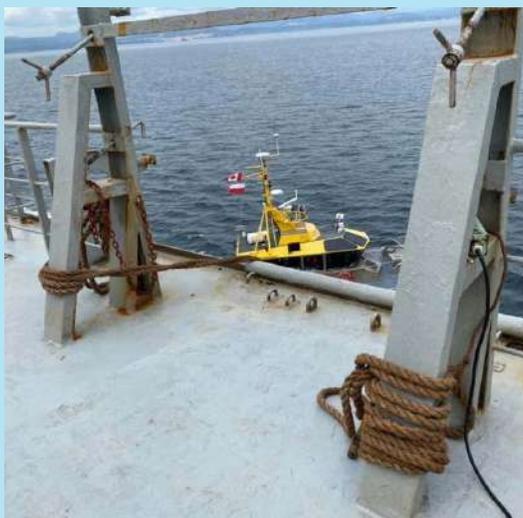
Pilot ladders should never be affixed to non-designated securing points such as seen here.

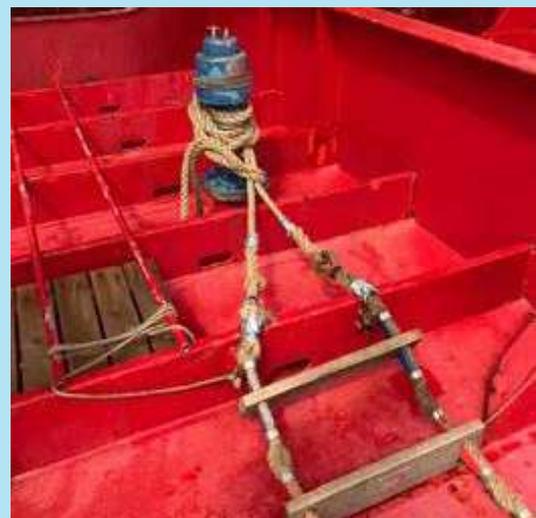
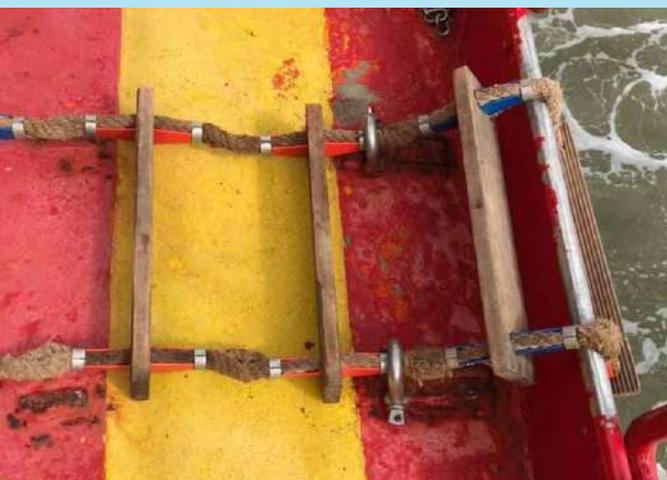
Steel shackles used to secure pilot ladder side ropes should also be avoided as they are not reliable to handle the weight and will damage the chocks.

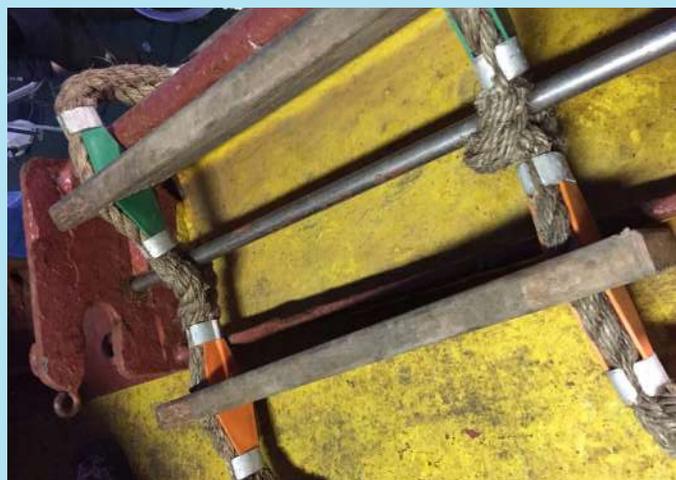
The use of steel bars to secure pilot ladders should also be avoided as they are strung through side ropes the can damage the ropes that are not designed to carry such loads at such points.

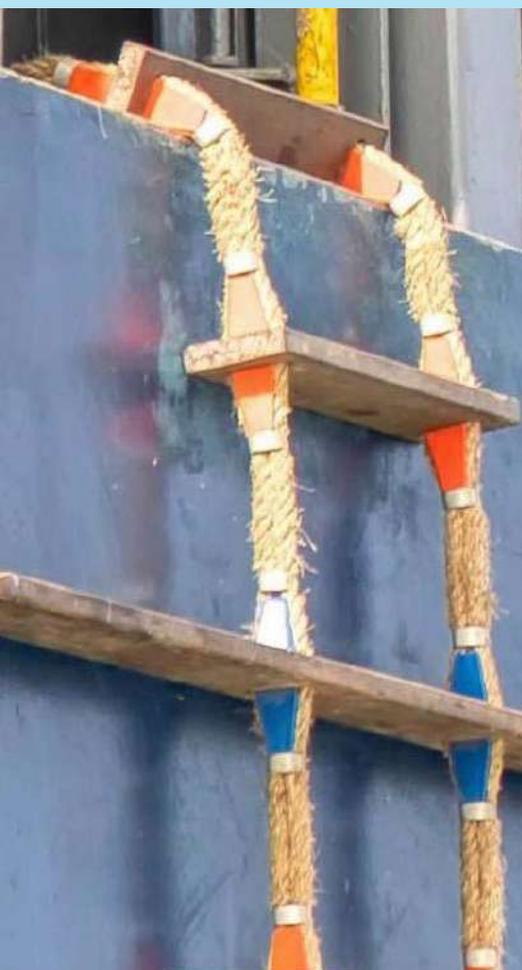
Pilot ladder over the side across a sharp edge.

“Failure by design” is an element of pilot ladder safety that is often beyond the vessel crew's control. A common example of this is the presence of sharp deck edges in and around the pilot's boarding station. It is imperative that crews remain vigilant and watchful of pilot ropes and other parts of the pilot ladder that can be damaged by sharp deck edges where pilot ladders go over the vessel's side. Such events can be injurious or fatal to the pilot or personnel on a pilot boat. A simple way to avoid this is to weld a round pipe over any sharp edges to safeguard the ladder against such damage. This will also avoid excessive wear to the ladder.

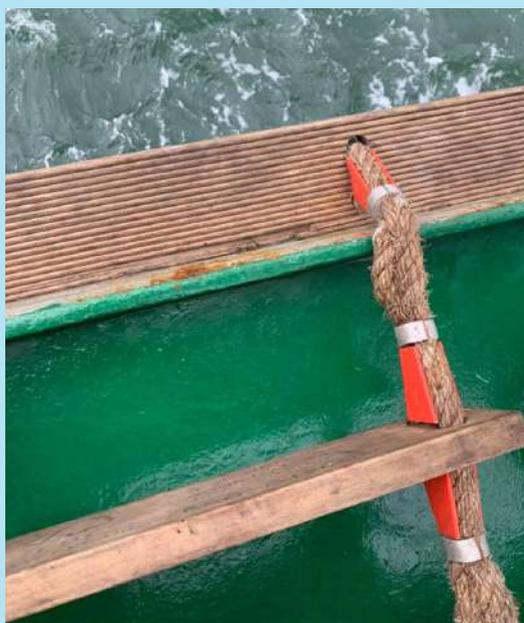
Wear and tear on the pilot ladder rope will occur at a faster rate if no sharp edge protection is in place.

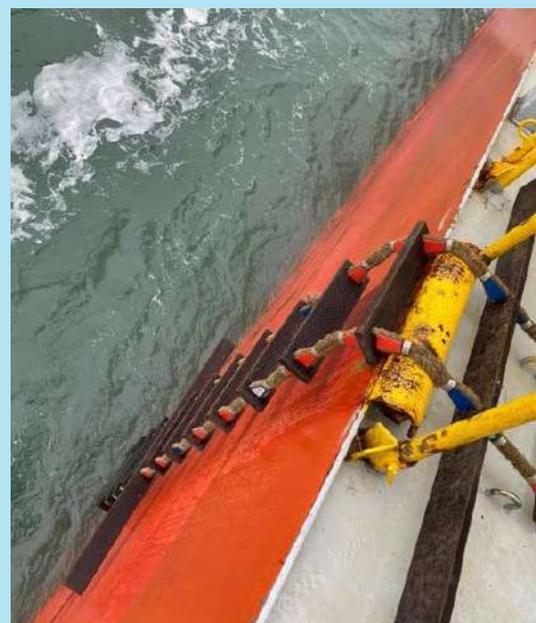
Well designed pilot station with a section of cut steel pipe affixed to ensure pilot ladder goes over a rounded edge.
