Report on the investigation of
the cargo tank explosion and fire
on board the chemical tanker

Stolt Groenland

Ulsan, Republic of Korea

28 September 2019

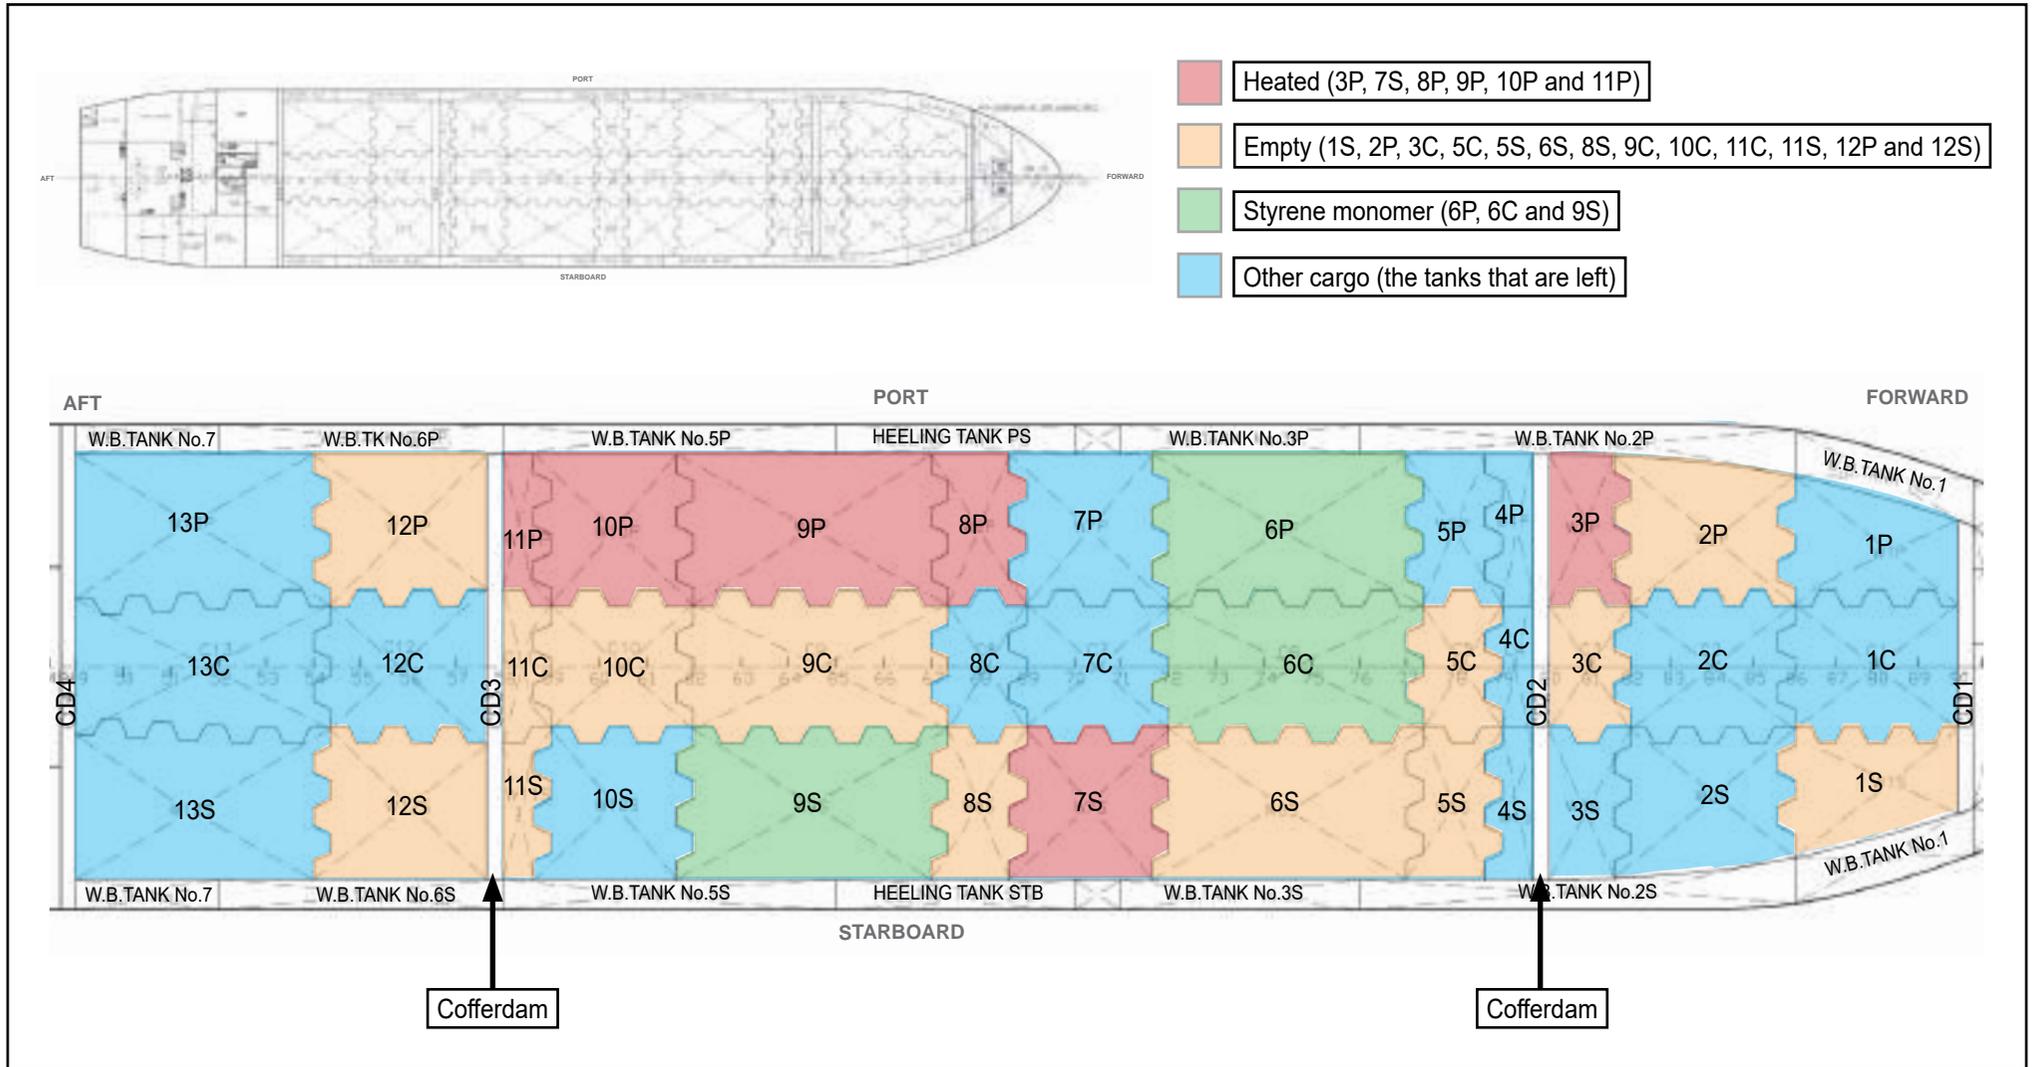
Figure 2: Cargoes remaining following discharge in Ulsan

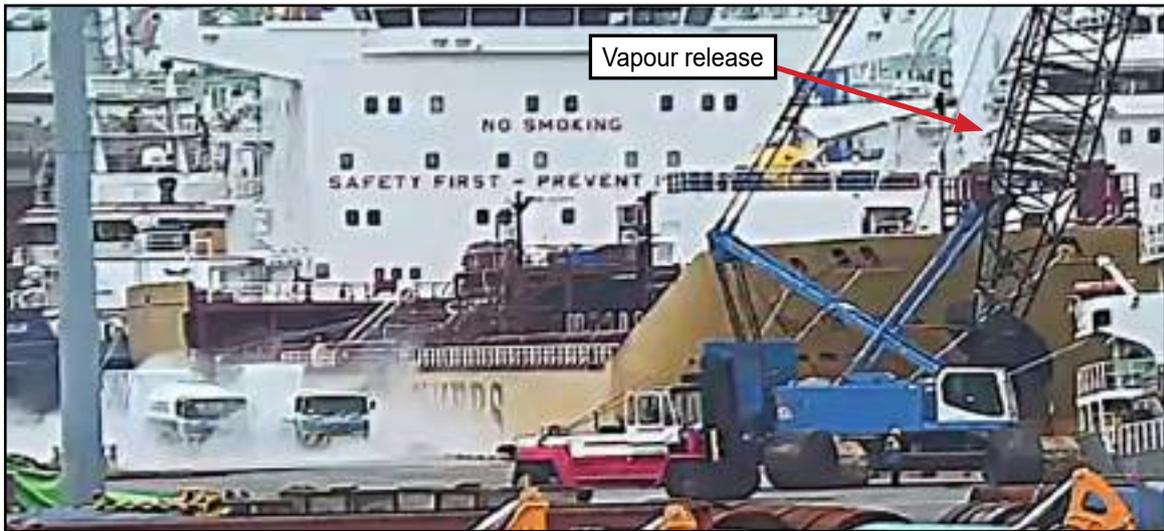
Figure 3: CCTV still showing vapour release from 9S p/v valve

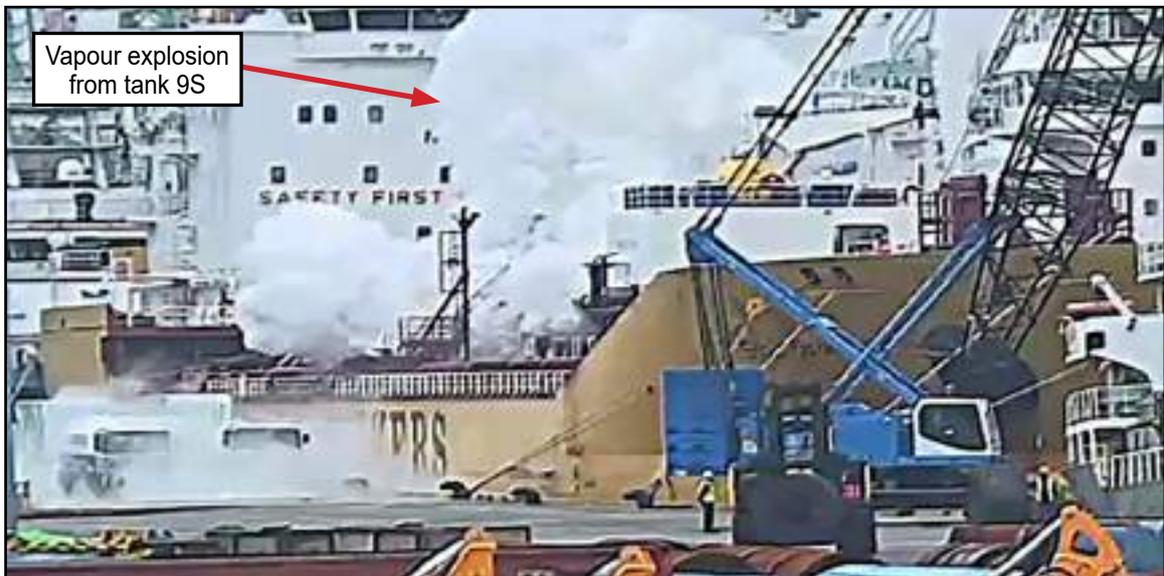
Figure 4: CCTV still showing tank rupture and vapour release

The runaway polymerisation resulted in the rapid volumetric expansion of the styrene monomer, which increased the pressure within 9S at a rate that exceeded the venting capacity of the tank's p/v valve. As a result, the tank ruptured through the main deck and the common bulkhead with the empty cargo tank 9C (**Figures 11 and 12**).

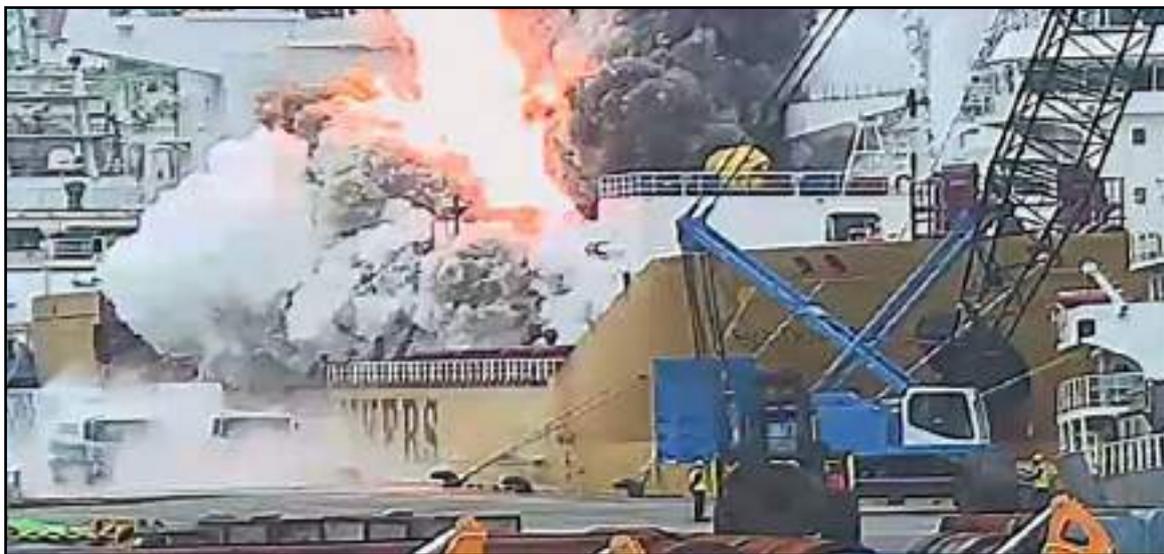
Figure 5: CCTV still showing vapour ignition

The styrene monomer vapour ignited almost immediately following the rupture. As the temperature of the cargo in 9S was well below the auto-ignition point for styrene monomer when the explosion occurred, ignition of the vapour must have been caused by an external source such as sparks created by static electricity or metal to metal contact during tank rupture.

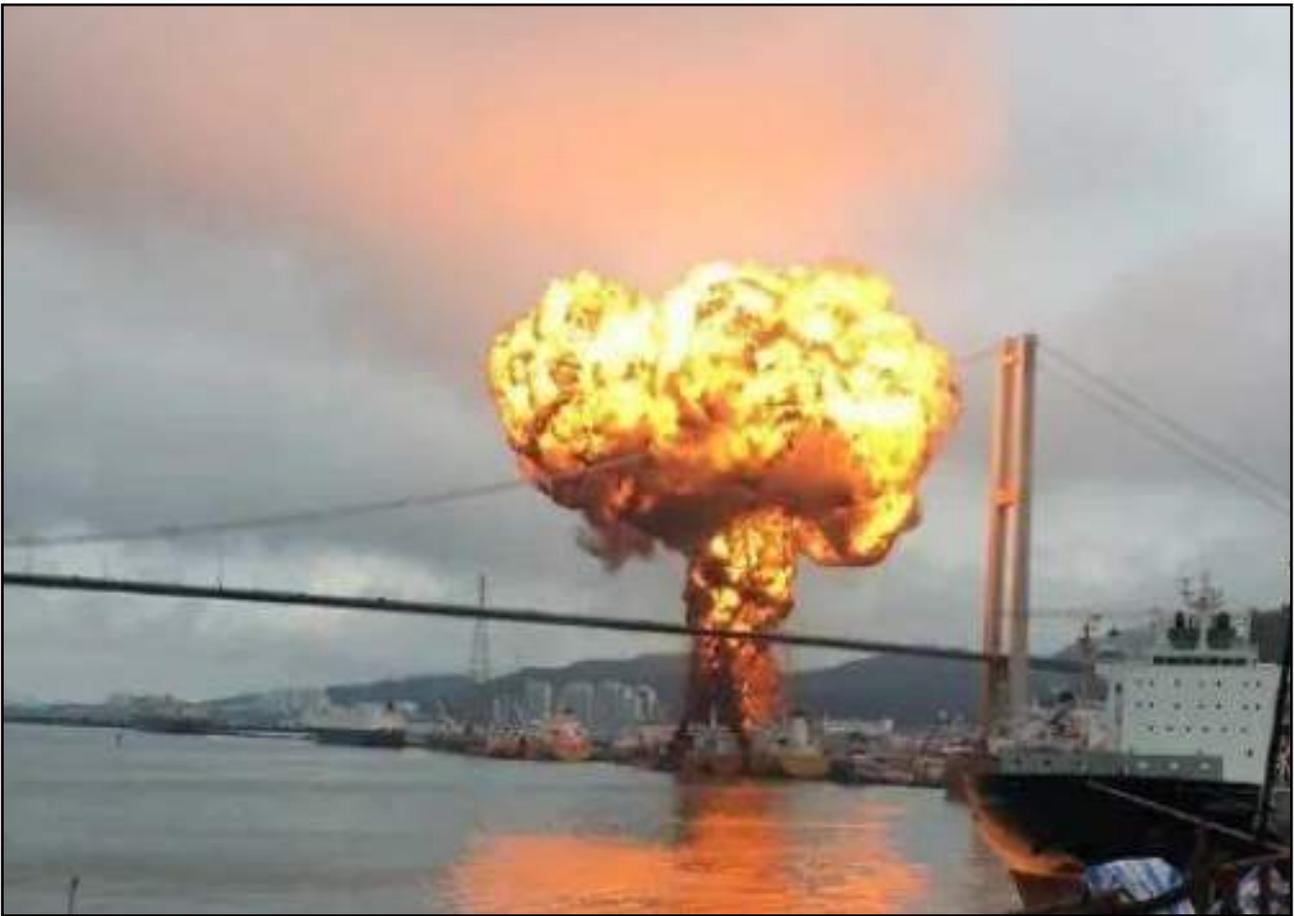
Figure 6: Fireball at Ulsan bridge

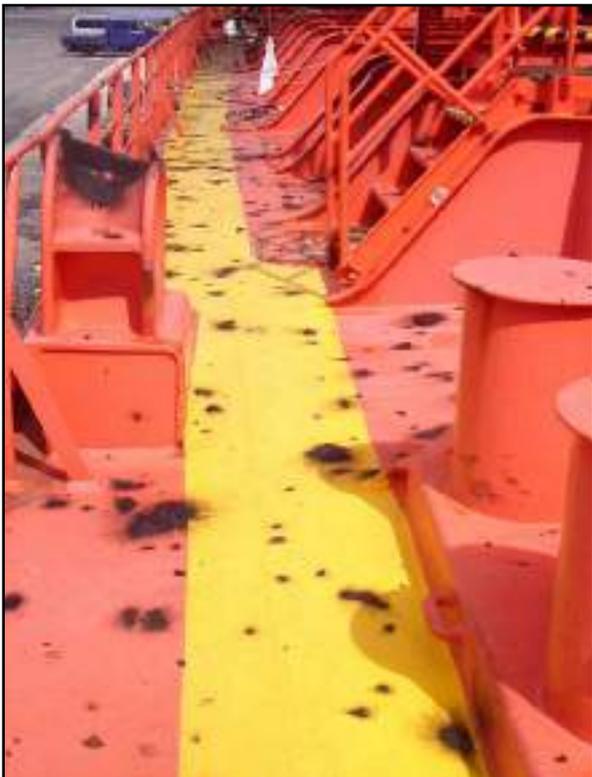
Figure 7: Bow *Dallian* main deck with burned styrene deposits

On 3 October, with the co-operation of *Bow Dalian's* owners and the Transport Safety Investigation Bureau of Singapore, MAIB inspectors and KMST staff visited *Bow Dalian* in Ulsan. The tanker's weather decks and accommodation block were spattered with burned residues (**Figure 7**). A sample of residue (**Figure 8**), and the overalls (**Figure 9**) from a crewman who had been on deck during the period of vapour release from 9S's p/v valve, were removed for analysis (see Section 1.20).

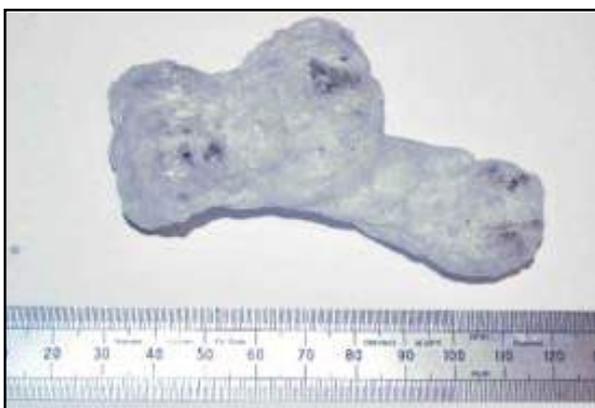
Figure 8: Styrene residue sample

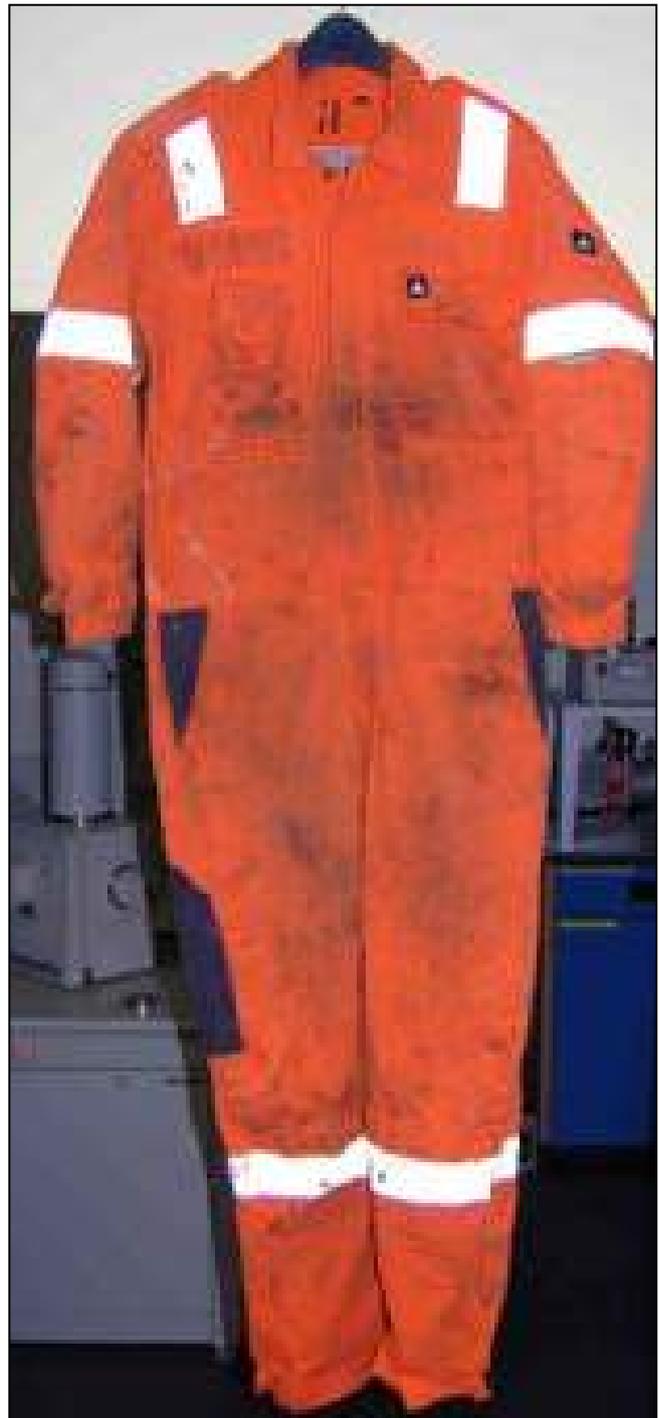
Figure 9: Overalls from *Bow Dallian* crewman

- *Styrene was identified on the overalls. This was observed in all areas but appeared more intense in areas of contamination.*
- *In high contamination areas (contaminated overalls) TBC was identified.*

- *If it is assumed that the styrene contamination of the overalls took place at the same time of the polymerization reaction and explosion was observed, then it can be stated that inhibitor was present, and detectable.*

TBC inhibitor is ineffective below 4ppm and at 40°C this level could be reached within 21 days. The laboratory tests conducted by LPD (Section 1.20) identified traces of TBC on the overalls worn by a crewmember who was working on *Bow Dalian's* deck when vapour from 9S cargo tank was venting from its p/v valve. This suggests that TBC was still present in the styrene monomer at the time of the explosion. However, given the prolonged elevated temperature of the cargo in 9S, it is highly likely that the TBC had become ineffective at some point during the voyage and probably before *Stolt Groenland* arrived at Ulsan.

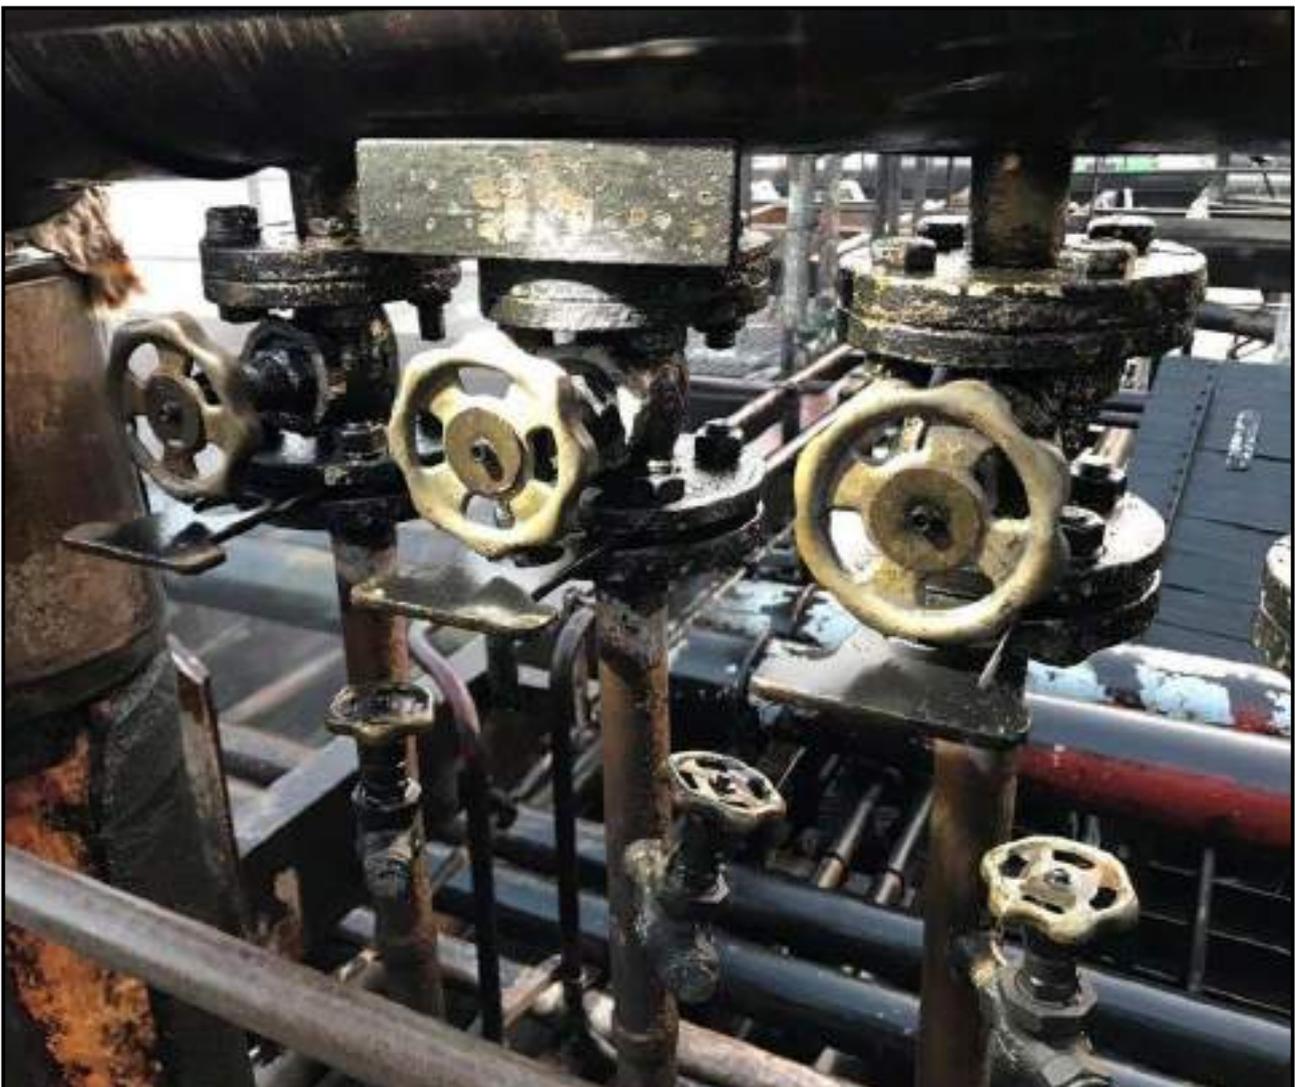
Figure 10: 9S heating control valves

On 7 October, the analysis of samples of styrene monomer taken from *Stolt Groenland's* cargo tanks 6C and 6P indicated that the concentrations of the inhibitor 4-tert-Butylcatechol (TBC) were 8 parts per million (ppm) and 7ppm respectively. The following day, MAIB inspectors were allowed access to the vessel. However, the presence of hazardous chemicals and fire damage limited the inspection to the main deck primarily. A further inspection on 12 November was co-ordinated by the Korea Coast Guard and the KMST. These inspections, and inspections conducted by or on behalf of Stolt, confirmed that the heating coils in 9C and 9S were closed and blanked (**Figure 10**), and that vapours released from the p/v valves for 9S and 9C had ignited.

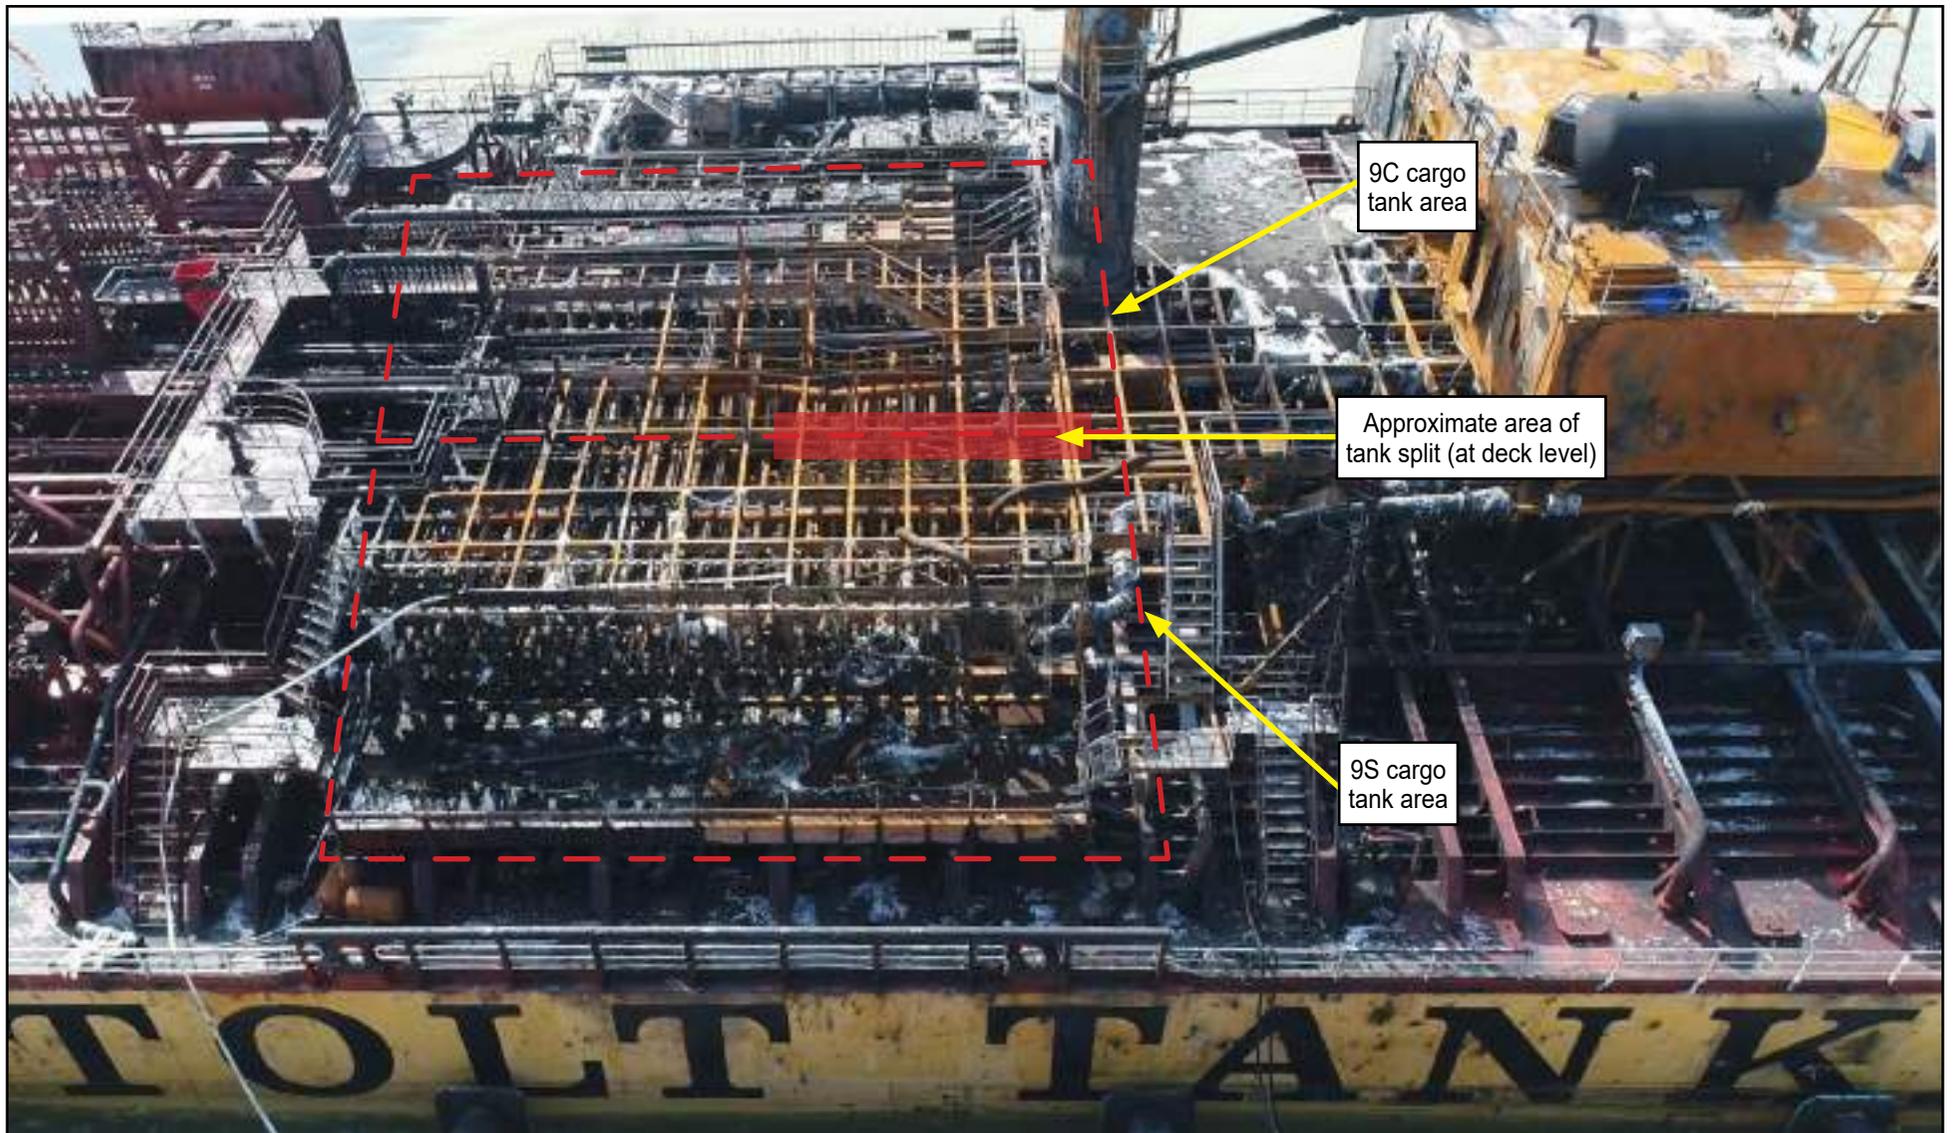
A large hole was found in *Stolt Groenland's* main deck in way of cargo tank 9S and its common bulkhead with cargo tank 9C (**Figures 11 and 12**). The access hatch cover to 9S had also been blown off (**Figure 13**). The manifold area was fire damaged to varying degrees, and the midships deckhouse was burned out (**Figure 14**).

Figure 11: Aerial view of main deck and location of 9S

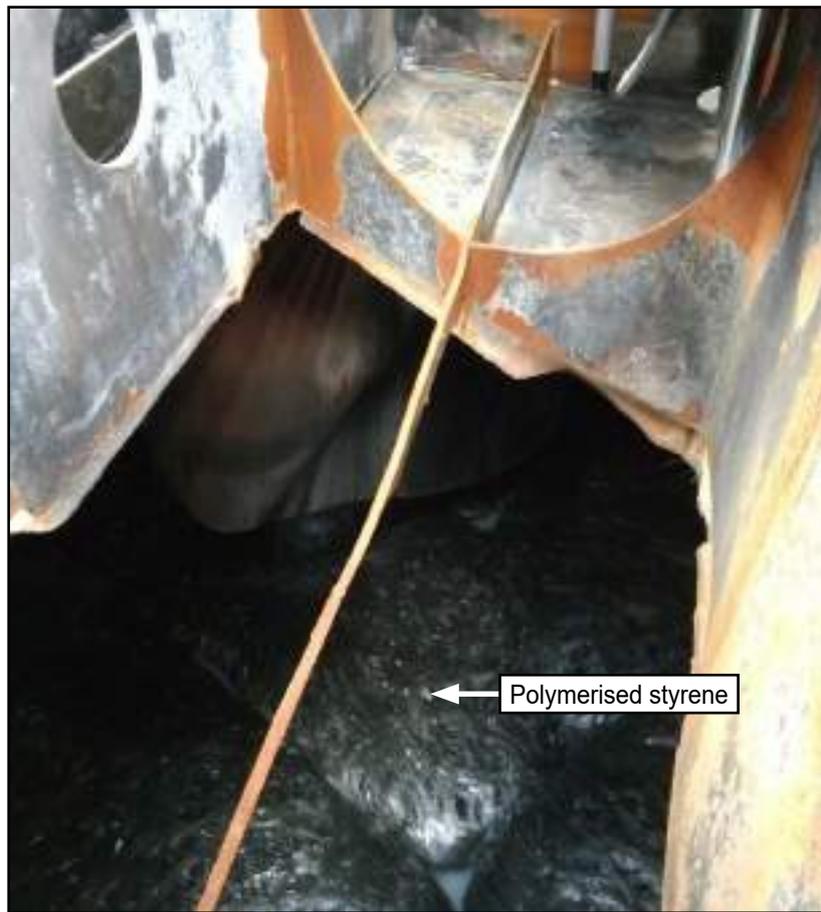
Figure 12: 9S tank rupture

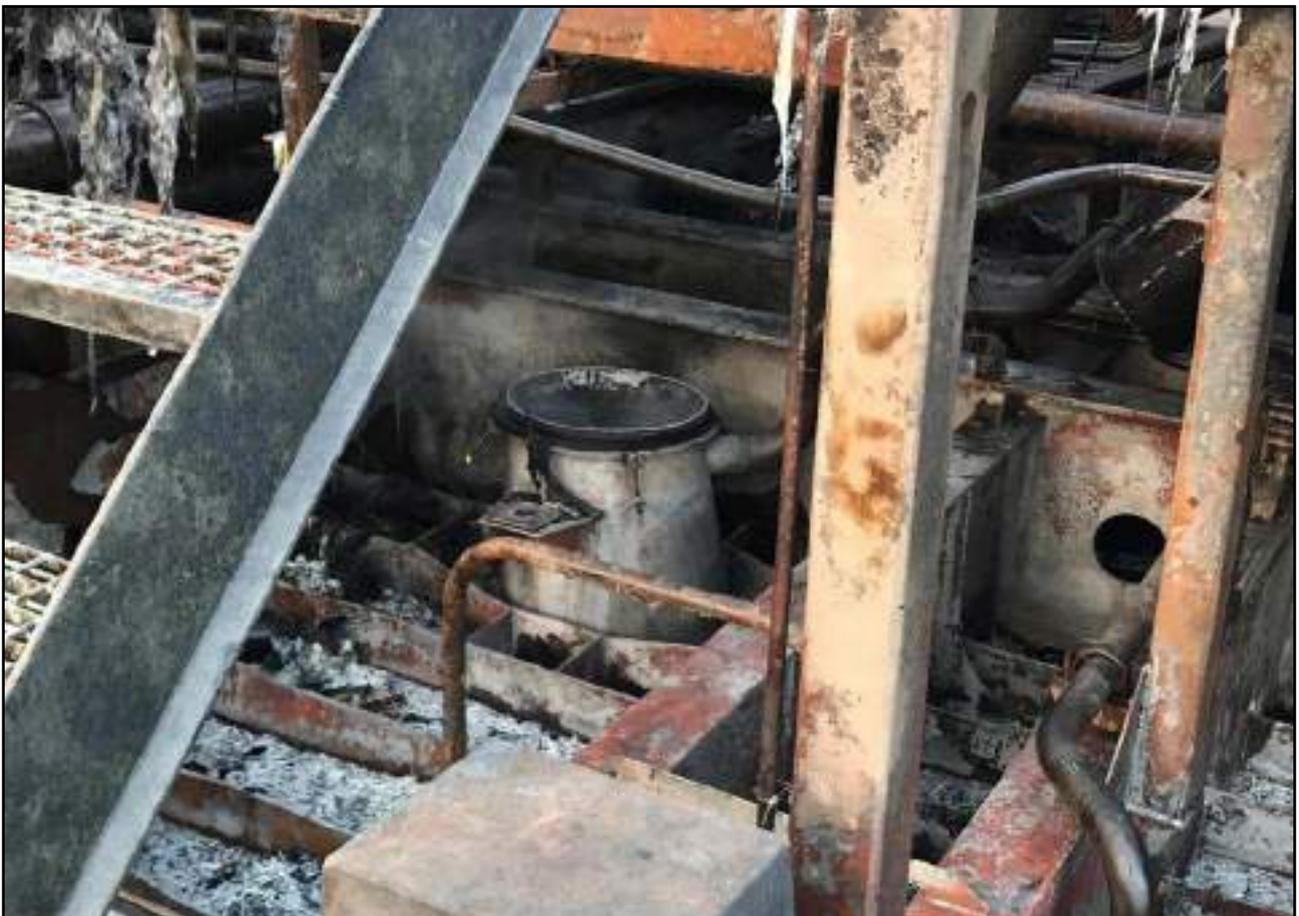
Figure 13: 9S access hatch

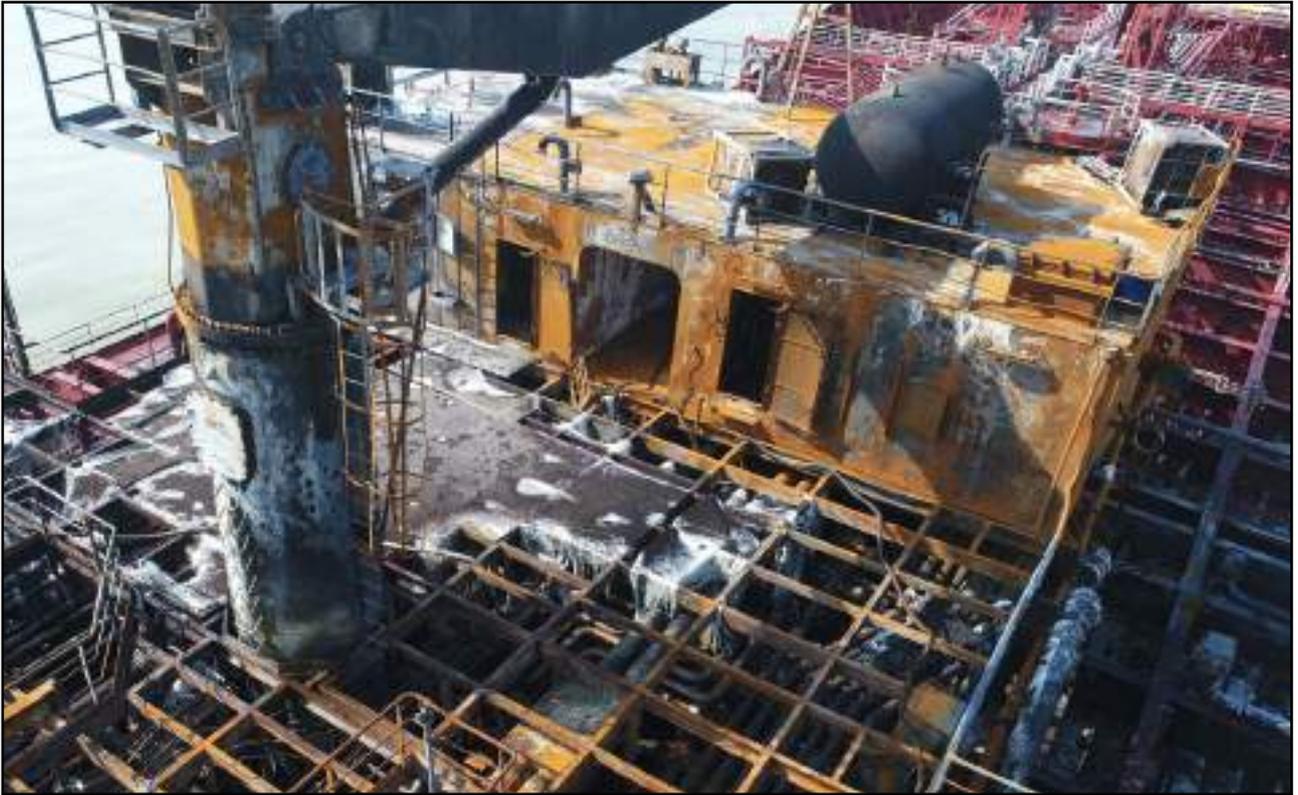
Figure 14: Midships deckhouse

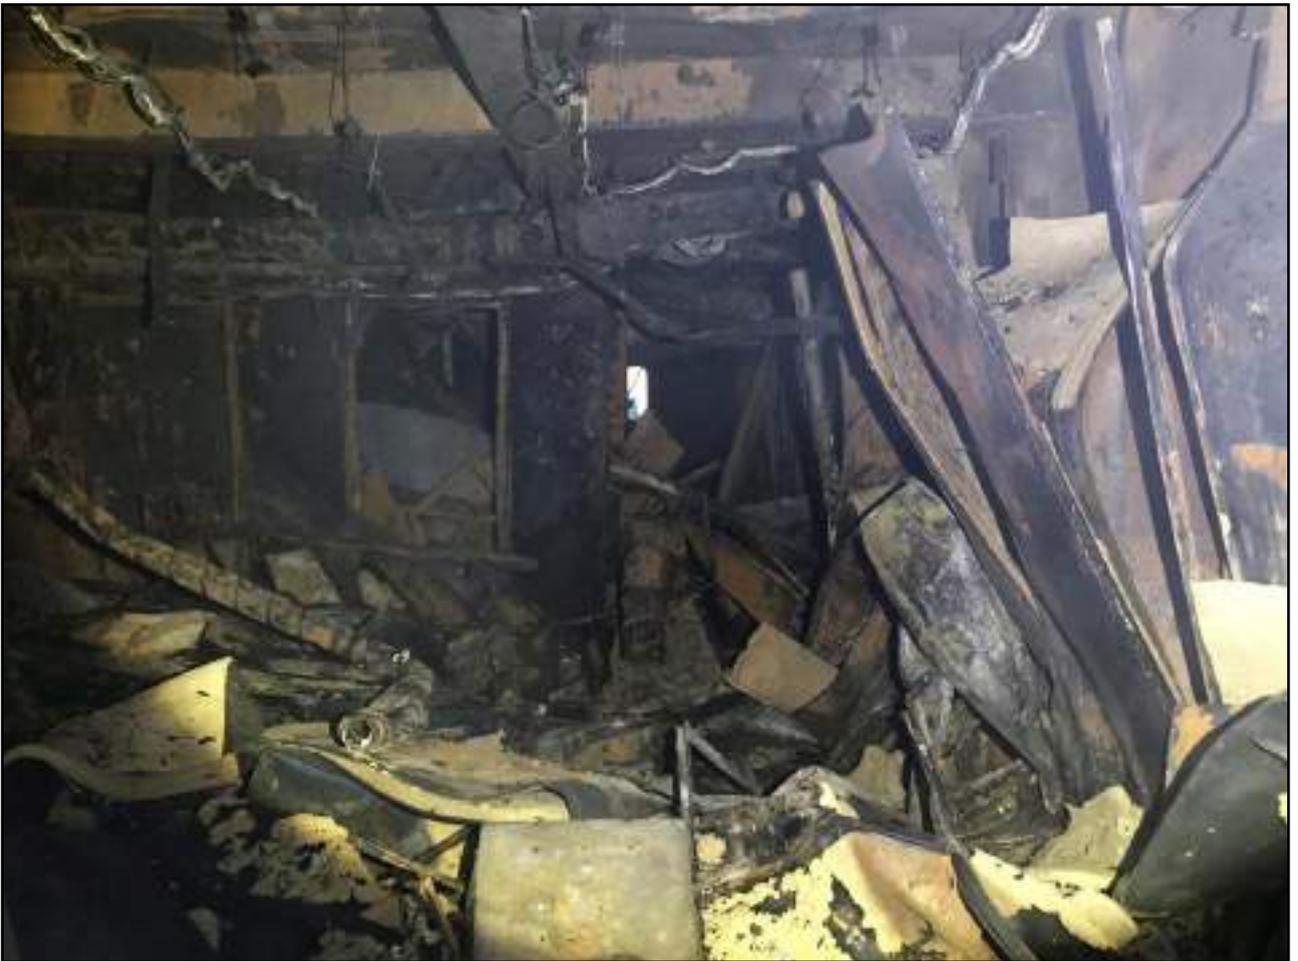
The tanker's accommodation block sustained extensive internal fire damage (**Figure 15**). The deck between the technical room and the CCR had collapsed, and both spaces were burned out. Heat and smoke had also penetrated the bridge and damaged much of its equipment. Other than broken windows, many of which were broken by firefighters during the emergency response, external damage to the front of the accommodation block was minimal (**Figure 16**).

Figure 15: Accommodation interior

The fire on board *Stolt Groenland* burned for 5½ hours, during which time it spread from the manifold area to the accommodation block. The path of the fire spread was not clear during the on-site inspection, as the accommodation front was relatively free from significant damage. It is possible that the spread into the accommodation resulted from flammable styrene vapour entering from either the gas detection or cargo tank heating systems.

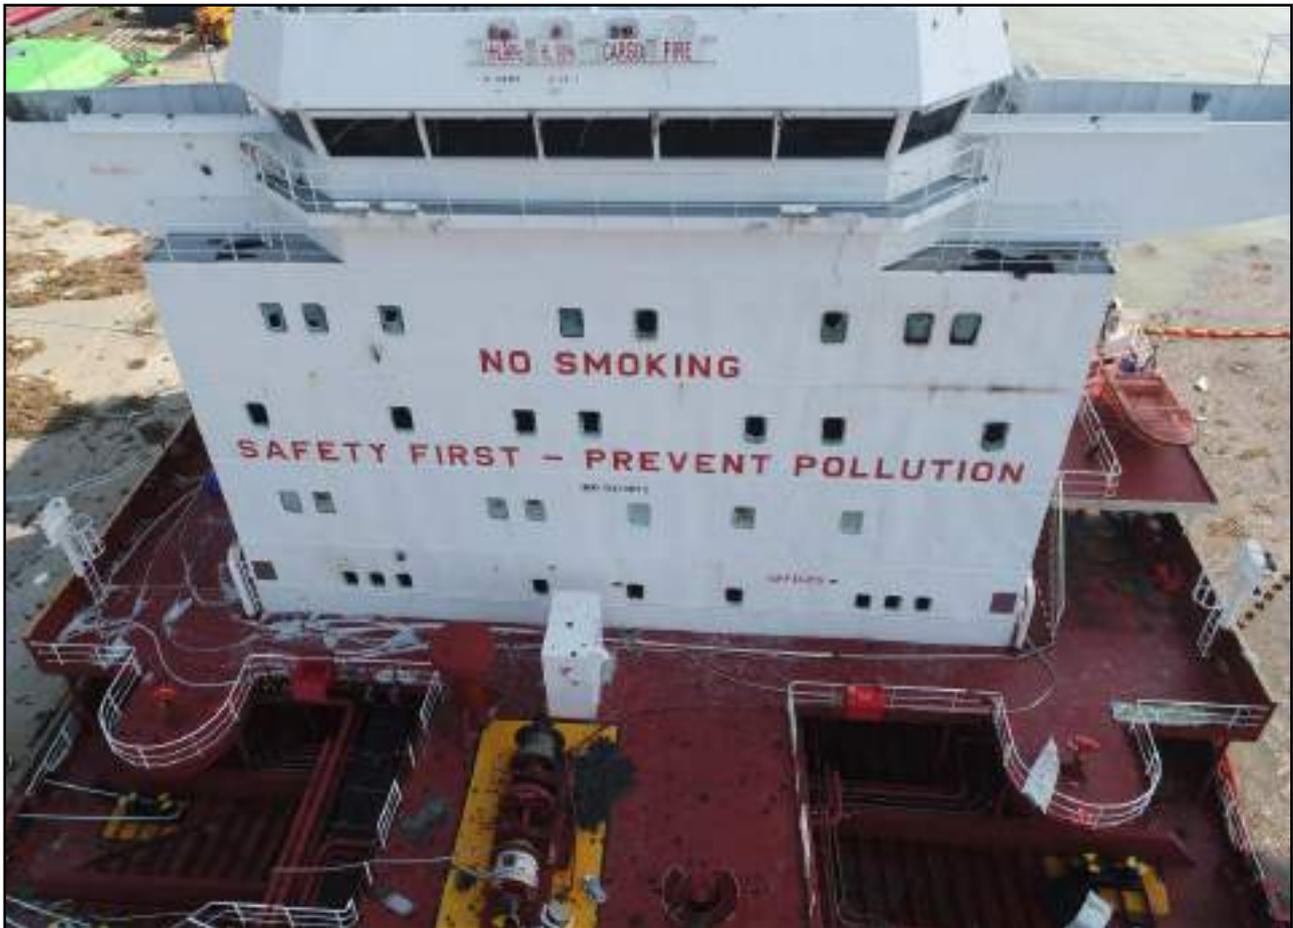
Figure 16: Accommodation front

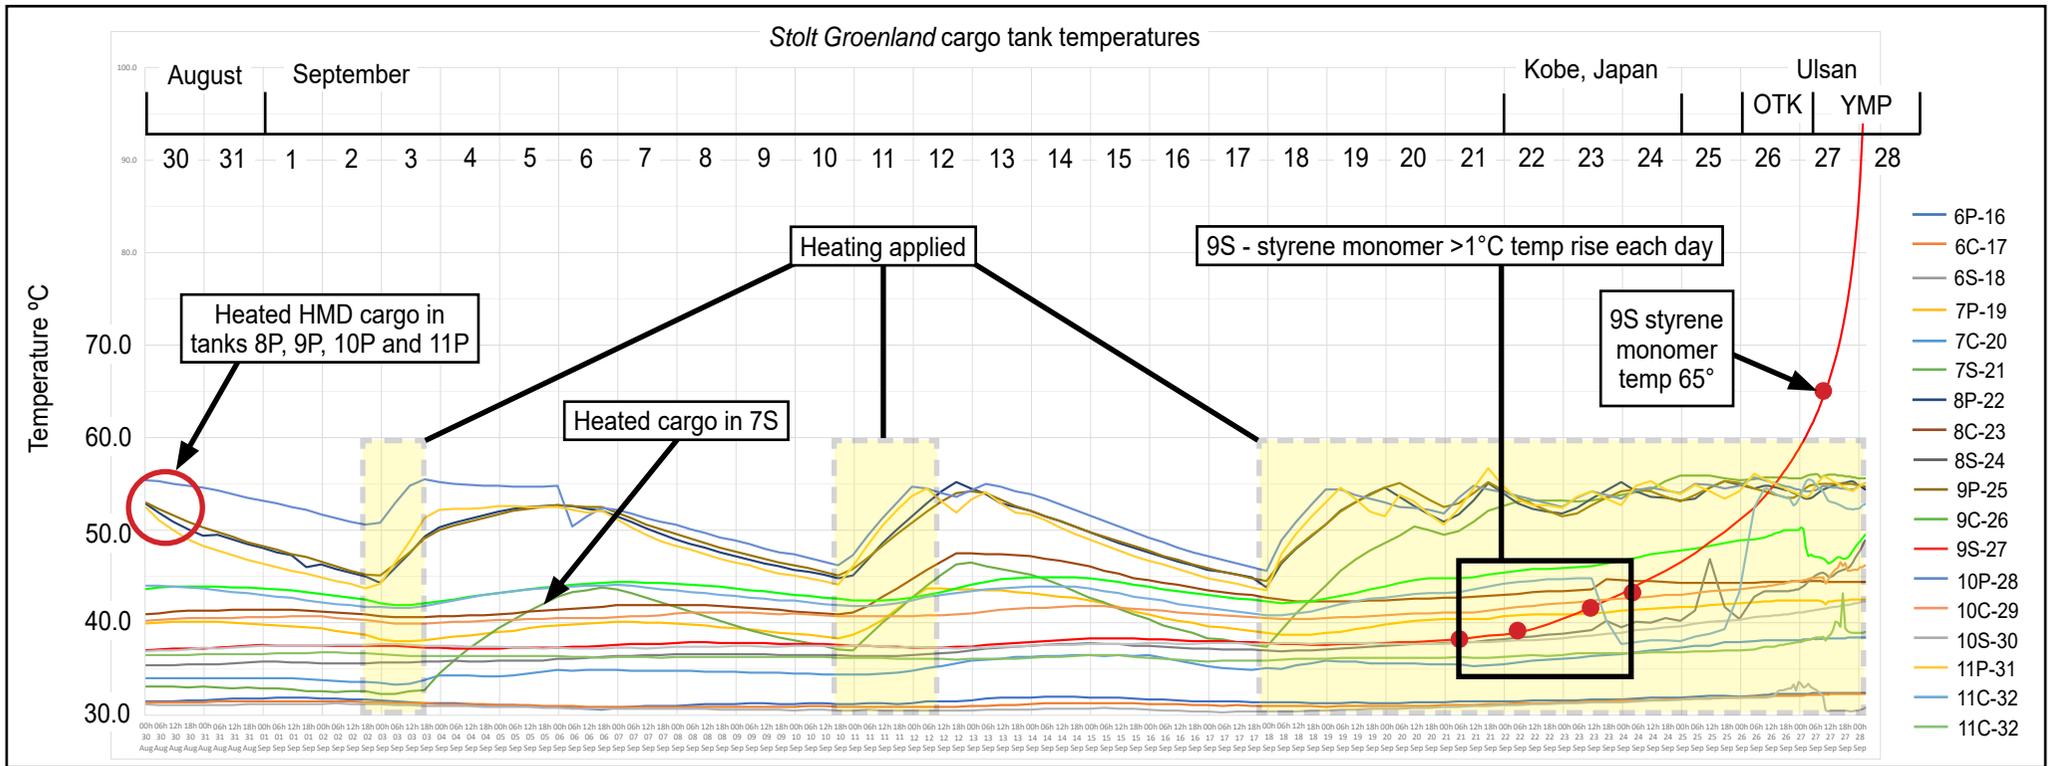
Figure 17: Cargo temperatures recorded on the VDR

Although unlikely to have been the single cause of the runaway polymerisation event, the elevated temperatures significantly increased the rate of TBC depletion and therefore the risk of polymerisation. It was therefore apparent that the elevated temperature of the cargo in 9S was the key factor in this accident.
