UK P&I CLUB

RISK FOCUS: MOORINGS

**Good condition of
equipment – but
worrying practices
and procedures**

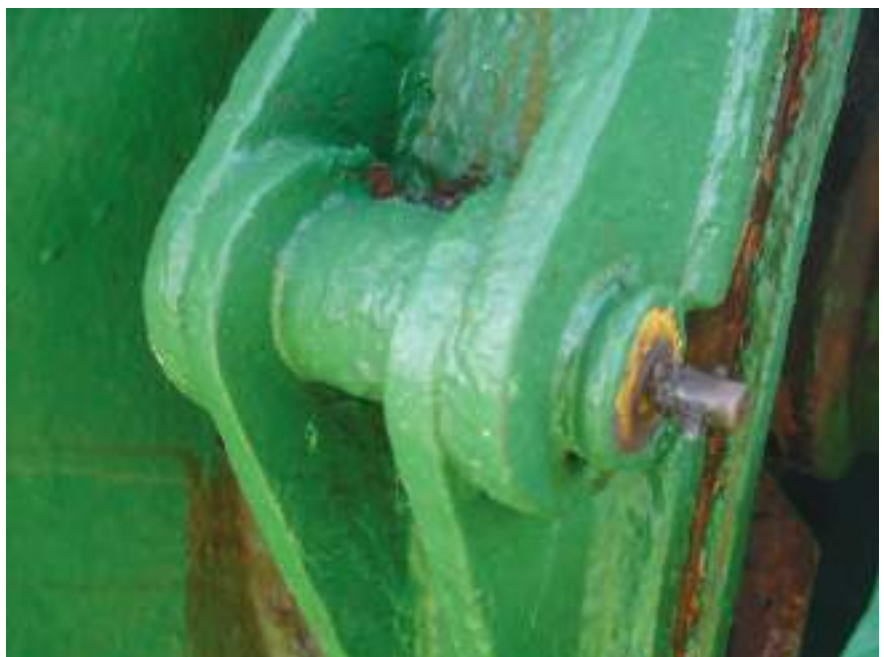
Ineffective grease point

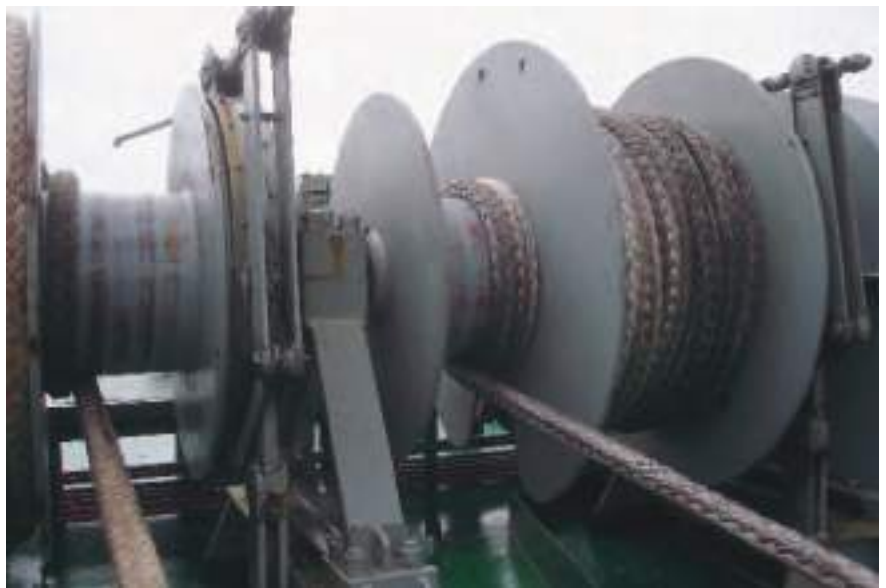
Despite the good overall winch condition, inspectors commented that on a number of vessels the split drums were not set-up correctly. The first picture below shows the correct way to set up a split drum, having only around 4 or 5 turns on the smaller drum and the remainder of the rope on the larger drum.

Correctly set up split drum

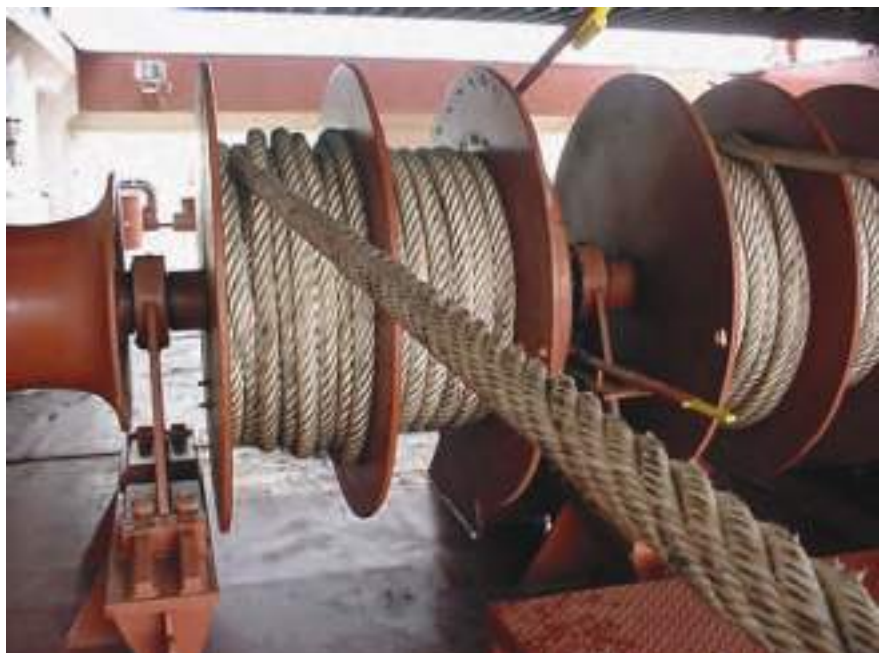
Incorrectly set up split drum with buried mooring line

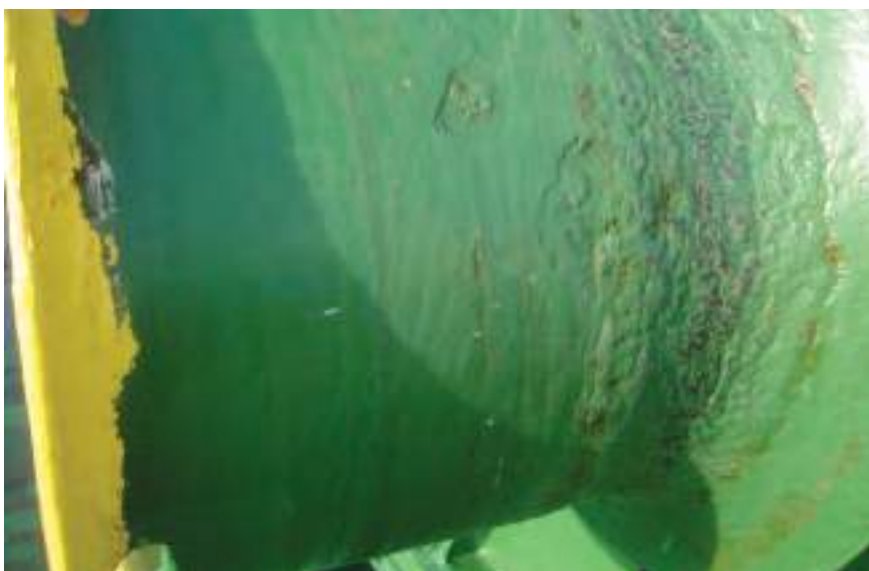
A further statistic showed that 94% of vessels had painted the drum ends. One hazard of over-painting is that the build up of paint on drum ends can cause rope damage. It is suggested that, if possible, drum ends should be smooth and coated with a thin layer of boiled linseed oil or other approved synthetic liquid for protection.

Build up of paint on the drum end

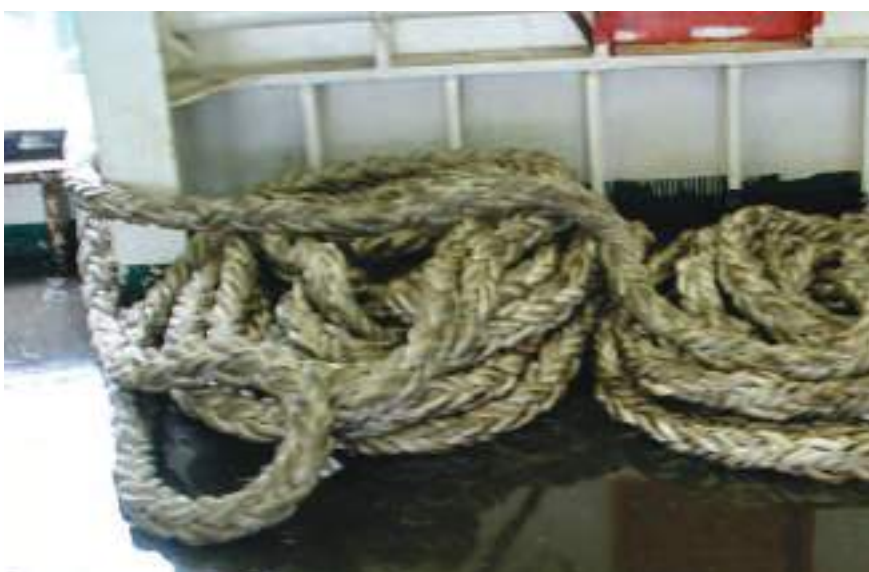
Ropes badly stored on wet deck

It is important that all ropes, wires and Tonsberg links used for mooring have a certificate. It is considered good practice for these certificates to be clearly labelled and kept in an easily accessible file ready for inspection by Port Authorities. Spare mooring ropes, wires and links should not be over stowed with paint, chemicals, or any other shipboard or general cleaning items. Spare mooring equipment should be stowed clear of the deck, preferably on a pallet and in a dry ventilated position. If mooring ropes and wires are stowed on deck during sea passages they should not be exposed to sunlight, sea spray or funnel soot. It is suggested that canvas or heavy duty polyethylene covers will prolong the life of the ropes/wires.

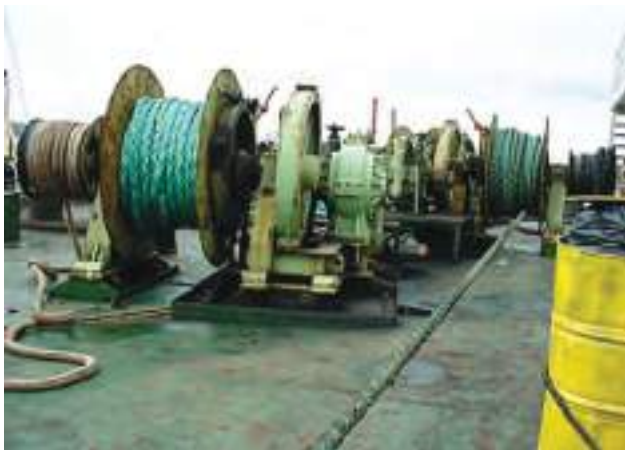
Poor and potentially unsafe mooring area example

Unfortunately this photo illustrates a sight sometimes experienced by the UK Club ship inspectors. Not only are the windlasses rusty and poorly maintained, but the mooring area as a whole suggests poor safety and maintenance standards on board:

- The mooring area is dirty and all surfaces are in need of maintenance.
- All surfaces are painted the same colour, hiding trip hazards such as save-alls, windlass platforms, forecastle access hatch and bits.
- There are no hazard highlightings or warning markings.

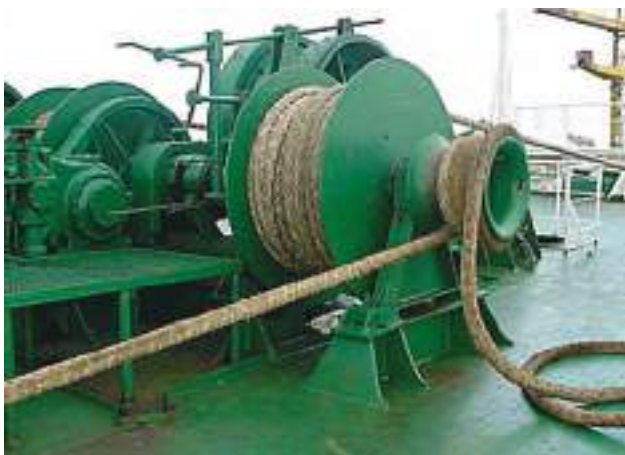
Well painted but poorly highlighted mooring station

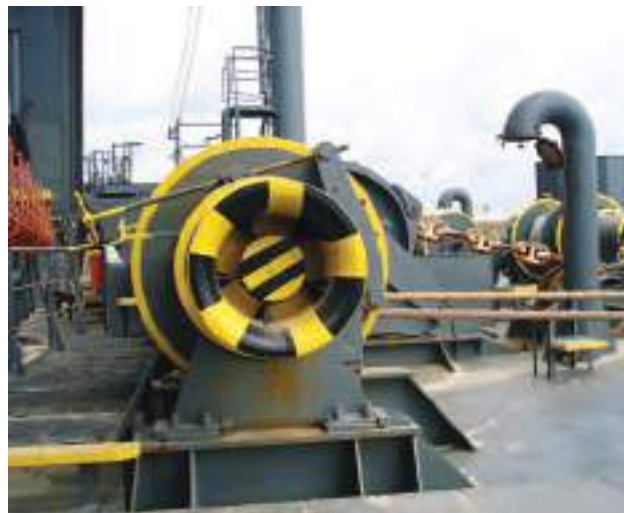
Mooring station with effective hazard markings

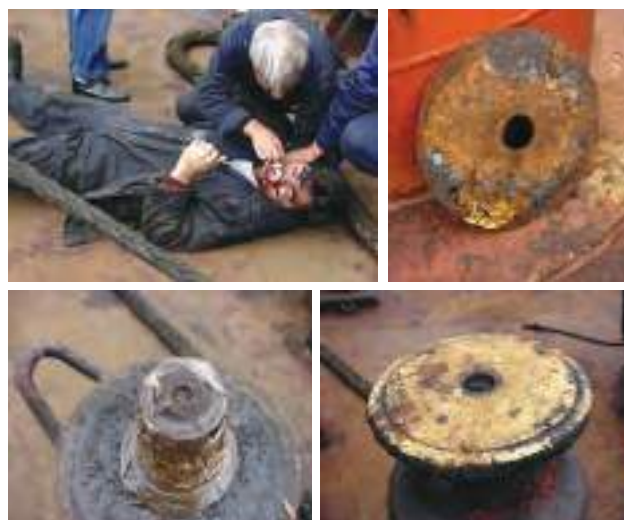
An A/B was seriously hurt when a roller fairlead detached from its pedestal whilst under the influence of a mooring line under tension. The A/B was standing in the snap-back zone and was struck by the rope, which hurled him into the foremast causing head injuries.

The rope hurled the roller fairlead 20 feet from the ship to the quayside.

The angle or directional lead of a rope should be considered when using leads in order to prevent incidents like this. But this particular incident also highlights the importance of proper maintenance of mooring equipment.

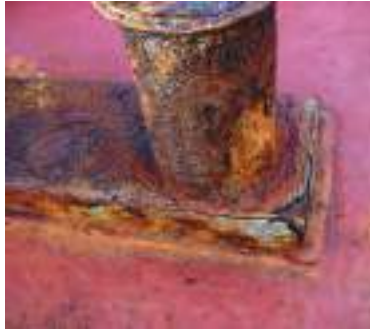
Mooring equipment that has suffered severe wastage will not perform to the certified standard. This also applies to the steel to which the equipment is welded. The image shows mooring bits that are badly wasted. The deck is in equally bad condition and there is a danger of the bits being torn from the deck.

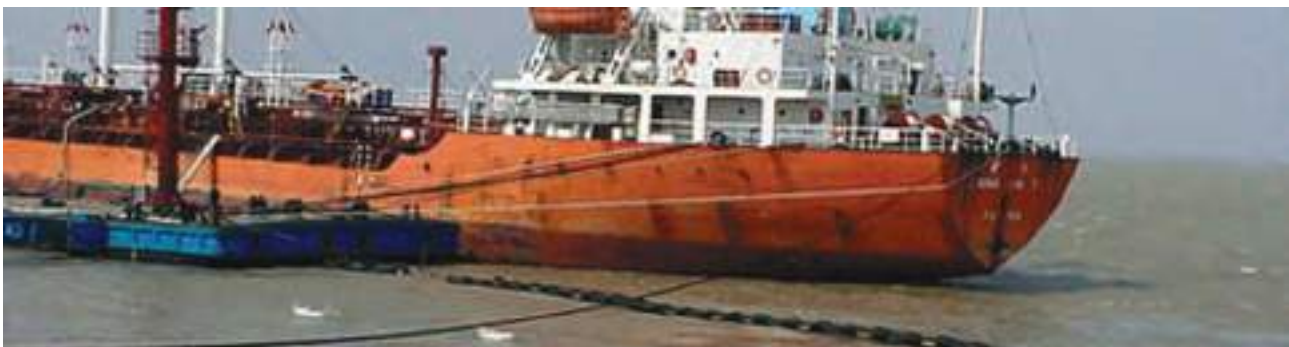
The image below shows a vessel considerably overhanging her berth. She is therefore unable to lead any stern lines aft of the ship. The image shows one line in particular being lead an extremely long distance, rendering it pretty much useless.

The ship has correctly put out as many lines as possible but should also consider the use of the anchor and mooring lines running aft from either the main deck or other suitable areas. In situations like this it is important to analyse local tidal and weather patterns in order to predict how the vessel will be affected. The vessel owners should be informed and cargo operations stopped (or not commenced) if conditions do not appear safe.

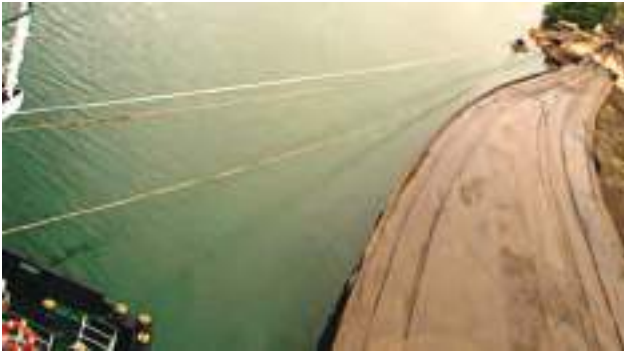
The following image shows insufficient mooring arrangements ashore and the vessel is forced to pay out an extremely long lead on the stern lines. In this event, the master should protest to the port authority, take photos and inform the owners.

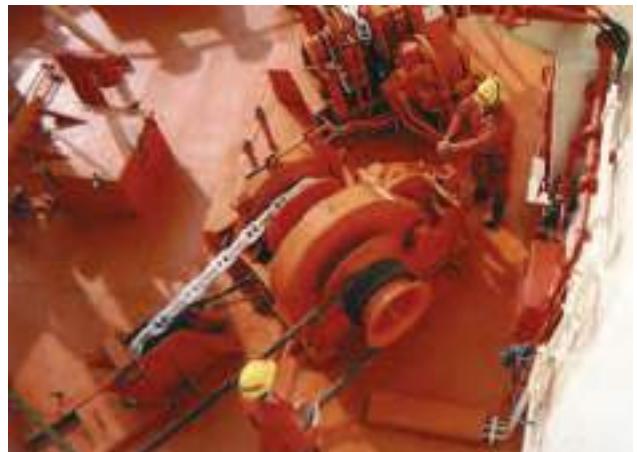
Mooring operations should be conducted in a safe manner. In the image below:

- The line on the windlass drum is being handled safely. The crewmember at the drum is keeping his hands clear of the turns and positioned so as not to become fouled in coils of rope.
- The crewmember operating the windlass has a good line of sight of the rope and the man handling it.
- Both crew are appropriately attired in correct personal protective equipment.

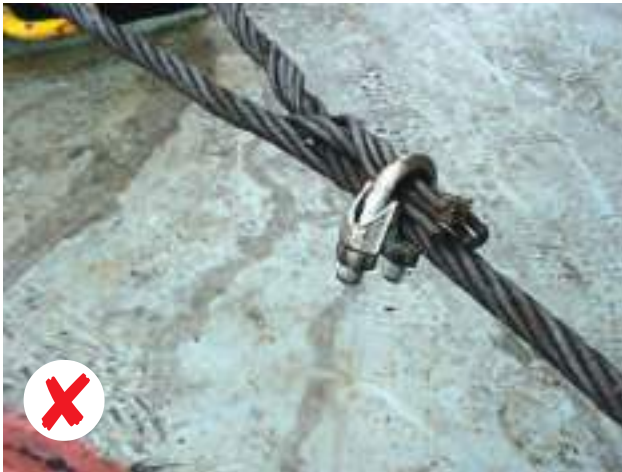
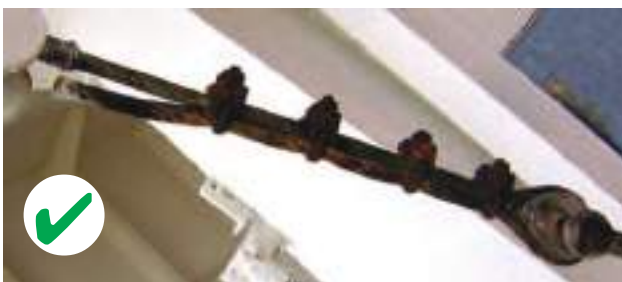
If it is necessary to create an eye in the end of a wire, then it would be worth investing in crimping equipment. Many ships prefer the use of bulldog-grips for creating an eye in the end of a wire rope, but there is a correct way of doing this:

- An allowance of 150 mm should be made between the last bulldog grip and the end of the 'dead' wire. It is important to ensure that the lashing wires are not cut short immediately next to the bulldog grips.

- Bulldog grips have a grooved surface in the bridge piece which is suitable for a standard wire of right-hand lay having six strands. Crosby grips have a smooth surface in the bridge piece. The grips should not be used with ropes of left-hand lay or of different construction.

- The first grip should be applied close to the thimble or at the neck of the eye if a thimble is not used.

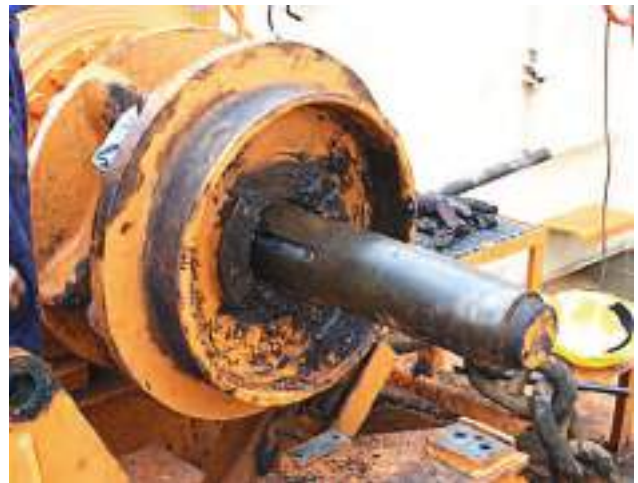
Windlass drums are not designed for taking the weight of mooring lines for a long period of time. If windlass drums are used for this purpose then over a period of time they will suffer damage and be in need of repair.

This windlass drum suffered bearing damage and is being overhauled

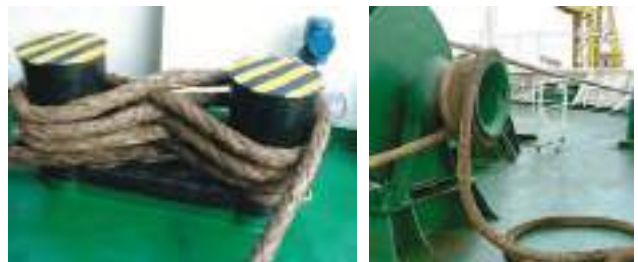
Once ropes have been hauled tight they should be secured to bitts as in the good example on the left

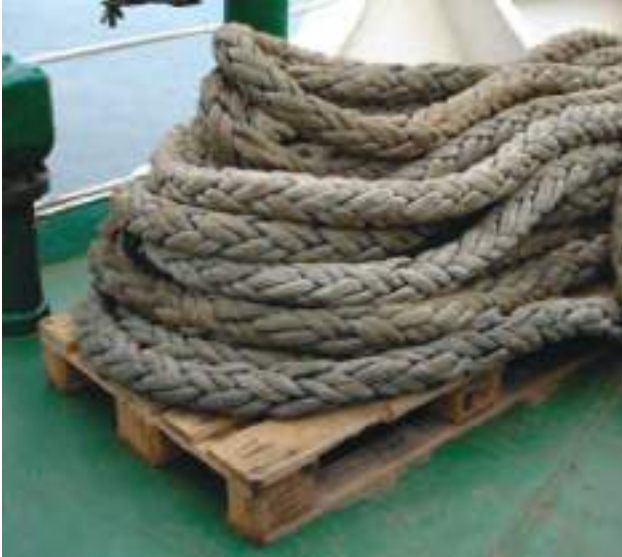
Ropes correctly stowed off deck

Do not store ropes on wet decks. Ensure they are stowed off the deck and if possible away from precipitation and direct sunlight. If baskets or other storage devices are not available then ropes should be coiled down on pallets (see below).

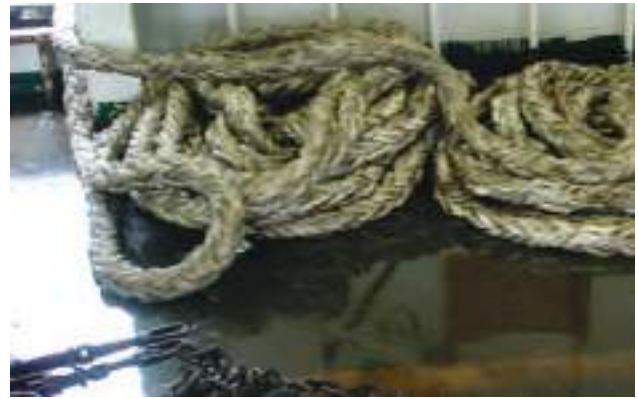
Ropes badly stored on wet deck
