ACCIDENT REPORT

Report on the investigation of two catastrophic engine failures, one resulting in a fire, on board the ro-ro passenger ferry

Wight Sky

SERIOUS MARINE CASUALTY REPORT NO 4/2022 APRIL 2022

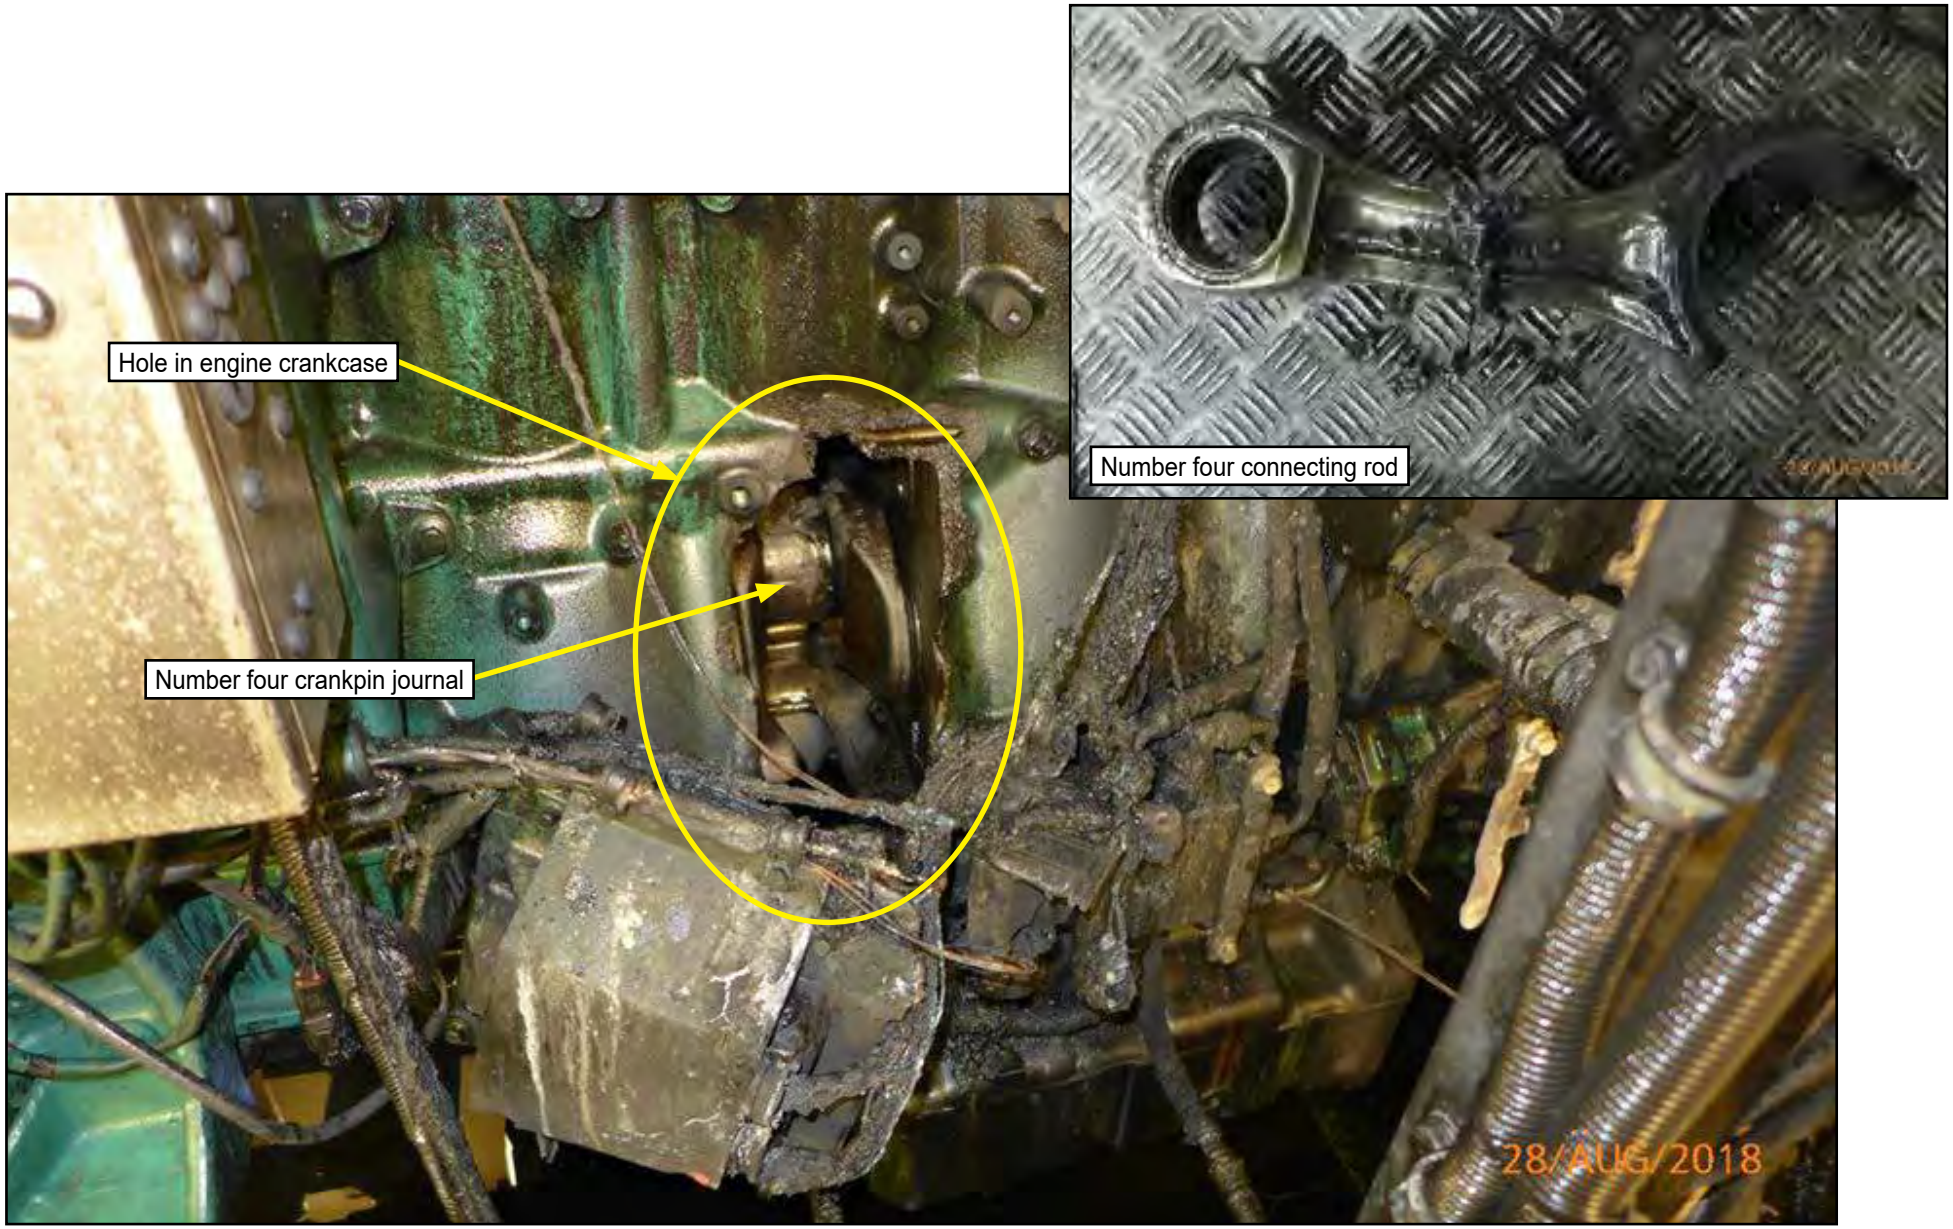
The initial ME2 inspection identified that the engine's number four cylinder connecting rod had failed and been ejected through the side of the engine crankcase **(Figure 4)**, and that a localised fire had ensued. The engine had accumulated 2241 running hours since its installation and, as the failure mode appeared identical to the previous ME2 failure, the MAIB began a new investigation.

Figure 4: Hole in ME2 crankcase, showing number four crankpin journal, and inset, showing number four connecting rod on the engine room deck plate

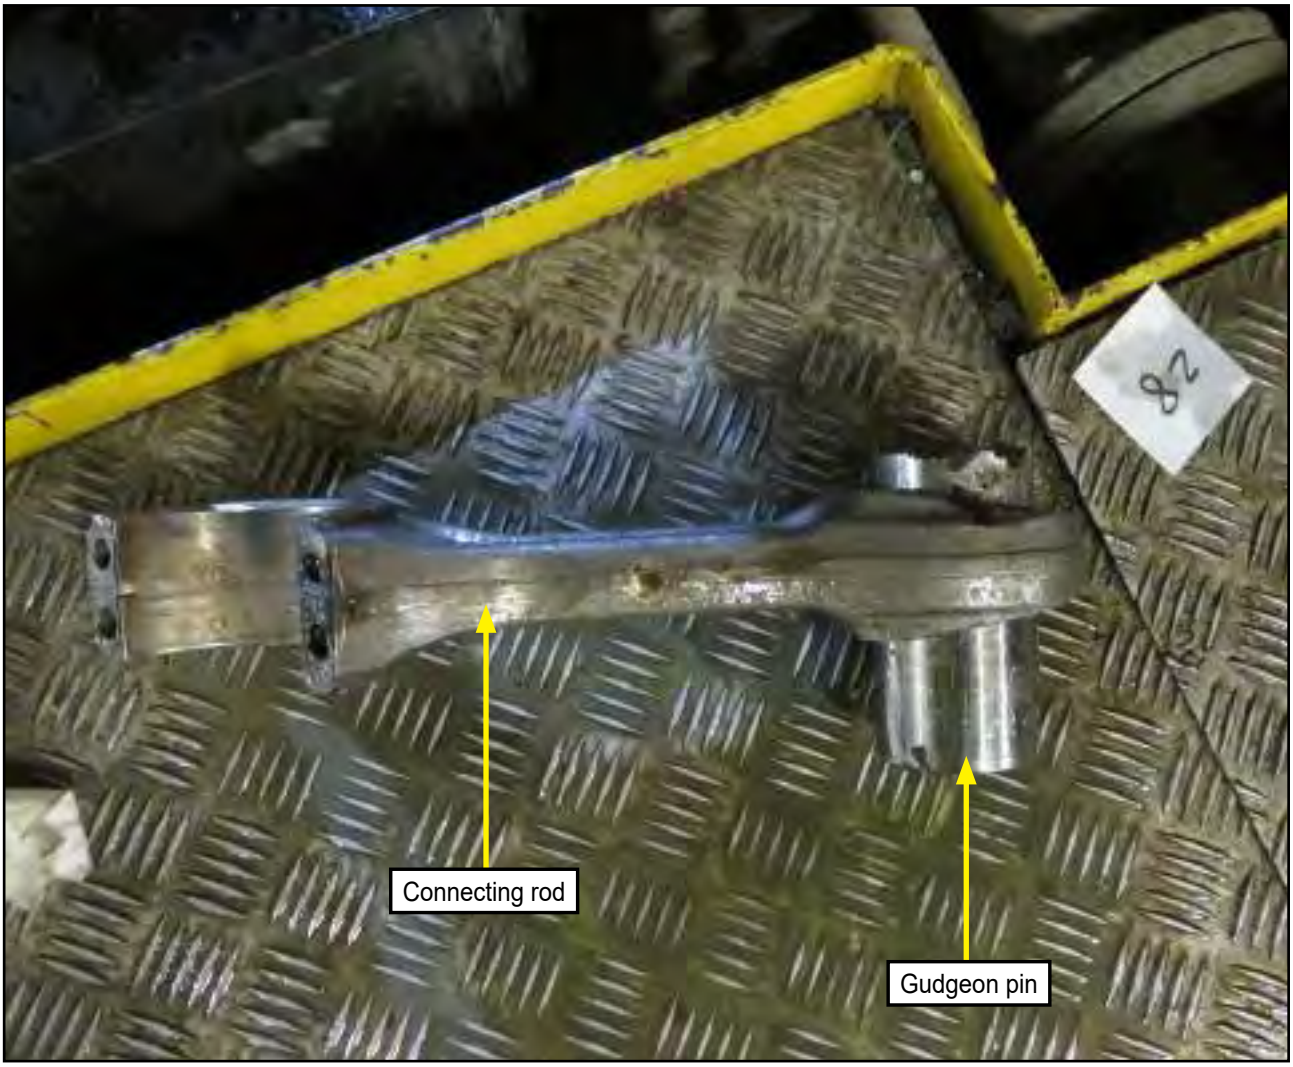
The initial inspection of the engine room identified that ME4 had failed catastrophically and that its number four connecting rod and gudgeon pin **(Figure 5)** had been ejected through the side of the engine crankcase **(Figure 6)** into the engine room. The engine room was unoccupied at the time and there was no evidence of a fire.

Figure 5: ME4 number four connecting rod and gudgeon pin

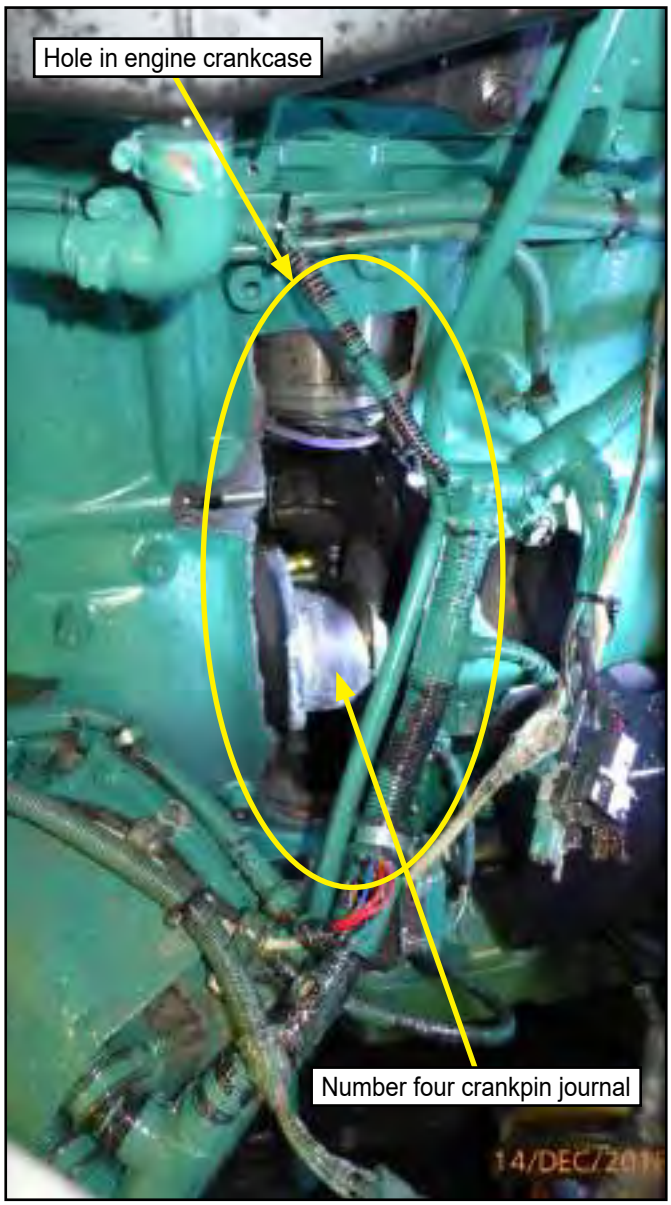
Figure 6: Hole in ME4 crankcase/engine block, showing number four crankpin journal

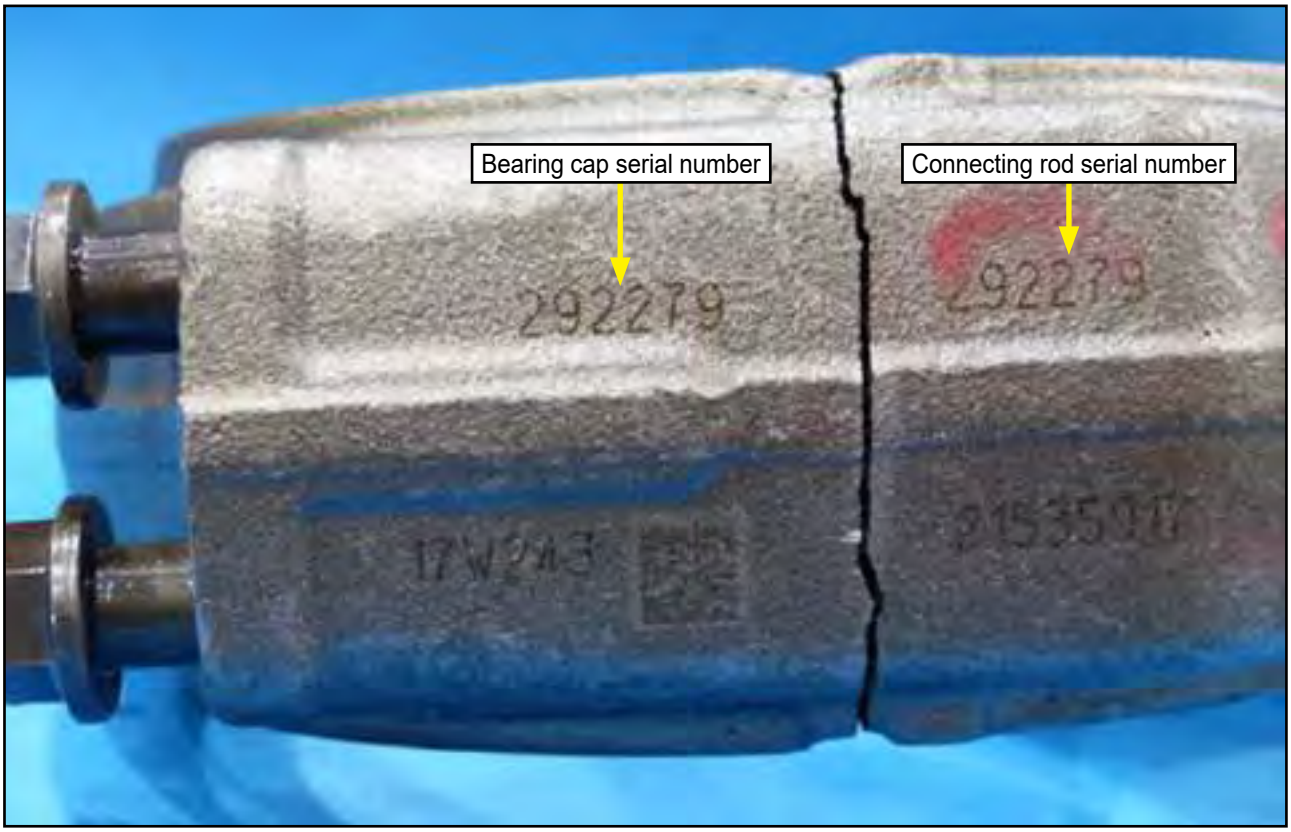
Figure 8: D16 MH bearing cap and connecting rod serial numbers

During the assembly process, the engine build technicians had to unbolt the connecting rod caps and place them on a work surface adjacent to the engine block before lowering the piston and connecting rod assemblies into their cylinder liners. Once the connecting rods (with bearing shells) were positioned on their respective crankpin journals, the technicians refitted the big end bearing caps. The bearing cap bolts were tightened to the specified torque and the resistance of the rotating crankshaft checked to ensure it was within tolerance. To help reduce the risk of transposing the rods and caps, the matched parts were each stamped with the same serial number **(Figure 8)**.

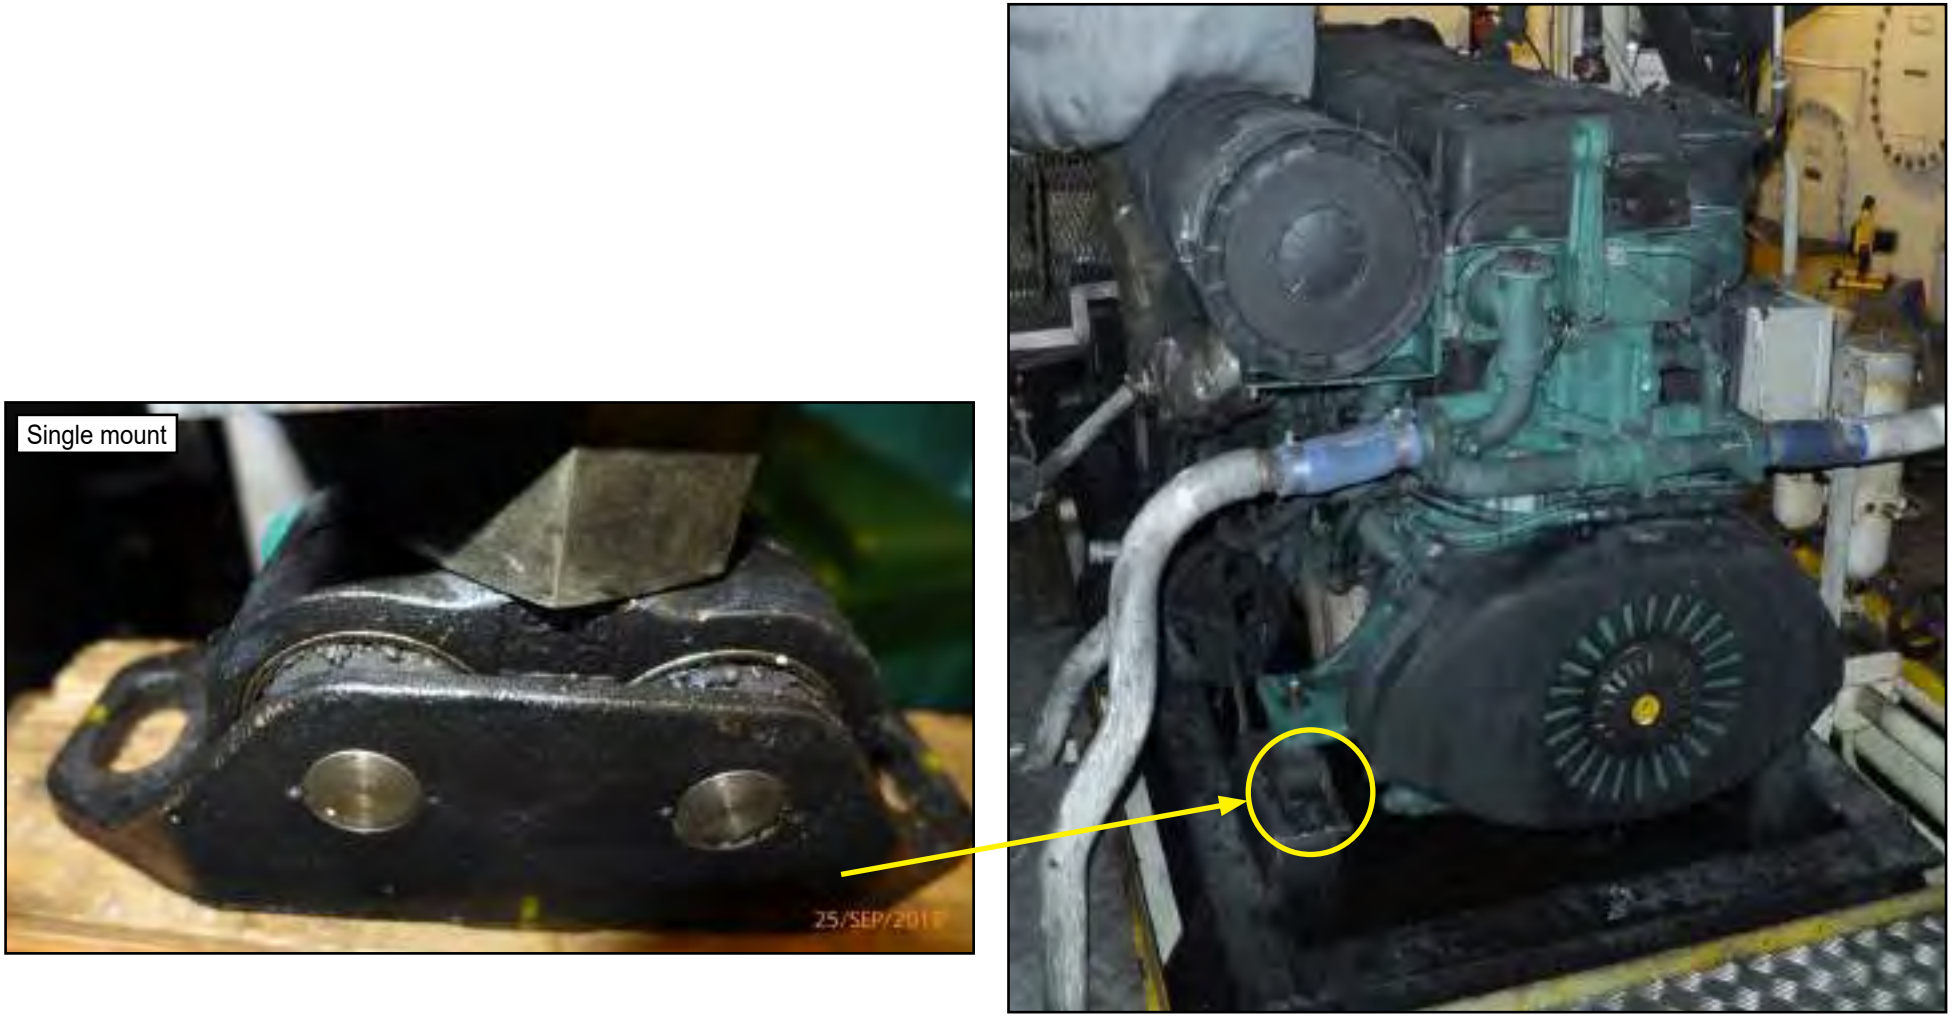
Figure 13: Flexible engine mounts

The engine, torsional damper and fluid coupling were secured to their bedplates using flexible mounts designed to absorb vibration **(Figure 13)**.

The engines were installed on four flexible mounts **(Figure 13)**; a further two mounts were used to secure the fluid clutch couplings. Volvo Penta's installation manual for its D5 to D16 engine range contained drawings that illustrated the correct order of installation. The manual stated:

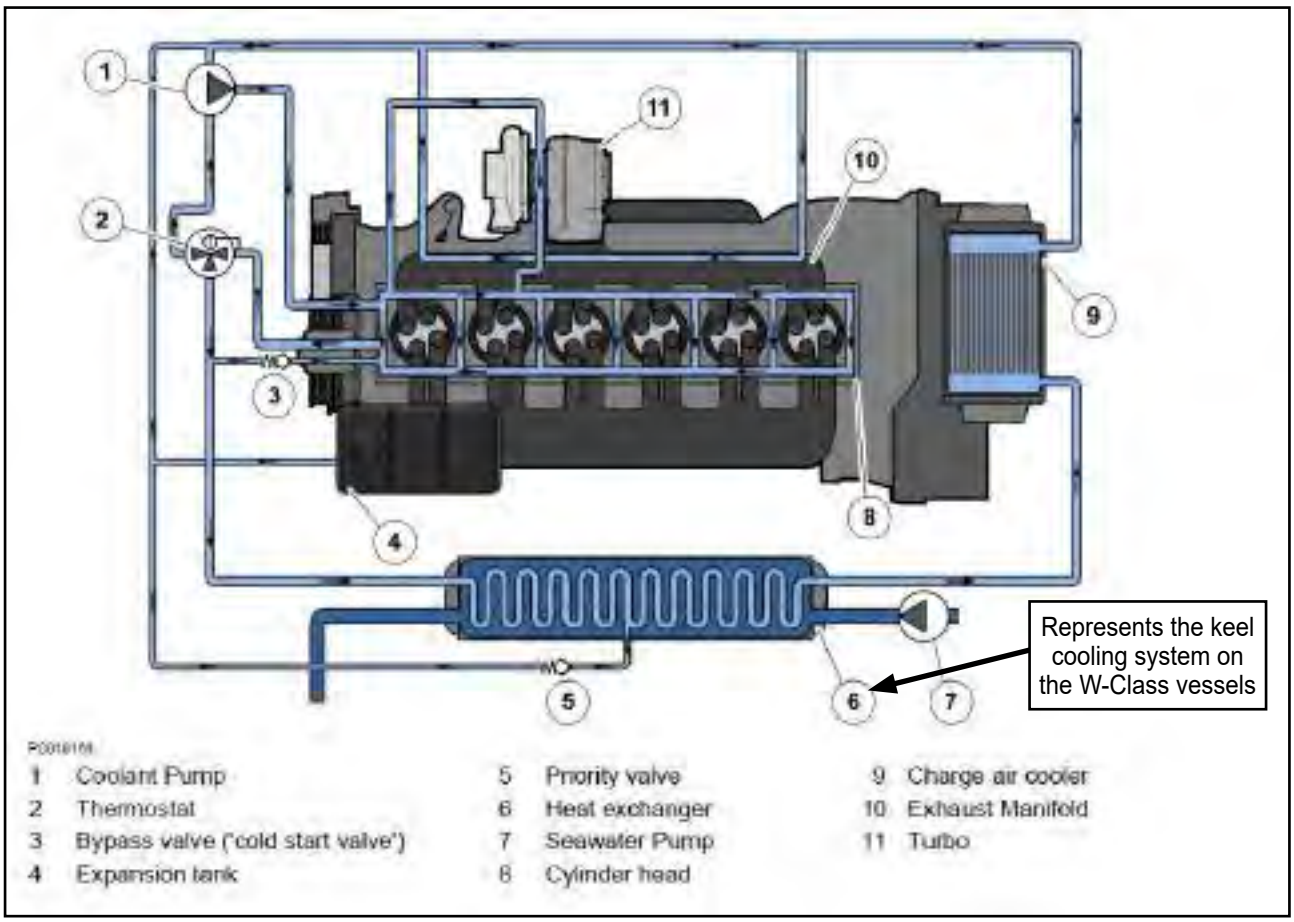
Figure 14: Engine cooling system

Each ME had a low temperature (LT) and high temperature (HT) cooling circuit, each of which circulated the engine coolant through seawater box coolers fitted into the vessel's hull **(Figure 14)**. The LT coolant was circulated through the engine's charge air cooler and the fluid coupling oil cooler by an electric booster pump. The HT coolant was circulated through the engine's oil cooler, cylinder jacket space, cylinder head, exhaust manifold and turbo charger by an engine driven pump. Both cooling systems had a pressurised expansion tank.

The separation of the LT and HT circuits differed from standard D16 MH engine installations, which operated a single circuit to and from an engine mounted expansion tank (saddle tank) that was fitted with a pressure relief cap, like those fitted to road vehicles. In the W-Class installation, the saddle tanks were modified by replacing the pressure relief cap with a pipe running to a HT expansion/header tank approximately 1m above the engine, which was fitted with a 100kPa (1 bar) pressure relief cap. Due to the structural arrangements, the pipework between ME1 and ME4's saddle tanks and HT tanks was routed under the engines, creating a U-bend. This made the venting of air from these systems difficult.

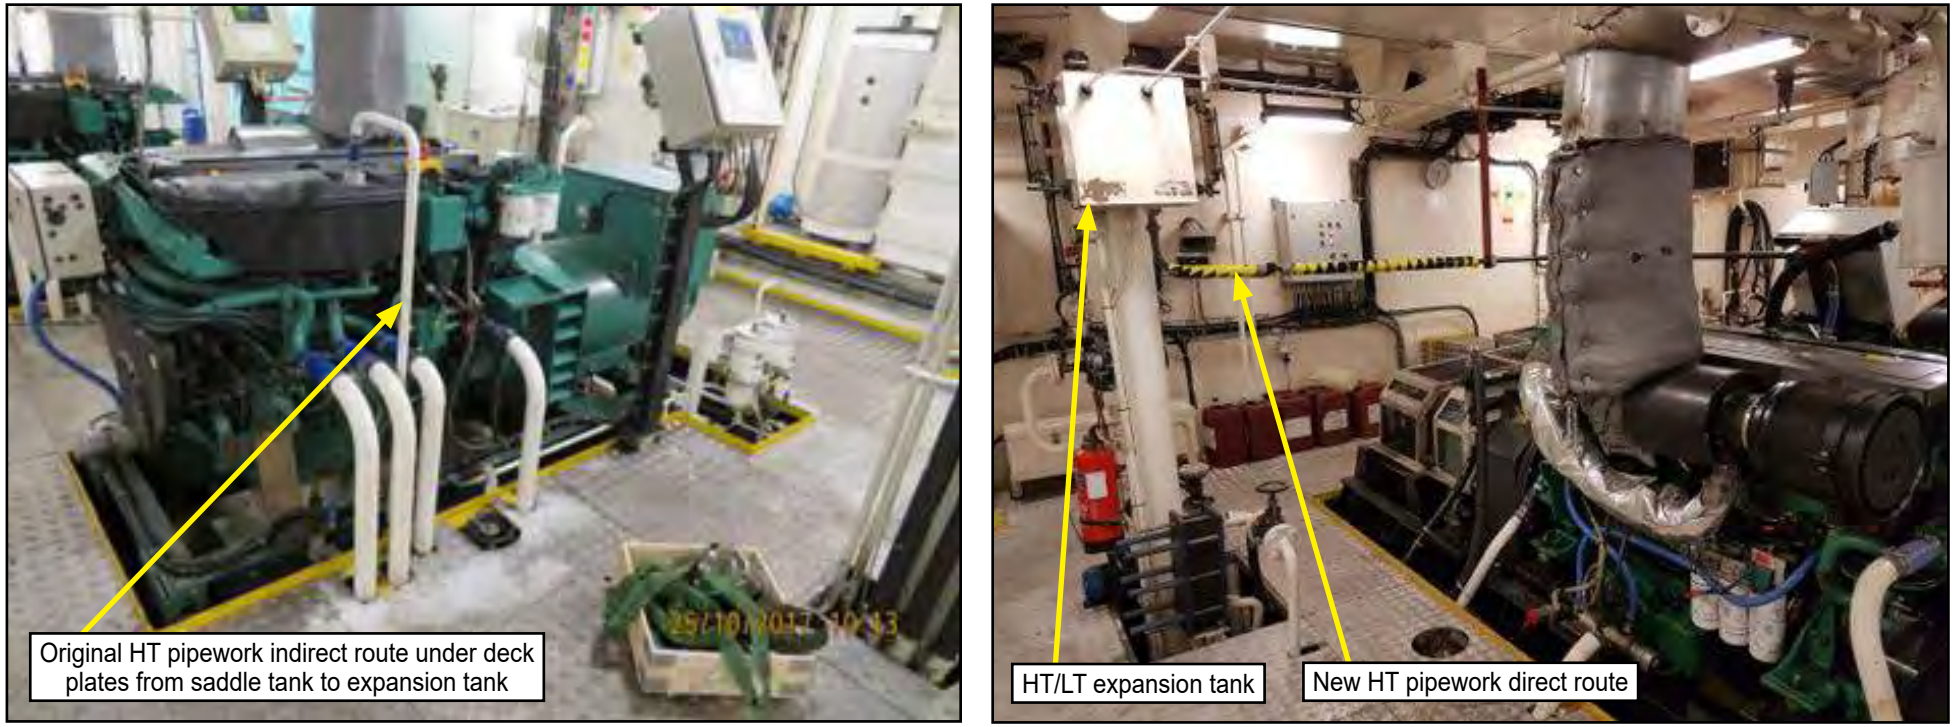
Figure 16: Modified cooling system high temperature circuit pipework

After about 18 months' operation, the vessels started to suffer from cylinder liner failures. These were thought to be a result of difficulty in venting the HT cooling system and Volvo Penta advised the installation of a T-piece to aid effective venting of the engines' cooling water saddle tanks **(Figure 15)**. Following the two catastrophic engine failures in 2018, Volvo Penta was unable to determine the justification for the T-pieces and advised their removal, along with a revision to the pipework design to remove the U-bend in the systems and a change to pressure relief caps rated at 75kPa **(Figure 16)**.

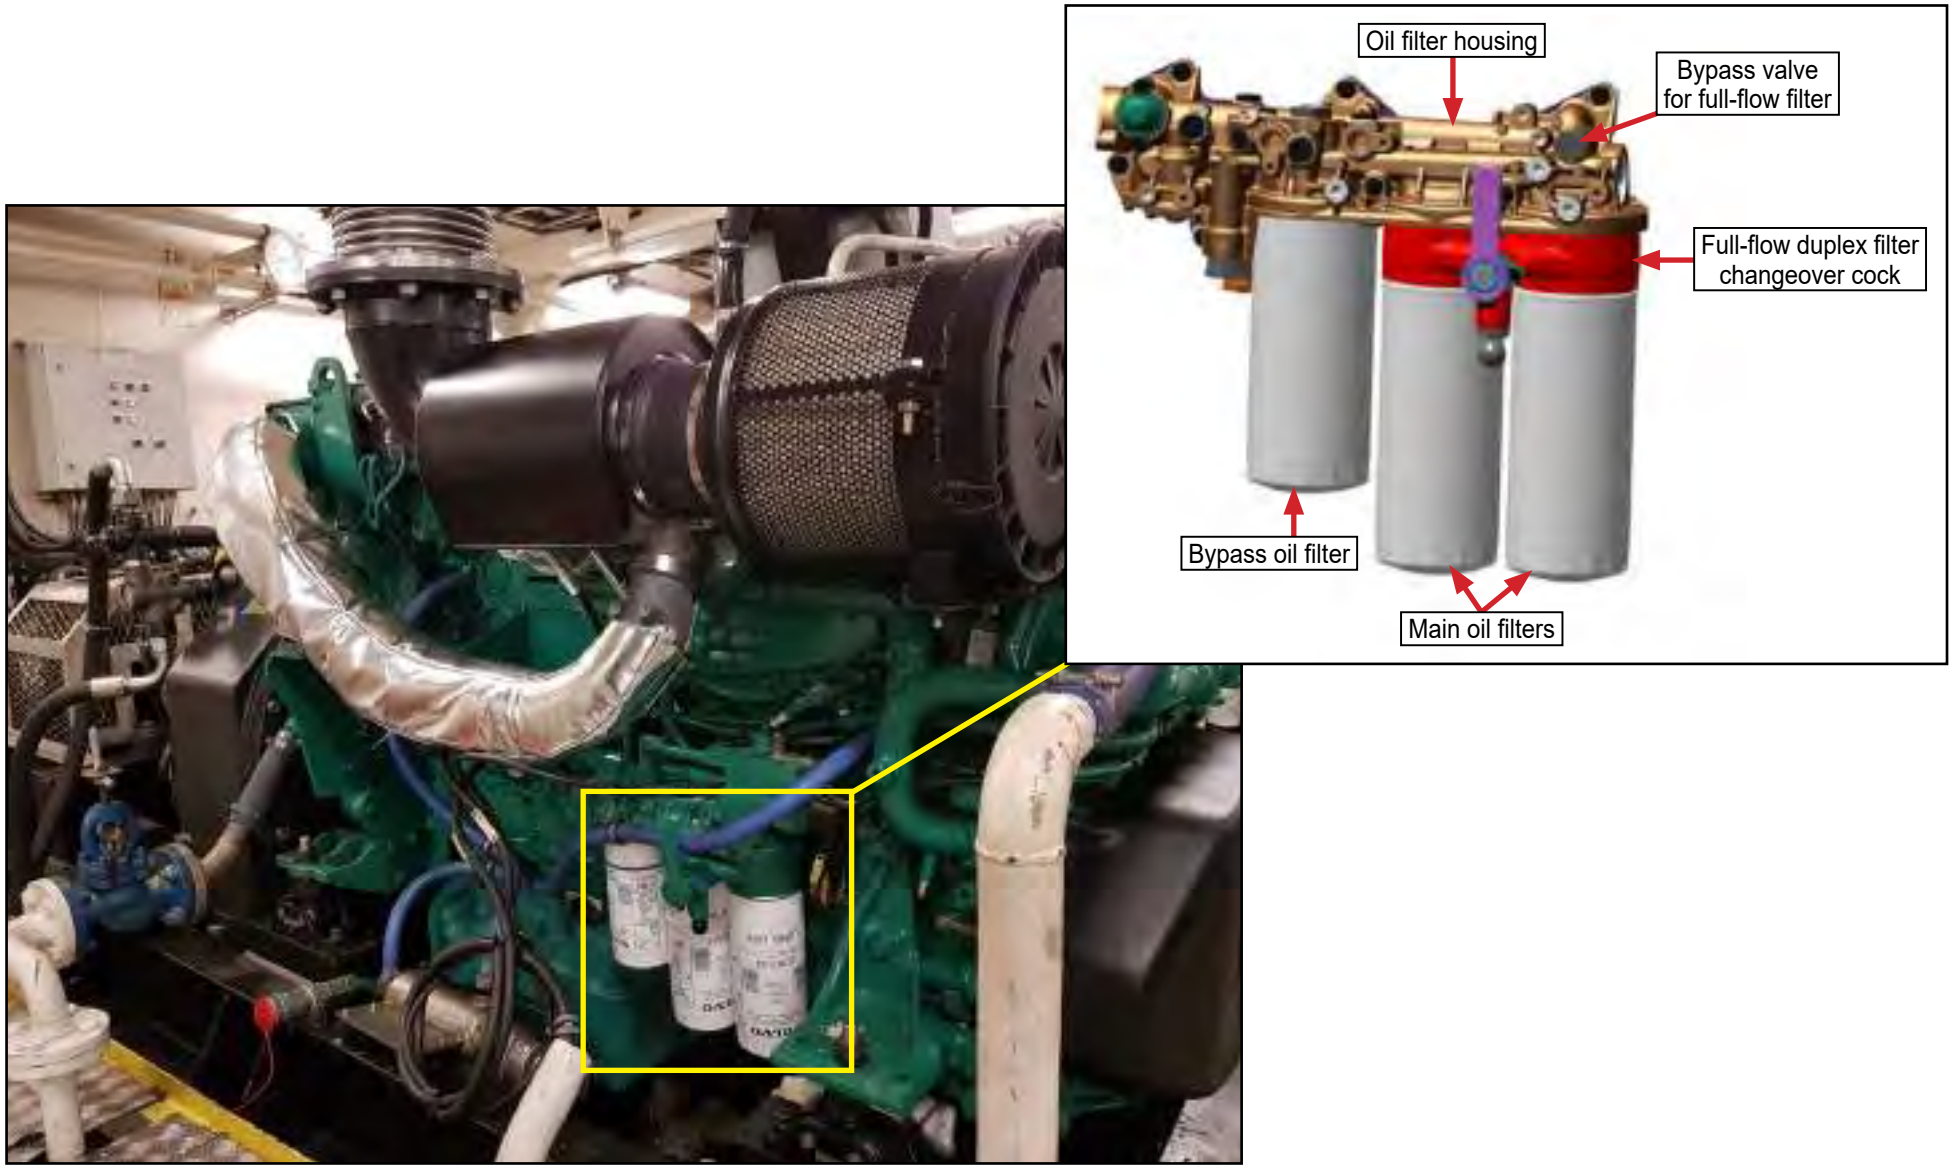
Figure 19: D16 MH lubricating oil filters (with changeover cock)

Up until 2015, classification society rules required the use of a switchable oil filter arrangement (duplex filter) that allowed the main oil filters to be changed individually while the engine was running. To meet this requirement the D16 MH engine full-flow oil filter had a central changeover cock **(Figure 19)**.

During Volvo Penta's investigations into the causes of the Wightlink engine failures, a design error was identified with the oil filter arrangement. It was discovered that, at full engine speed, the full-flow filters' bypass valve opened slightly and allowed 10 to 20% of unfiltered oil to flow through the circuit. The overflow valve for the main filters was affected by the pressure drop caused by the changeover cock. In April 2019, Volvo Penta informed Wightlink and subsequently issued a D16MH/MG service bulletin for the overflow valve spring replacement. In Wightlink's case, as the changeover cock was no longer required to meet classification society requirements, Volvo Penta advised its removal from the oil filter block. This work was completed on the W-Class vessels **(Figure 20)**.

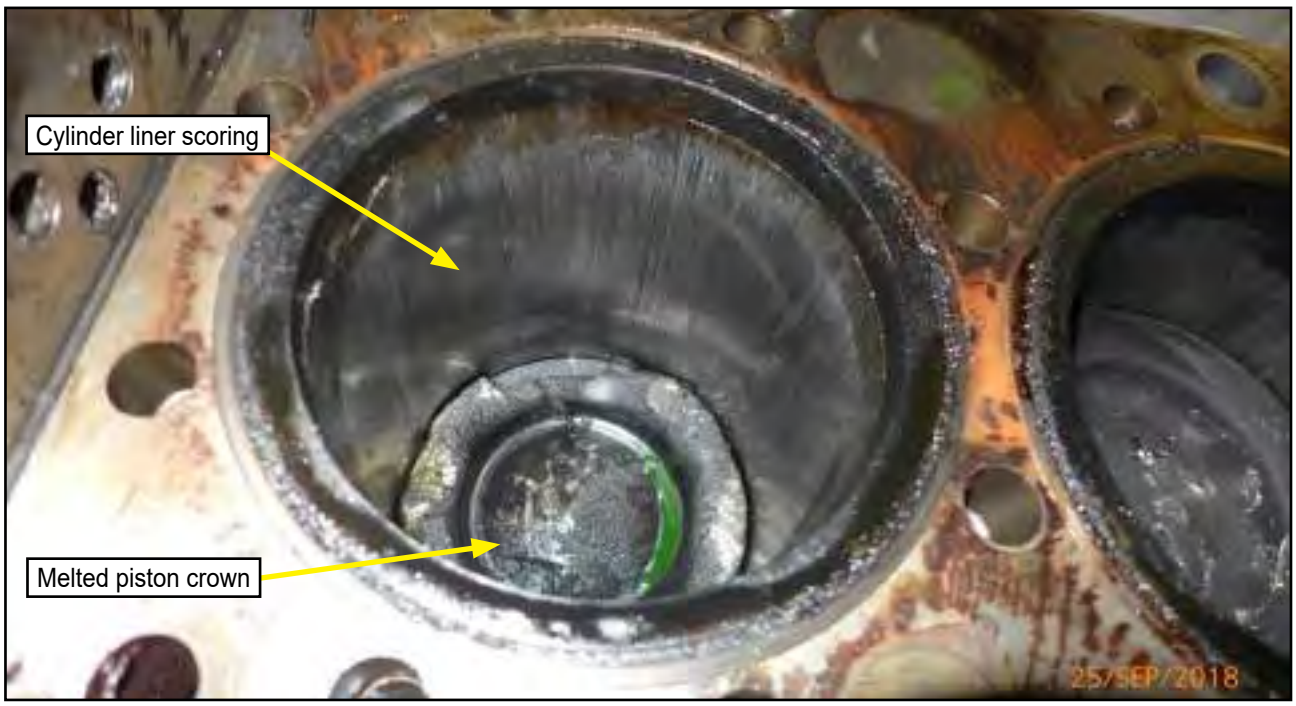
Figure 23: Event 3 – number six cylinder scoring and melted piston crown

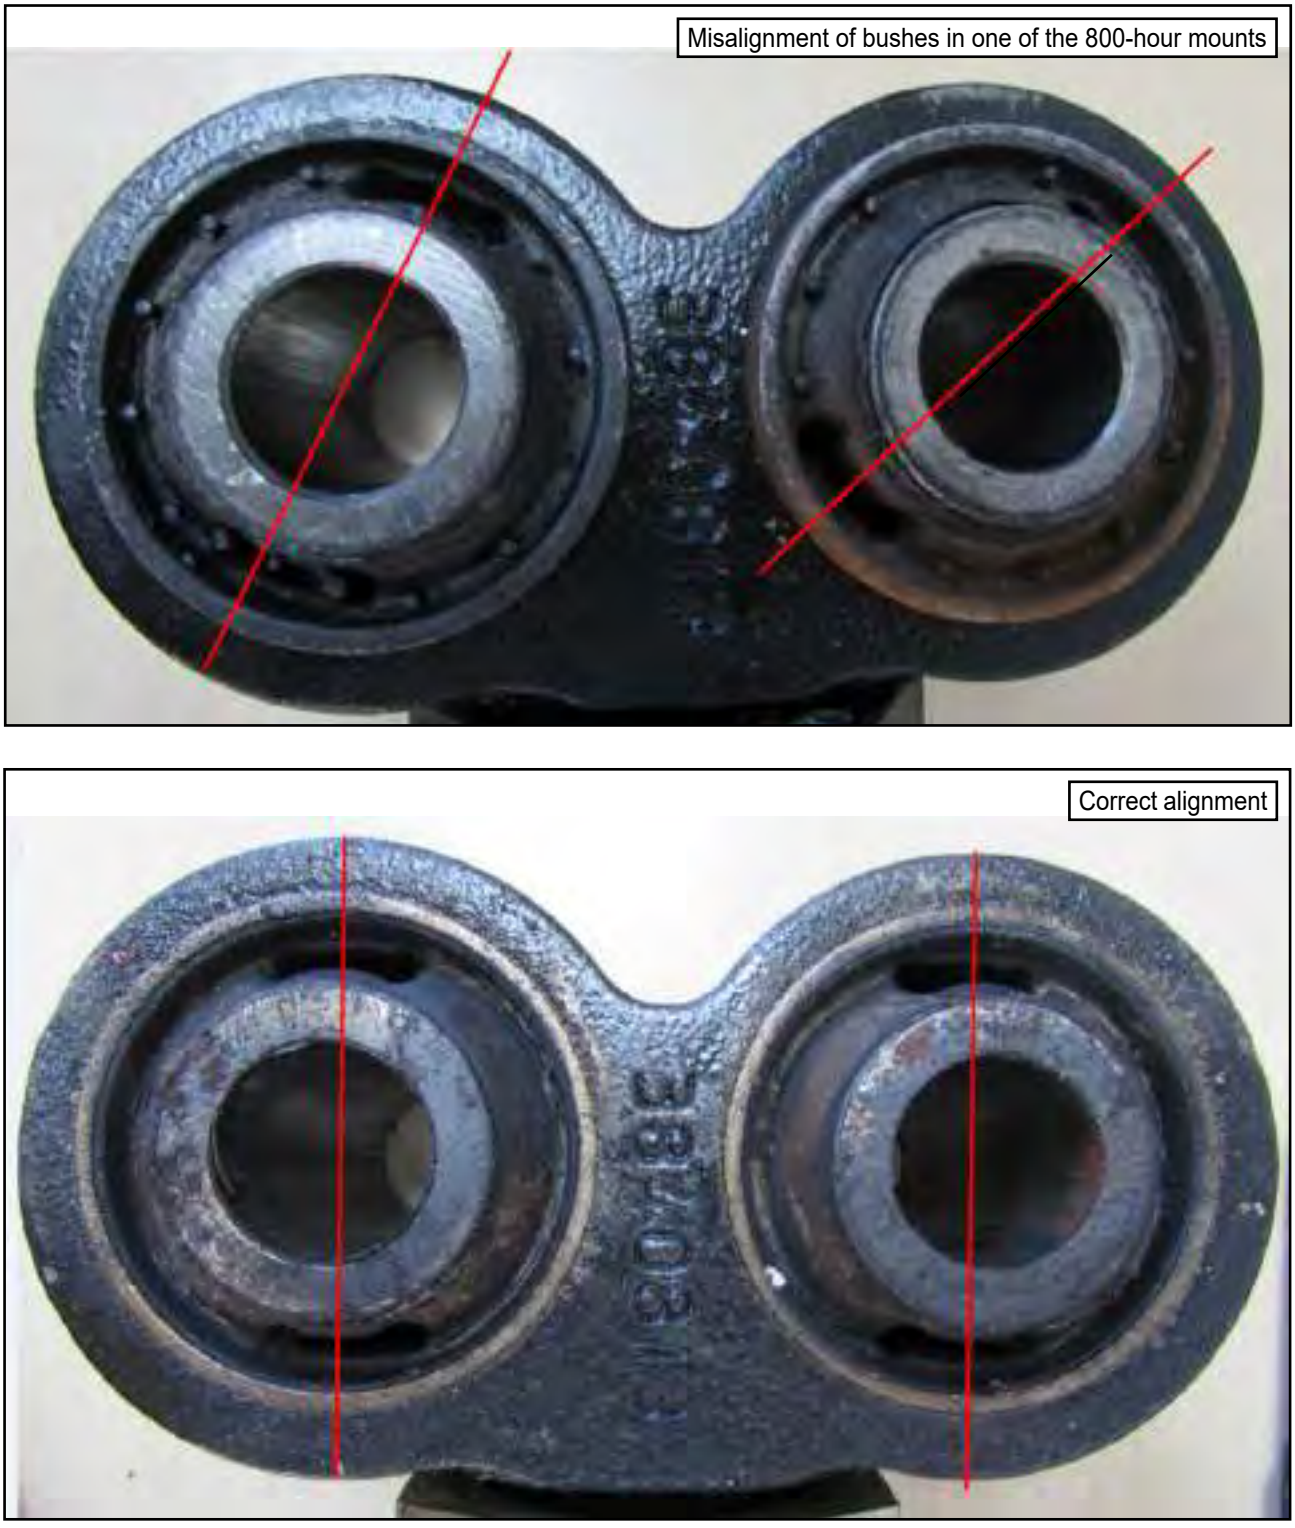
- Two engines with debri s in the sump pan and one with debris in the lubricating oil pump strainer. The debris included old cable ties **(Figure 29)**.

Figure 28: Engine flexible mount rubber bush misalignment

Figure 29: Debris found in engine sump pan and lubricating oil strainer
