MARINE ACCIDENT INVESTIGATION BRANCH

SAFETY DIGEST

Lessons from Marine Accident Reports

2/2022

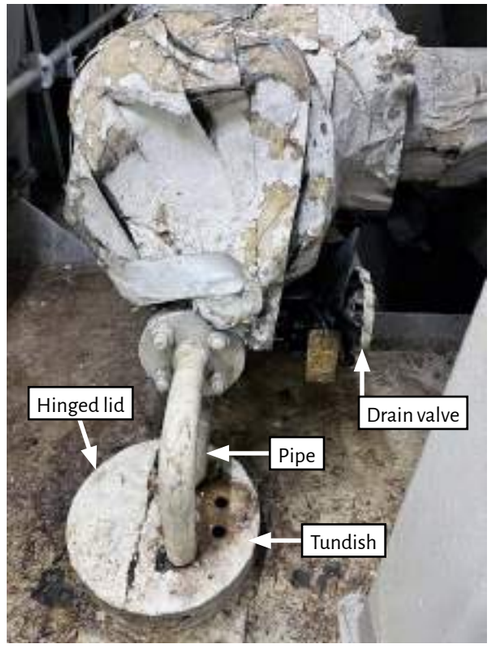
During rounds, a cruise ship's third engineer discovered a leak on the drain valve for one of the vessel's four economisers. There was an open-ended pipe running from the valve to a tundish drain in the deck (see figure). The chief engineer (C/E) was briefed and a decision was taken to conduct a repair. The economiser's circulating pump was stopped and the inlet and outlet valves were shut; the plan was to leave the system to cool down overnight before the repair.

However, after the isolations were in place, the second engineer (2/E) decided to check the system by opening the drain valve. Leaning over the valve, the 2/E cracked it open and pressurised hot water and steam burst out of the drain pipe. The force of the discharge caused the hot water to deflect upwards off the tundish, severely scalding the 2/E's face. After initial medical treatment on board, he was evacuated to a nearby hospital for specialist burns care.

Figure: Economiser drain valve and tundish

1. **Hazard →** The opening of drain lines on pressurised systems must be undertaken with extreme caution. The 2/E intended to check that the drain line and valve was unobstructed before the economiser was drained the following day when the system had cooled. It is reasonable practice to use residual system pressure to check a drain line, but it must be done in a controlled manner. The economiser working pressure was 8 bar. It is good practice to allow the working pressure to lower and the system to cool sufficiently before opening the drain valve.

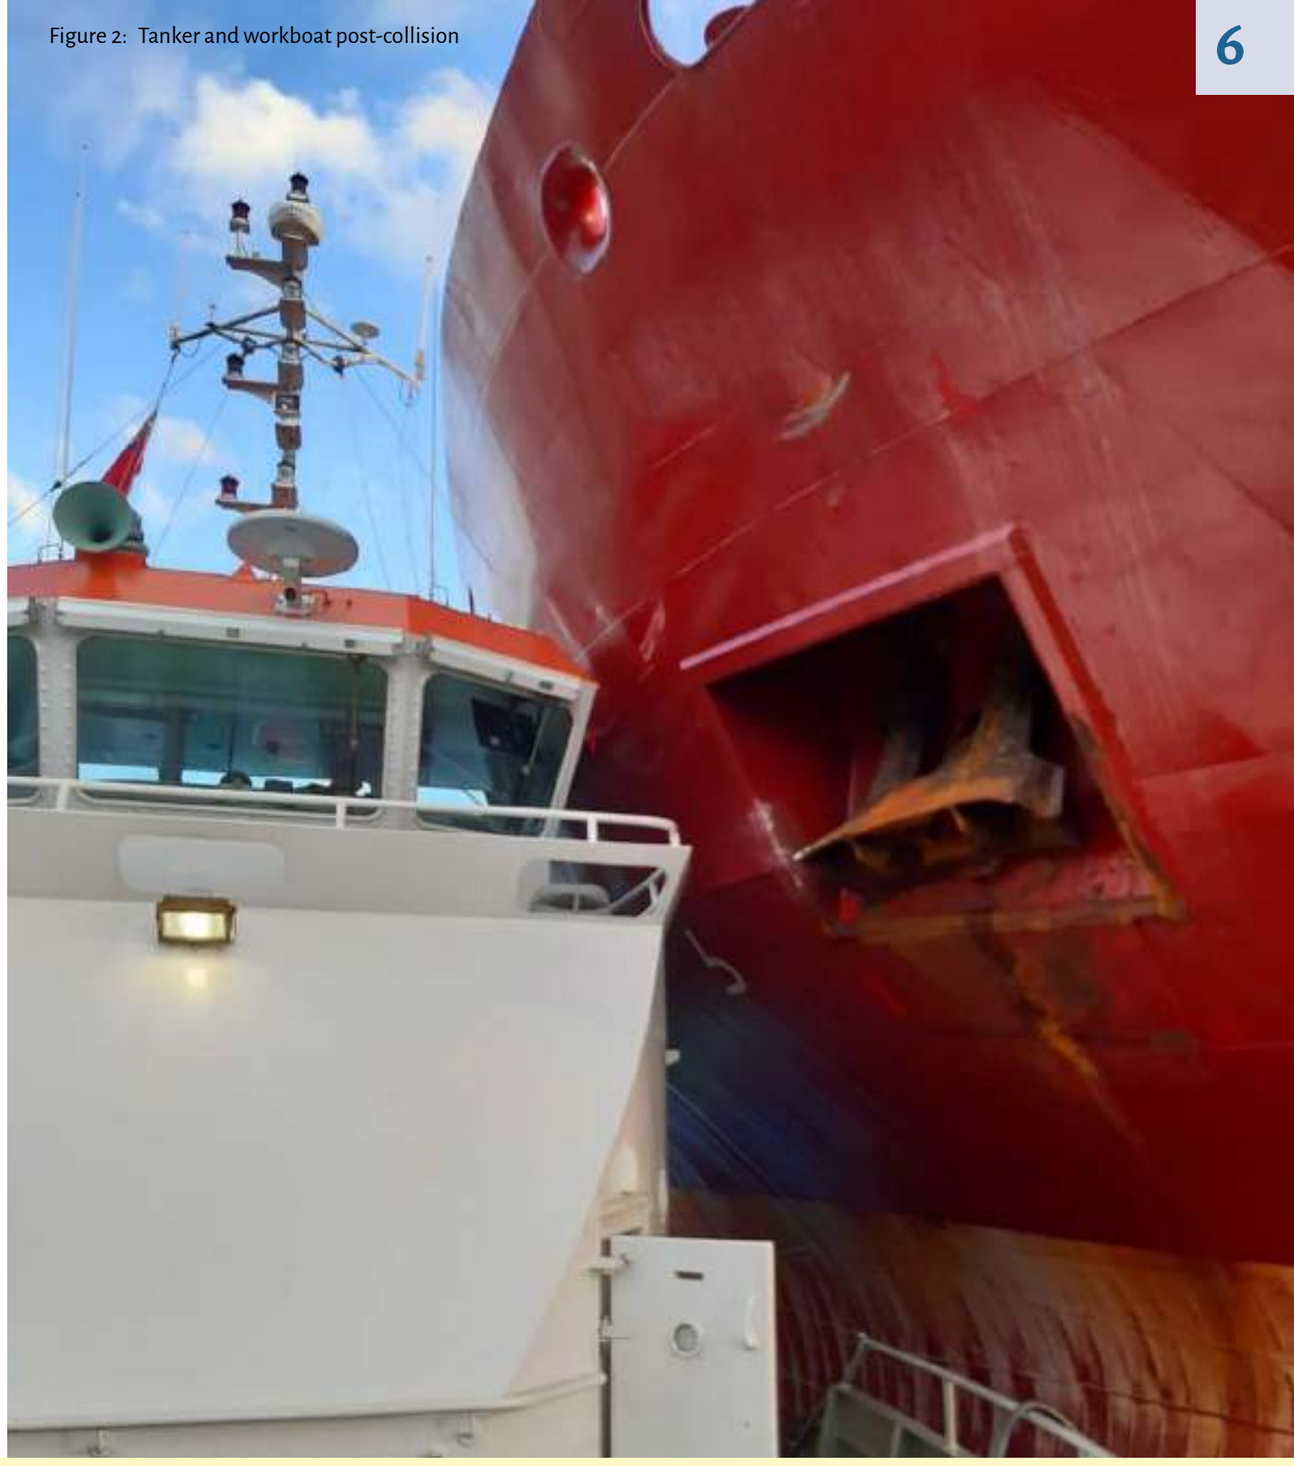
The forward movement was sufficient to break mooring lines and for the vessel's bow to make contact with an adjacent berthed workboat and ground (Figure 2). The workboat sustained minor damage and the tanker was refloated at high water with the assistance of tugs.

Figure 2: Tanker and workboat post-collision

1. **Procedure →** Standard operating procedures exist for a reason. A post-accident investigation determined that a defective circuit board in the propulsion control system had caused the demanded ahead pitch. However, the procedure for transferring control had been incorrectly followed and the first failed attempt had been a warning that something was wrong. This failure should have been thoroughly investigated before any further attempt was made to transfer control. The company has since updated its procedure to ensure that the bridge has control of propeller pitch before the engine is clutched in.

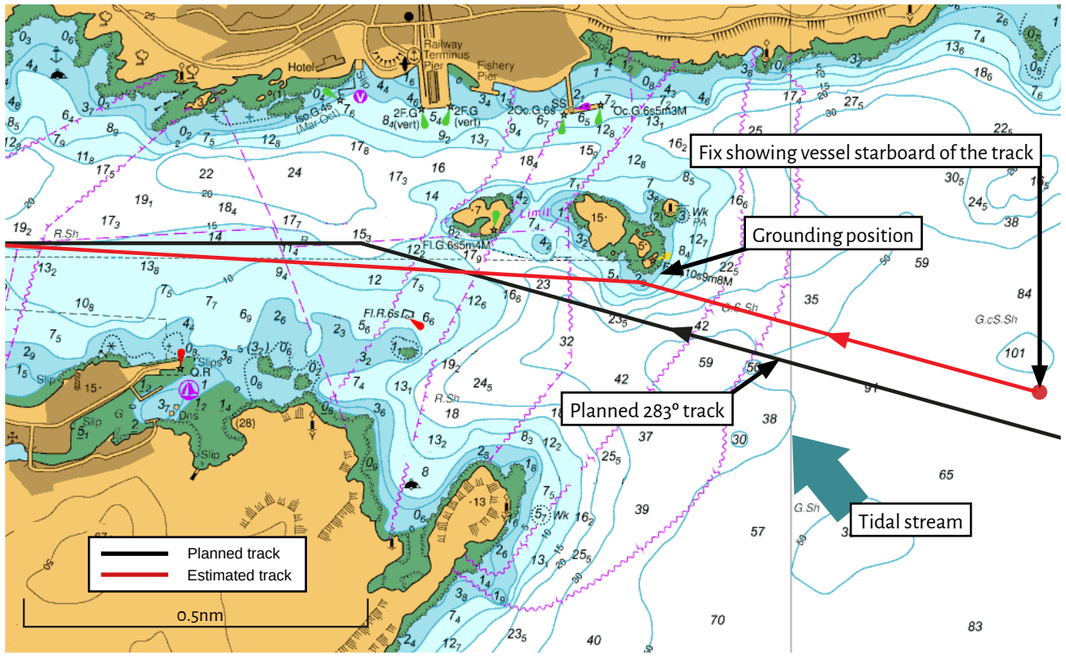
Aware that the vessel had probably grounded but also that there were further dangers to navigate, the master decided to press on with the voyage. Once clear of danger, the speed was reduced and a full check of the internal compartments and systems was completed in accordance with the emergency checklists; no damage or water ingress was found. On arrival into harbour the following day, a dive survey was organised and revealed shell plating damage.

Figure 1: Chart showing planned track and estimated track

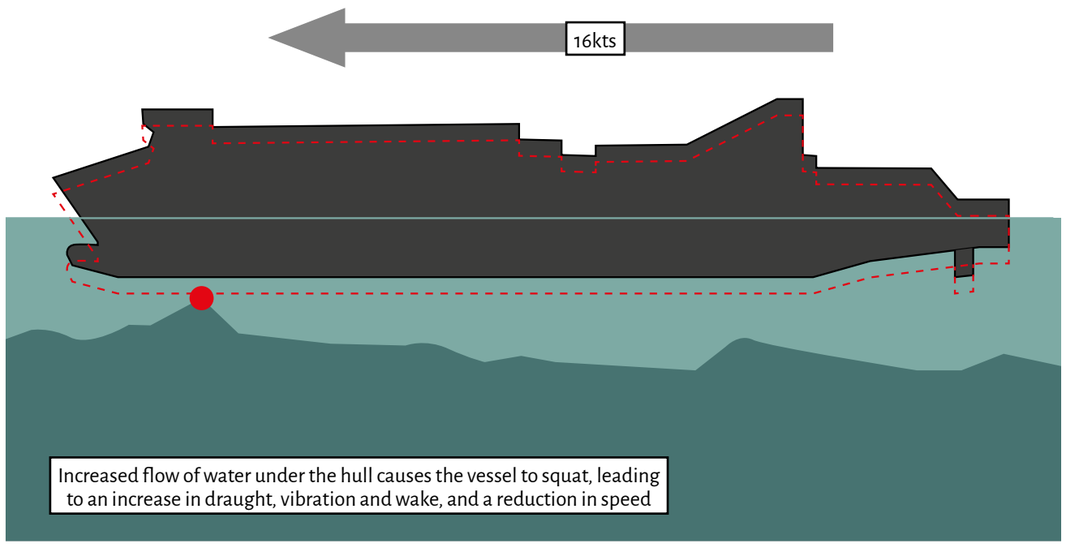
2. **Action →** As soon as the vessel began to experience the telltale signs of squat – vibration, a speed reduction and increased wake (Figure 2) – the master took the correct action. Slowing the vessel, and thereby reducing its draught, minimised the risk of further hull damage.

Figure 2: The effects of squat

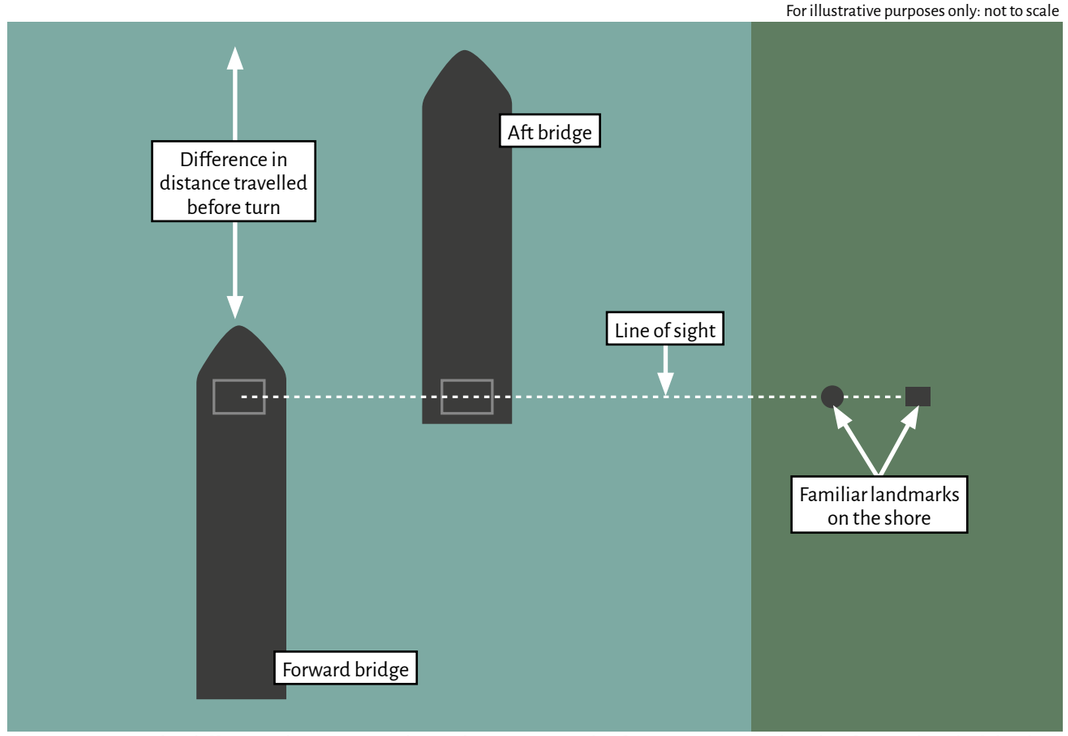
Figure 2: The difference between applying the same visual reference to a vessel with a forward and aft bridge superstructure

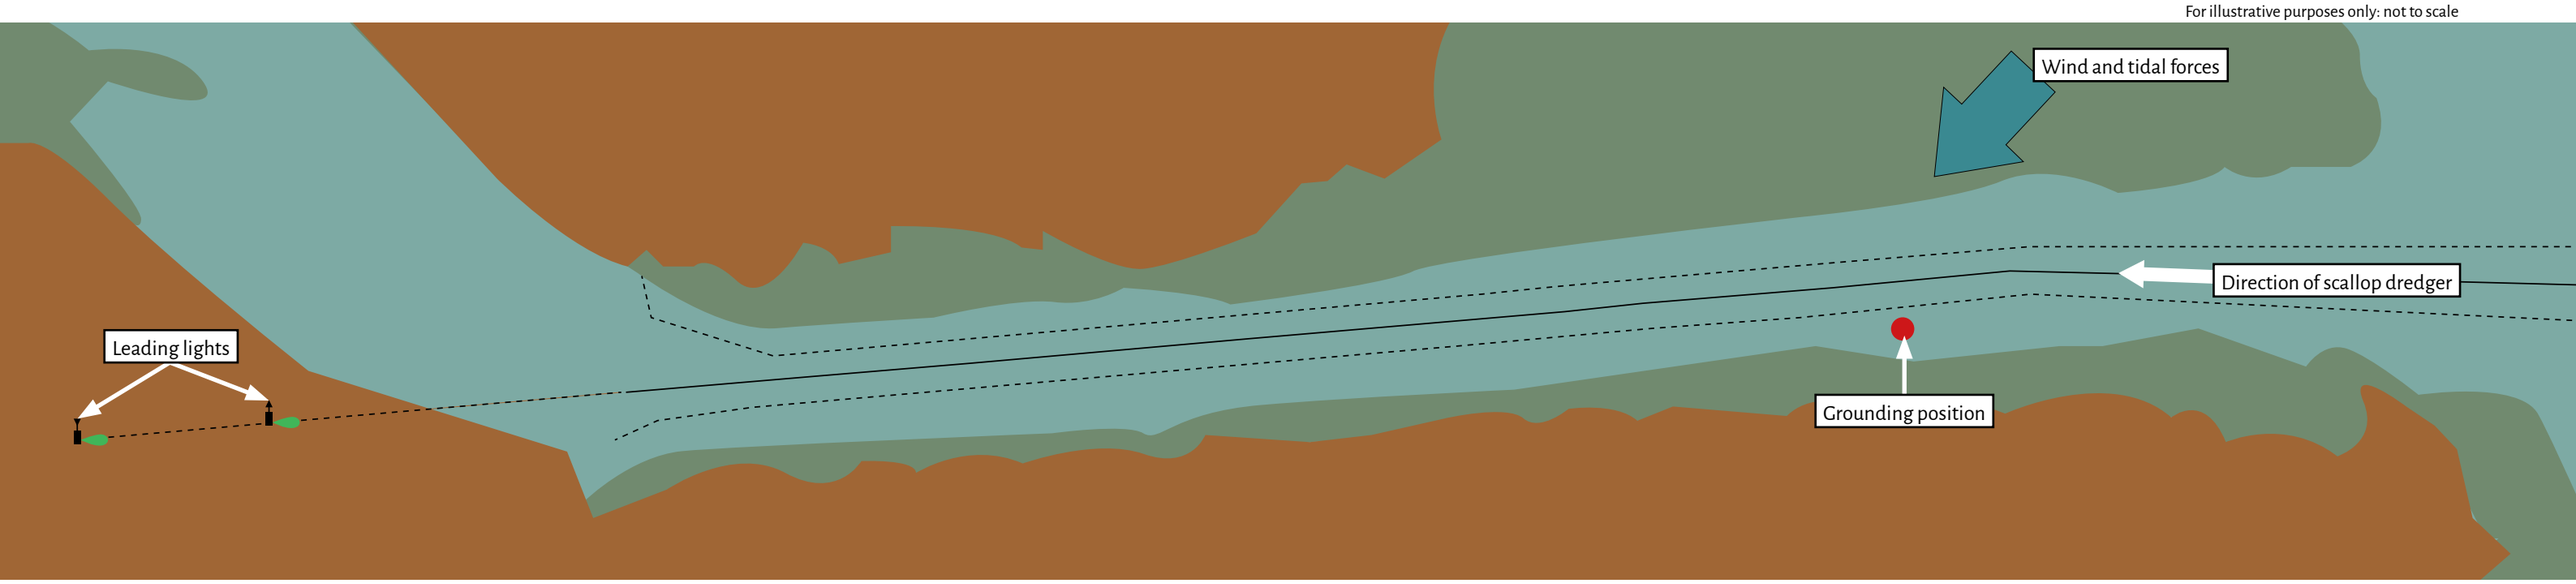
The skipper became confused by the multitude of shore lights and struggled to ascertain his position in the channel. The leading lights had not been identified and the vessel drifted out of the channel, running aground in mud and sand (Figure). Under its own power, and with the aid of the local lifeboat, the scallop dredger was hauled off the bank undamaged.

Figure: Chart of the port, showing the channel

1. **Plan →** Avoid ad hoc pilotage; every arrival and departure must be appropriately appraised and planned. Such preparation should include: a chart assessment, identification of danger areas, safe navigable water and suitable navigational aids, evaluation of the environmental conditions, suitability of daylight versus darkness channel navigation, and the experience of those in the wheelhouse.

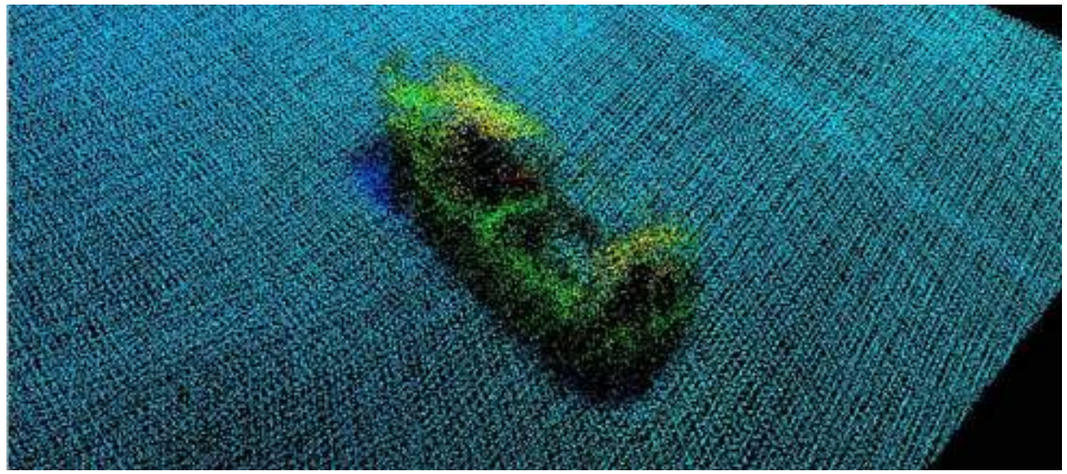
Realising that the situation was out of control, the skipper and mate set a course for the nearest harbour. Now heading directly into sea and wind, the vessel started to ship water over the bows. Concern was mounting and so, prompted by the coastguard, a “Pan-Pan” call was issued. Within seconds, the vessel capsized to starboard and all radio communications were lost. The local RNLI station’s lifeboats were conducting some training in the area and, with the help of another vessel, soon located the (Figure 1). The skipper and mate were cold and in shock but were rescued unharmed from the liferaft. Their vessel had found a new home on the seabed some 35m below the surface (Figure 2); the source of the flooding remains unknown.

Figure 2: The fishing vessel upright on the seabed

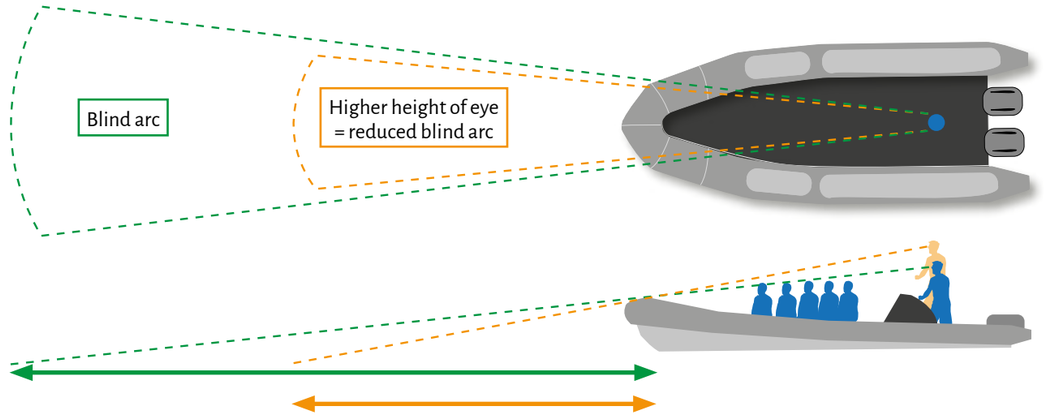
Figure 3: The effect on blind arc by raising the driver's height of eye

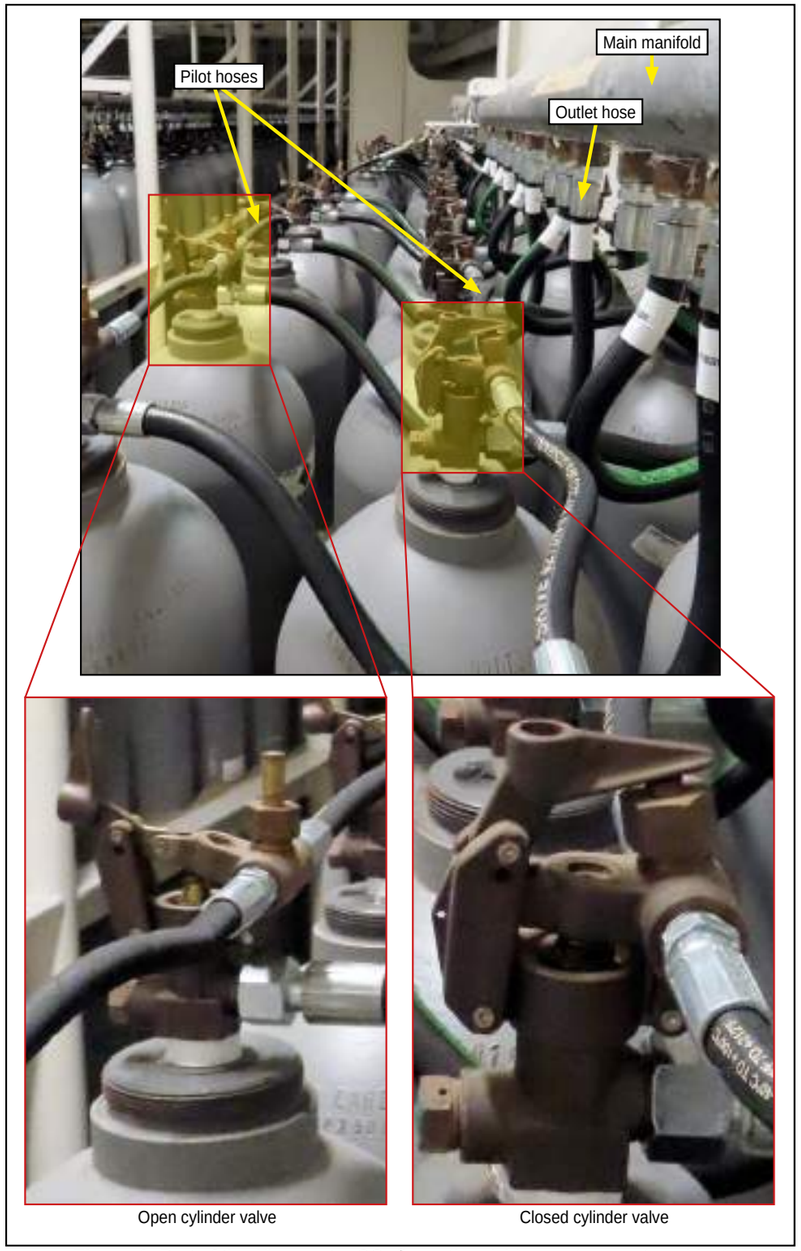
- The quality assurance processes of the pilot hose assembly supplier did not identify that the hose couplings had not been fully bored through.
- Viking's onboard installation testing processes did not identify both that some of the hose assemblies were blocked and that there were leaks in the CO_2 system pilot lines.

Figure 1: Part of the *Finnmaster* CO_2 fire extinguishing system post-accident

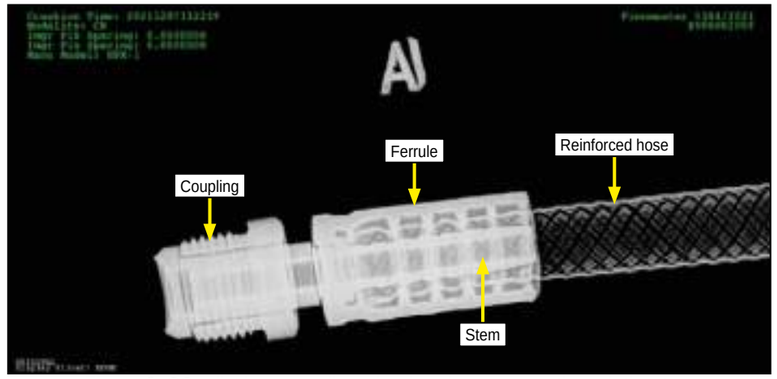
Figure 2: CO_2 pilot hose coupling, showing clear passage through the stem

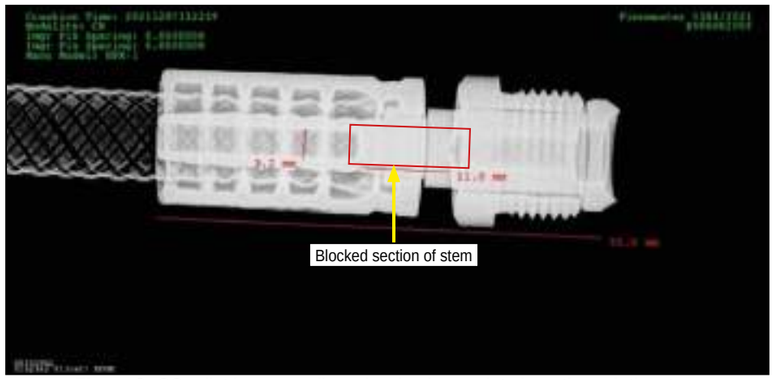
Figure 3: CO_2 pilot hose coupling, showing incomplete bore through the stem
