Inquiry 11-204: Container ship MV *Rena* grounding,  
on Astrolabe Reef, 5 October 2011

# Final Report

Marine inquiry 11-204  
Container ship MV Rena grounding  
on Astrolabe Reef, 5 October 2011

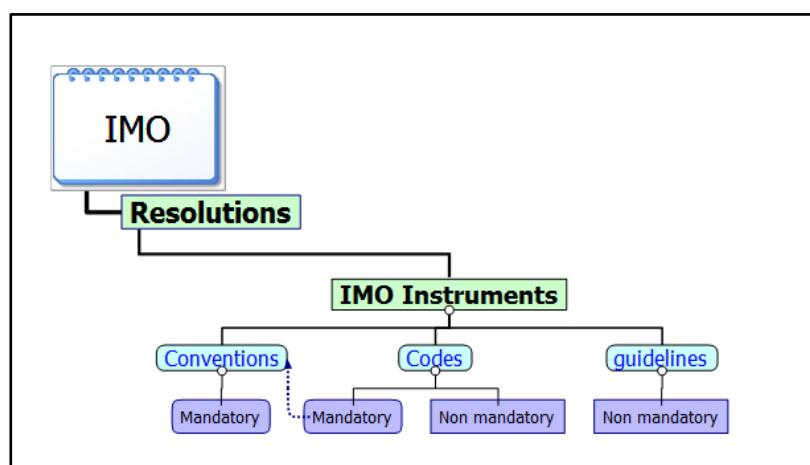
Figure 5  
Diagram of structure showing IMO instruments

- 4.1.5. International standards are published by IMO. IMO facilitates forums, during which member states agree through resolutions on various instruments such as conventions, codes and guidelines that set or recommend minimum standards covering all aspects of ship design, construction and the way ships are operated. Conventions are mandatory. Codes can be mandatory or non-mandatory, depending on the resolution. If a code is mandatory it becomes, in effect, part of any convention to which it relates. Guidelines are non-mandatory but are generally considered “best practice”. States elect which IMO instruments they will adopt. Once a state signs up to a mandatory IMO instrument, it is responsible for adopting the standards in the instrument into its domestic legislation and checking that ships under its registry comply with them. Refer to Figure 5.

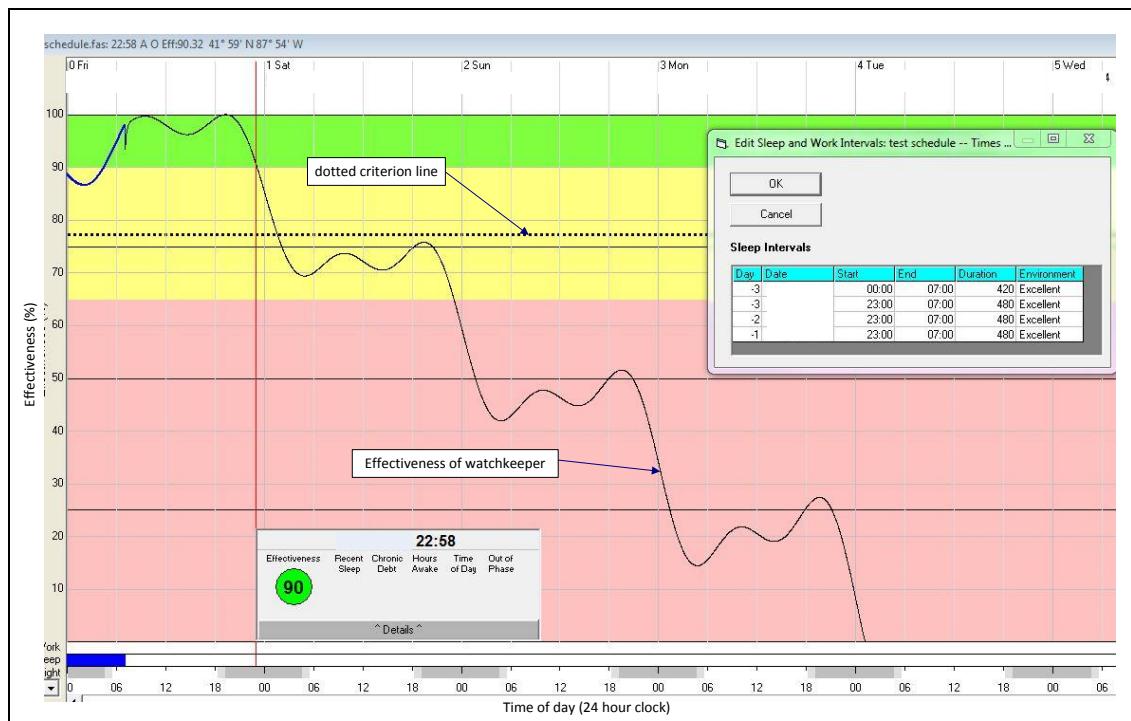
**Figure 6**  
Sample screenshot for FAST fatigue modelling software

Specifically, for the period preceding the grounding, the second mate's cognitive effectiveness has been assessed as being within the yellow zone, with time of day being highlighted as a risk factor".

- 4.4.11. The terminology used by the FAST software developers refers to the yellow zone and then the dotted criterion line within the yellow zone. Entering the yellow zone starts occurring during the night when someone is missing an entire night's sleep. That is, a watchkeeper may start drifting into the yellow zone as they start not getting their normal sleep. If they go a whole night without sleep (awake for 24 hours) they will fall below the dotted criterion line within the yellow zone. As a watchkeeper approaches the time that they would normally sleep on the second night (effectively 40 hours without sleep) they will begin to enter the red zone.
- 4.4.12. Figure 6 shows a sample screenshot for a watchkeeper who begins with normal sleep and no work (green zone), then data is entered for obtaining no sleep in successive days.

- 4.4.13. The Commission considered the reports of Dr Gander and the ATSB. The methodology used in each was different, but both agreed that the extent to which fatigue contributed to the grounding was difficult to quantify. The ATSB said that the FAST analysis of the work/sleep evidence showed that both the master's and the second mate's performance was at least mildly affected by fatigue. The ATSB also said that their actions and omissions on the night of the grounding were consistent with fatigue. However, those same actions and omissions were occasionally demonstrated throughout the Rena's voyages as discussed earlier in this report. For example, the lack of cross-checking information during the watch handover from second mate to master on the morning of the grounding was consistent with fatigue, but it was also consistent with typical watch handovers between the second mate and the master on other voyages.
