SAFETY DIGEST

**Lessons from Marine
Accident Reports
2/2015**

SAFETY DIGEST
Lessons from Marine Accidents
No 2/2015

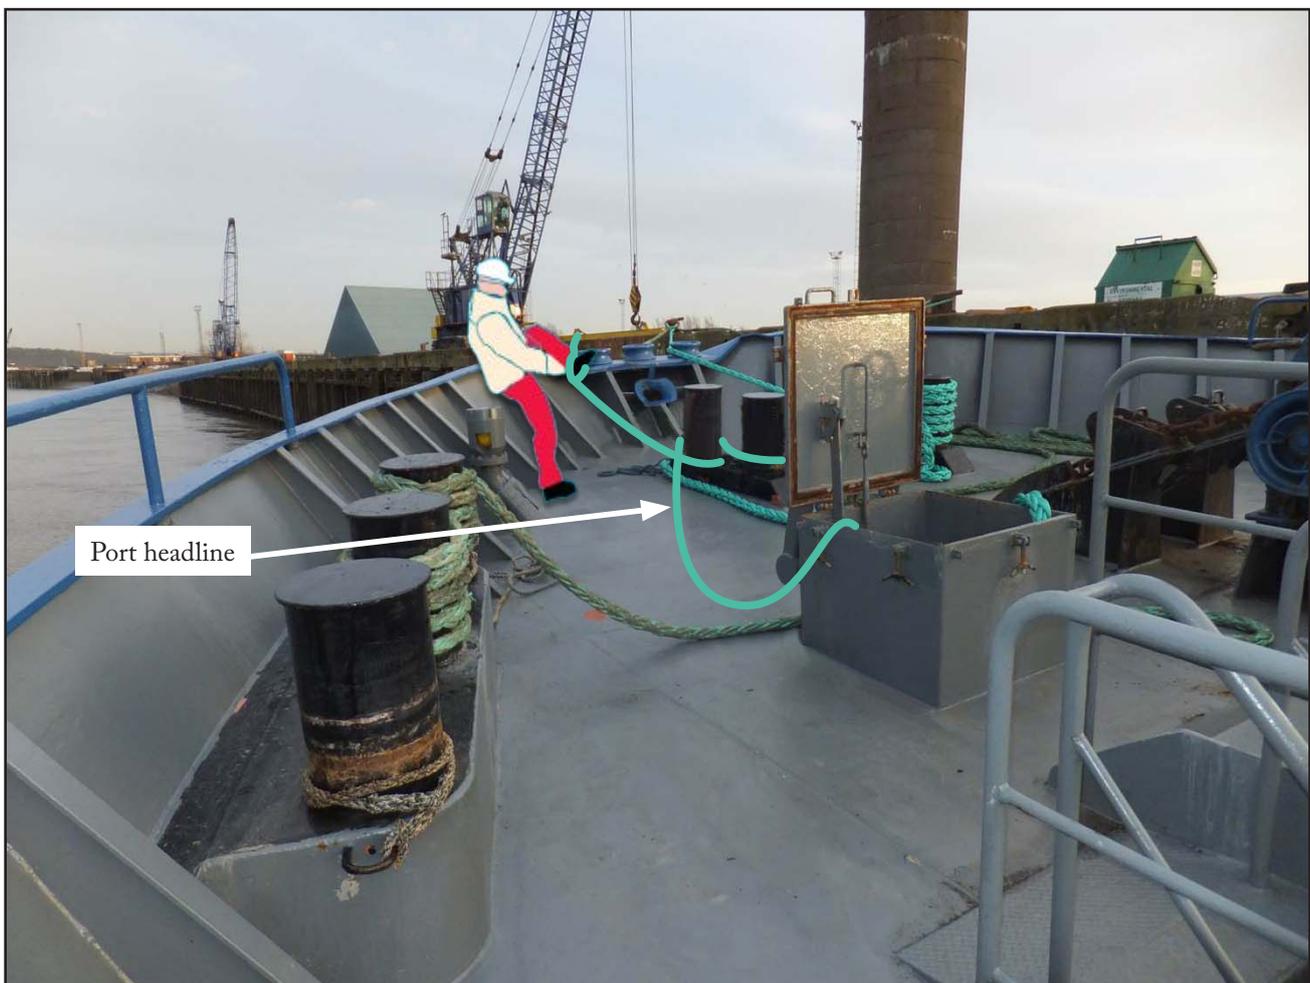
2. The crewman was unsupervised at the time of the accident and it is probable that his foot became trapped in a bight when he was controlling the slack rope with his foot as the headline paid out. Mooring operations should always be supervised by a competent person who can retain an effective overview of the operation, to ensure that appropriate safety standards are maintained.

Reconstruction of accident scenario

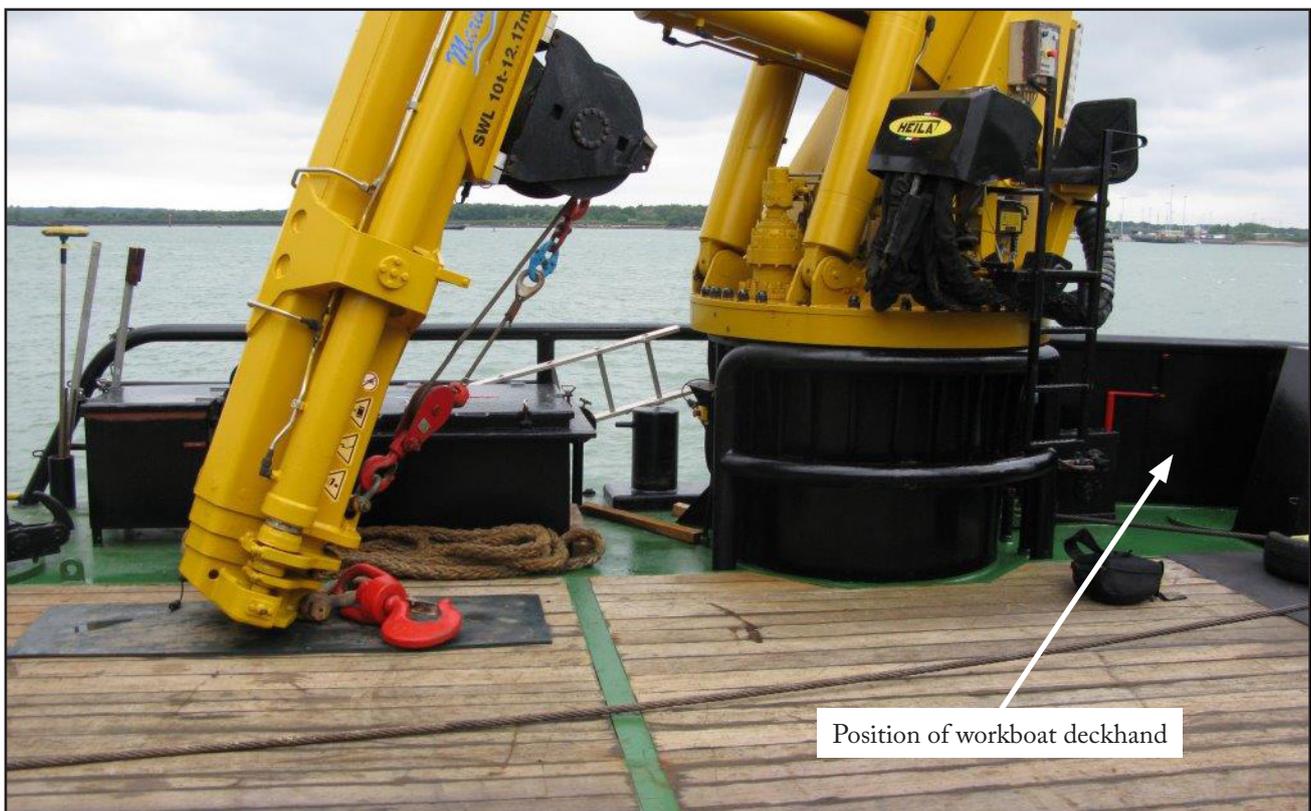
Figure 2: View towards port side

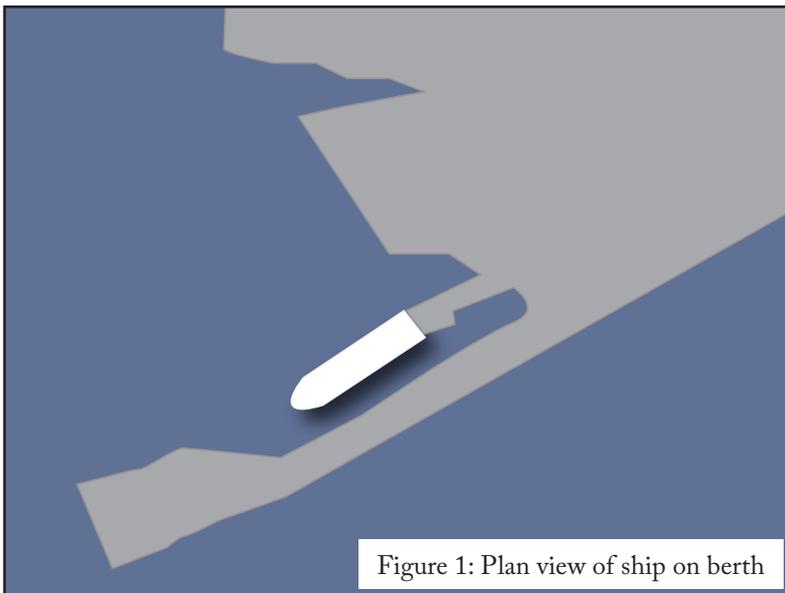
Figure 1: Plan view of ship on berth

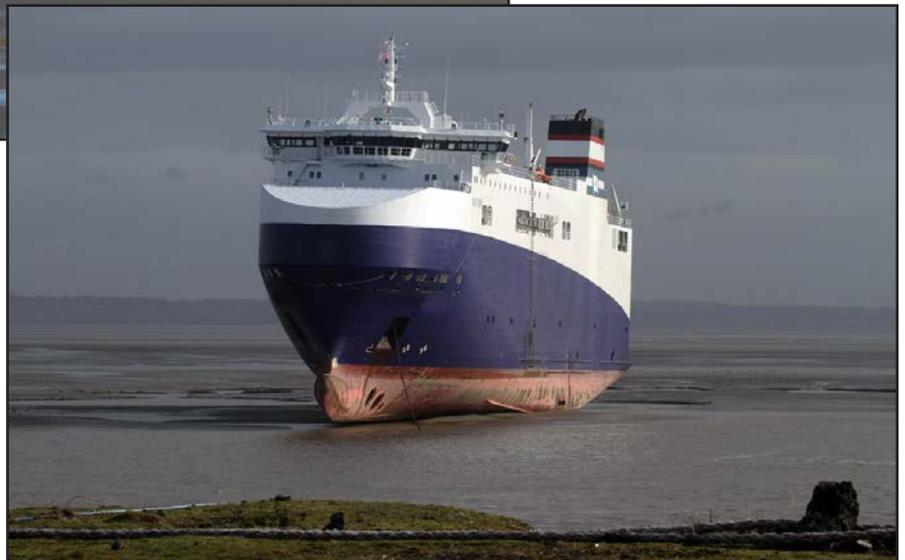
As the vessel was blown out of the dredged area of the port towards shallow water, a port pilot embarked to assist the master and they agreed that, due to the high winds, it was no longer possible to sail into open water. The master, helped by the pilot, spent the next 50 minutes trying to reduce the vessel's exposure to the wind and to keep the vessel in deep water. However, the vessel ultimately grounded on sand and mud 45 minutes after high tide (Figures 2a and b).

Figures 2a and b: Vessel aground

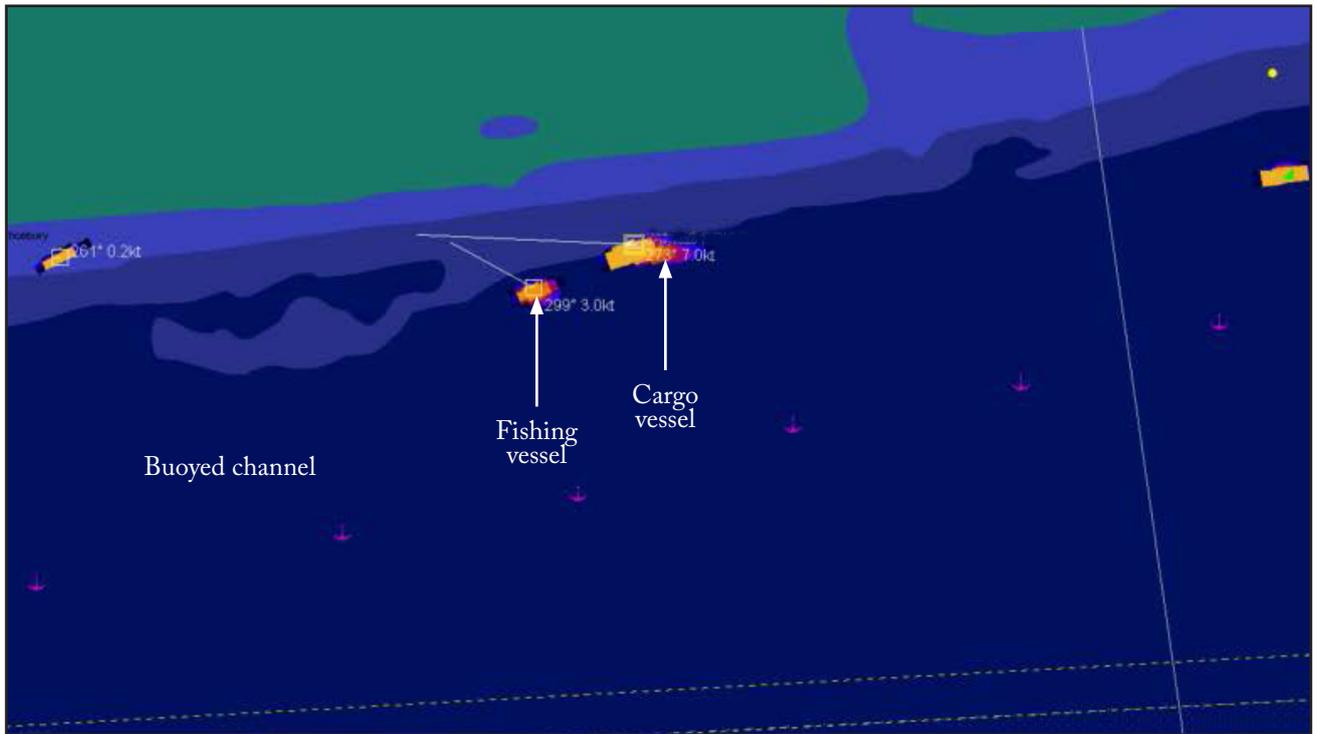
The cargo ship was only 0.2nm away and the vessels were now heading for a collision (Figure 3). In response, the cargo ship's deckhand turned the cargo ship further to the north, reduced its speed and sounded the general alarm. However, the vessels collided soon after (Figure 4); the trawler's bow struck the cargo ship's port side. The cargo ship then ran aground in shallow water outside the channel.

Figure 3: Snapshot 3

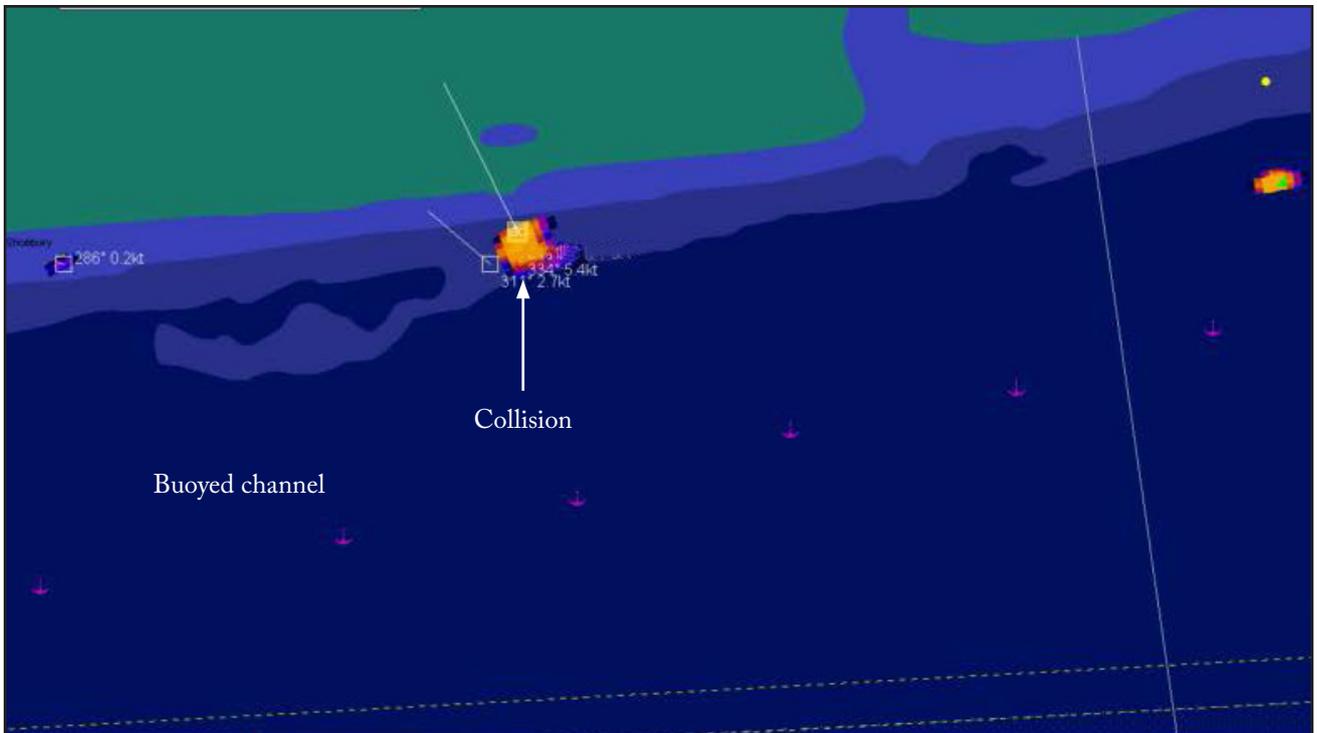
Figure 4: Snapshot 4

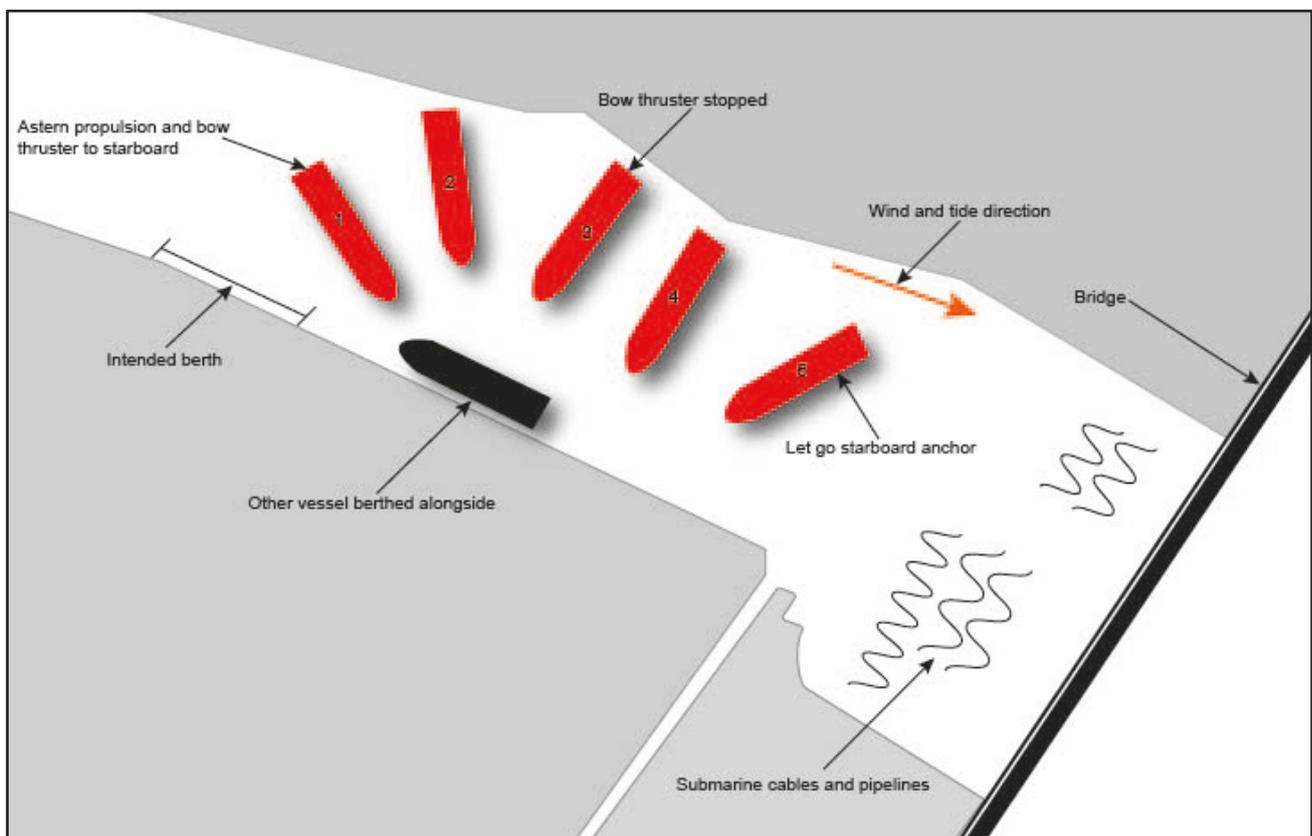
The pilot ordered astern propulsion and bow thruster to starboard. Halfway into the turn, the bow thruster stopped. Aware that the vessel was being set towards a bridge that spanned the waterway, and that he would be unable to complete the turn using only helm and propulsion, the pilot ordered the starboard anchor, and then the port anchor, to be let go. Although this had the effect of assisting the turn, the vessel was too close to the bridge to prevent its stern impacting with it.

Sequence of events leading up to the accident

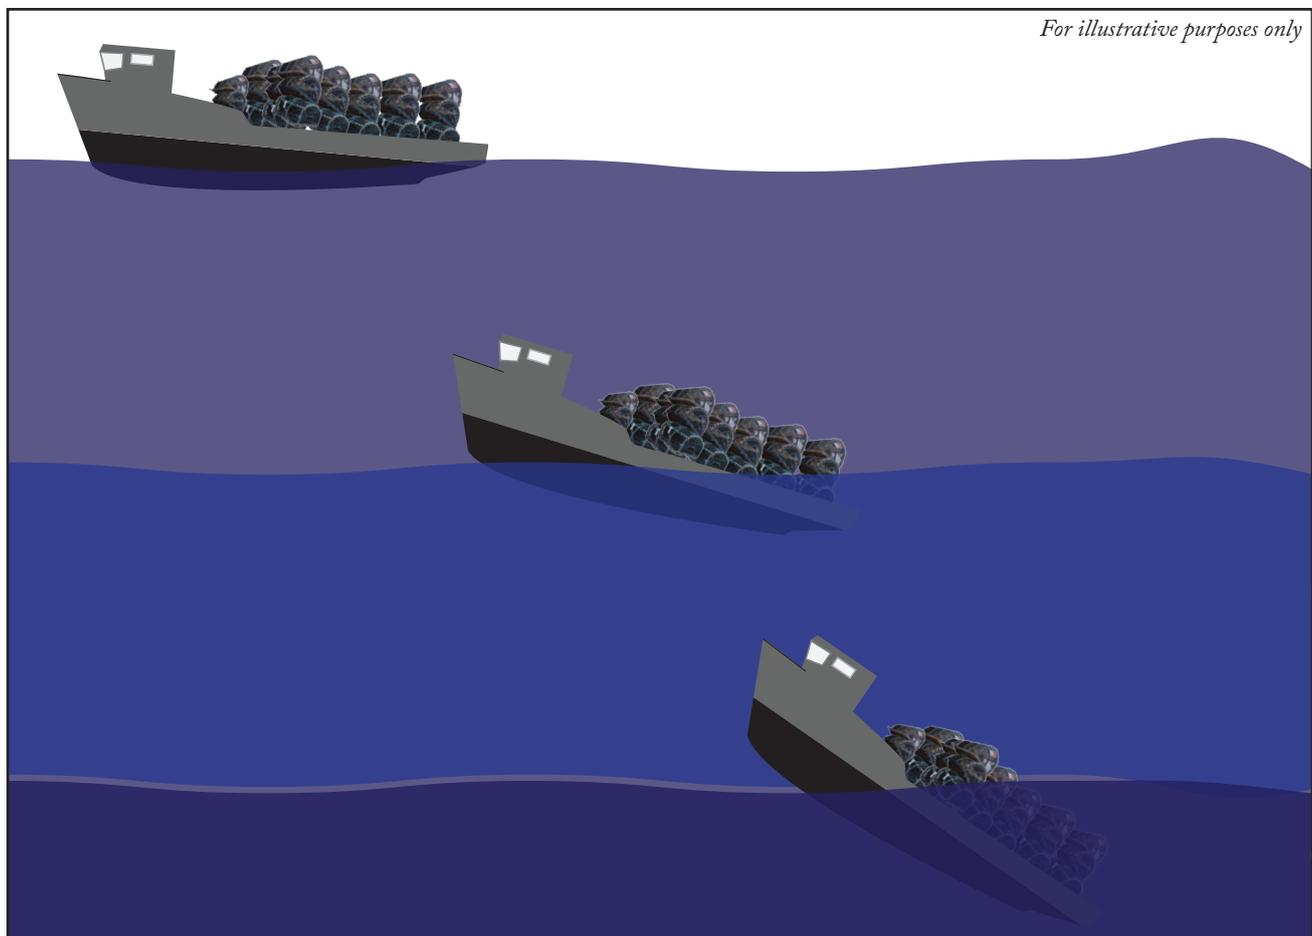
The skipper had previously disconnected the fish hold bilge alarm, relying solely on the engine room bilge alarm, which had been tested a week before the accident.

Behaviour of fishing vessel with heavy stern trim during flooding

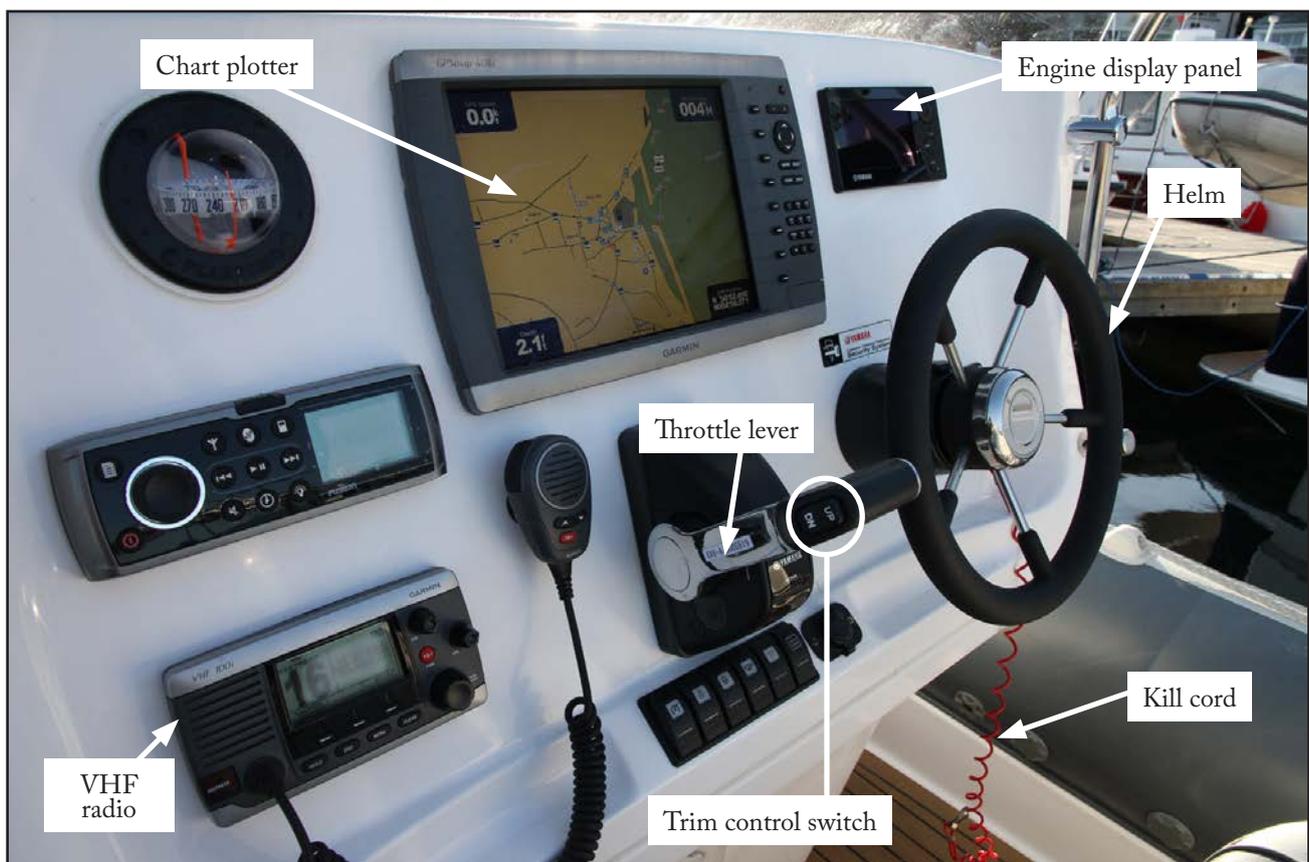
1. When the accident occurred the driver was not wearing a kill cord. Regardless of how short the planned journey may be, a powerboat driver should always attach the kill cord around his/her leg before the engine is started.

Figure 1: Steering console

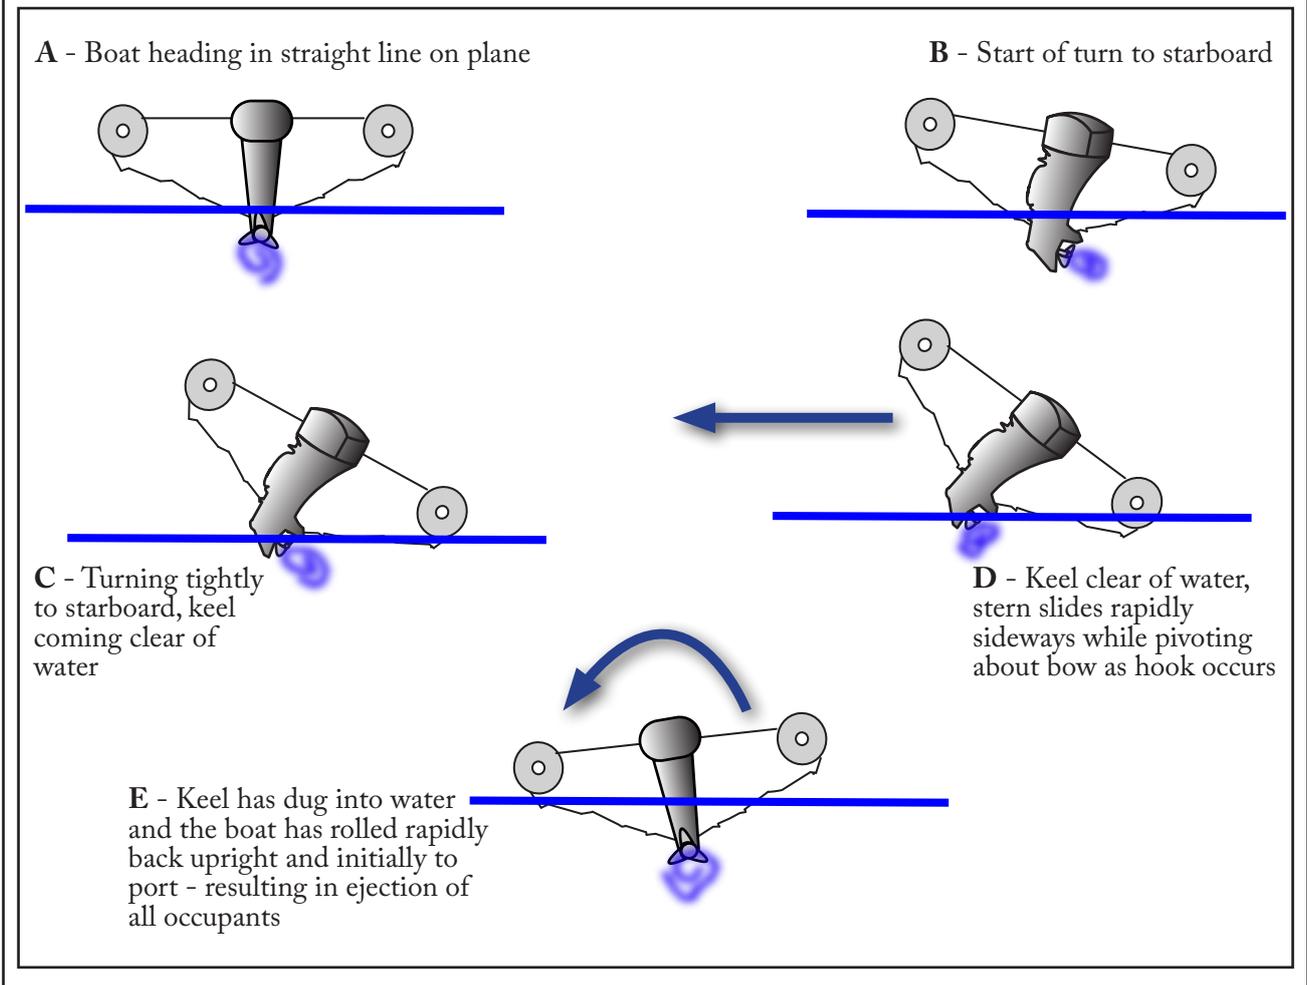
2. The adults did not have a good understanding of how the boat would perform in a high powered turn and were not prepared for the forces exerted when the boat 'hooked'. Entry level powerboat training courses may not be sufficient preparation for the safe operation of boats with powerful engines. Always ensure you are sufficiently well trained to safely handle your boat.

Figure 2: Diagram showing a hook during a turn

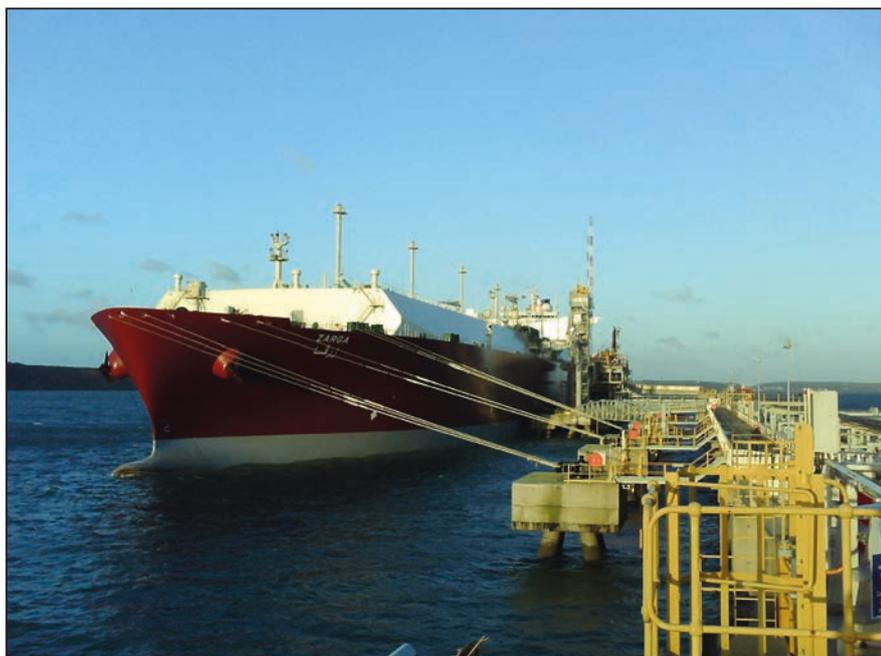
Figure 1: Zarga alongside South Hook LNG terminal

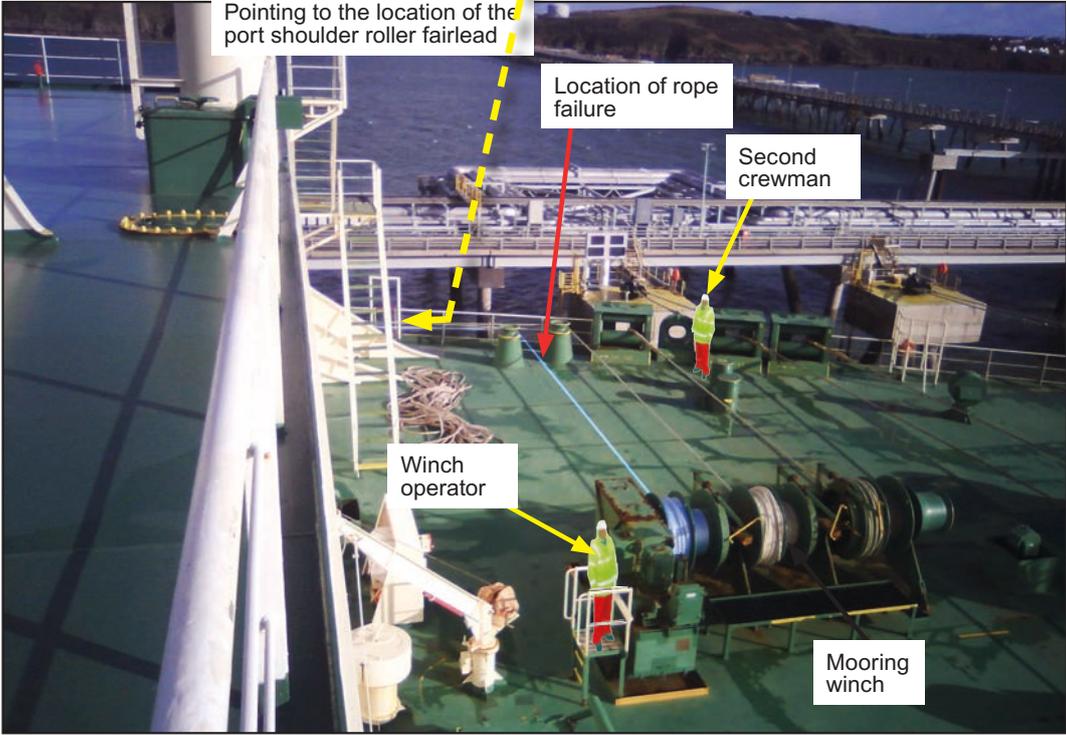
Figure 4: Port side forward mooring deck
