Report on the investigation of
a main engine room fire on board

Pride of Canterbury

while berthing in Calais

on 29 September 2014

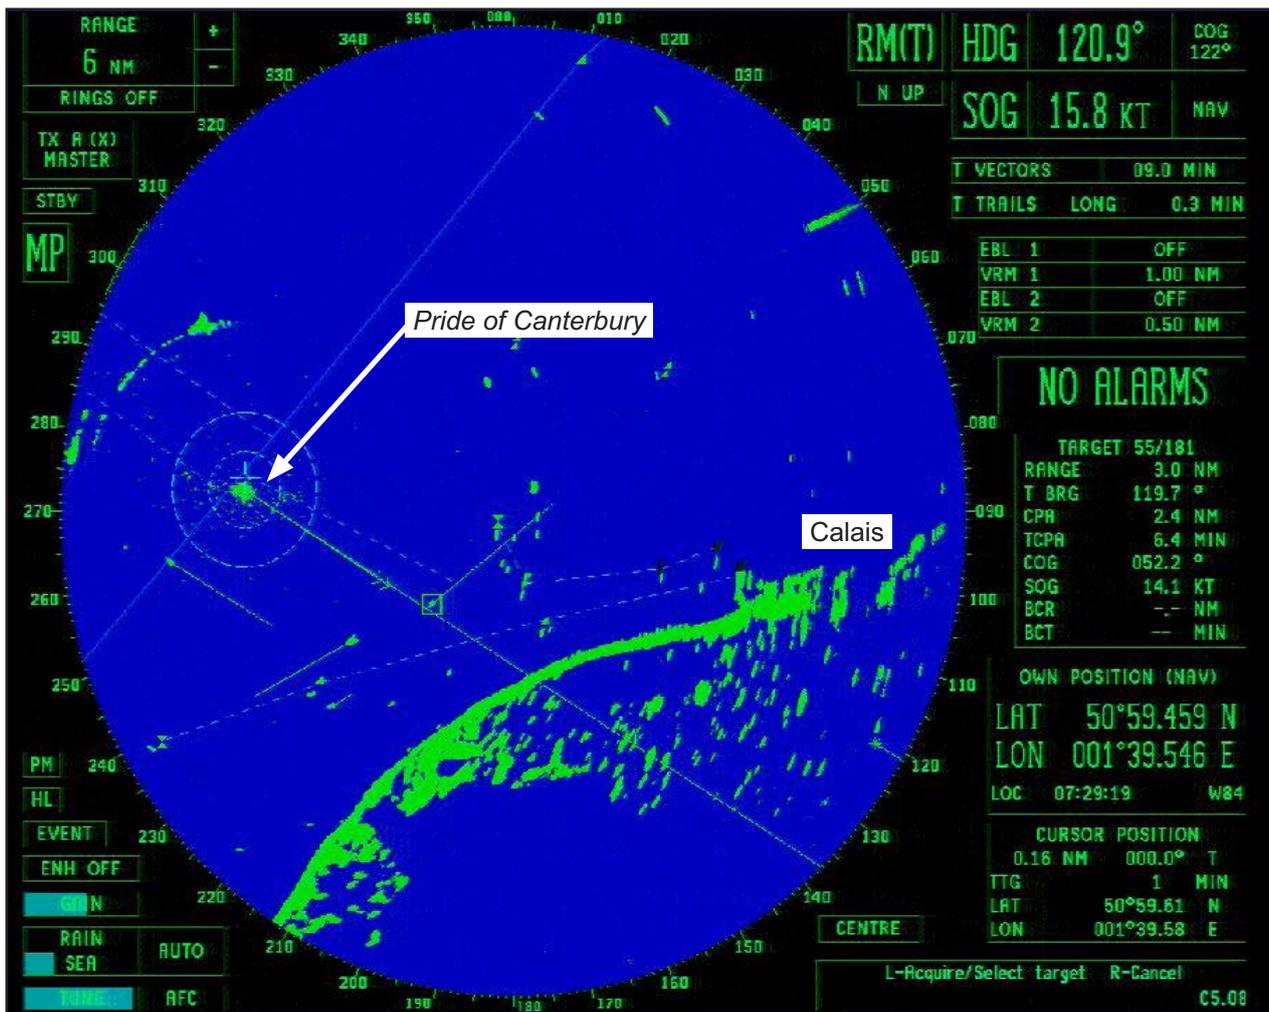
Figure 1: Radar display at 0729 on approach to Calais

At 0729 (**Figure 1**), just as the second engineer in the engine control room (ECR) received a call from the bridge giving him 15 minutes' notice of end of passage, the starboard controllable pitch propeller (CPP) hydraulic oil system high temperature alarm sounded. The senior third engineer left the ECR for the main engine room to investigate (**Figure 2**).

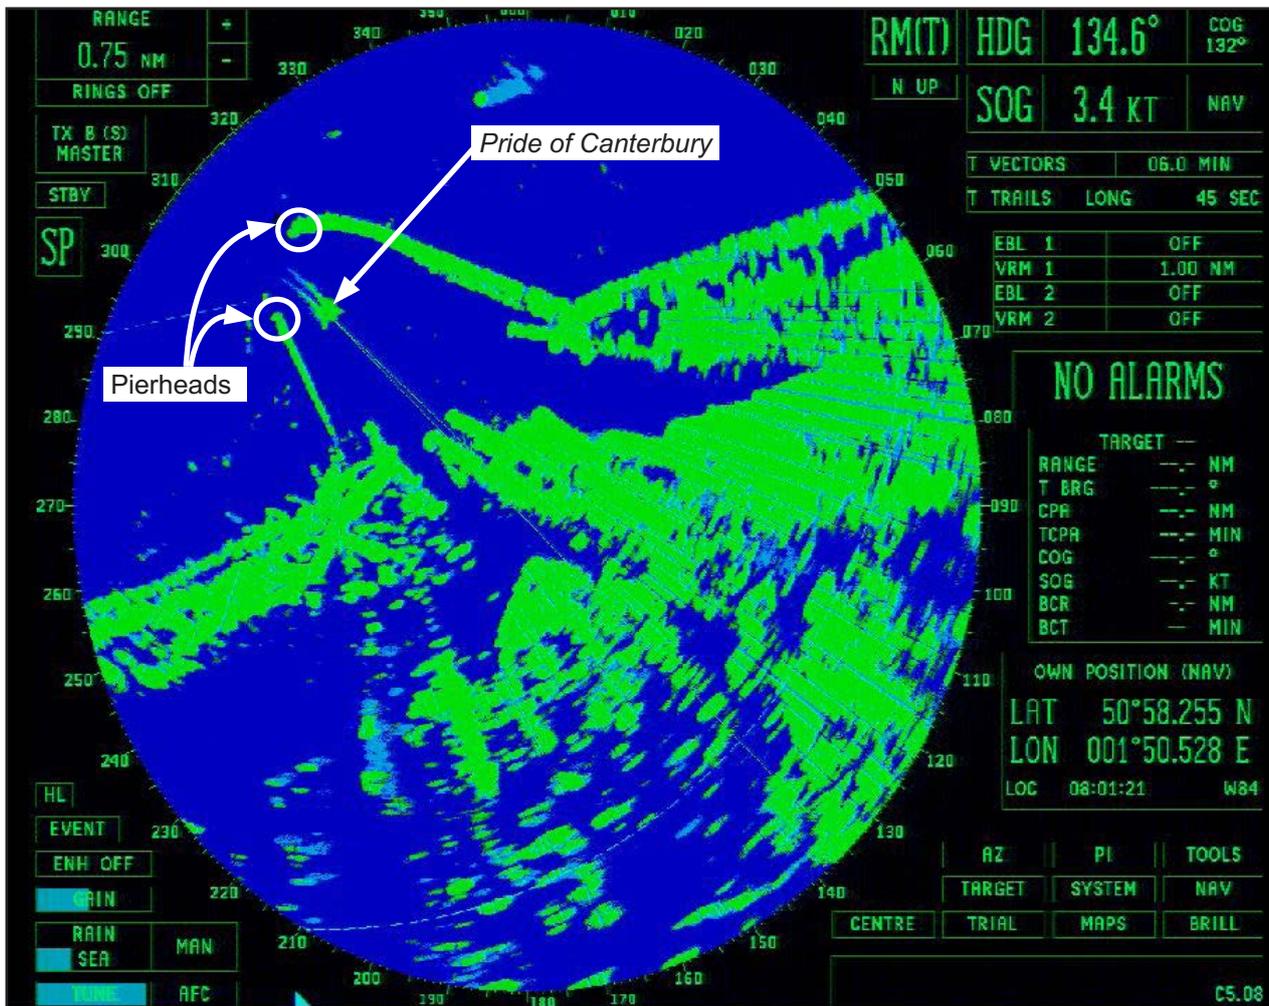
Figure 4: Radar display at 0801 on final approach to berth

At 0801, with *Pride of Canterbury* approximately 4 cables from the berth (**Figure 4**) the master moved from the centre console to the starboard wing console and took control of the port CPP, both rudders and one bow thruster.

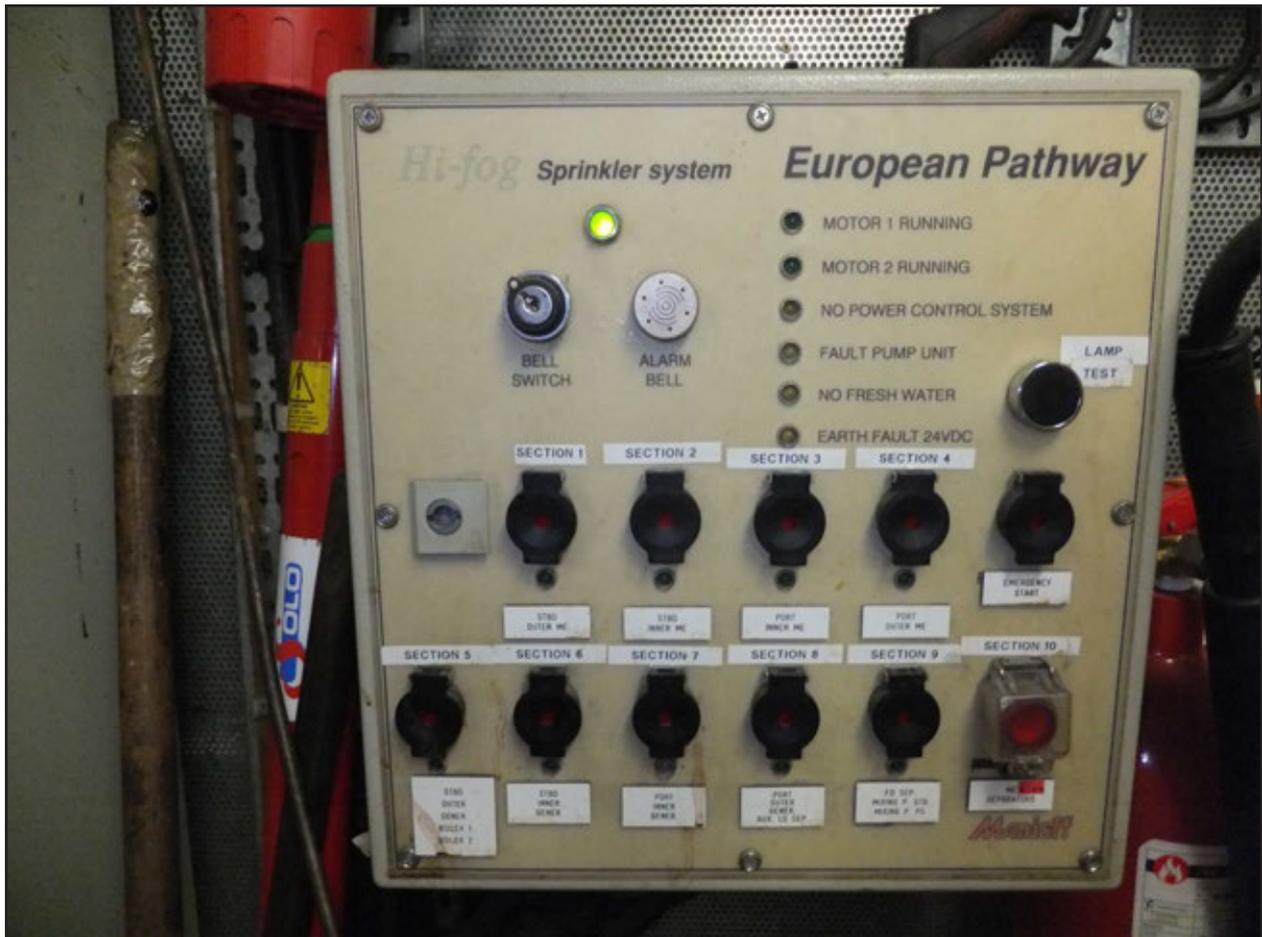
Figure 7: Hi-fog control panel in engine control room (*Pride of Canterbury* was previously named *European Pathway*)

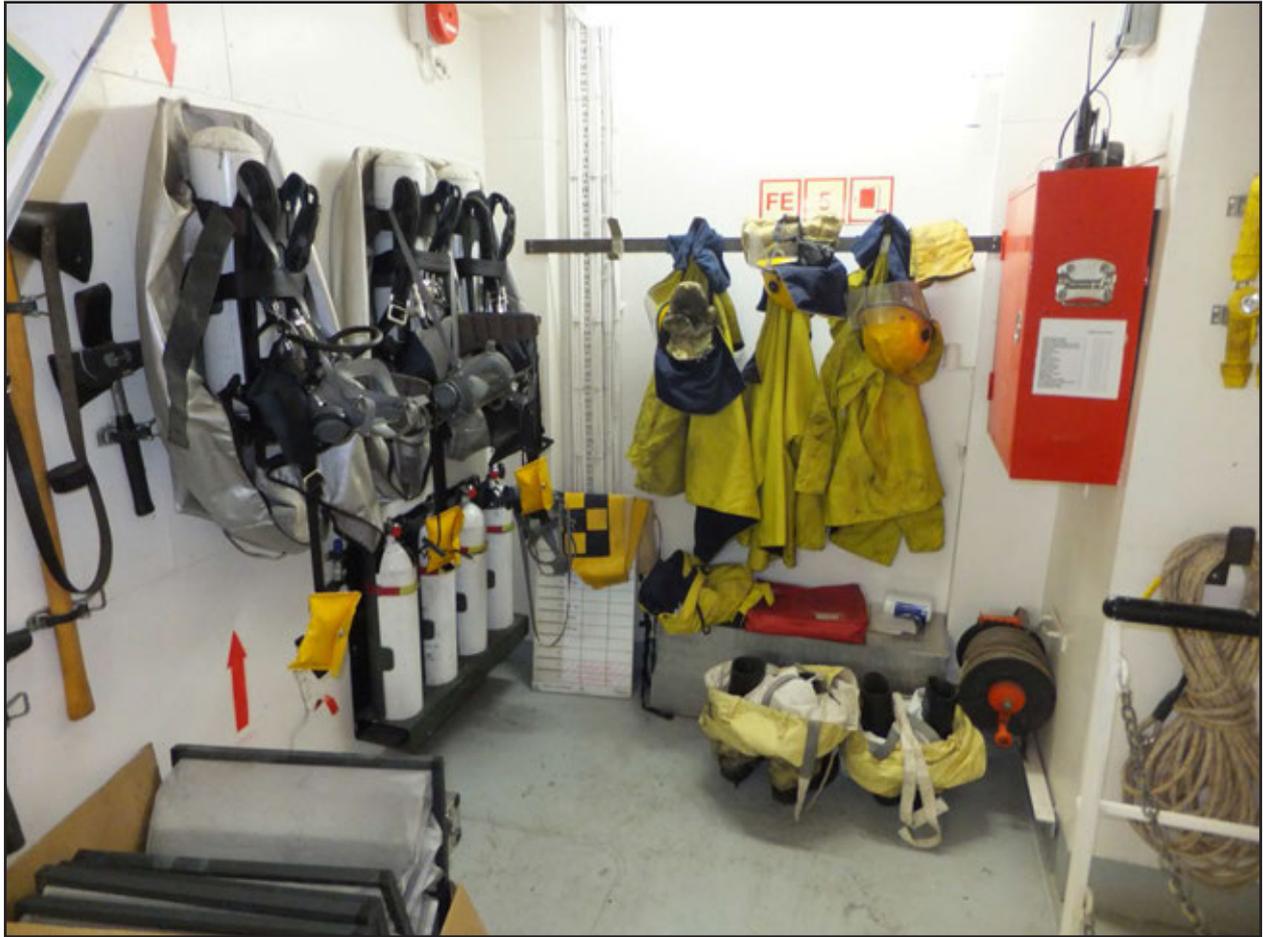
Figure 8: Fire party muster station

The chief engineer instructed the junior third engineer and motorman to don breathing apparatus (BA) at the fire party muster station outside the ECR (**Figure 8**), and a fire hose was rigged in the auxiliary engine room ready for re-entering the main engine room. The chief engineer briefly spoke to the master and informed him that he would like to shut down the port main engines as soon as possible. This was acknowledged by the master. At 0810, a tug arrived and was requested to stand-by the ship's stern ready to push the ship alongside.
