Fire on board the livestock carrier *Ocean Drover*

Fremantle, Western Australia | 9 October 2014

ATSB Transport Safety Report
Marine Occurrence Investigation
315-MO-2014-012
Final – 11 March 2016

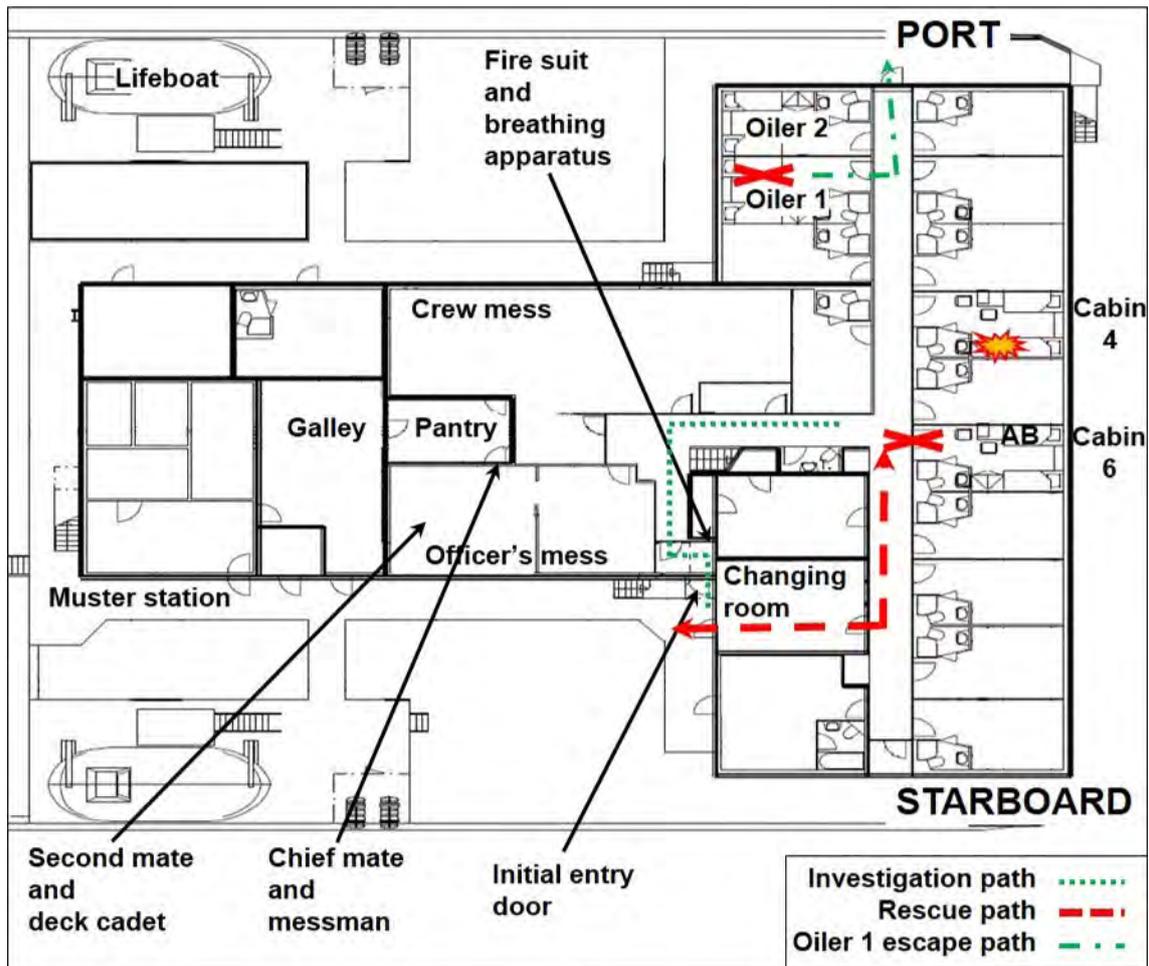
Figure 2: Diagram of upper deck accommodation showing key locations and paths

At the time, most other crewmembers, including watch keepers, were in the accommodation spaces. One able seaman (AB) and an oiler (oiler 1) were asleep in their cabins after their night watches (Figure 2). Another crewmember, oiler 2, was due to start work in the engine room at 0800 and was in an adjoining cabin.

Shortly after 0745, when oiler 2 left his cabin, he immediately smelled smoke and heard a crackling sound. He traced the sound to the nearby cabin 4. He opened the door and was confronted by flames, intense heat and thick, black smoke. He dropped to his hands and knees and hurried away toward the officer's mess room to raise the alarm. The door of cabin 4 remained open.

At about 0750, oiler 2 entered the officer's mess room (Figure 2) shouting that there was a fire. The chief mate, second mate, deck cadet (cadet) and mess man were in the mess room. At about the same time, the ship's fire alarms began to sound.

At about 0800, the second mate, wearing a firefighter's outfit and BA, entered the accommodation via the starboard upper deck doorway, adjacent to the external stairs up to the bridge deck (green dotted path in Figure 2). Once inside, he moved along the passageway, inboard and then forward, toward the crew cabins.

Shortly afterwards, the second mate re-entered the accommodation through the changing room which led directly to the port-starboard corridor (red dashed path in Figure 2). The chief mate stood by outside the changing room and handled the safety line attached to the second mate. With a fire extinguisher in hand, the second mate crouched low and entered the corridor. The smoke was very thick, he could not see and could no longer hear any calls for help. He dropped to a crawling position and began feeling his way further along the corridor.

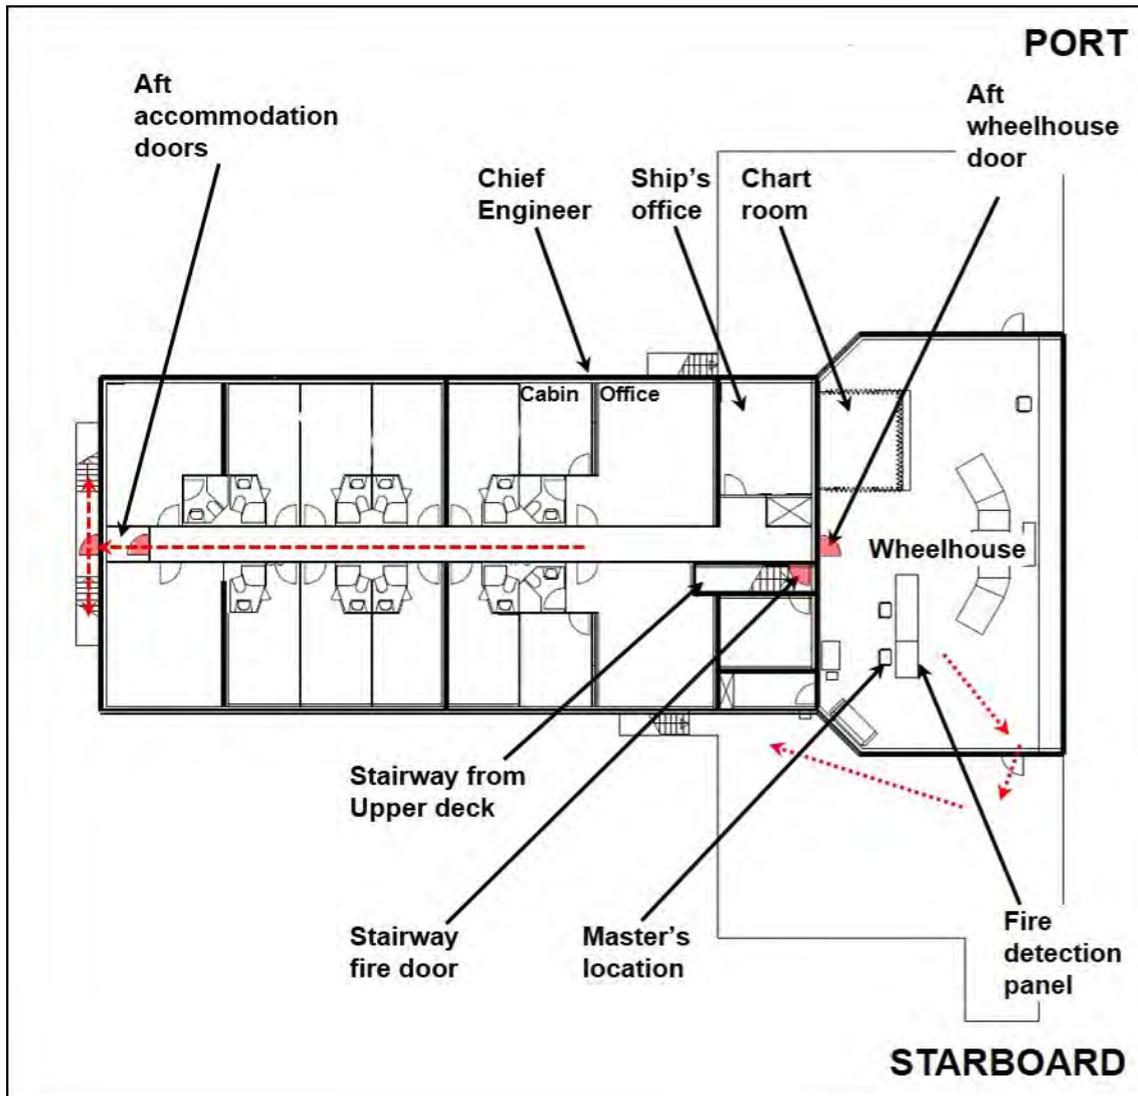
Figure 3: Bridge deck plan

The ATSB investigation found that the cabin door was left open after the fire was discovered allowing smoke and flame to spread beyond the cabin. Further, the bridge deck stairwell fire door was hooked open, which allowed the fire to rapidly spread and engulf both the upper and bridge decks.

At 0750, *Ocean Drover's* master was in the navigation bridge (wheelhouse) on the bridge deck (Figure 3) when the fire detection system alerted him to a fire in the accommodation.² Shortly thereafter, the ship's fire alarms began to sound. When the master opened the aft wheelhouse door, he saw smoke coming up the nearby stairwell from the deck below.

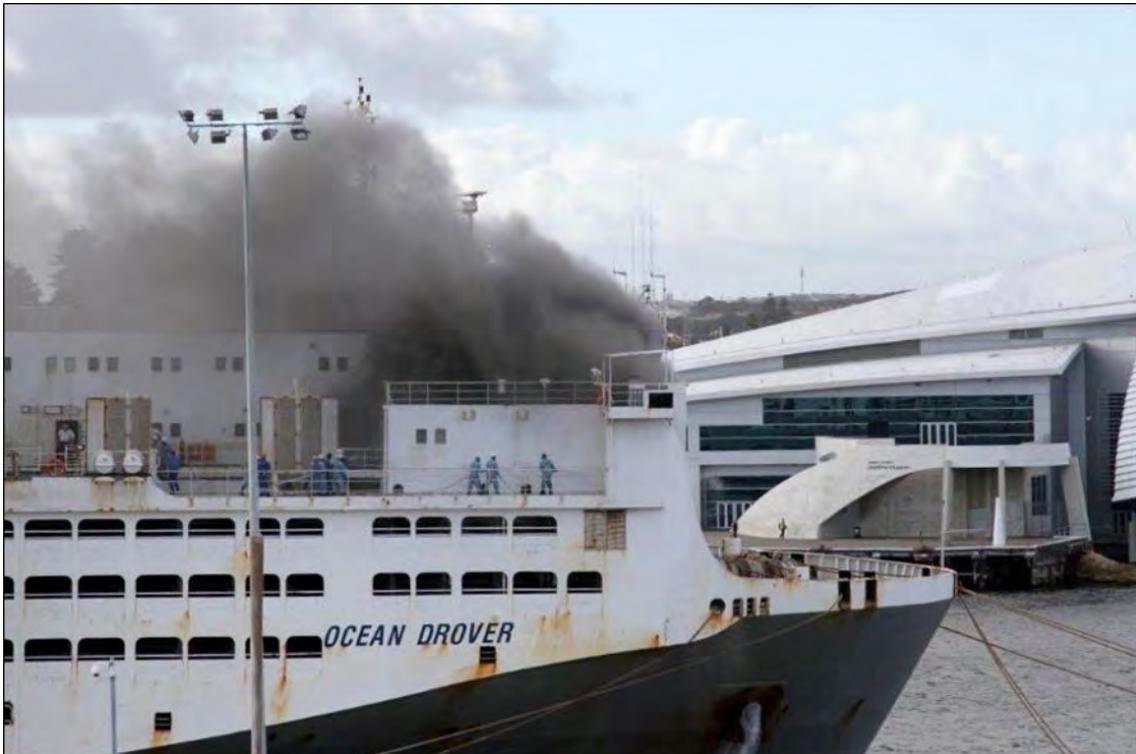
Figure 9: Ship's crewmembers fighting the fire with water hoses

Despite this, the ship's crew, with limited guidance from the master and ship's officers, organised themselves into cooling and attack parties prior to the arrival of the DFES (Figure 9).

As the emergency unfolded, the ship's crew responded effectively. They followed their training and compensated for changes of leadership and personnel.
