UK P&I CLUB

# RISK FOCUS: ENGINE ROOM FIRES

*The majority of onboard fires originate in the engine room*

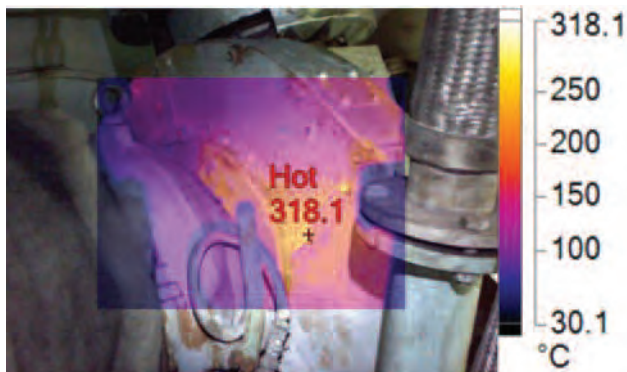
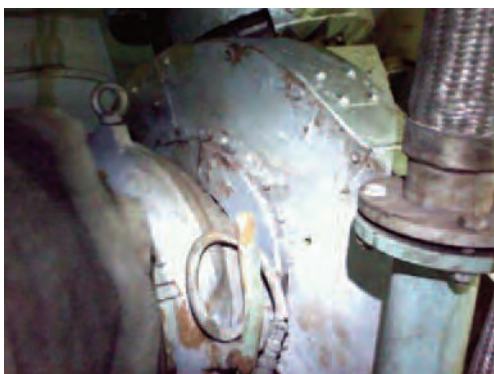
IR001153.IS2-NO1 Auxiliary engine

Alternatively, surveys can be carried out by using more expensive thermal imaging equipment which provides a clear image of the surface temperature profile as illustrated in the example below, where the thermal image is compared with the visible light image.

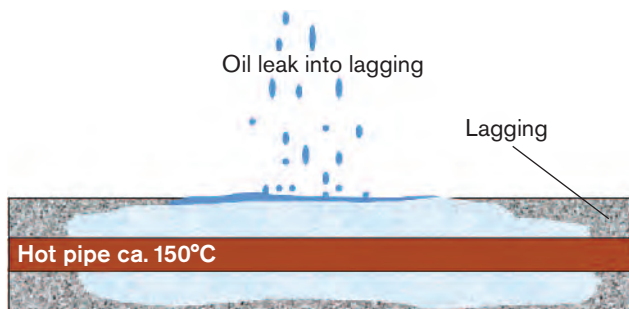
#### Risk of 'spontaneous ignition'

If mineral oils (fuel oil, diesel oil, lube oil) soak into lagging on pipe work operating at a temperature above about 150°C there is a risk that the oil will oxidise slowly within the matrix of the lagging and eventually ignite spontaneously, causing the lagging to disintegrate and oil from a persistent leak to ignite. This process can take many hours, and there may be little external warning of the imminent danger until smoke appears shortly before the fire becomes visible. It is essential, therefore, that oil leaks are attended to promptly and that permanent repairs, including the replacement of oily lagging, are made correctly rather than resorting to makeshift solutions.

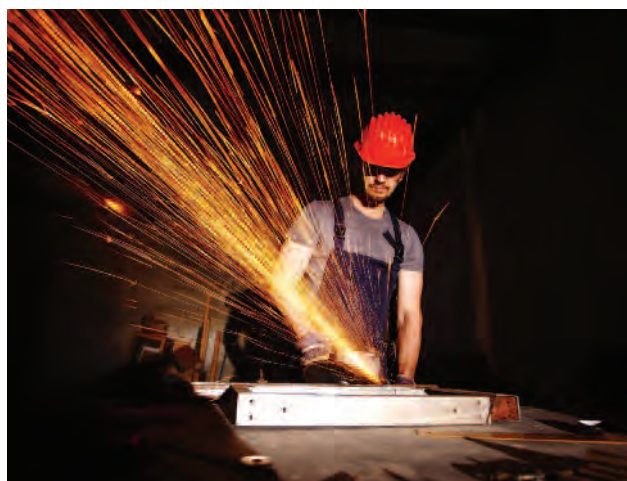
Angle grinding and disc cutting operations should be included in the 'hot work' category because, although the size of incandescent particles produced is generally very much smaller than those produced by welding and flame cutting operations, a stream of grinding or disc cutting sparks landing in the same area of a solid fuel can be sufficient to initiate a smouldering fire. Frictional heating of the work piece may also act as an ignition source, e.g. of oil residues on its surface.

**A stream of sparks from disc cutting**

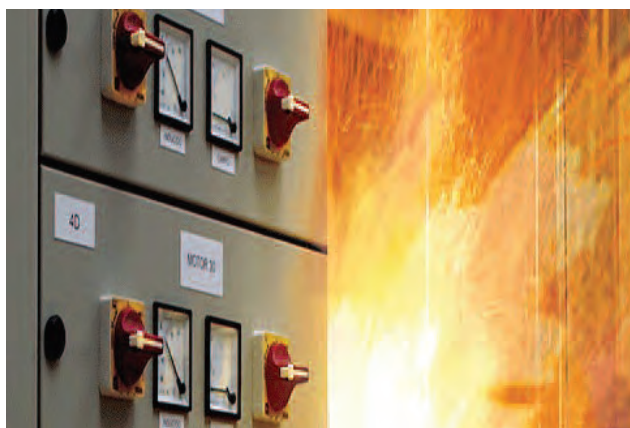
Arc flash incidents can occur where engine room personnel work carelessly on live equipment and cause a short circuit with a tool. No matter how well a person may be trained, distractions, weariness, pressure to restore power, or over-confidence can cause an electrical worker to bypass safety procedures, work unprotected, drop a tool or make contact between energised conductors. This may not only lead to serious injury or death, but also provide a source of ignition for a fire.

**Arc flash incident**

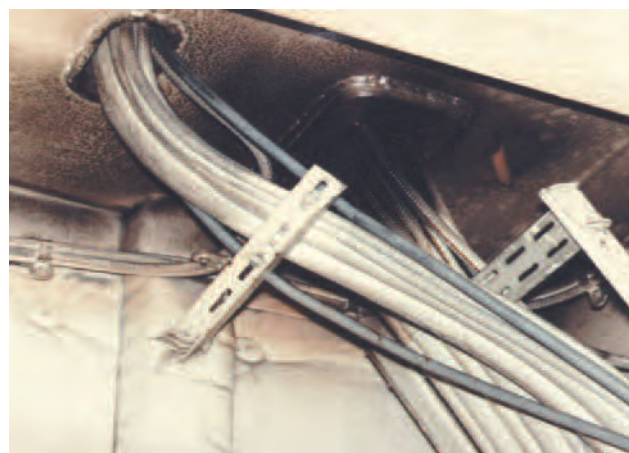
**Cables entering a distribution board through fire stopped openings in the casing**

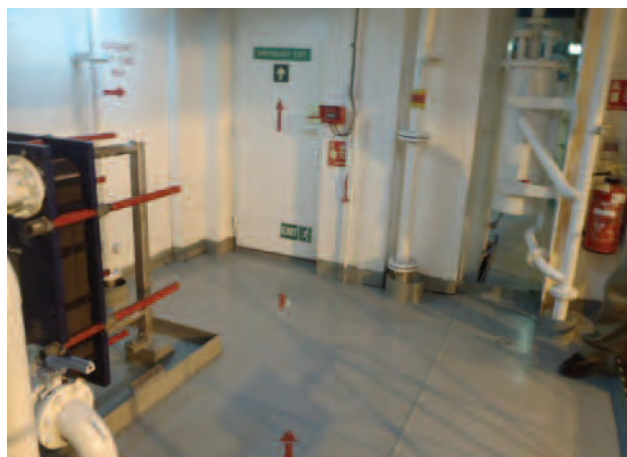
In the UK Club Technical Bulletin No. 39/2012 (Escape from Engine Rooms) it is suggested that arrows are painted on the deck plates pointing to the nearest escape route. This good practice is commonly seen on UK P&I Club ships, but sometimes the arrows could be laid out more clearly. The photographs show excellent arrows leading to the escape trunk, but none to the steering gear compartment which is an alternative escape route.

**Well marked escape route arrows**

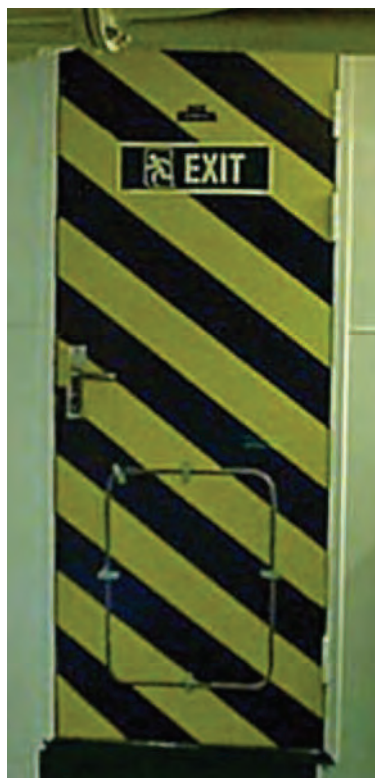
**Well marked door**

Technical Bulletin No. 39/2007 also recommends that the exit doors are clearly highlighted. In both the above photographs, it can be seen that white painted doors do not stand out well against white painted bulkheads. Doors painted with “tiger stripes” or marked with retro reflective tape are far more obvious.

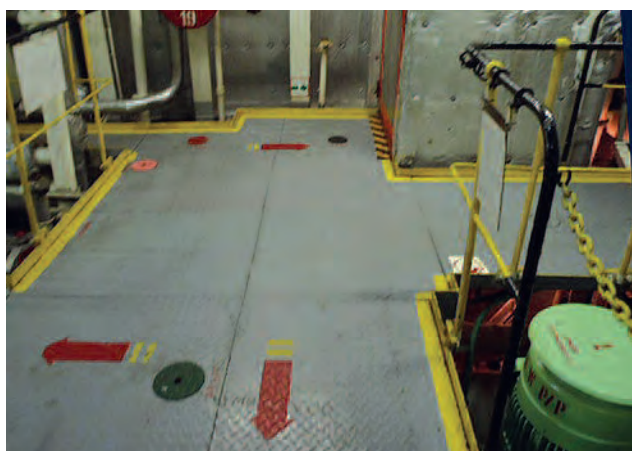
The best escape route from an engine room fire will depend on the location of the fire and its severity and so it is, therefore, difficult to generalise. However, careful thought should be given when marking emergency escape routes and these should not be confused with normal exit routes. In a fire situation, the safest escape route may not be via the internal ladders leading up to the accommodation exits, but sideways (or even downwards) via the escape trunk, the steering gear room or other “safe” areas such as shaft tunnels and side passageways.

**Arrows leading away from exit door**
