**Lessons from Marine
Accident Reports
2/2017**

SAFETY DIGEST
Lessons from Marine Accidents
No 2/2017

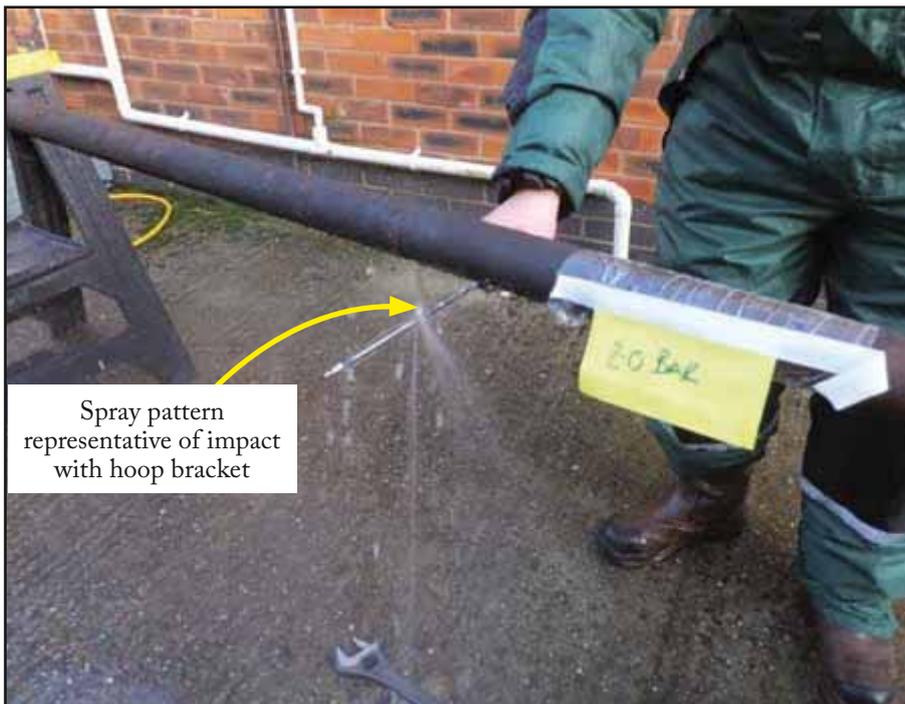
Figure 2

In order to progress the repair, the engineer climbed into the bilge to access the bracket. Fuel from the leaking pipe atomised on contact with the surrounding structure (Figure 2) and soaked the engineer's coverall with diesel. Sparks generated during the cutting process ignited the atomised diesel, setting light to the engineer's coverall and starting a fire in the engine room.

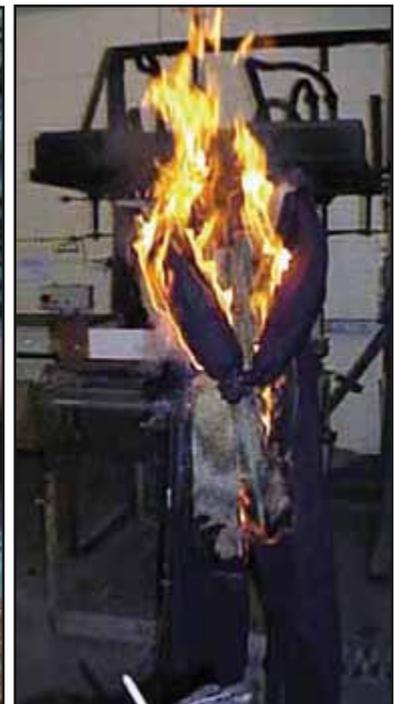
Figure 3

3. Although not specifically identified as a 'hot work' process, cutting and grinding with abrasive discs generates high energy sparks that are capable of igniting an available fuel source. An HSE research project commissioned in 2004 specifically investigated the risk of coveralls being ignited by sparks from angle grinders. The resulting report (HSE Research Report 222) highlighted that only coveralls with fire retardant treatments offer protection from ignition. It demonstrated that natural fibre garments (i.e. cotton) have very little benefit over coveralls constructed from man-made fibres (i.e. polyester/cotton mixtures) (Figure 3).

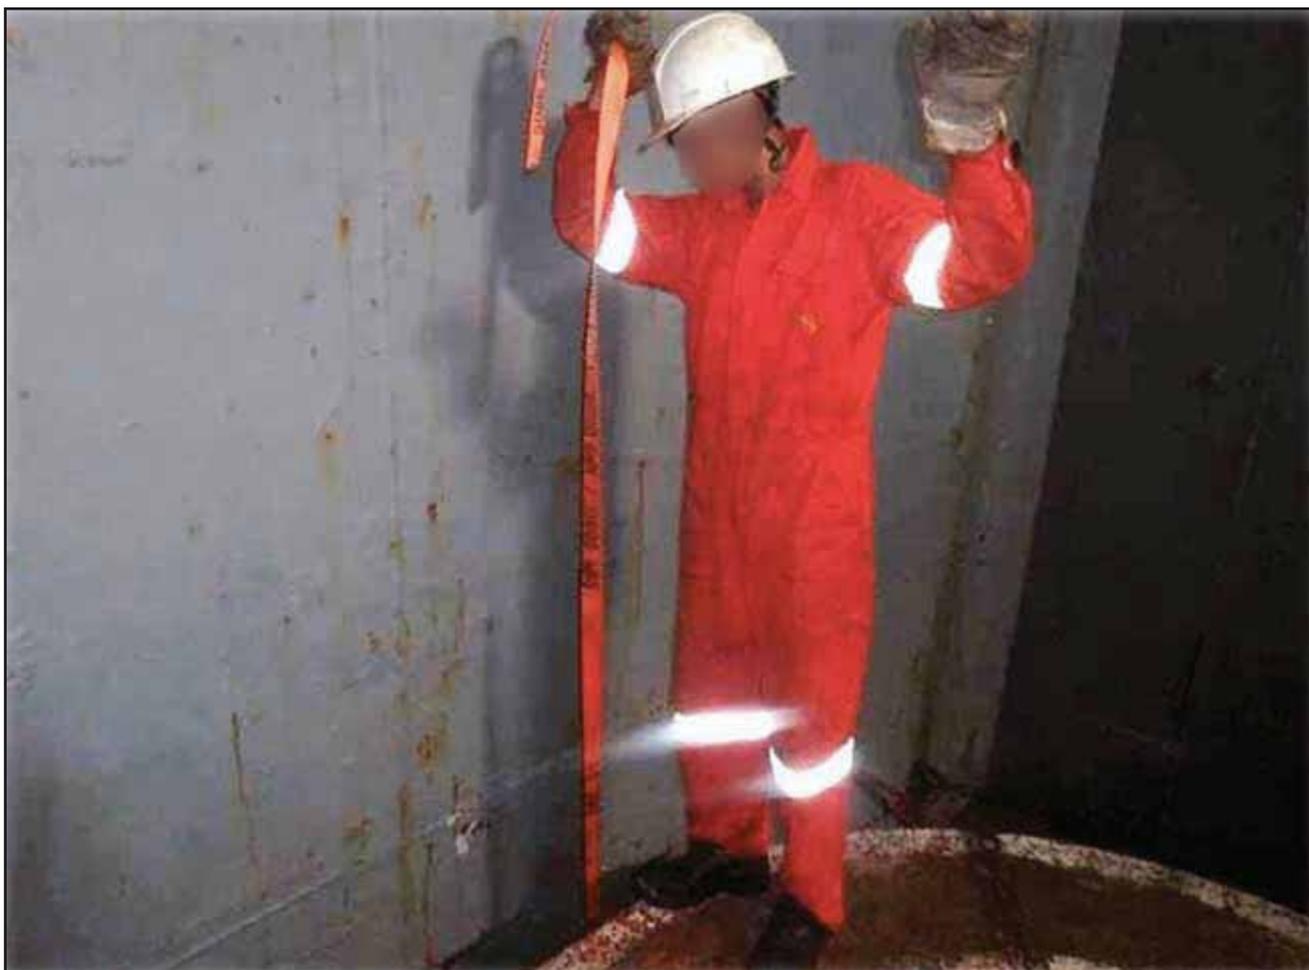
held onto one of two webbing straps that were being used to lift the unit (Figure 1). Suddenly, the unit and/or a strop shifted, causing the chief officer to lose his balance and fall through a hole in the steel unit and onto the deck (Figure 2).

Figure 1: Position of chief officer prior to fall (simulation)

1. Although hazardous, it is not unusual for crew members to stand on top of cargo during loading and discharge in order to get a job done. However, standing on the top of cargo that is being lifted is inherently unsafe and unnecessary.
2. A 'can do' attitude is invariably seen as a positive personal quality, but a 'can do safely' attitude is far better. When a problem arises while working the cargo, take time to weigh up the options and decide on the most efficient and safe course of action. The forces at play are too considerable to rush.
3. Every fall from height is potentially life-threatening. Internal injuries are always possible, no matter the distance travelled.
4. Healthcare varies considerably in different parts of the world; it might not always be up to the standard you are used to.

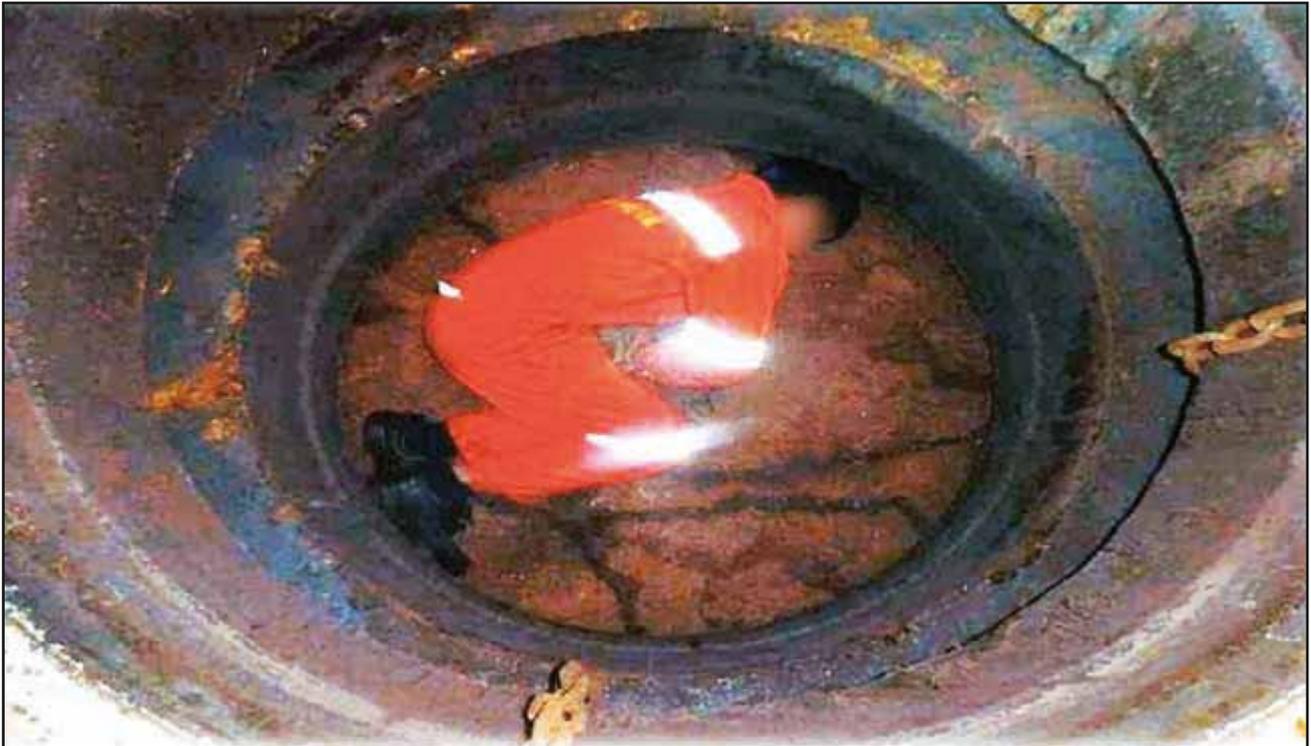
died shortly afterwards from bleeding and pneumothorax in his right chest cavity. He also suffered broken ribs and a broken humerus.

Figure 2: Position of chief officer after fall (simulation)

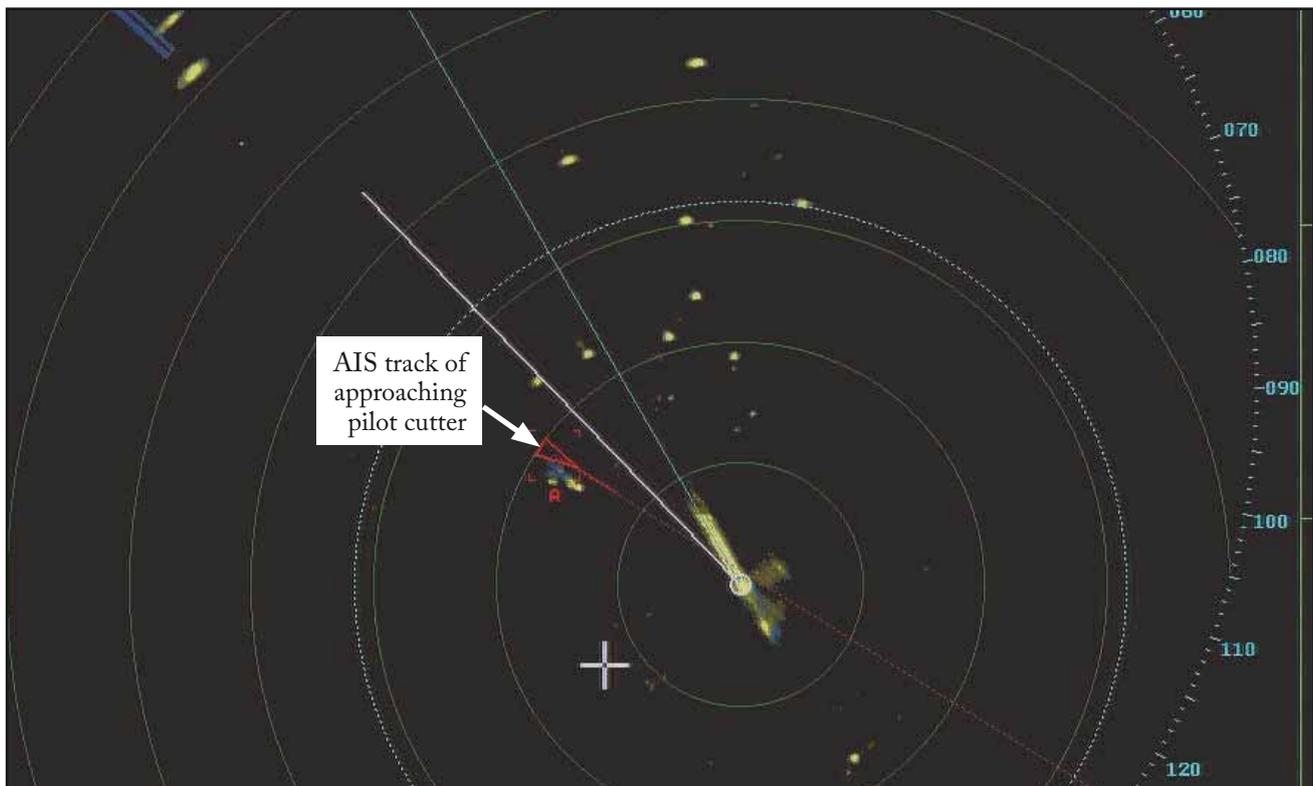
When the pilot arrived on the tanker's bridge, he realised that the fishing boat was only about 20m ahead, so he ordered full starboard rudder in an attempt to swing away from the anchored boat; however, the tanker and the fishing boat briefly came into contact. The fishing boat's anchor line broke after snagging on the tanker and the fishermen fended off by hand until the tanker had passed.

Figure: Extract of the tanker's radar picture 6 minutes prior to the collision, showing the pilot cutter approaching and the fishing vessels ahead

3. Sound signals should be used when the actions of another vessel are uncertain. It was good, daylight conditions and neither vessel thought to use sound signals to warn the other.

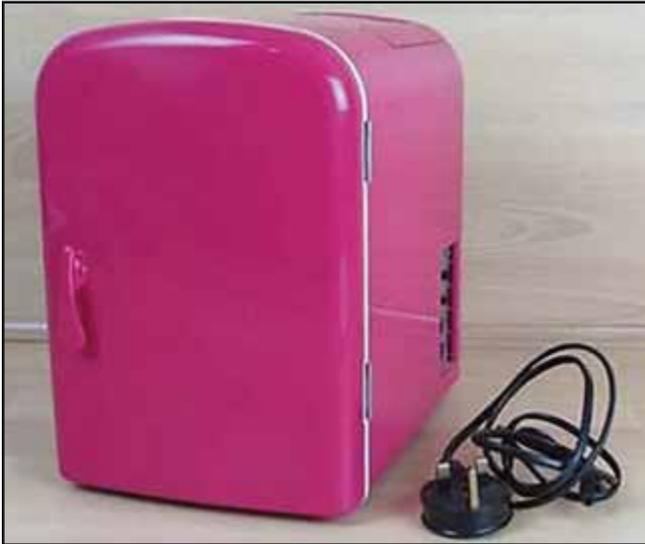
Once the area was declared safe, the ship's fire investigation discovered that the seat of the fire was located where a mini fridge (Figure 1) had been placed. The carpet, cabin furniture and surrounding bulkheads were damaged, with smoke deposits and scorch marks clearly indicating that the fridge was the source of the fire. The fridge's plastic casing had melted and its power cable had suffered severe damage (Figure 2). The metal centre core of the fridge and the cans of juice inside were almost undamaged.

The fridge had been in the cabin for about 4 years, and always located in the same position - on top of the carpet, against the wardrobe. The investigation concluded that, due to its location, the fridge didn't have proper ventilation around it, and therefore this could have caused it to overheat. The investigation further found that the cabin inspection routine had neither identified this hazard nor picked up that personal electrical equipment was not being inspected.

Figure 1: Similar travel fridge to the one in the cabin

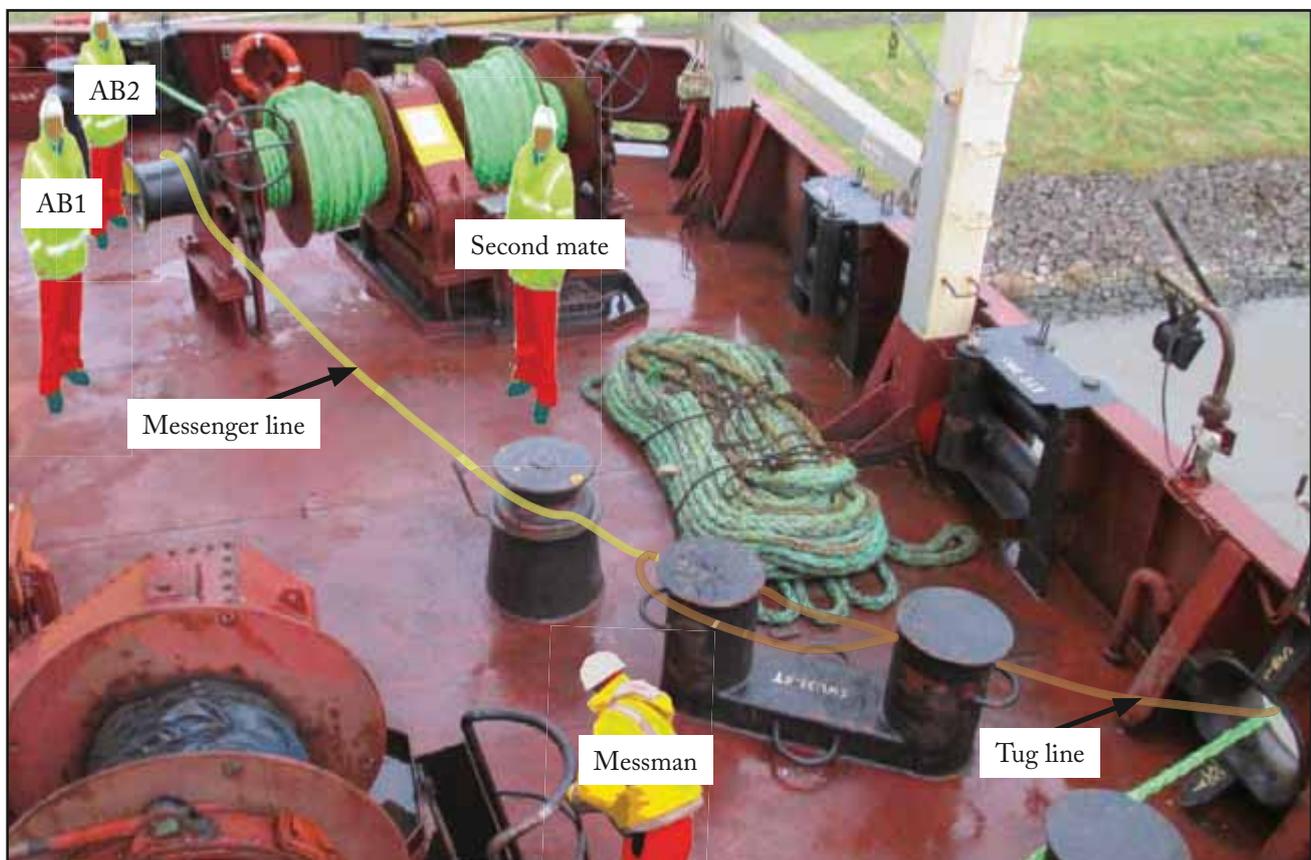
Figure: Locations of the aft mooring team

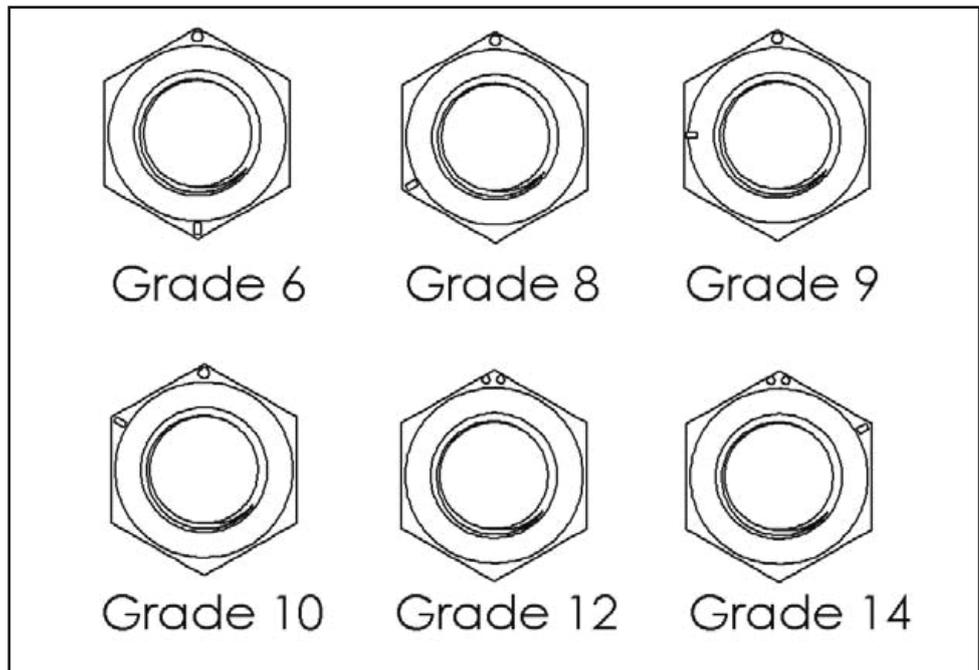
Figure 6: Clock face marking on nuts

3. To be fully effective, testing procedures and visual inspections during thorough examinations must be followed to the letter. Short-cuts and work arounds can easily lead to deficiencies not

being identified, and the absence of installation guidance makes it impossible to tell whether a crane has been fitted in accordance with the manufacturer's design intent.

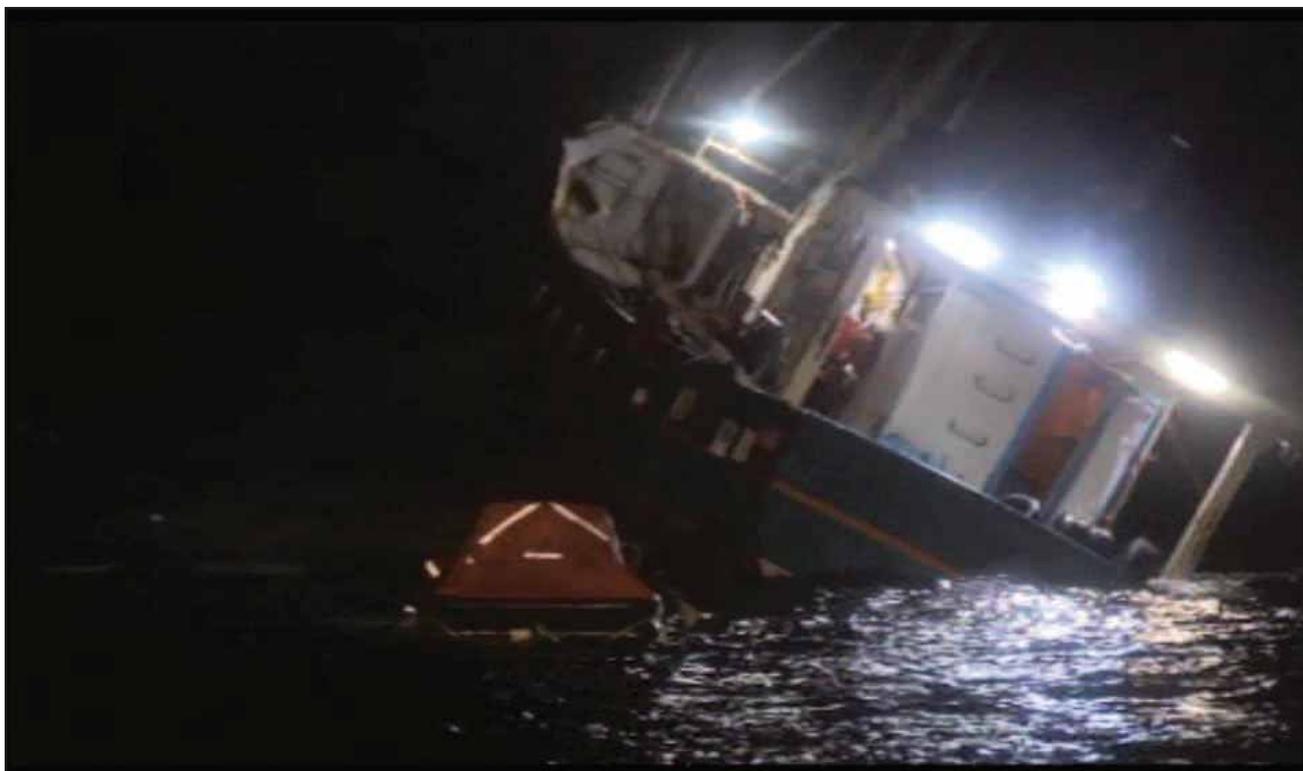
of hours later, the scalloper was to the starboard of the route on the plotter. As the vessel approached the entrance to the sound at 9 knots, it suddenly veered off course and grounded on a small island. Although the scalloper did not appear to be taking water, the tide was falling and it soon took on a starboard list. Attempts to refloat it were unsuccessful, so with the list worsening the crew abandoned into a liferaft (Figure 1). They were soon picked up by a lifeboat.

Figure 1: Crew abandoning vessel into a liferaft

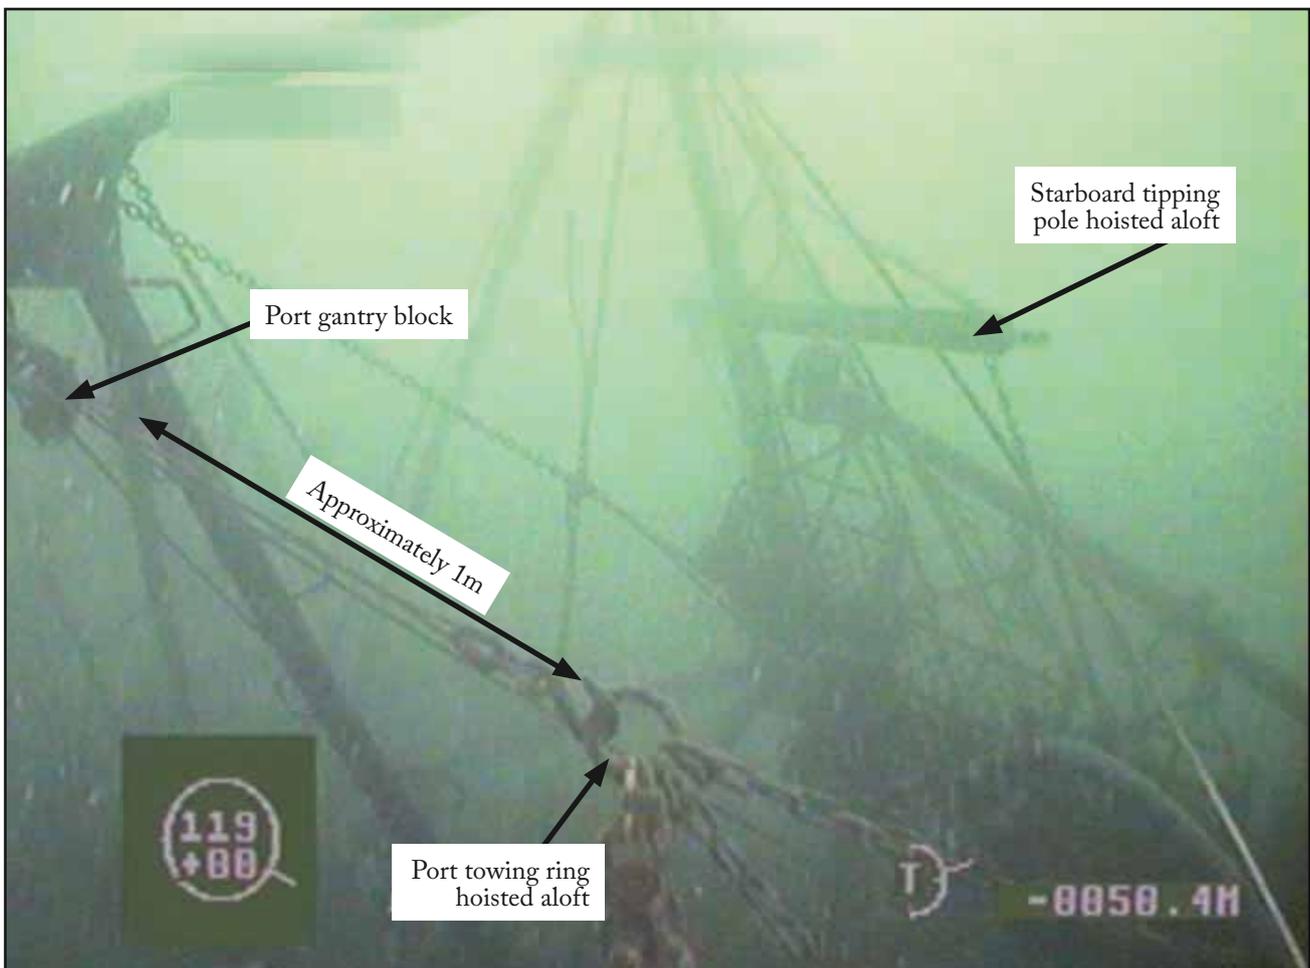
From the evidence gained from underwater surveys (Figure 1) along with the vessel's salvage (Figure 2) and subsequent stability assessment, it was apparent that it had capsized quickly while the two crew were in the process of emptying the starboard scallop dredges with the port dredges suspended from a gantry block. The scallop dredger's poor initial stability had been worsened by a low fuel level, the suspension of weights from a high point, storing catch on deck and uneven loading initiated by the earlier winch failure.

Figure 1: Underwater image of port and starboard scallop gear

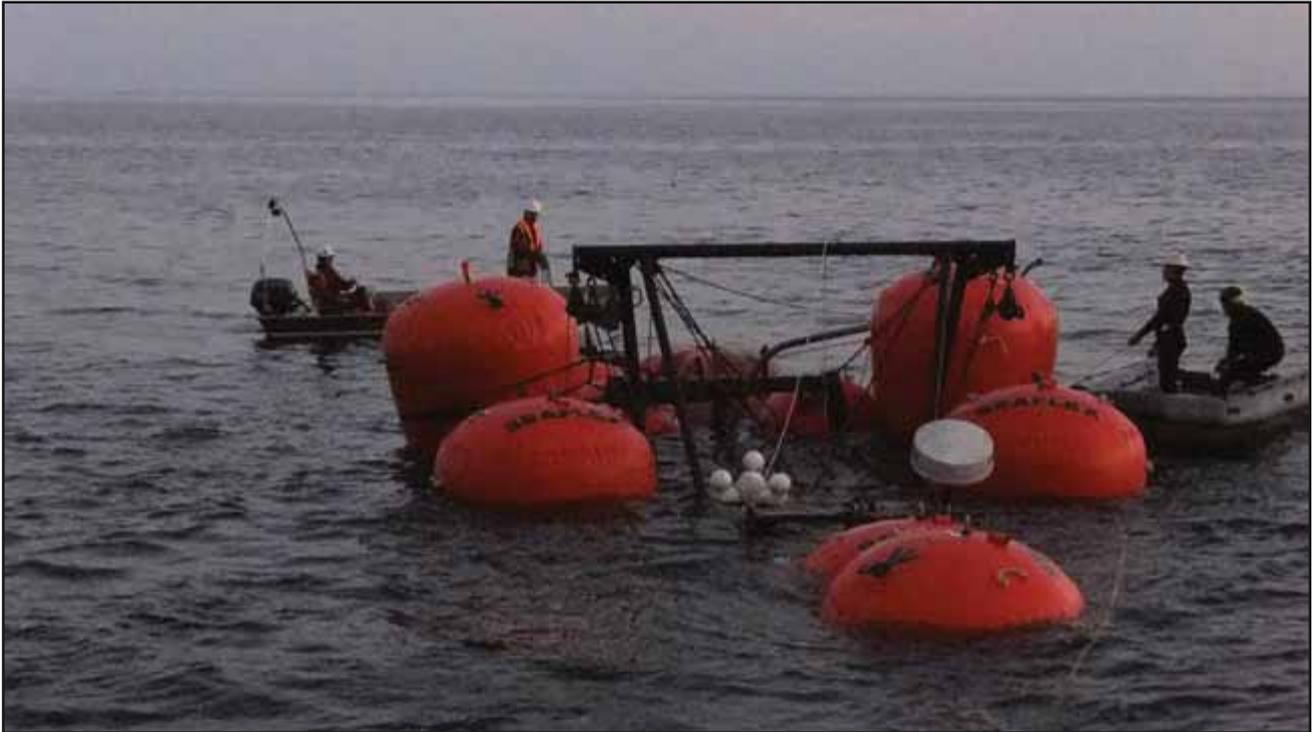
The vessel had been built as a stern trawler but had been modified for scallop dredging. A high gantry had been fitted to lift the scallop dredges, but no calculations had been required or carried out to assess the use of the gantry on the vessel's stability.

Figure 2: The vessel's salvage

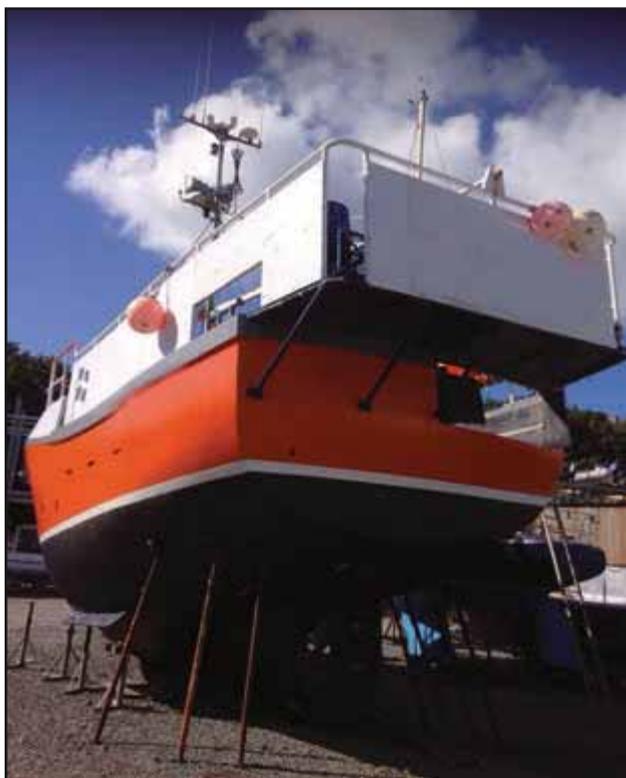
The boat was designed to allow self-shooting, with a large opening in the transom through which the baited pots were deployed. Each string worked by the boat contained between 50 and 60 pots. As each string was hauled the catch was removed, the pots re-baited and then stacked three pots high on the port side of the main deck, ready to shoot. Despite the vessel being designed for self-shooting, the normal practice on board required a certain amount of manual intervention by the crewman on deck.

Figure 1: Opening in transom

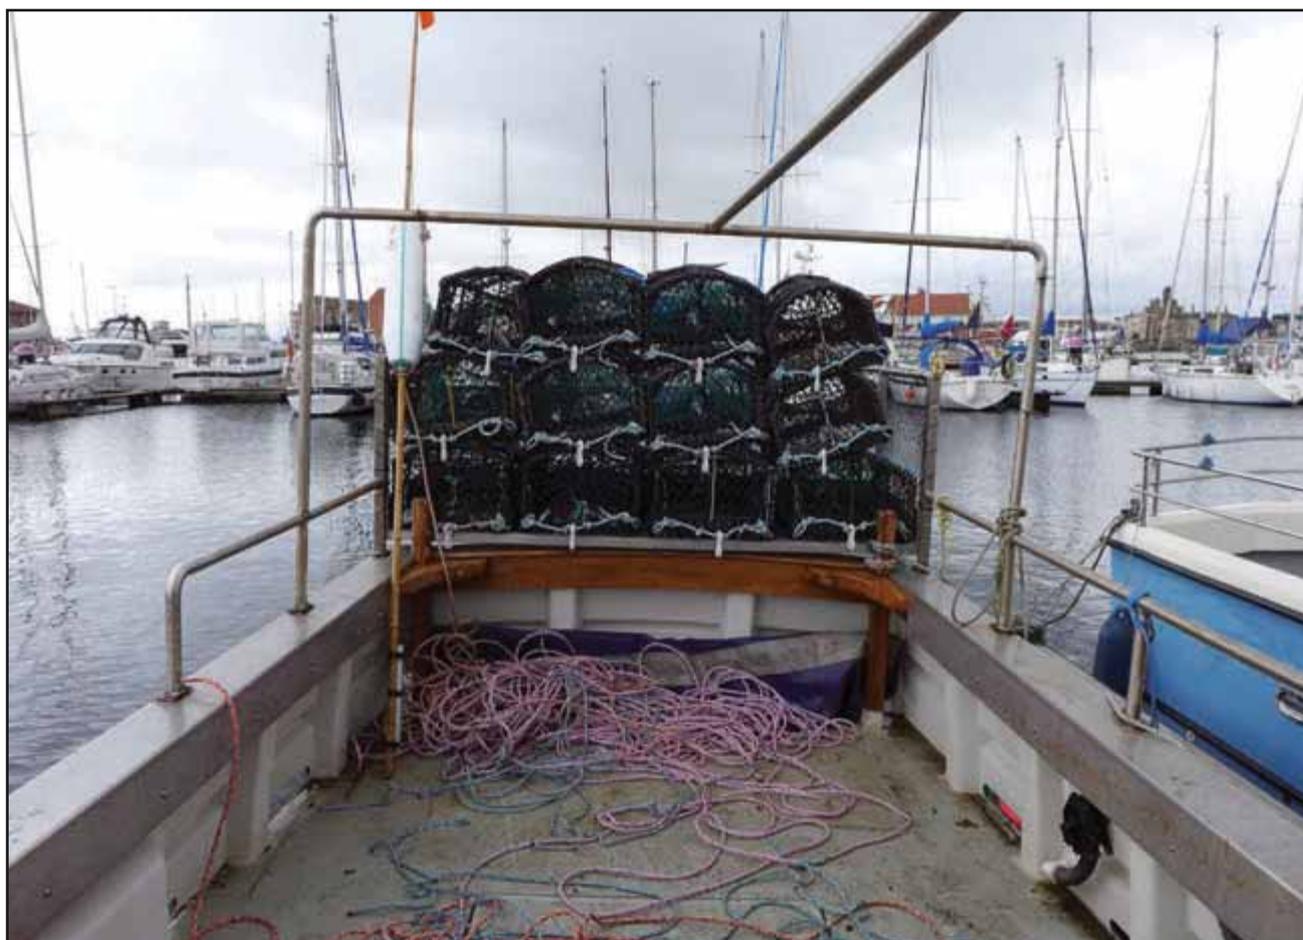
Having alerted the coastguard by calling on the VHF radio, the skipper motored the boat back at full speed to pick up the surface marker buoy at the end of the string and started hauling the pots back on board as fast as possible. The last pot emerged from the sea with the crewman still entangled in the gear. The crewman had been under water for about 20 minutes and, despite the efforts of the skipper and the emergency services, could not be revived.

Figure 1: Reconstruction of the deck at the time of the accident showing the hazard associated with loose ropes

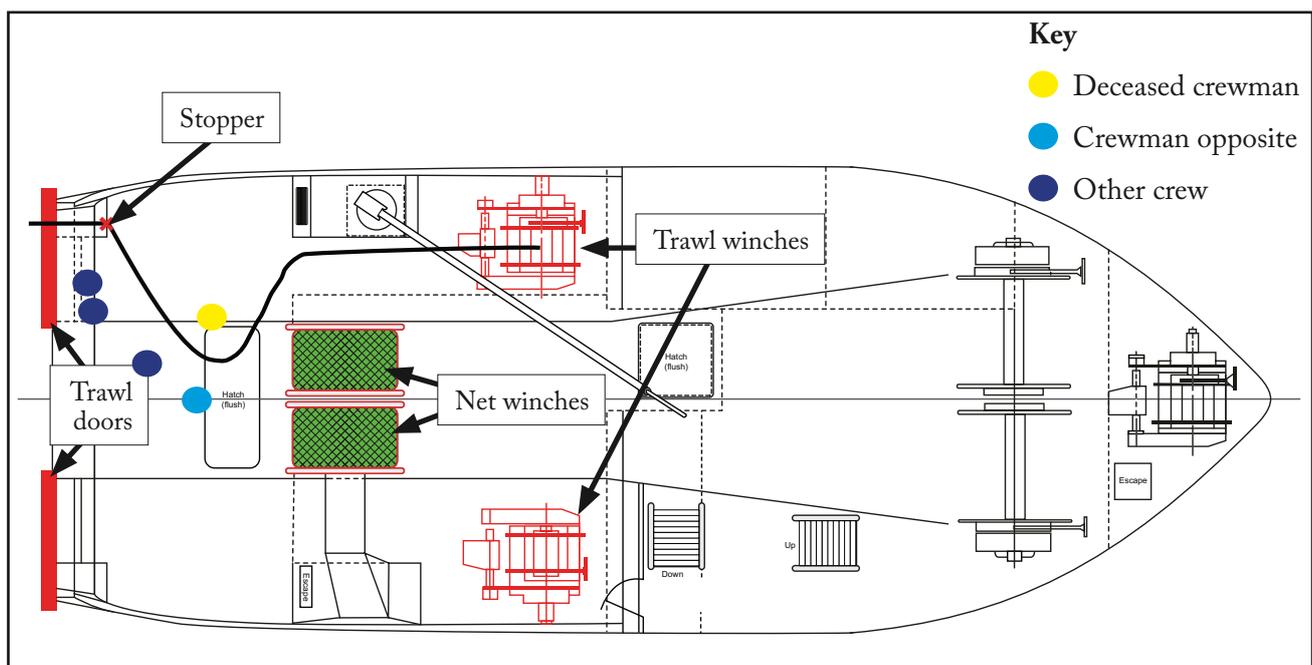
Moments later, the rope stopper failed and the trawl warp snapped tight. The warp struck the crew member across his chest and violently hurled him backwards over the side of the boat and into the sea. Although probably injured by the force of the impact, the crewman was alive and treading water astern of the vessel.

Figure 1: Positions of the deck crew when the stopper failed

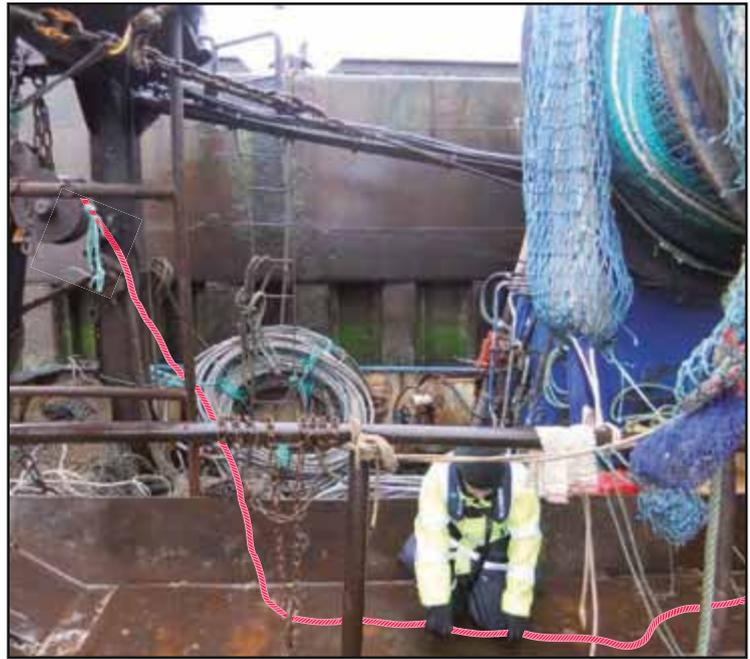
Figure 2: Reconstruction of marking the warp

The crew were not practised in manoverboard recovery and the vessel did not carry a dedicated manoverboard recovery device. In addition, none of the crew were wearing PFDs while attempting to mark the trawl warps.

4. The method used to mark the trawl warps was unnecessarily hazardous and could have been achieved in a much safer manner while the vessel was in port.

5. The hazards associated with this particular task had not been thought through before it was started. There was no documented assessment of risks for the task attempted, even though it had been performed on board several times previously. A well-considered risk assessment should have identified the hazards of kneeling in the bight of the slackened rope (stand in the safe area), the failure of the stopper (in this case, use a chain and not rope) and falling overboard (wear a lifejacket). Risk assessments need not be complicated, nor difficult to perform. Simply by discussion among the crew, hazards in a task can be identified, highlighted in the consciousness of staff, and then guarded against while working.

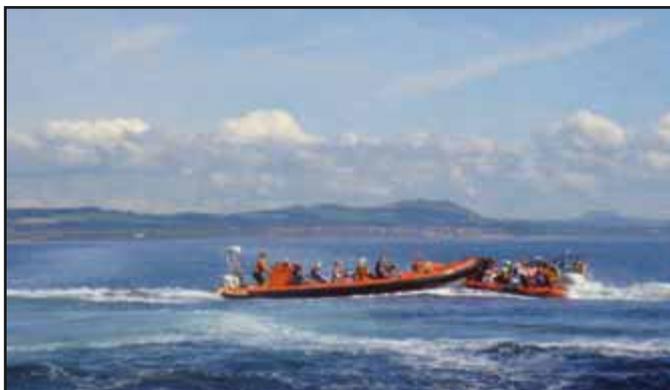
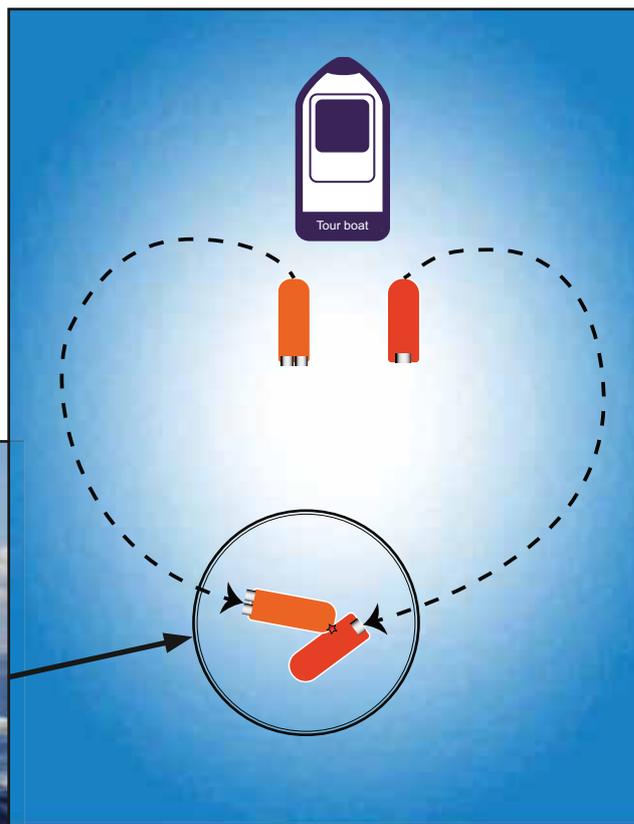
Figure 1: Power turn manoeuvre and collision

A passenger who was sitting on an inflatable tube of one of the RIBs was crushed between the helm console of the RIB she was sitting on and the bow of the colliding RIB. She sustained serious resulting injuries.

The use of a kill cord is fundamental to the safe operation of small planing craft. It is imperative that skippers of passenger carrying RIBs wear a kill cord at all times.

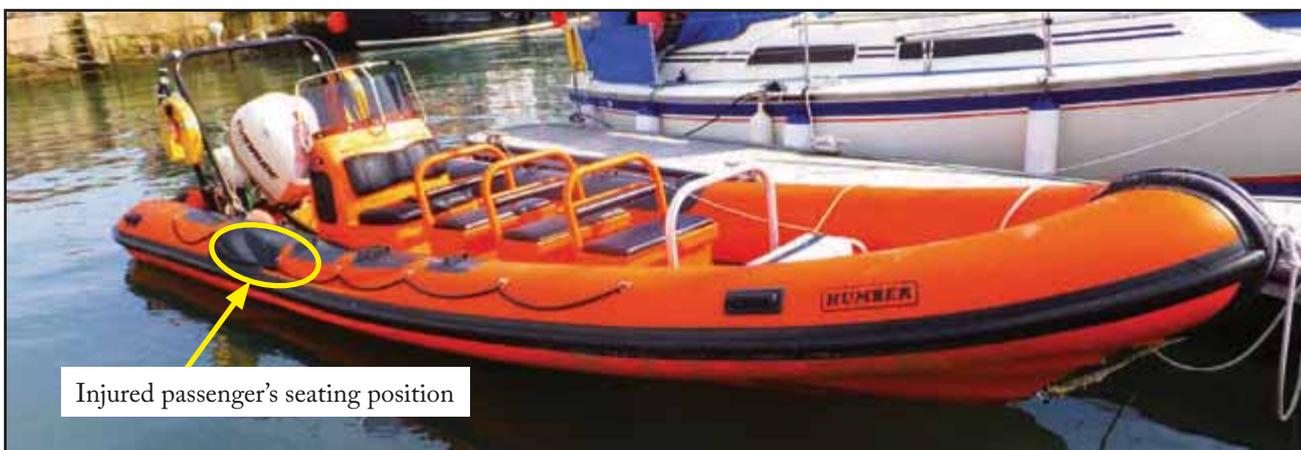
Figure 2: RIB's sitting arrangement showing location of injured passenger

Injured passenger's seating position

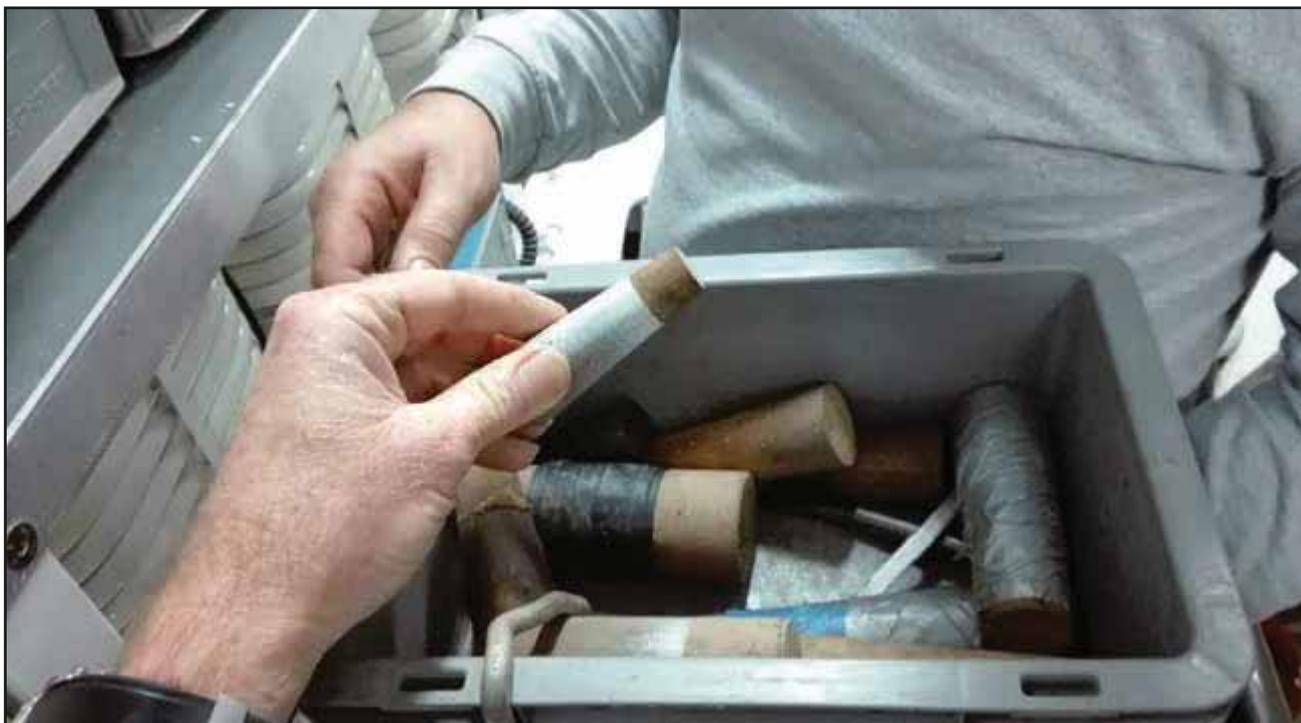
Figure 1: Damage control equipment

The crew of a large luxury yacht were completing maintenance of the hull following a 20-year special survey in preparation for the forthcoming season. The work involved cleaning and de-scaling the engine room bilges before applying anti-corrosion treatment. As the work was being conducted below the yacht's waterline, the master had instructed the crew to have damage control equipment (Figure 1) ready in case the worst should happen.

1. The master's risk assessment of the task had identified the potential for flooding and he had mitigated this through the readying of damage control equipment. Without this preparation, the crew would not have been able to take such effective prompt action and the yacht might have been lost. Careful planning clearly brings its rewards.

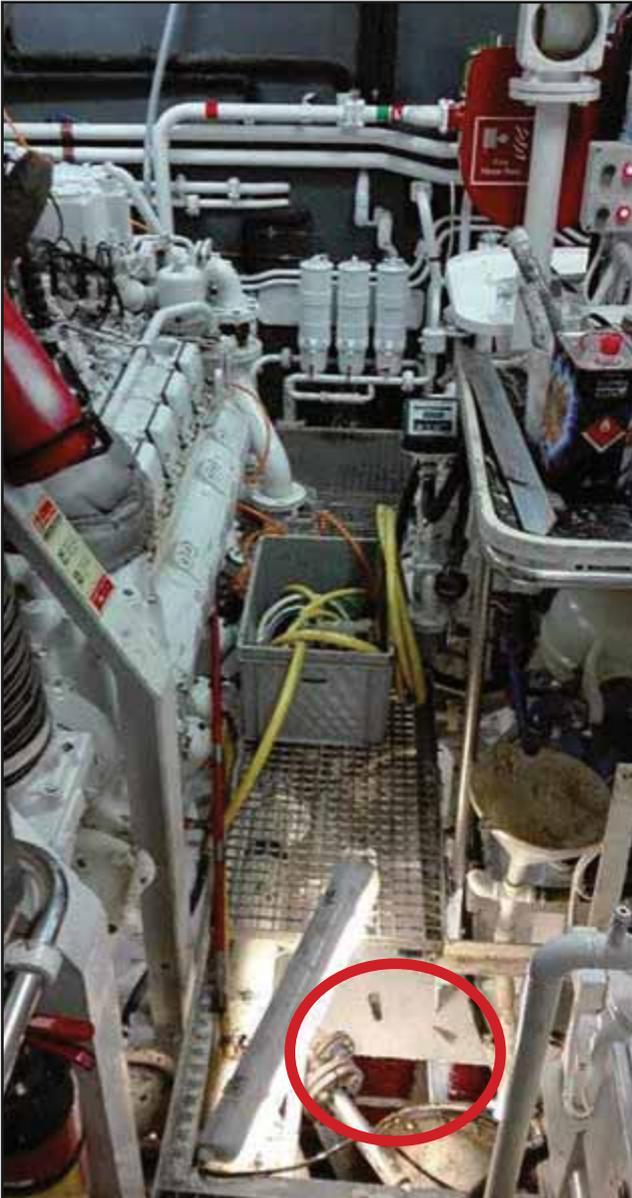
Figure 2: Location of works

The last area of the hull that required maintenance was an area of the hull plating between the main engines (Figure 2). This part of the hull was not accessible when the yacht was operational and was prone to corrosion as

The descaling was going well until the needle gun suddenly punched straight through the hull plating. As the hole was below the waterline, water started flooding quickly into the engine room bilge. The crew immediately used a bung from the damage control equipment to plug the hole, and secured it in place with resin (Figure 3). This initial fix was later replaced by a tapered bung applied by a diver from outside the hole. The tapered plug was secured in place by resin on both sides of the hull plating.

2. The hull of any vessel may be a point of failure if not adequately maintained. Difficult to reach locations are sometimes neglected due to their inaccessibility and are prone to corrosion if not properly maintained. Don't rely solely on surveys to tell you about the condition of your hull; you will know best where the likely weak points are.

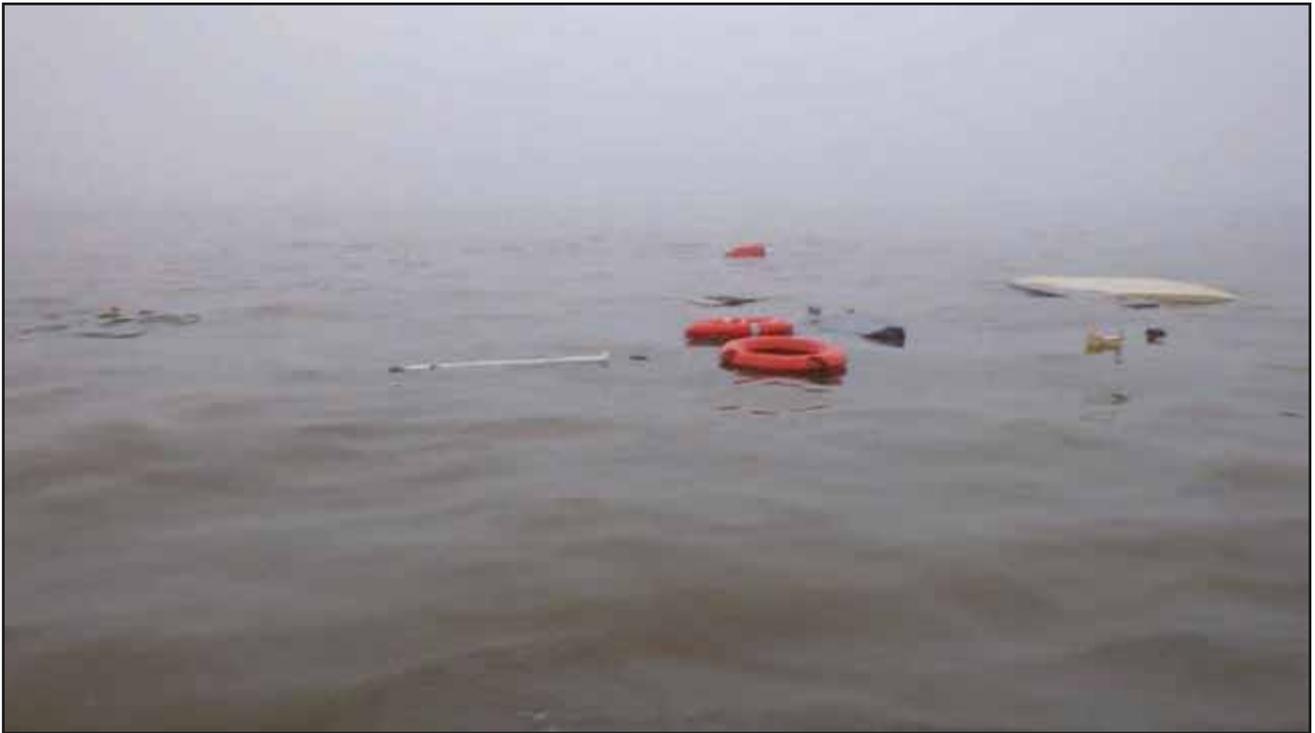
Seconds later, the launch's skipper saw the ferry's bow looming above him. He attempted to manoeuvre away, but saw that a collision was inevitable, and shouted a warning to the crewman. The ferry's port bow struck the launch, seriously damaging the structure and hull. The bridge team were unaware of the collision and the ferry continued its voyage.

The skipper saw that the launch was badly damaged and foundering bow-first. He called a "Mayday" on his VHF radio and then he and the crewman set about getting the liferaft ready. As the launch continued to sink, a local pilot vessel rescued the skipper and crewman. The launch sank about 30 minutes after the collision.

1. Changes to the environment cannot be controlled but should prompt a review of the voyage plan to ensure that it is still fit for purpose. If it is not, then it must be altered so that the challenges presented can be dealt with safely. If this is not possible then the voyage must be delayed.

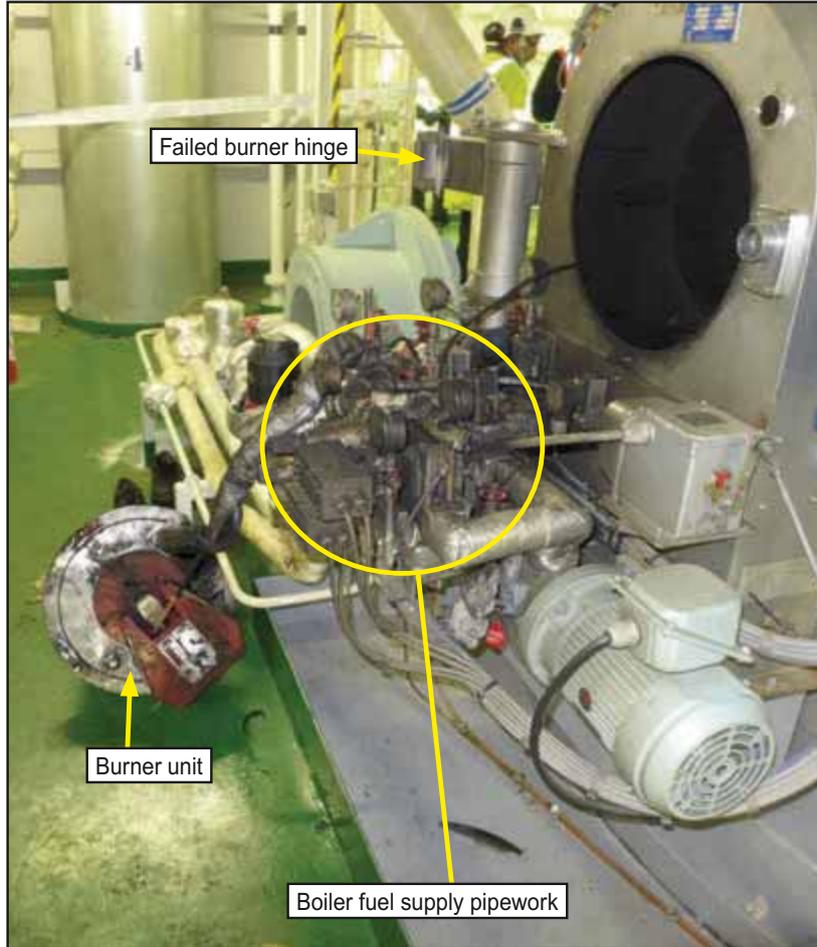
Figure 2: Boiler and burner unit

The boiler explosion occurred while the second engineer and the oiler were trying to restart the boiler burner unit following a flame failure cut-out. The force of the explosion blew open the boiler burner unit door (**Figure 2**) and propelled the burner's air diffuser into the engine room (**Figure 3**). The oiler was standing directly in front of the burner unit and the second engineer was close by.

The tests found that the fuel had a CFPP of 14°C and a PP of less than -9°C, requiring a minimum fuel operating temperature of 15°C. The ambient air temperature at Felixstowe on 19 January 2017 was about 4°C, low enough for wax formation. The CP of the fuel could not be obtained because the test samples had a dark appearance, which was attributed to the mixing of residual HFO deposits with the MGO in the system pipework.

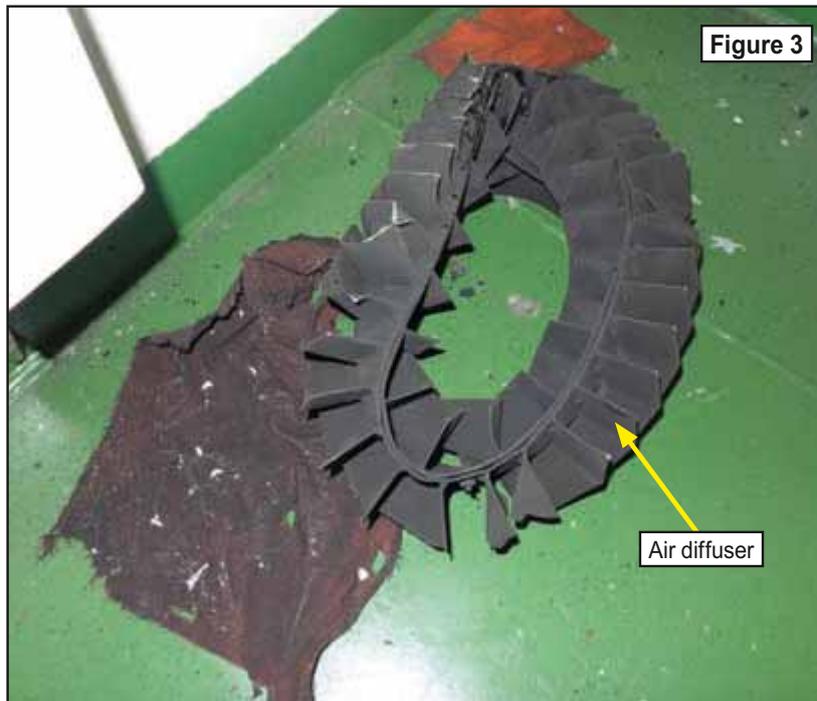
Figure 3

Air diffuser
