Report on the investigation of the

grounding of

Muros

Haisborough Sand

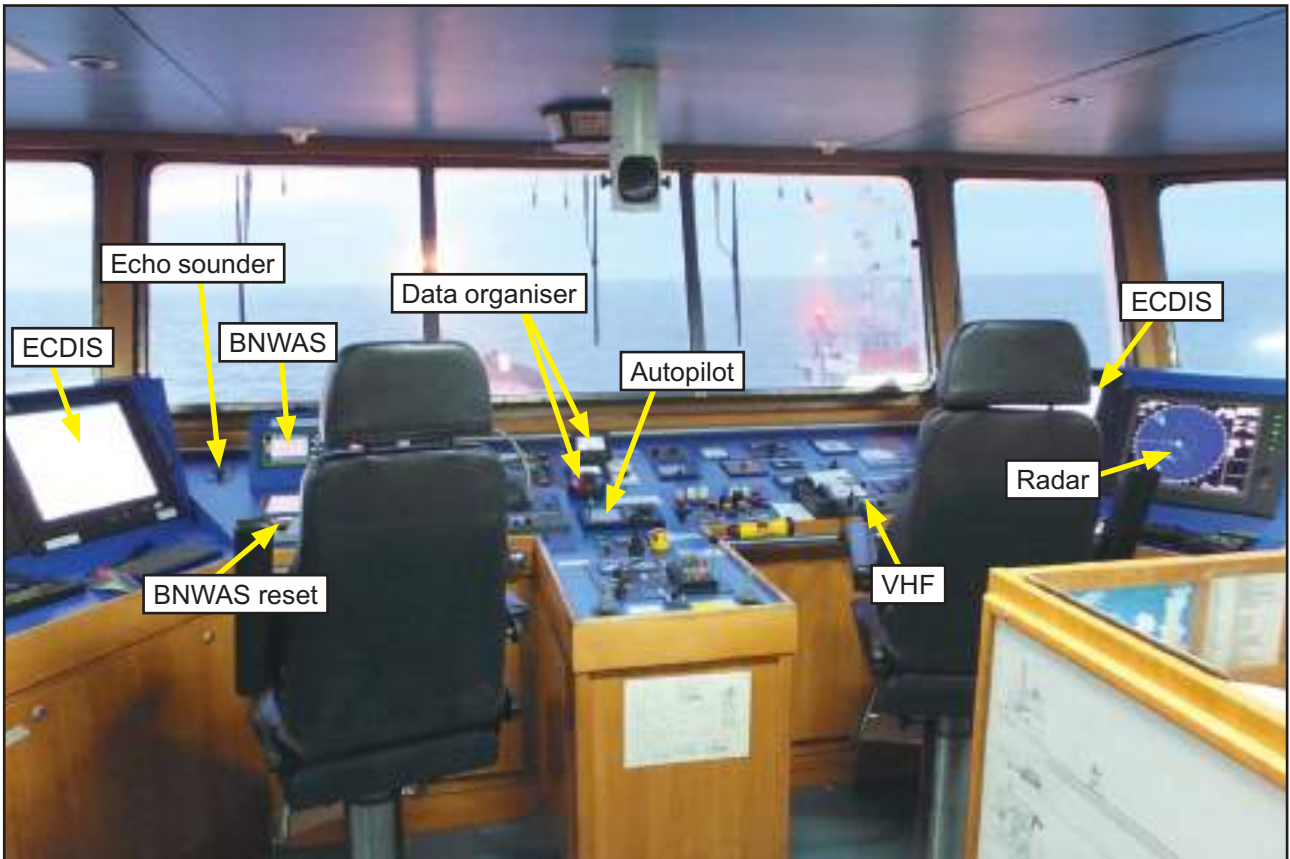
Figure 2: Bridge layout

Muros's ECDIS comprised two terminals, one on each side of the bridge centre console (**Figure 2**). The port terminal was marked as 'planning' and the starboard one as 'monitoring'. However, both terminals could be used in either mode. The vessel's electronic navigational charts (ENC) were supplied by PRIMAR, operated by the Norwegian Hydrographic Service.

During the bridge watch, the 2/O adjusted the autopilot heading at 0208 and noticed the speed reductions at 0220 and 0248. However, although the starboard ECDIS display was easily visible from where the 2/O was sitting (**Figure 2**), she did not:
