DEPARTMENT OF THE NAVY
OFFICE OF THE CHIEF OF NAVAL OPERATIONS
2000 NAVY PENTAGON
WASHINGTON, DC 20350-2000

Enclosure (1) Report on the Collision between USS FITZGERALD (DDG 62) and Motor Vessel ACX CRYSTAL

Enclosure (2) Report on the Collision between USS JOHN S MCCAIN (DDG 56) and Motor Vessel ALNIC MC

REPORT ON THE COLLISION BETWEEN USS FITZGERALD (DDG 62)
AND MOTOR VESSEL ACX CRYSTAL

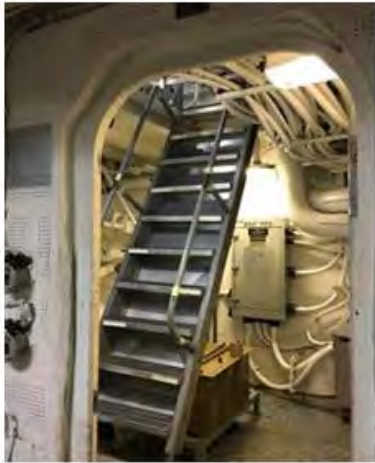
Figure 11 – Sample Berthing 2
Starboard Side Egress – Ladder
Up

FITZGERALD. A non-watertight door leads from Berthing 2 to the starboard access trunk. In that trunk, a ladder leads up one deck into a space just outside of Berthing 1. Figures 11 through 13 are examples of the starboard side egress on a ship of the same class as FITZGERALD. There is no hatch separating the starboard access trunk outside Berthing 2 and the space above it. Also in this starboard access trunk is a hatch and watertight scuttle connected to a ladder going down to the Forward Interior Communications (FWD IC) space. FWD IC is not manned underway and has no other exits.

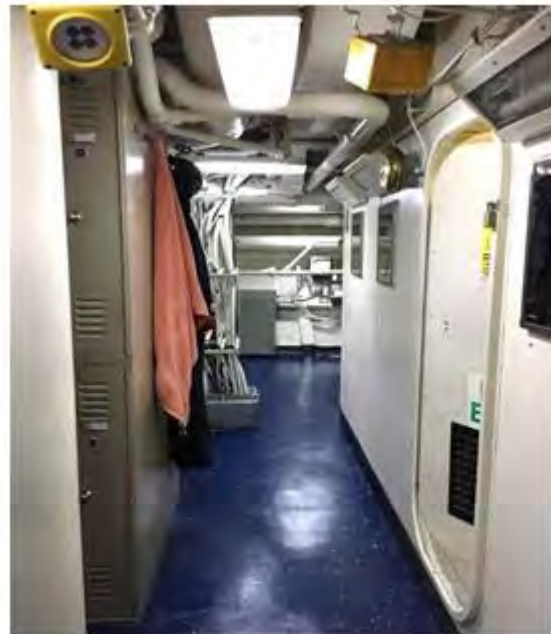
Figure 14 – Sample Berthing 2 View from Row 3 of racks to the port side (open door on right leading to head)

Sailors recall that after the initial shock, occupants lined up in a relatively calm and orderly manner to climb the port side ladder and exit through the port side watertight scuttle. Figure 14 provides an example of the route Sailors would have taken from their racks to the port side watertight scuttle on a ship of the same class as FITZGERALD. They moved along the blue floor and turned left at the end to access the ladder. Figure 14 provides an example and sense of scale. Even though the Sailors were up to their necks in water by that point, they moved forward slowly and assisted each other. One Sailor reported that FC1 Rehm pushed him out from under a falling locker. Two of the Sailors who already escaped from the main part of Berthing 2 stayed at the bottom of the ladder well (see Figure 8) in order to help their shipmates out of the berthing area.

The door to the Berthing 2 head (bathrooms and showers) was open and the flooding water dragged at least one person into this area. Exiting from the head during this flood of water was difficult and required climbing over debris.

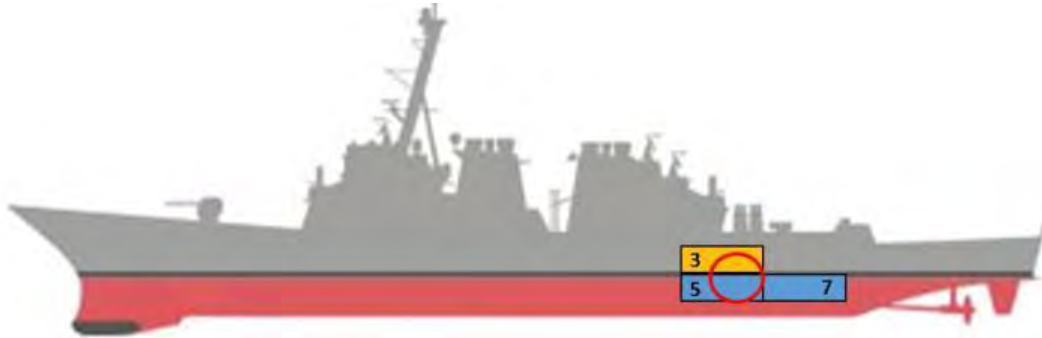
Figure 10 - Depiction of Approximate Location of Point of Impact

The point of impact was centered on Berthings 3 and 5 as noted in Figure 9. All significant injuries occurred to Sailors that were in Berthing 3 at the time of the impact. All ten of the fallen Sailors were in Berthing 5 at the time of impact.

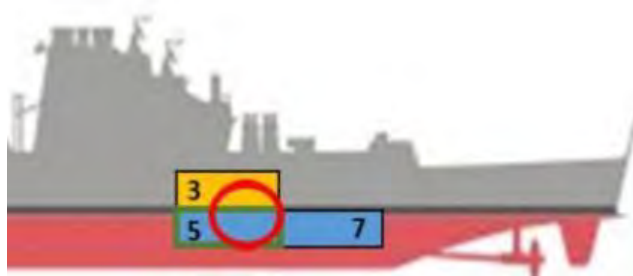
Figure 11 - Relative Positions of Berthings 3, 5 (in green), and 7, and point of impact

Berthing 5 is located aft (near the back of the ship) on the port side. See Figure 10. It is approximately 25 feet by 15 feet and has 18 racks, stacked as bunk beds three-high. Each row of racks has a locker for Sailors' belongings. There is a lounge with seats, a small table, and a wall-mounted television. There is a head with one toilet, one shower stall, and one sink.

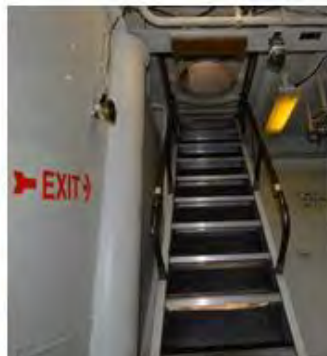
Figure 12 – Primary egress from Berthing 5
Left: from within Berthing 5
Right: Above on the deck outside Berthing 3

There are two means to exit Berthing 5: the primary egress (ladderwell) through a hatch with a scuttle (Figure 11) and an escape scuttle into Berthing 3 on the deck above (Figure 12).

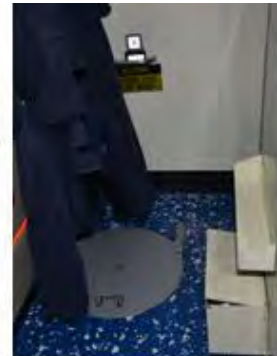
Figure 13 – Escape Scuttle from Berthing 5
Left: From within Berthing 5
Right: Above in Berthing 3

During Modified ZEBRA, the hatch is closed, but the scuttle is open for ease of access. The escape scuttle is normally closed at all times, as it was at the time of the impact. The collision knocked debris in Berthing 3 on top of the escape scuttle connecting Berthing 3 to Berthing 5 below it. This would have made any attempts to open and exit through the escape scuttle very difficult.

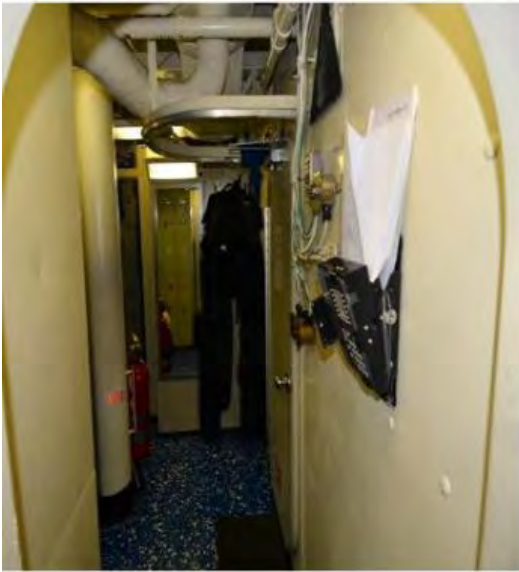
Figure 15 – Berthing 3 facing port

At 0530, the DCA began receiving reports of a ruptured fire main and water and fuel flooding into Berthing 3. The port side of Berthing 3 suffered substantial damage, including a large hole in the bulkhead. See Figure 13. Racks and lockers detached from the walls and were thrown about, leaving jagged metal throughout the space. Cables and debris hung from the ceiling.

Hearing reports that Sailors were trapped in Berthing 3, the Executive Officer and a group of Sailors, including some who evacuated Berthing 7, went to check on their shipmates. Several Sailors were pinned in their racks as a result of the collision, but, as the two ships pulled apart, the twisted metal shifted and most of the Sailors in Berthing 3 were able to escape as the debris moved. One of these Sailors was pinned in his rack underneath two racks that had collapsed and a number of lockers that became dislodged during the collision. He was able to escape after ALNIC MC detached. See Figures 14 and 15.

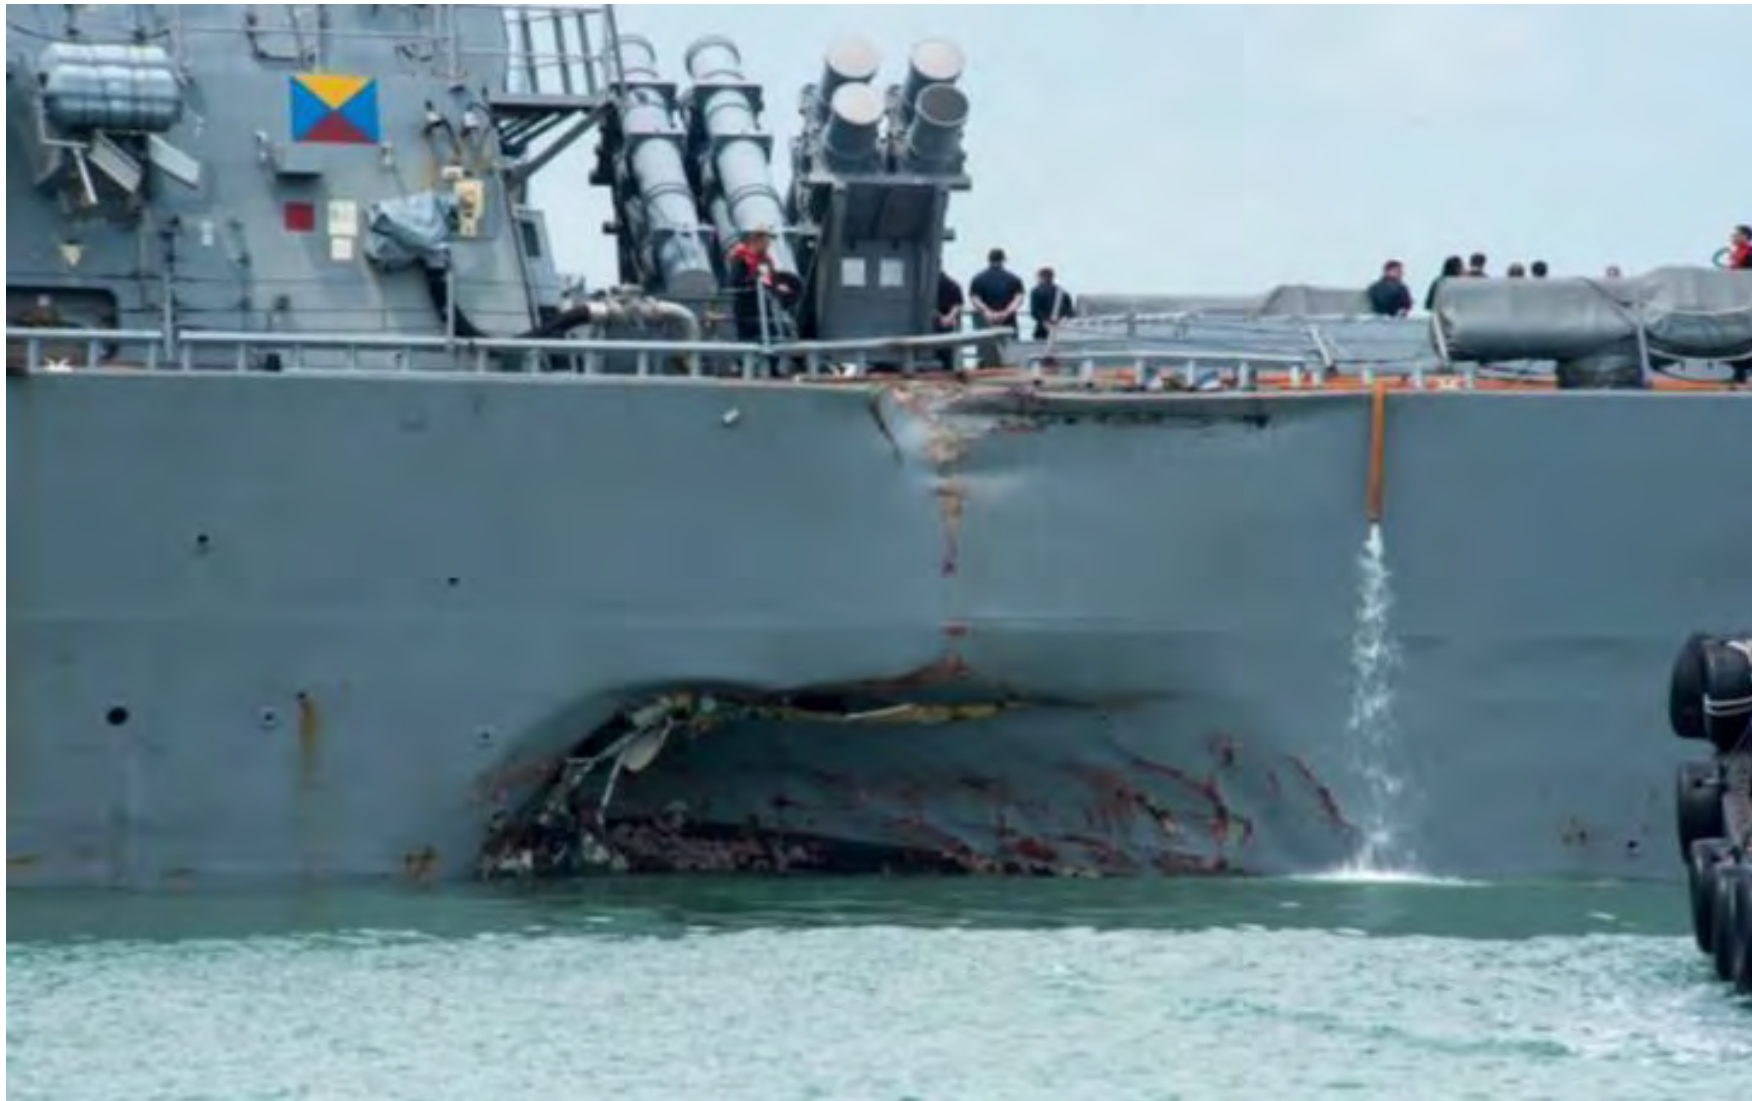
B1: Port side view of JOHN S MCCAIN post-collision

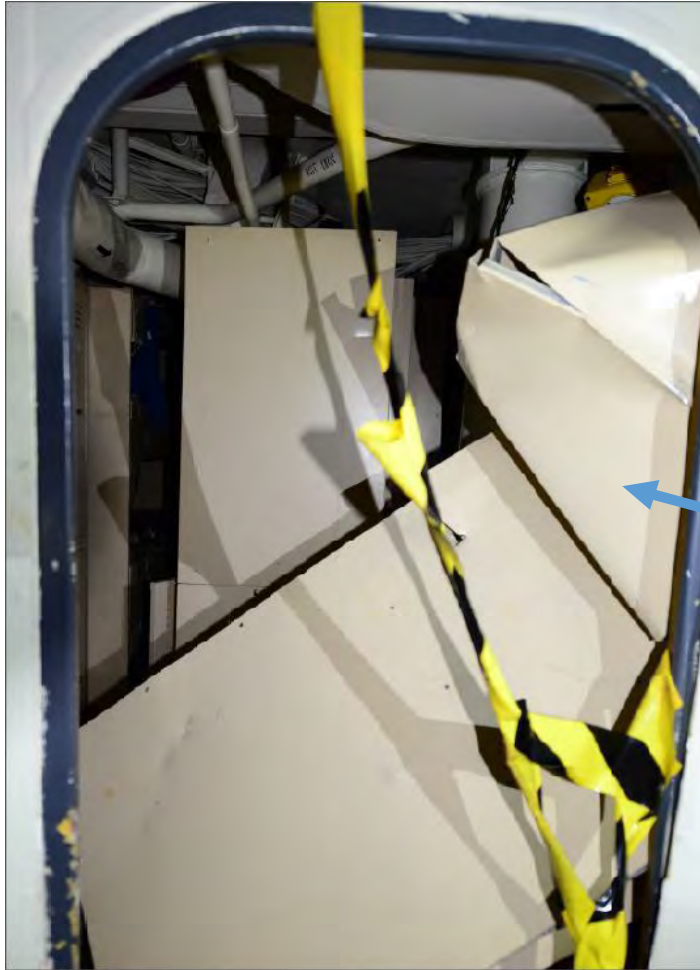
B3: Berthing 3 Primary egress (ladderwell) of JOHN S MCCAIN post-collision, with views into Berthing 3

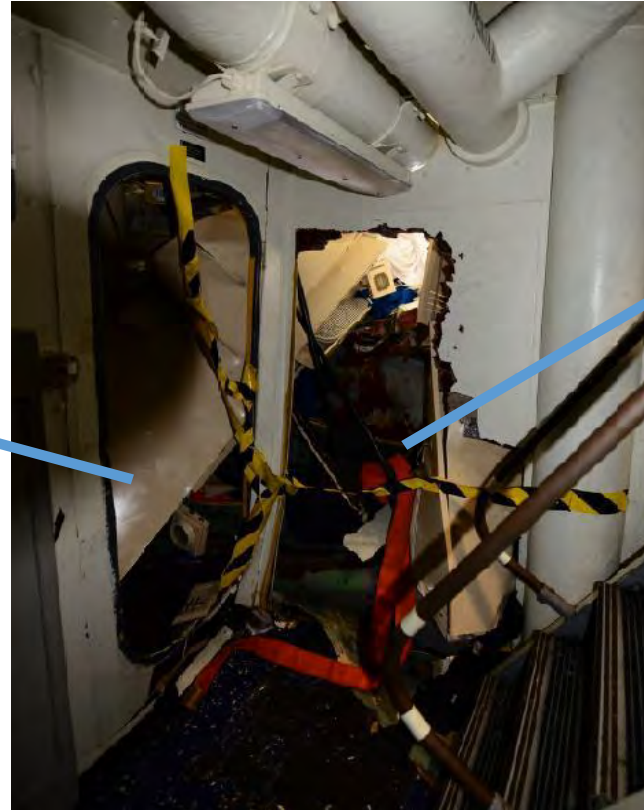
View through hatch into Berthing 3

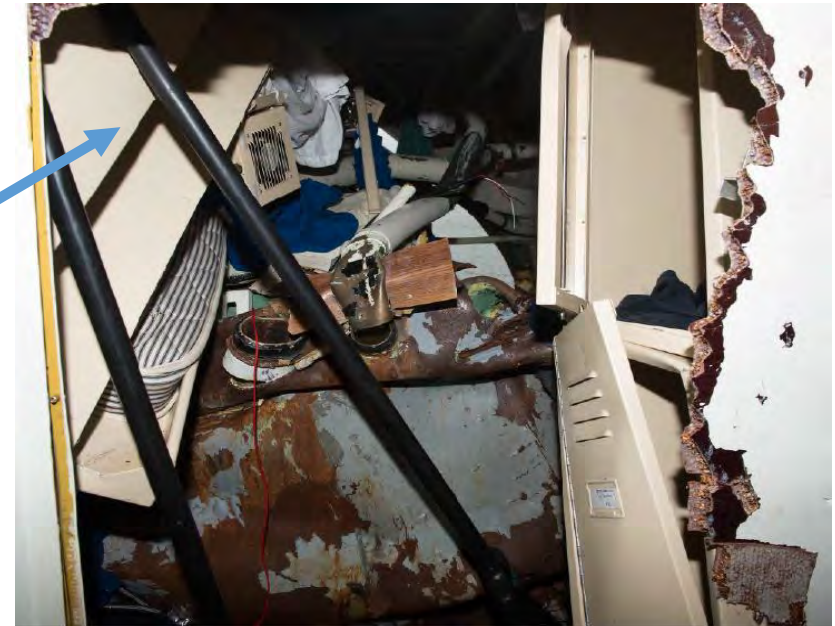
View through hole cut into bulkhead (wall)

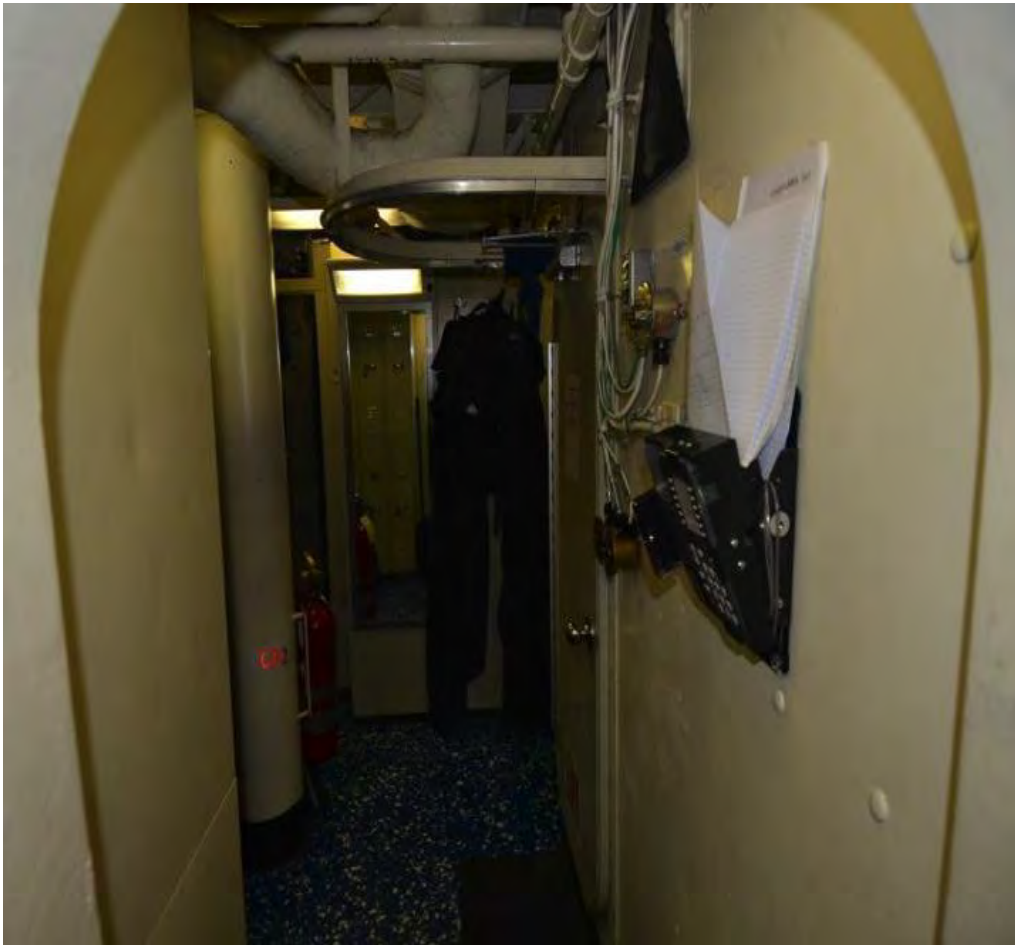
B4: View within Berthing 3, facing port (comparison)
