Report on the investigation of the
explosion of gas released from a cargo
of unprocessed incinerator bottom ash on

Nortrader

at anchorage in Plymouth Sound

on 13 January 2017

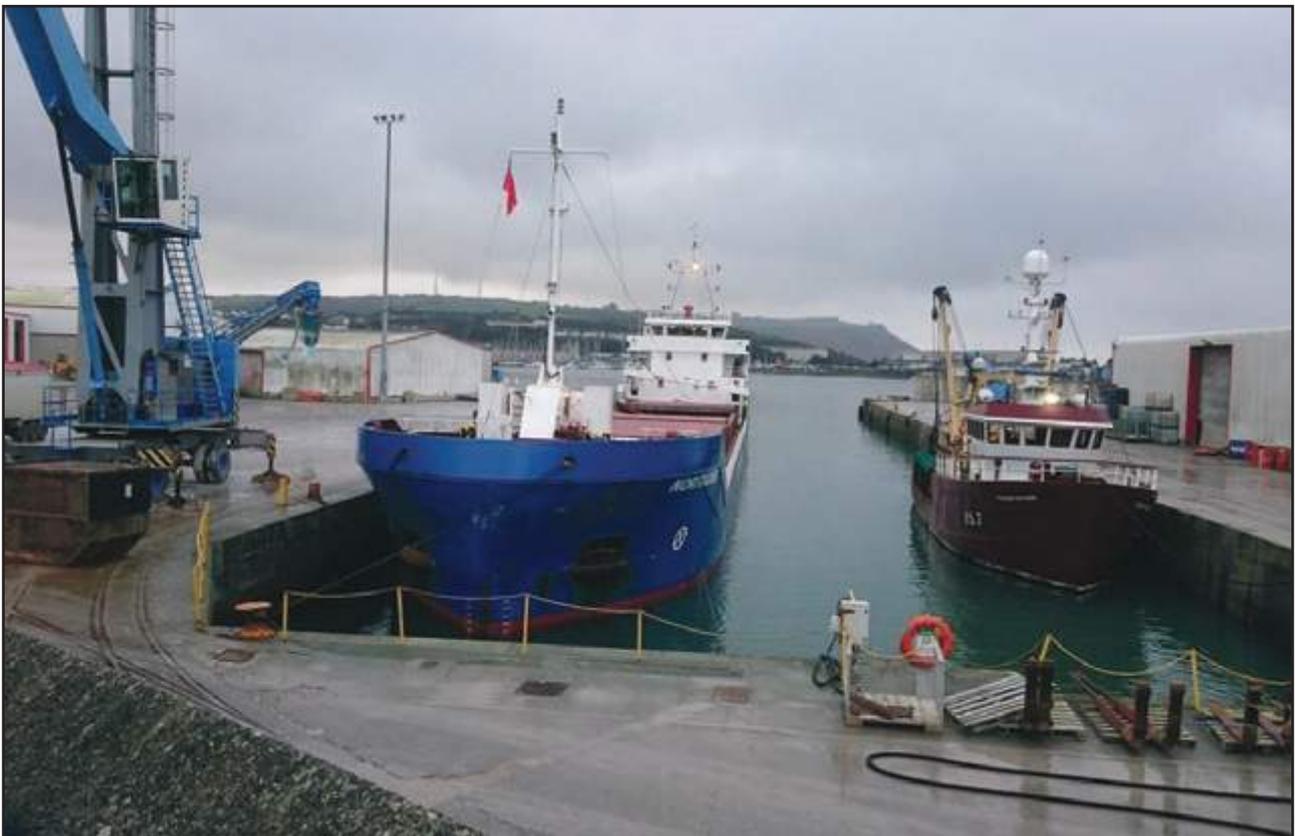
Nortrader berthed at Victoria Wharf, Plymouth, at 0655 on 12 January. Loading commenced at 0815, and by 1600 that day 2333t of U-IBA had been loaded in heavy and persistent rain (**Figure 1**). After completion of the final draught survey, the master checked the weather forecast and decided to anchor off Plymouth and wait for the imminent bad weather to pass. At 1900, the vessel left the berth and anchored 30 minutes later in Plymouth Sound (**Figure 2**).

Figure 1: *Nortrader* at Victoria Wharf, Plymouth

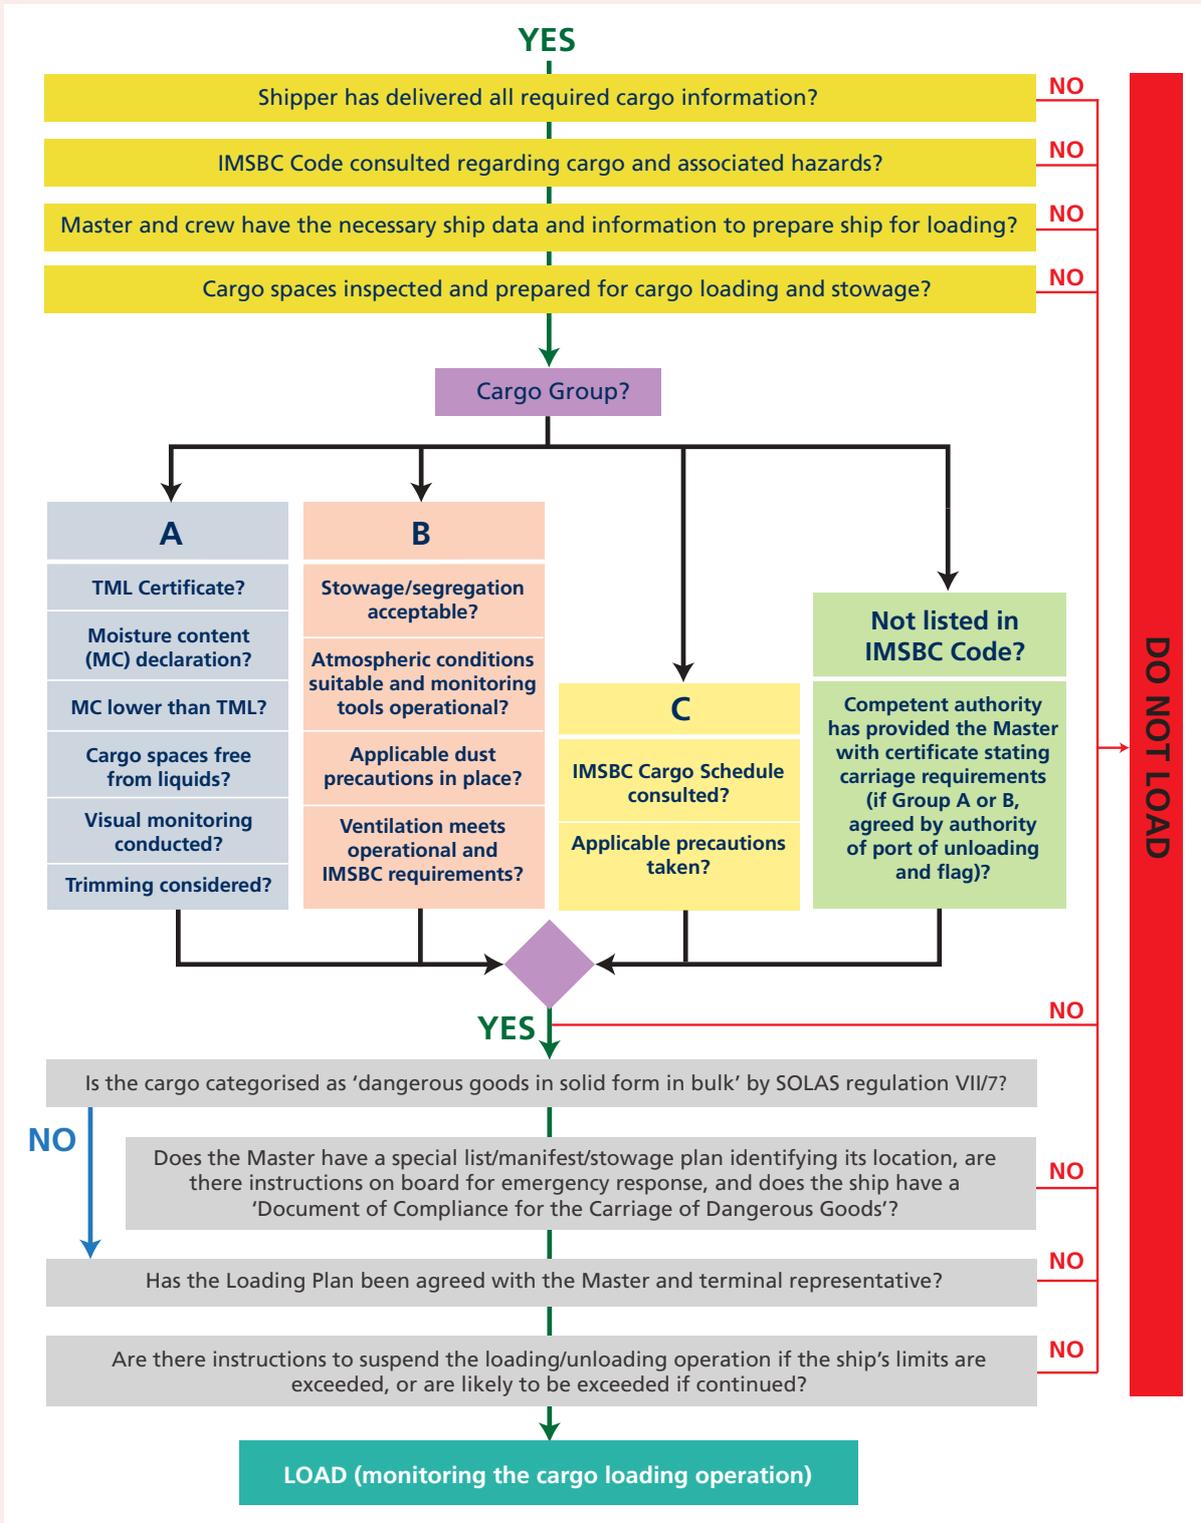
A loading flowchart contained in this guide provided clear guidance to the seafarer on the steps required to be taken before agreeing to load solid bulk cargoes (**Figure 11**).

Figure 11: Quick guide to IMSBC Code
