Sinking of the US Cargo Vessel *El Faro*

Illustrated Digest

This digest of the National Transportation Safety Board's (NTSB's) Marine Accident Report **NTSB/MAR-17/01** contains a description of the accident and safety issues, and summarizes some of the safety recommendations intended to prevent such an accident from happening again. The full report and docket can be found at www.nts.gov.

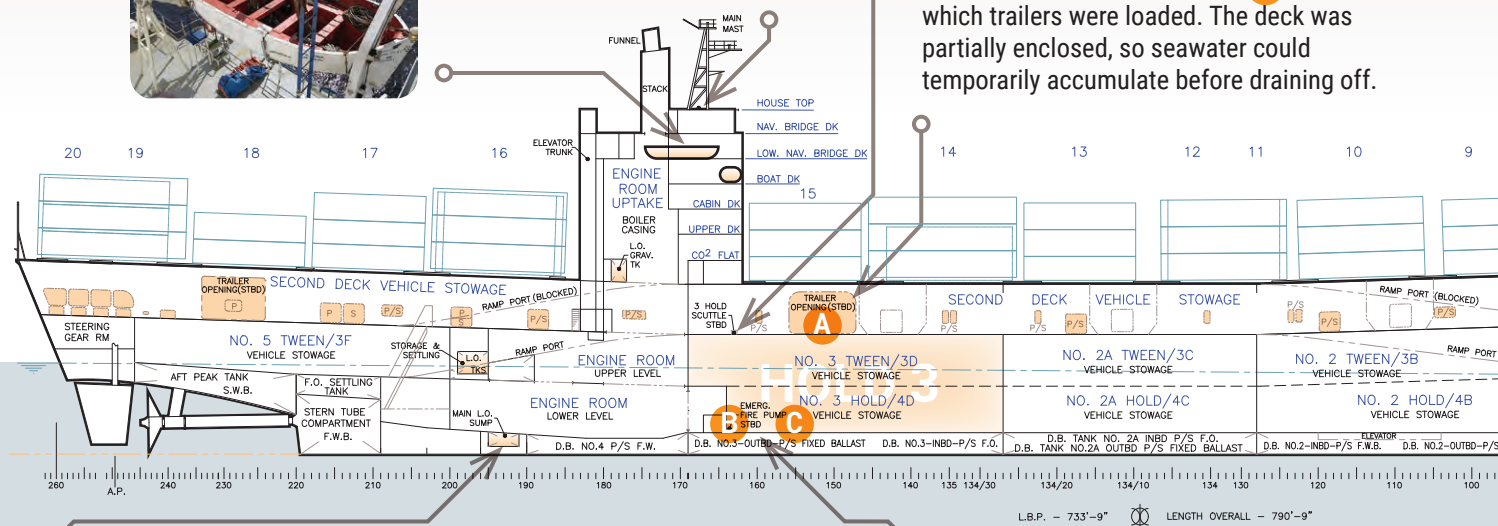
Seawater could flow onto *El Faro*'s second deck through openings, including large openings in the starboard side **A** through which trailers were loaded. The deck was partially enclosed, so seawater could temporarily accumulate before draining off.

According to logbook entries, the level of lube oil in the sump had been kept at 25 or 26 inches for most of the 2 years before the accident. In rough seas, this could lead to loss of propulsion (see Loss of lube oil suction, p. 7).

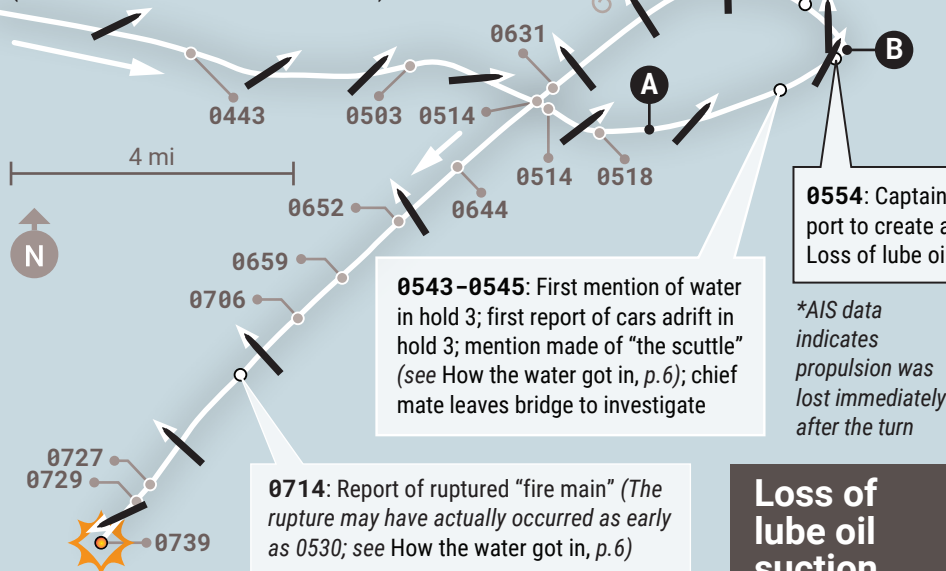
El Faro's final maneuvers

El Faro's captain and crew turned the vessel's bow into the wind several times. Then, at **0554**, the captain ordered a turn to port to get the wind on the ship's starboard side, generating a port list. A few minutes later, *El Faro* lost propulsion (see Loss of lube oil suction, below).

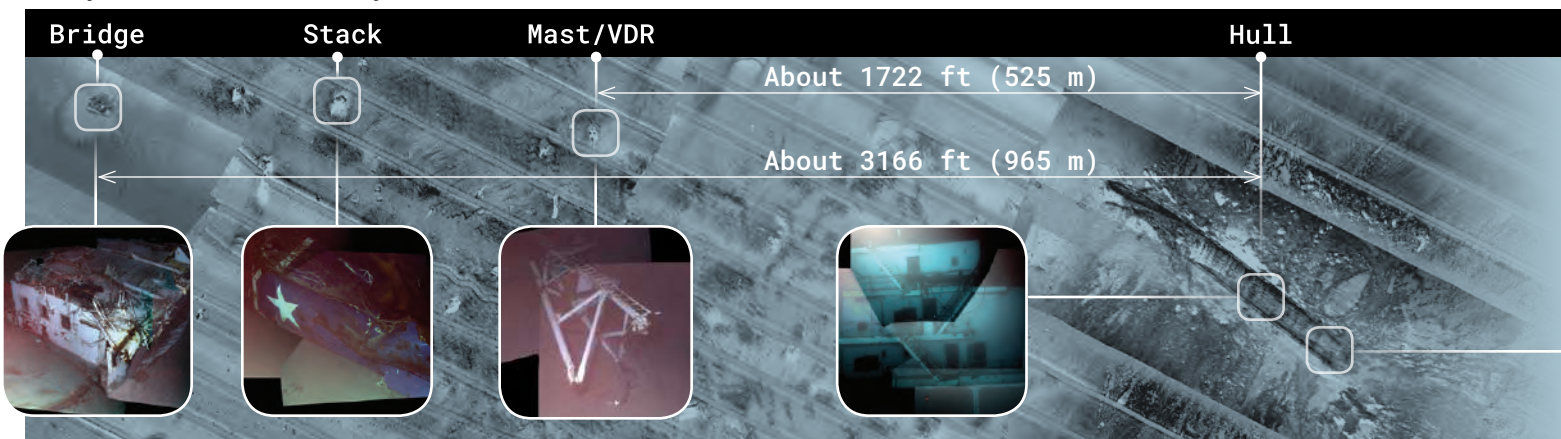
Sentry side-scan sonar survey of debris field
