## Final Report

Marine inquiry MO-2016-202  
Passenger ship, *Azamara Quest*, contact with  
Wheki Rock, Tory Channel  
27 January 2016

Approved for publication: March 2018

# Transport Accident Investigation Commission

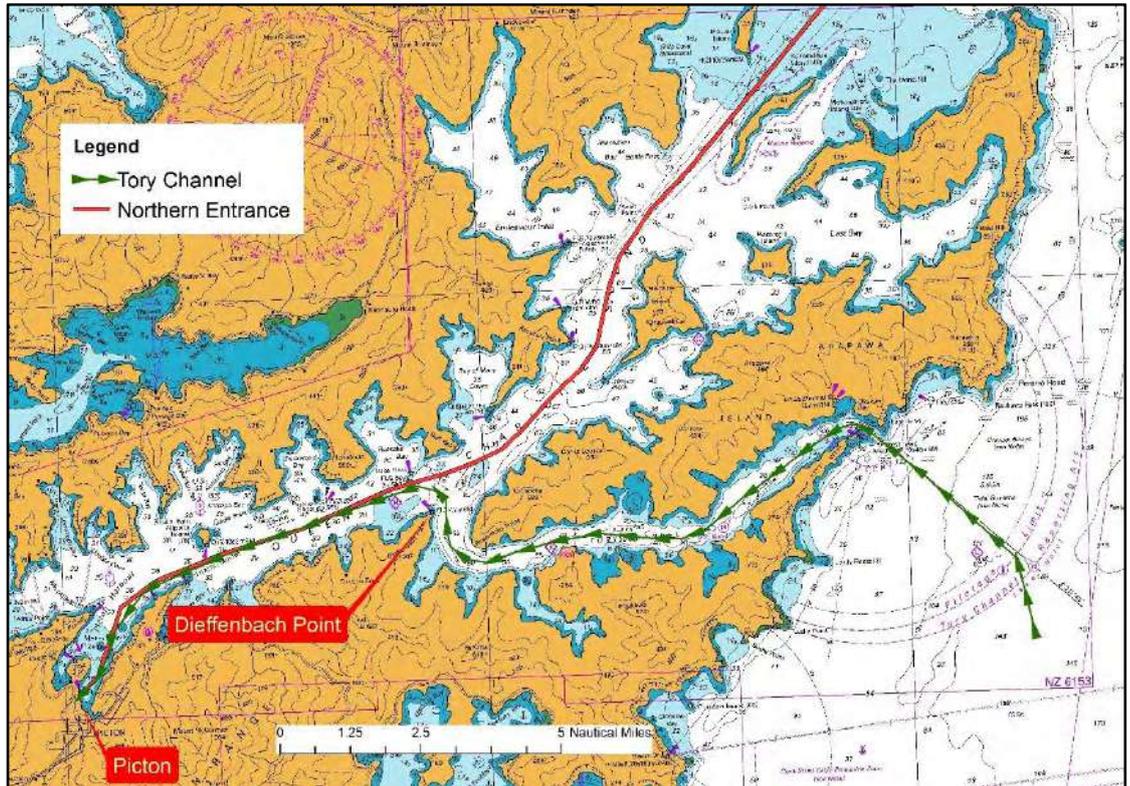
Figure 1  
Chart detailing the two routes to Picton

- 3.1.1. On 26 January 2016 the Maltese-flagged passenger ship, the *Azamara Quest*, was on passage from Akaroa to Picton on the north-eastern coast of New Zealand's South Island. The ship was on its maiden voyage to Picton and was due to arrive the following morning, on 27 January 2016. There were 652 passengers and 394 crew on board.
- 3.1.2. The port of Picton was accessible via two routes: a more direct northern entrance through Queen Charlotte Sound (shown in red, Figure 1); and a more difficult eastern entrance through Tory Channel (shown in green, Figure 1).

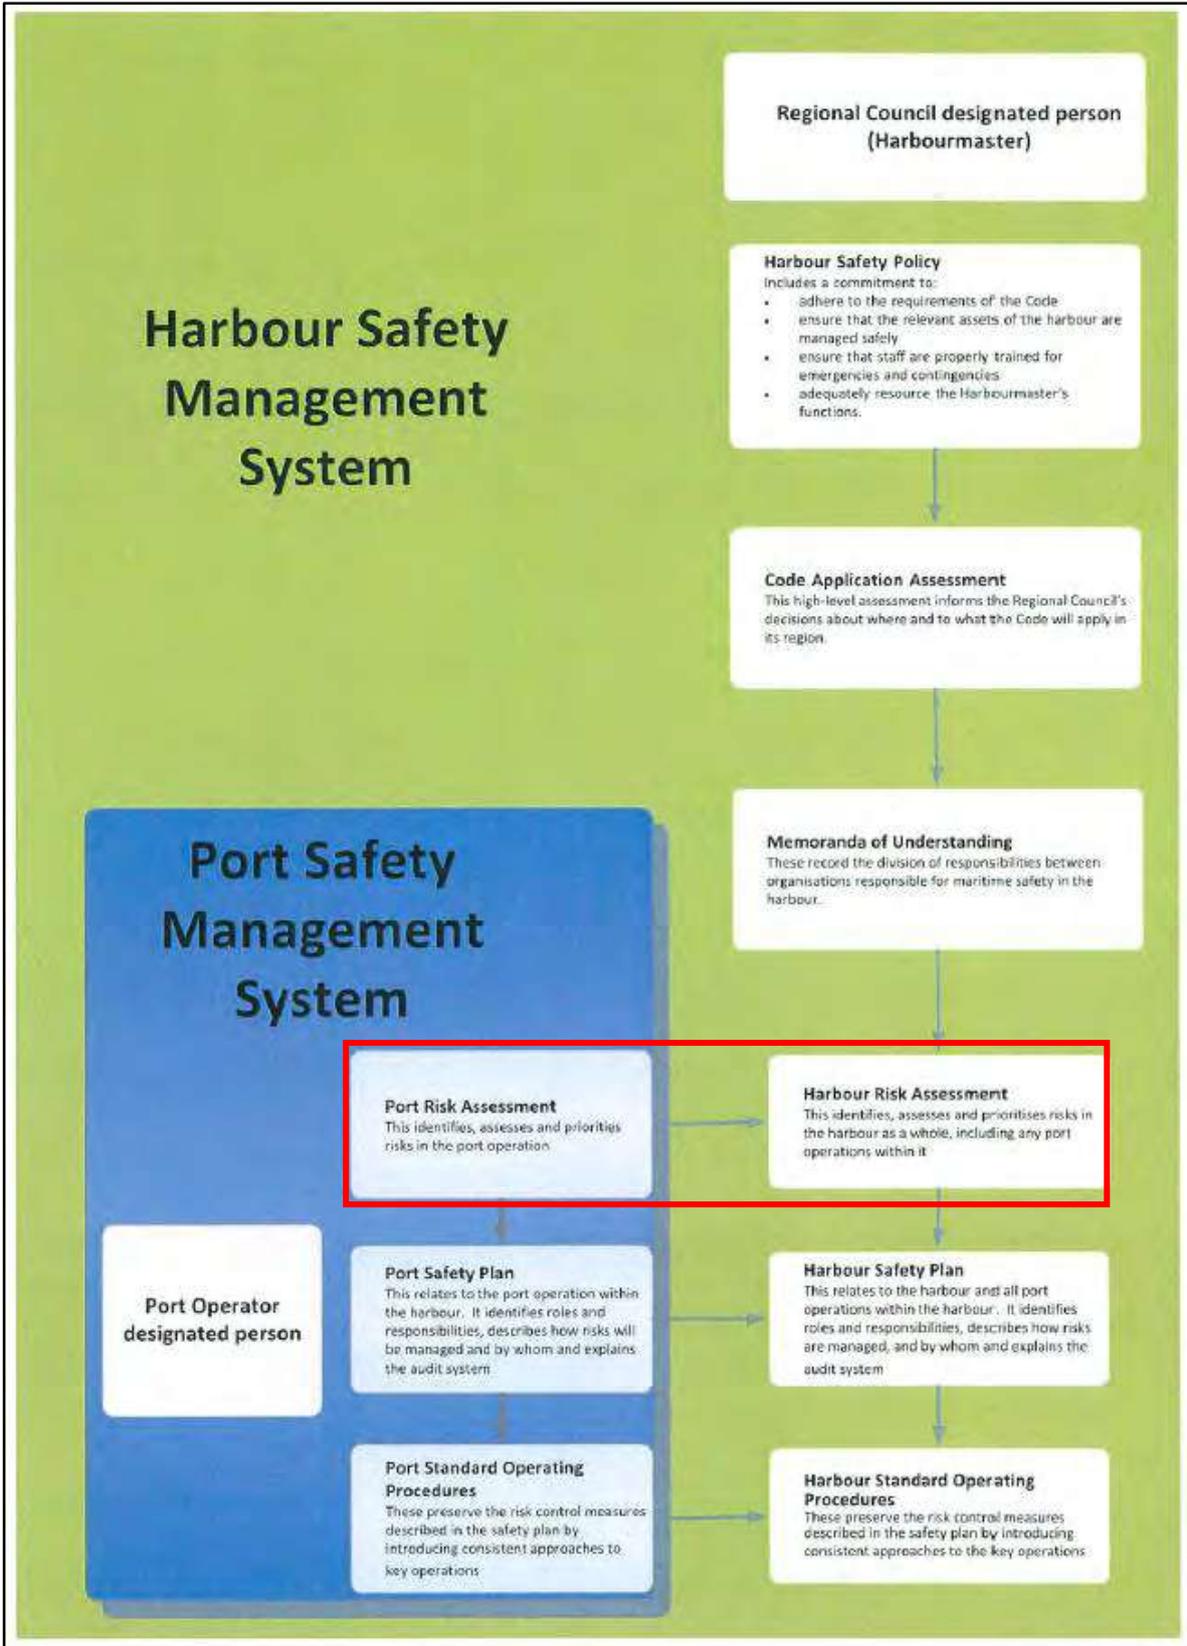
Figure 6  
Port and harbour safety management system

- 3.4.3. A step in implementing the code is for regional councils and port operators to each develop and document its own safety management system. The harbour safety management system is built around a harbour risk assessment undertaken by the regional council. It incorporates a port risk assessment carried out by any port operator for areas and activities covered by its port marine operations (see Figure 6).

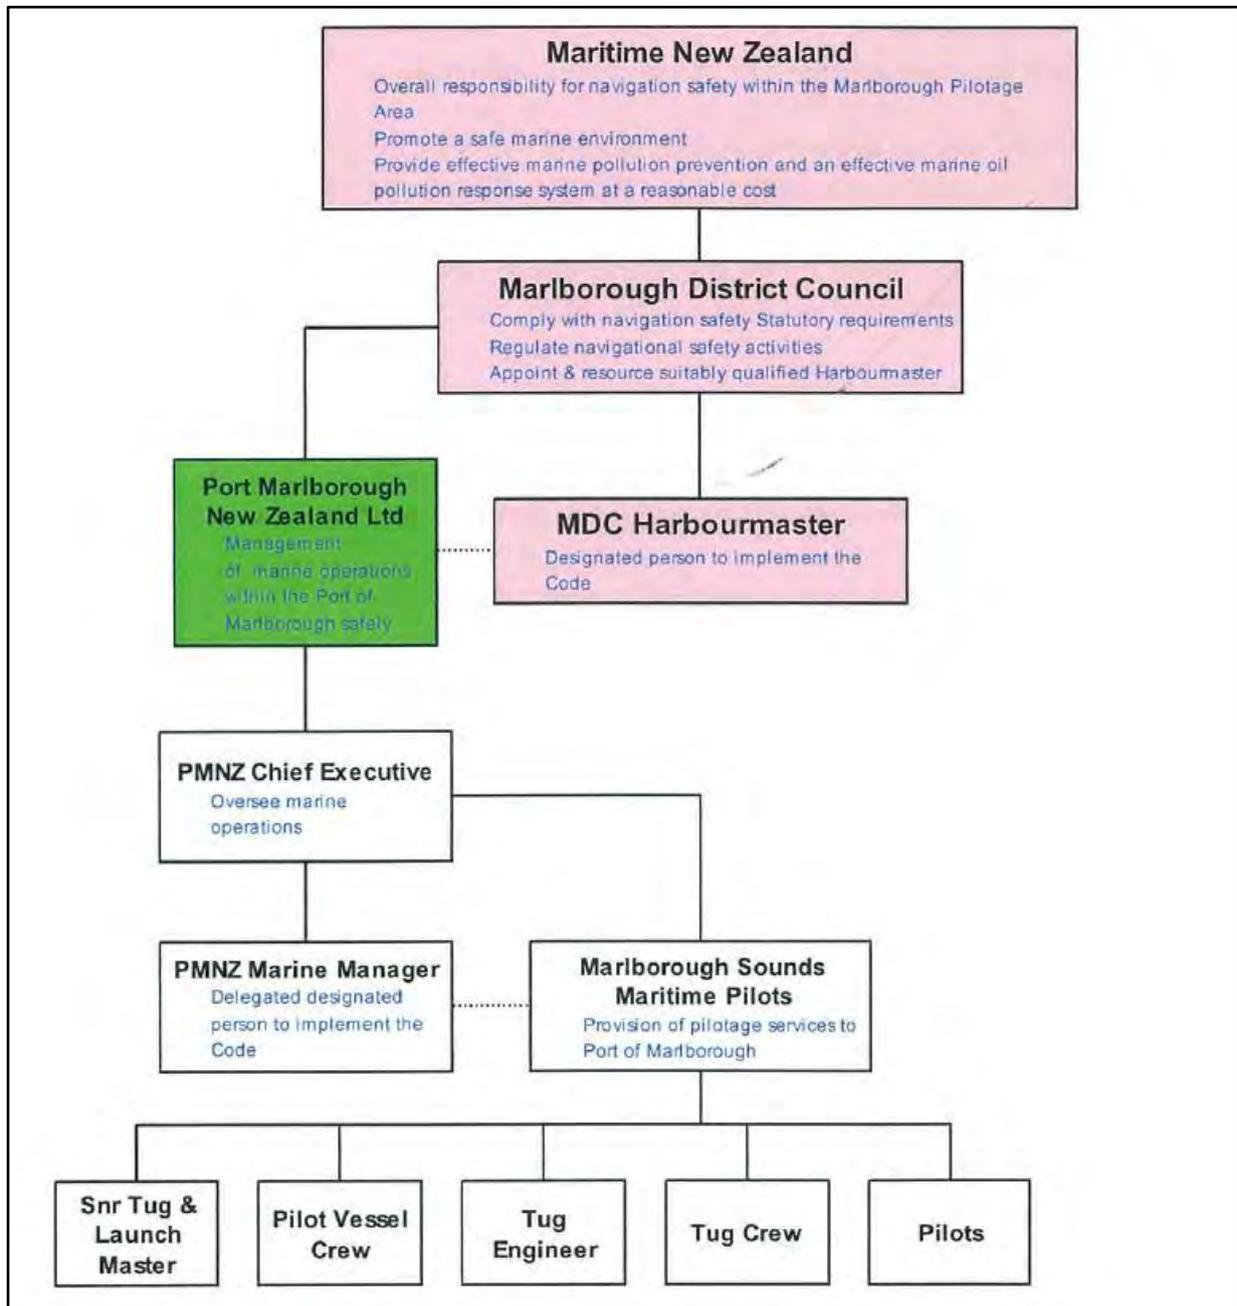
Figure 7  
Flow chart showing relationship between Maritime New Zealand, Marlborough District Council and Port Marlborough

3.4.4. Commercial activities at the port of Picton were undertaken by Port Marlborough, a company wholly owned by Marlborough District Council. Marlborough District Council was also the harbour authority responsible for the navigation and safety of all maritime activities within the harbour. Marlborough District Council discharged this responsibility through a council-appointed harbourmaster. Pilot and harbour towage services for shipping in Marlborough were provided by Port Marlborough New Zealand Limited Marine Services. Figure 7 shows how the different organisations at the port of Picton interfaced.
