**[Investigation Report No: 100E / 2018]**

**Very Serious Marine Casualty**

**Fatality due to fall into the sea while working over the ship's side from the Container Ship “MATAR N” on the 20<sup>th</sup> of July 2018**

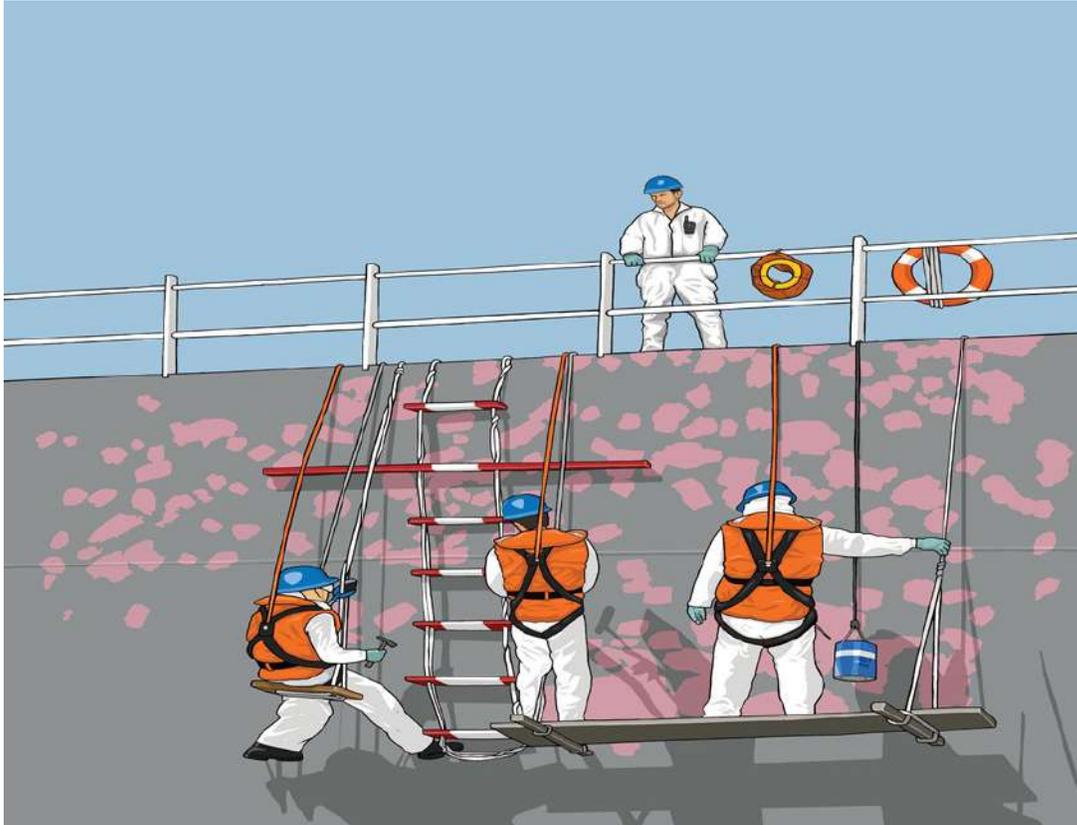
No any certificates existed for the Safety Line, Safety Harness, Jacobs Ladder and Painting Stage. During the demonstration, the snap hooks of the safety line were operating properly. The Jacobs ladder and the painting staged seemed to be in good condition.

**Stage:** Plank, or planks, fitted with transverse bearers, slung by ropes and put over ship's side, or in holds, for men to work on.

**Stage Lashing:** New, soft-laid, hemp rope used for lashing stages and other purposes. Is pliable and grips well.
