# National Transportation Safety Board

## Marine Accident Brief

### Collision between Fishing Vessel *Polaris* and Tanker *Tofteviken*

<b>Accident type</b>	Collision	<b>No.</b>	DCA18FM023
<b>Vessel names</b>	<i>Tofteviken</i> and <i>Polaris</i>		
<b>Location</b>	Atlantic Ocean, about 30 miles south of Montauk, Long Island, New York 40°31.40' N, 071°57.78' W		
<b>Date</b>	May 12, 2018		
<b>Time</b>	1913 eastern daylight time (coordinated universal time – 4 hours)		
<b>Injuries</b>	None		
<b>Property damage</b>	\$716,047		
<b>Environmental damage</b>	None		
<b>Weather</b>	Visibility 10 miles, light breeze, seas 2–4 feet, air temperature 52°F, water temperature 51°F, sunset 1955		
<b>Waterway information</b>	North Atlantic Ocean. Navigational approach to New York Harbor.

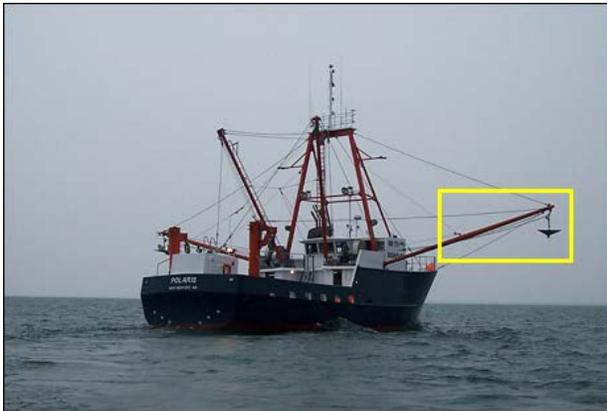
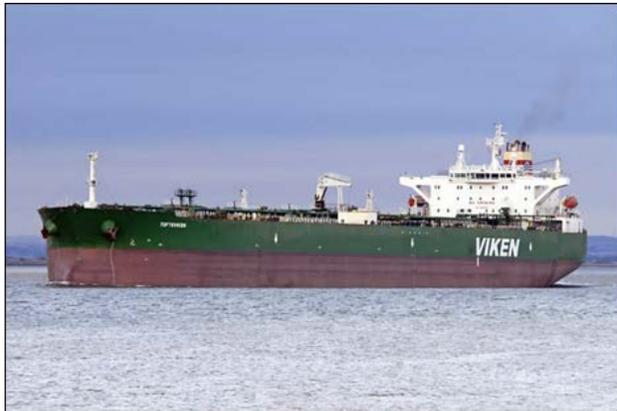
Fishing vessel *Polaris* (left) and tanker *Tofteviken* (right) before accident. Yellow rectangle identifies extended outrigger and paravane on *Polaris*' starboard side. (Photos from Eastern Fisheries and Viken Shipping<sup>2</sup>)
