Report on the investigation of the
grounding of the general cargo vessel

Priscilla

on Pentland Skerries, Pentland Firth, Scotland

on 18 July 2018

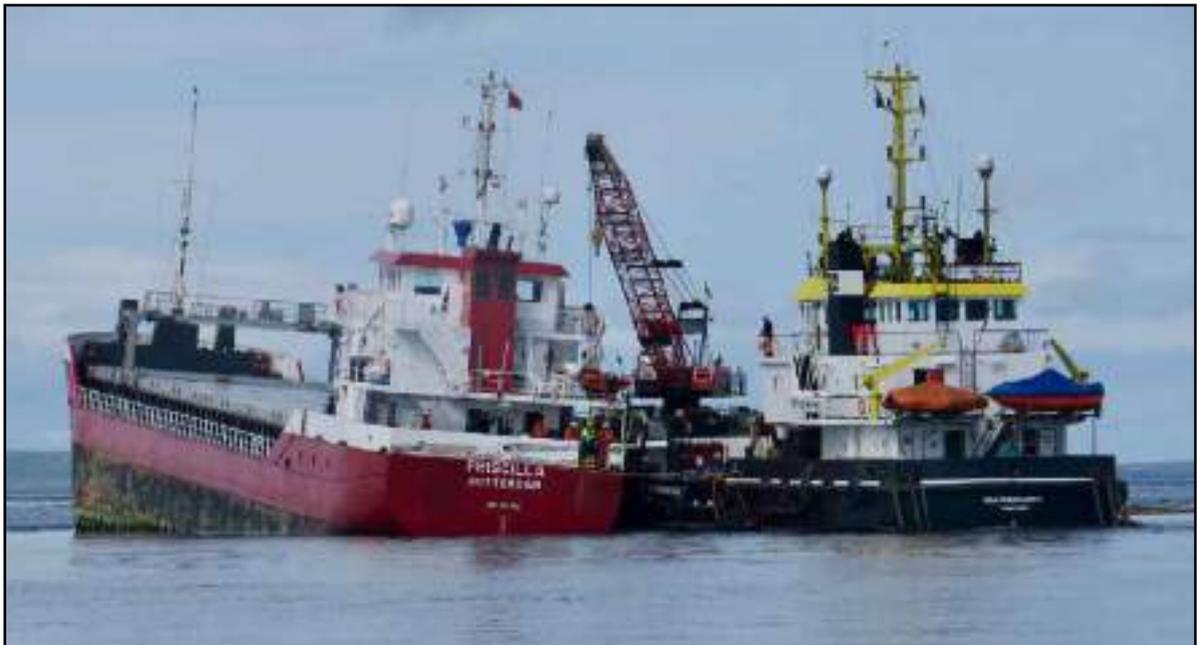
In the following days and at high water, two unsuccessful attempts were made to haul *Priscilla* off the rocks using tugs. On 20 July 2018, a salvage team arrived on board *Priscilla* and 3 days later, after a partial cargo discharge (**Figure 5**), the vessel was refloated and towed clear of Pentland Skerries. Following a diver inspection at Scapa Flow, *Priscilla* proceeded under its own power to Silloth to complete the cargo discharge. Thereafter, *Priscilla* proceeded to dry dock in Swansea, Wales where a full inspection revealed extensive structural damage throughout the forward section of the hull, including gouging and distortion to the shell plating (**Figure 6**).

Figure 5: Partial cargo offload from *Priscilla* when aground

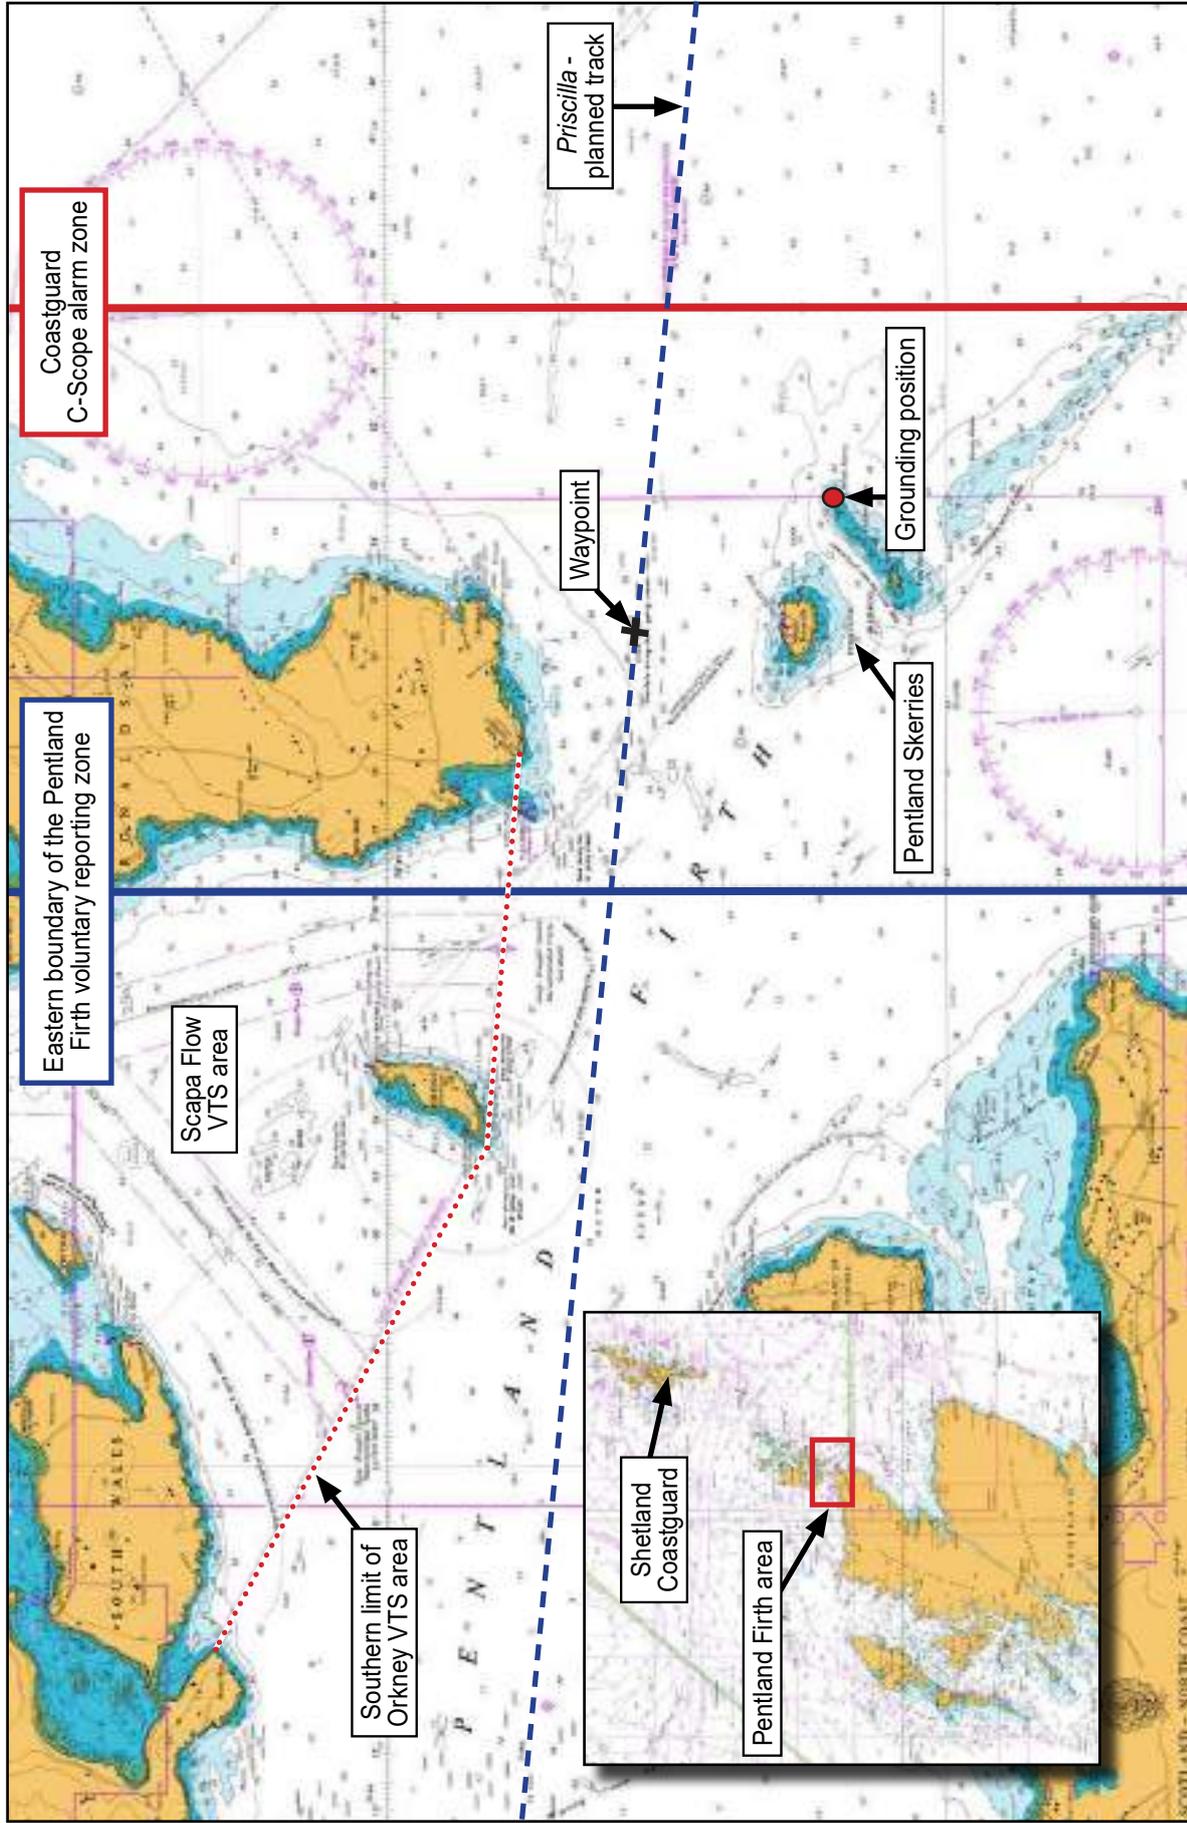
Figure 7: Chart showing Pentland Firth, *Priscilla's* planned track, Orkney VTS limit, the boundary of the Pentland Firth voluntary reporting scheme and the coastguard's C-Scope alarm boundary

Priscilla grounded outside the Pentland Firth voluntary reporting scheme but inside the C-Scope alarm boundary (**Figure 7**). However, *Priscilla* had not been identified or monitored by the watchkeepers at Shetland CGOC. Indeed, the Shetland CGOC officers only became aware of *Priscilla* heading towards the Firth following the phone call from the Orkney VTSO. This happened because the duty officers at Shetland CGOC had not logged on to terminals with operational C-Scope. It was also unhelpful that *Priscilla's* OOW did not make the MAREP call using VHF radio 1 hour before entering the scheme as this would also have alerted the Shetland CGOC watchkeepers.

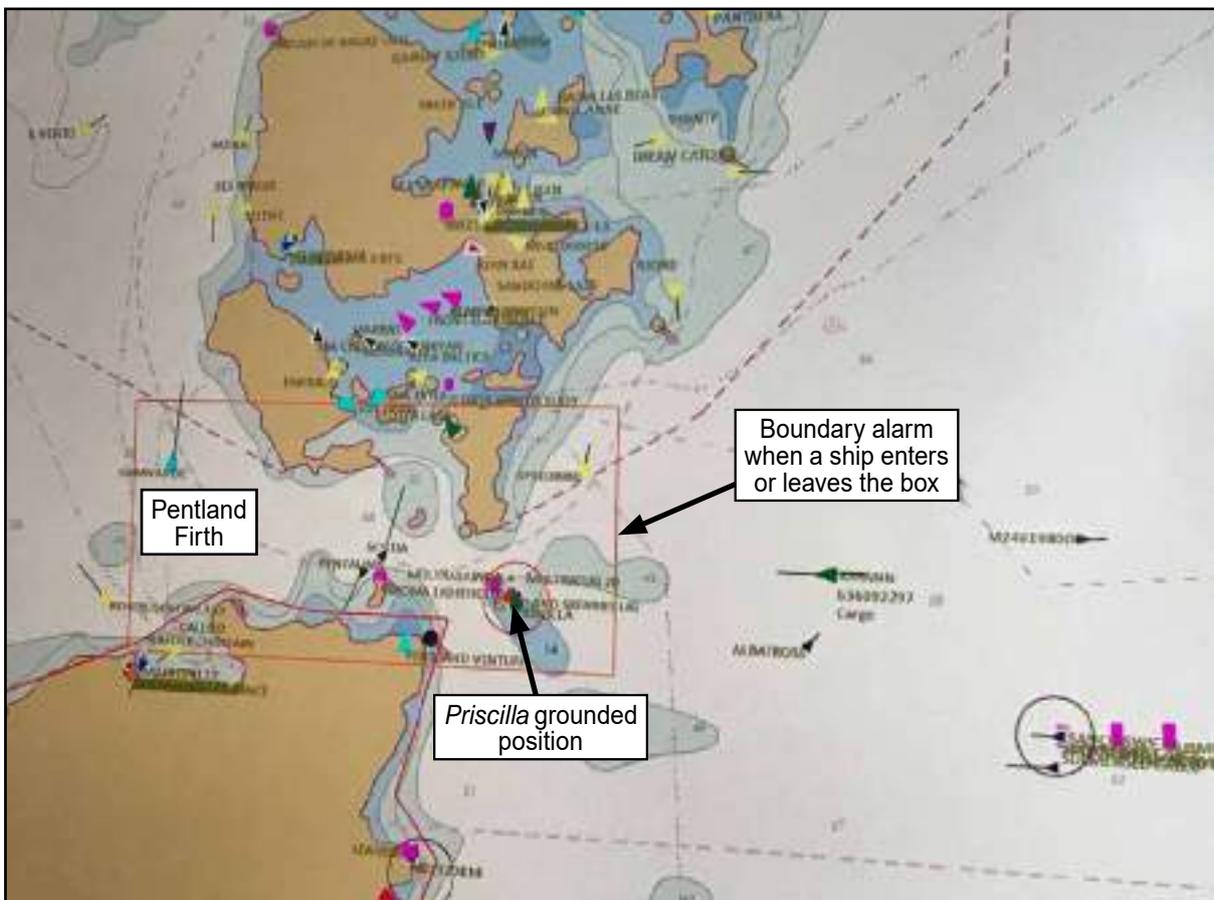
In Shetland CGOC (**Figure 8**) the C-Scope system was installed on three of the six operator terminals. Each of these terminals had been configured to provide an audible and visual alarm to the duty officers when a vessel entered the C-Scope alert zone around the Pentland Firth (**Figure 9**).

Figure 9: Shetland Coastguard's C-Scope display showing the alarm boundary
