SAFETY INVESTIGATION REPORT

REPORT NO.: 20/2019

MV *Khosrov Bey* **Fatal fall down in the engine-room** **in position 41° 35.6' N 028° 44.0' E** **03 November 2018**

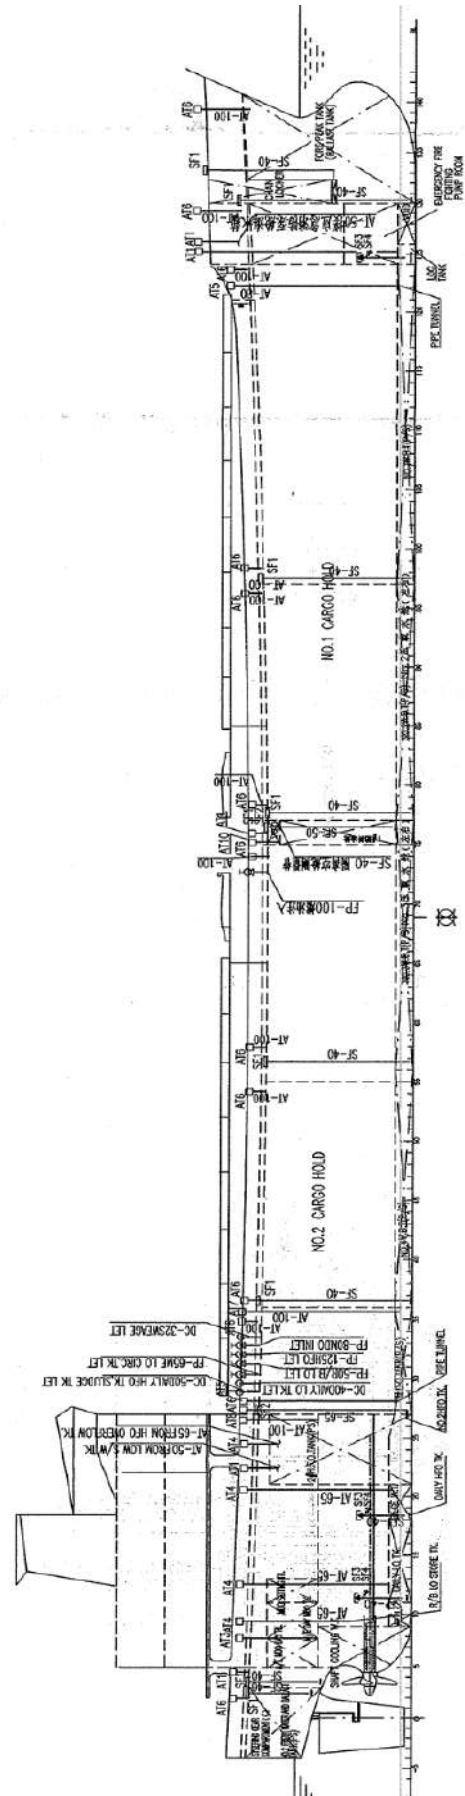
Figure 1: GA plan of MV *Khosrov Bey*

Khosrov Bey (Figure 1), a 4,109 gt general cargo ship, was built in 2007 and was registered in Malta. She was owned by PAL Bulk 2 Shipping Co. Ltd., managed by Palmali Gemicilik ve Acentelik A.S. of Turkey and classed with BV. The vessel had a length overall of 99.89 m and a moulded depth of 8.40 m.
