# Annual Digest 2019

Reports and Insight Articles

# Annual Digest of Reports and Insight Articles

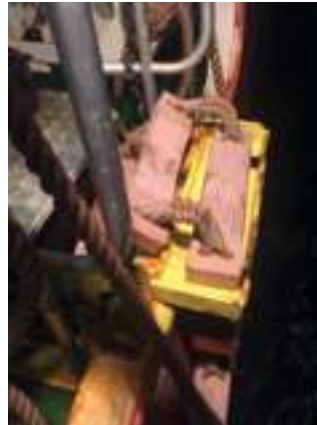
This class of vessel has a side door access. The ladder is rigged via slots in an angle bar bracket, thus putting the load on the step lashings rather than on the side ropes. By my reading of the rules and Witherby's Pilot Ladder Manual, this arrangement is not compliant.

Pilot ladder rigged via an illegal angle bar bracket rather than side rope lashings.

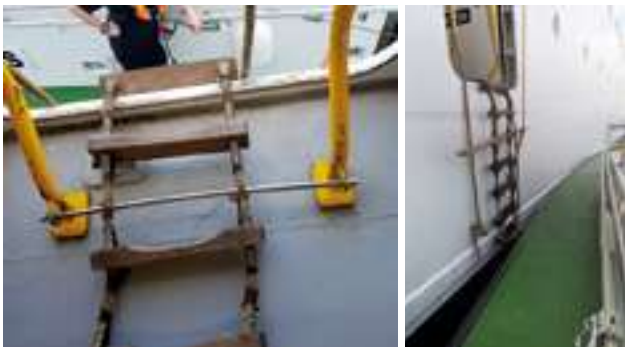
A metal bar had been placed between the ladder side ropes which relied solely on the whipping on the chocks to hold the weight of the ladder and the pilot. The side ropes were left on the deck and not secured to anything. I refused to use the arrangement and provided advice to the crew to correctly rig the ladder. There were strong points provided at the head of the side door where the manropes had been secured. In view that there were no other strong points provided, I suggested that this would be a better securing point for the side ropes of the ladder. At first the crew informed me that they always rig the ladder in the presented manner, that it was safe and there were no issues with it. After some discussion the crew eventually re-rigged the ladder so that the weight of the ladder was carried through the side ropes in line with SOLAS regulations. The manropes provided were left with a large knot at termination which would prove a snagging issue to the pilot boat should it roll. There was also a pre-rigged orange line to a lifeboat/tender which impinged over the pilot ladder spreader bar, (photo below from pilot boat shows this). After disembarkation I reported to the vessel via VHF that they should review their pilot ladder arrangements to ensure compliance with SOLAS regulations.

The crew showed no awareness of the SOLAS requirements for correctly rigging a pilot ladder. There was no officer overseeing the operation, only two AB's and a security team member who had escorted me from the bridge. This is a common issue on cruise ships where it is very rare for a deck officer to be present for pilot transfer.

**Completely illegal and highly dangerous method of rigging a pilot ladder**

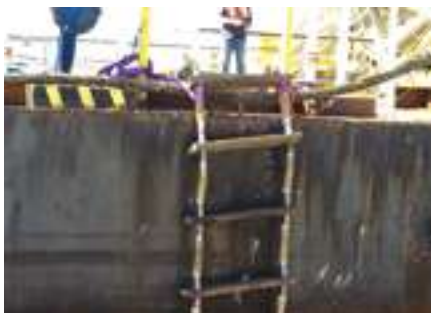
**Figure 3 – Ladder supported by strops and not the side ropes**

In addition to the lack of stanchions and the ladder running over a wire, it is important to note that the strops in figure 3 are purple (which signifies 1 tonne SWL). This is significantly less than the 24 kN required by regulation and again the ladder weight is not being taken by the side ropes.

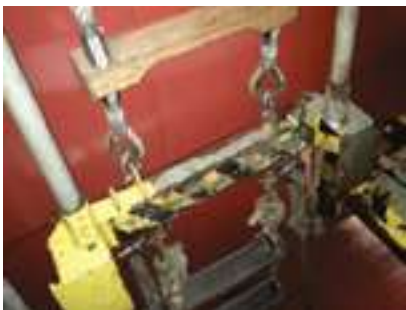
A single length of ladder, lying flat against the hull and secured 1.5 metres above the accommodation ladder trapdoor is the requirement – this however often means that the pilot has to lean back in order to effect access through the trapdoor. This is illustrated in the following two pictures where the two-stage ladders are also non-compliant. Pilot ladders are suspended from the accommodation ladder frames rather than directly from their side ropes.

**Figure 8 – Two stage non-compliant ladder – weight is not held by man ropes at all**

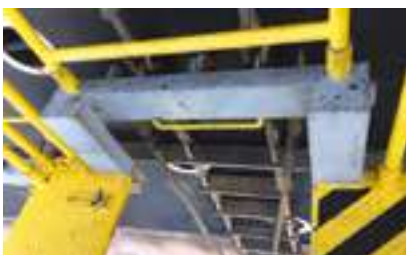
**Figure 9 – Pilot has to lean back to gain access to trapdoor**

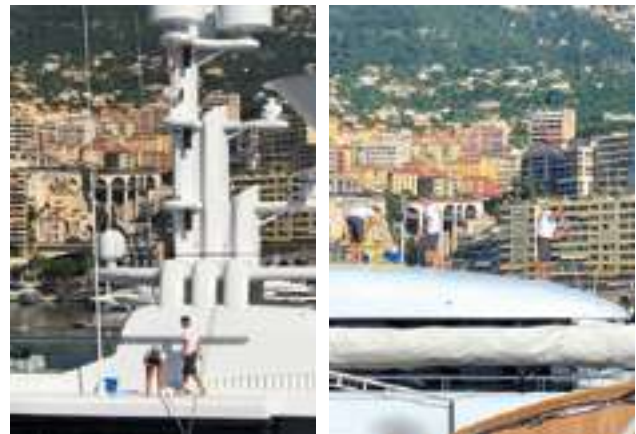
Recently I witnessed several deck personnel on the yacht on our port side working at height without any safety equipment. They were working at a considerable height above the waterline washing down with detergent, which in my opinion increased the risk of slipping and falling over the side. As you can see in the photos attached, certain crew members were leaning over the side of the vessel trying to clean the superstructure.

The photos clearly demonstrate the lack of crew safety awareness and a poor on board safety culture.
