# STONE I

Marine accident report on loss of control

4 JANUARY 2020

**MARINE ACCIDENT REPORT ON LOSS OF  
CONTROL ON STONE I ON 4 JANUARY 2020**

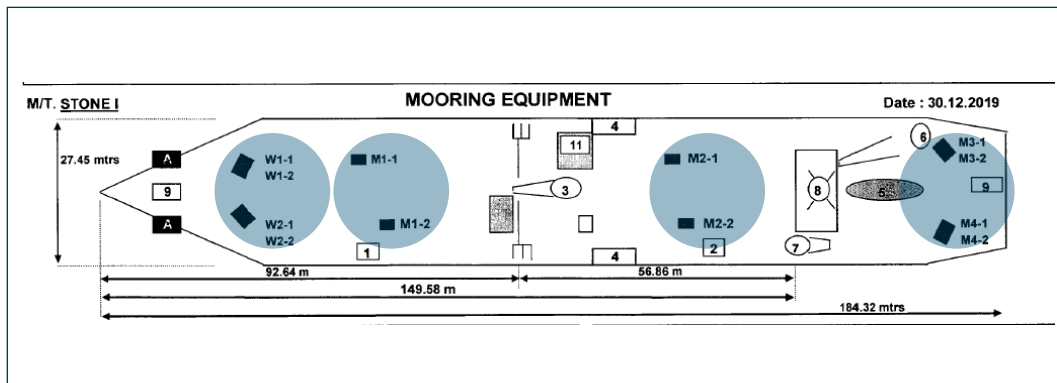
Figure 5: Basic drawing of mooring winch location on STONE I  
Source: Zenith Gemi Isletmeciligi AS / DMAIB

STONE I was equipped with eight hydraulically driven mooring winches. The basic layout drawing below (figure 5) below shows the location of the mooring winches. The mooring winches on the aft and on the forward mooring stations were fitted with double split drums divided by a notched flange with a tension section and a rope storage section (figure 6).

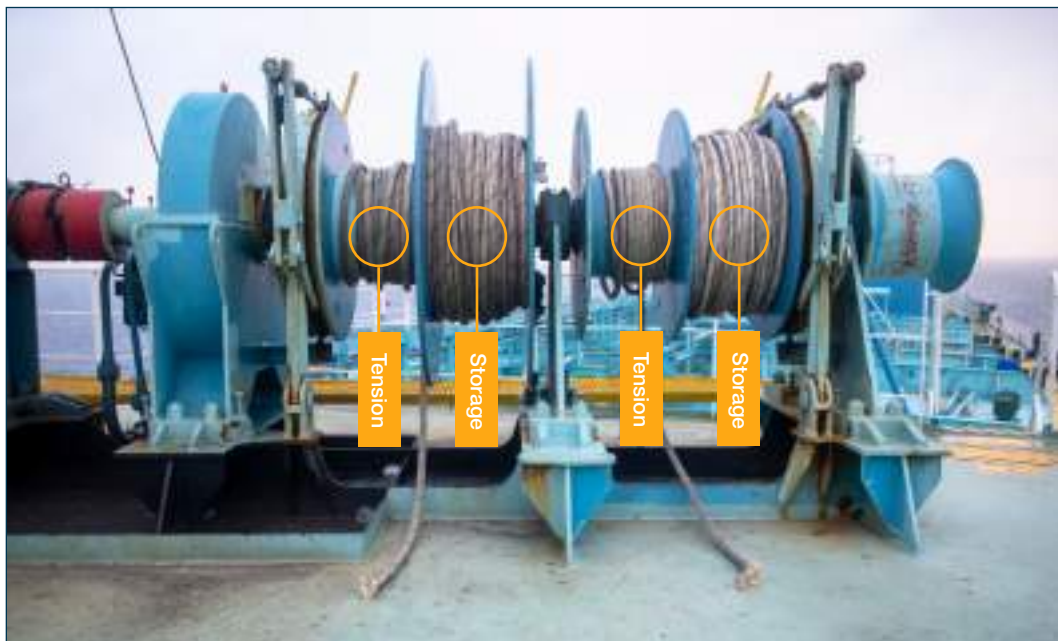
Figure 6: Combined windlass and double split drum mooring winch.  
Source: DMAIB

The mooring winches forward of the accommodation and aft of the forecastle intended for spring lines were single split drum mooring winches. On the tension drum, the rope was reeled in one layer. Only the rope reeled on the tension drum was under tension. The winch brakes had a maximum holding capacity of 40.8 tons each, but to allow for a safety margin, the brake holding capacity on the winches was adjusted to 29.4 tons, corresponding to 60 % of the ship's design minimum breaking load.

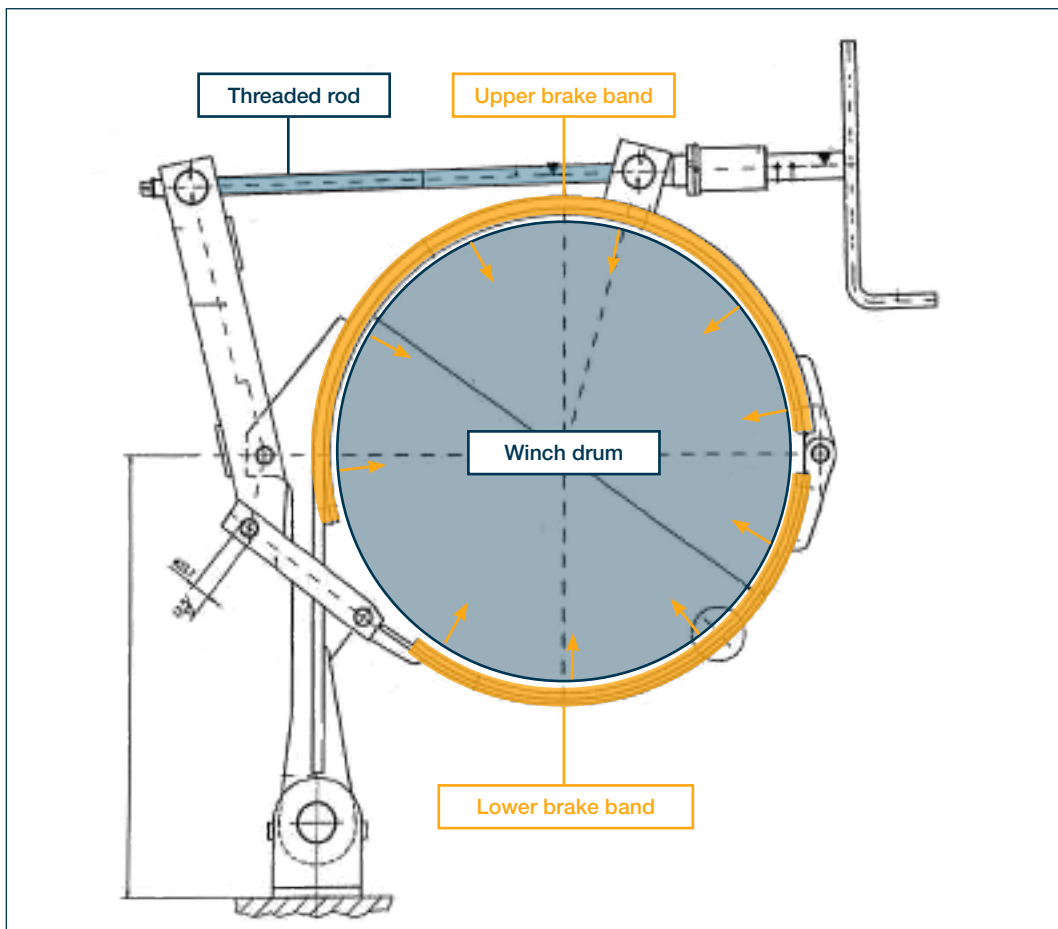
Figure 8: Basic drawing of mooring winch  
Source: Zenith Gemi Isletmeciligi AS / DMAIB

The hand wheel was connected to a threaded rod that drew the upper and lower halves of the brake band together (figure 8), which brought the brake band into contact with the brake drum. Brake setting indicator nuts for the spring load were fitted on the rod close to the hand wheel, visually indicating whether the brake had been properly calibrated. Paint markings on the threaded rod indicated how much the brake had been tensioned (figure 9). These visual cues had the purpose of enabling the crew to determine, whether the brakes were properly tensioned. The paint marking on the threaded rod indicated two turns on the rod. Hence, the visual indicators made it readily visible for the deck crew to determine if the brakes were sufficiently applied.

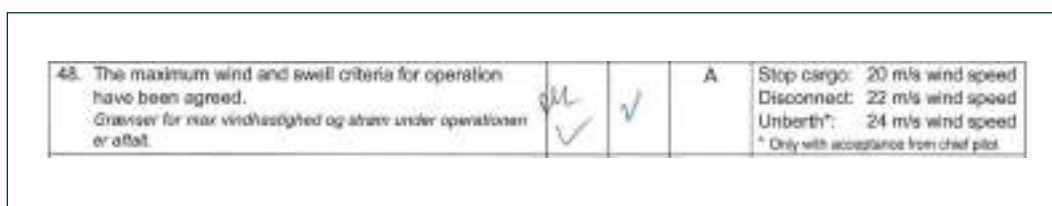
Figure 10: Extract from the terminal's ship-shore safety checklist  
Source: Inter Terminals Denmark EOT Aps / DMAIB

Upon arrival at the jetty, the terminal's ship-shore safety checklist was completed. According to the ship-shore safety checklist, the maximum wind criteria for operation had been agreed on before loading operation commenced (figure 10).

48. The maximum wind and swell criteria for operation have been agreed. Grænser for max vindhastighed og søbøl under operationen er aftalt.	✓	✓	A	Stop cargo: 20 m/s wind speed Disconnect: 22 m/s wind speed Unberth*: 24 m/s wind speed * Only with acceptance from chief pilot
--	---	---	---	--

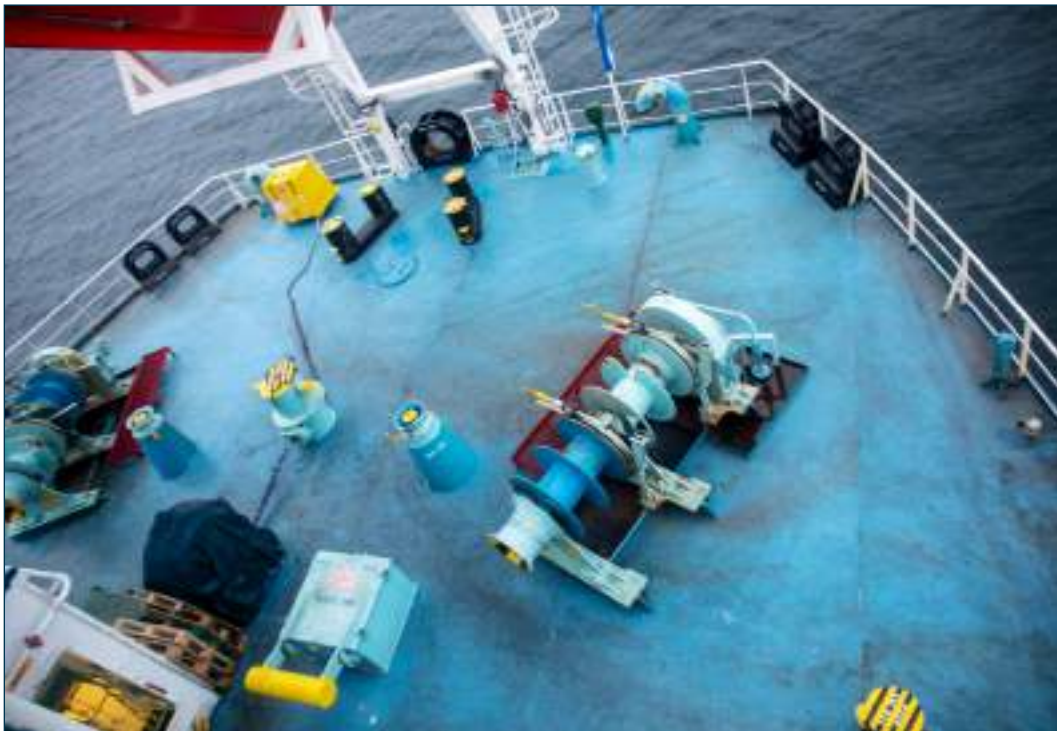
Figure 13: Mooring arrangement aft deck  
Source: DMAIB

STONE I had four mooring stations: one aft, two on the main deck and one on the forecastle. On the aft mooring station, the mooring fittings consisted of two double drum mooring winches, Panama fairleads, bollards and pedestal rollers. Both winches had two specific fairleads allocated in each side of the ship to which the mooring lines could be led directly. The pedestal rollers could not be used for directing mooring lines from the winches to any other fairlead, because they were not aligned with the tension drum on the winches. The pedestal rollers were aligned with the winch head and were thus meant to be used for tightening loose mooring lines or bringing towing lines on board through the centre fairlead. It was only possible to use the centre fairlead for loose mooring lines or towing lines (figures 13 and 14, next page).

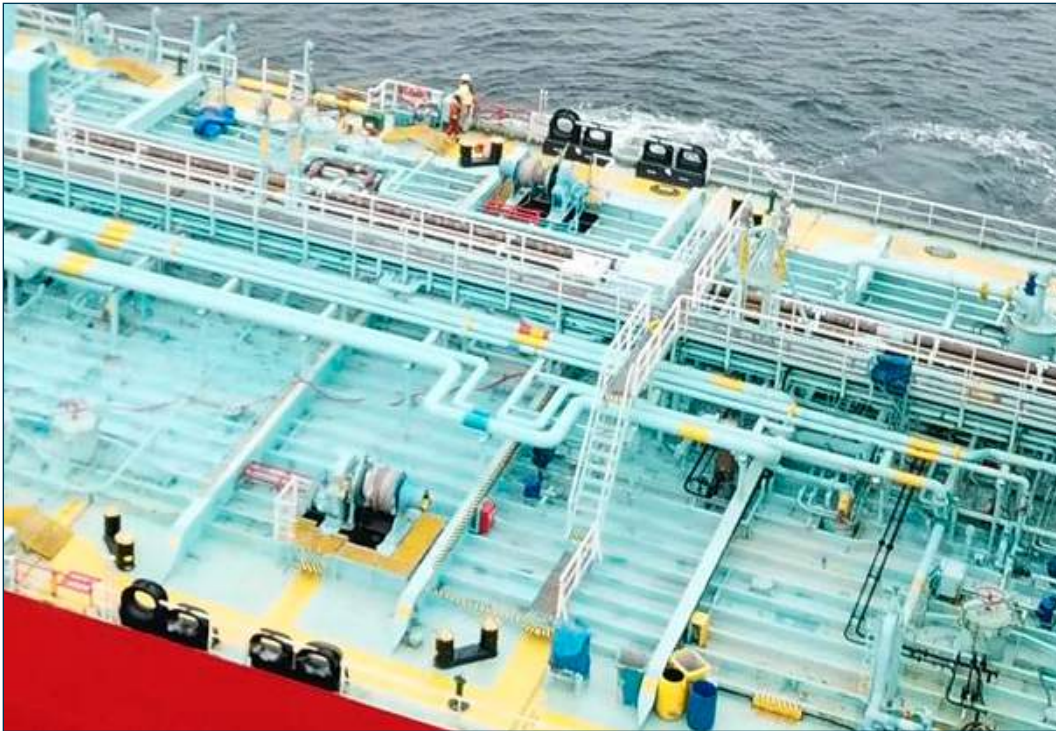
Figure 15: Mooring arrangement on the main deck  
Source: DMAIB

The two mooring stations on the main deck had a similar layout. On each of the mooring stations, the mooring fittings comprised two single split drums, fairleads and bollards. The winches were located on each side of the ship and had one designated fairlead in each side of the ship. The bollards also had designated fairleads in each side. It was not possible to use the bollards for loose mooring lines, as there were no aligned winches to tighten the lines (figure 15, next page).

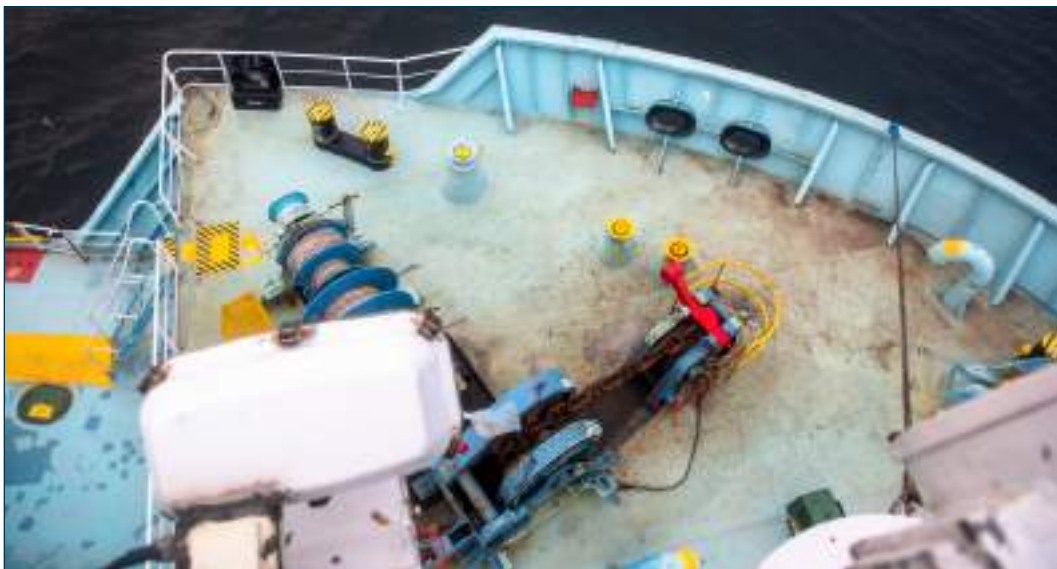
Figure 16: Mooring arrangement forecastle port side  
Source: DMAIB

From a review of the general arrangement it was noted that the bollards located near the centre fairlead were symmetrically placed, however on the ship they were not. Additionally, two pedestal rollers were placed on portside, which did not appear on the general arrangement. It was only possible to use the centre fairlead for loose mooring lines or towing lines (figures 16 and 17).

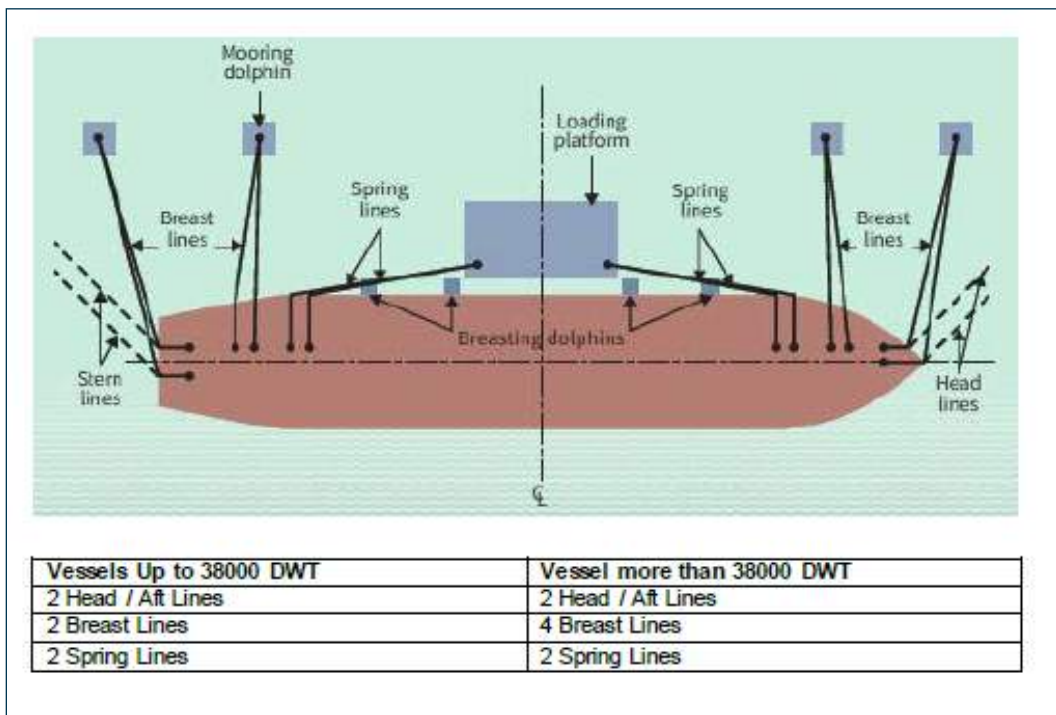
Figure 19: Mooring philosophy according to the mooring management plan  
Source: Zenith Gemi Isletmeciligi AS / DMAIB

The ship's initial mooring philosophy was based on a typical mooring pattern, which is shown in figure 19 below.

The mooring pattern described in STONE I's mooring management plan was based on OCIMF's mooring equipment guidelines, which described that the mooring lines should be as symmetrical as possible about the amidships point of the ship. Breast lines should be oriented as perpendicular to the longitudinal centre line of the ship and positioned as far aft and forward as possible. Spring lines should be oriented as parallel as possible to the longitudinal centre line of the ship. The vertical angle of the mooring lines should be kept to a minimum.

The mooring philosophy in the mooring management plan stated the principles for the optimal mooring pattern of tankers. However, the mooring management plan recognised the fact that an optimal mooring pattern was not always achievable, e.g. due to mooring hooks, mooring dolphins or mooring winches being out of service, or if breast lines could not achieve the optimal perpendicular lead. According to the mooring management plan, it was the master's responsibility to utilise these alternate arrangements at his discretion in such situations, considering the prevailing environmental conditions. In the event of deteriorating weather or sea conditions, the mooring management plan stated that the master should not hesitate to put out extra moorings, if he considered this to be necessary, and that weather forecasts, tide tables and unpredicted changes in environmental conditions should be monitored closely while at berth, in order to avoid the vessel breaking out from its berth.

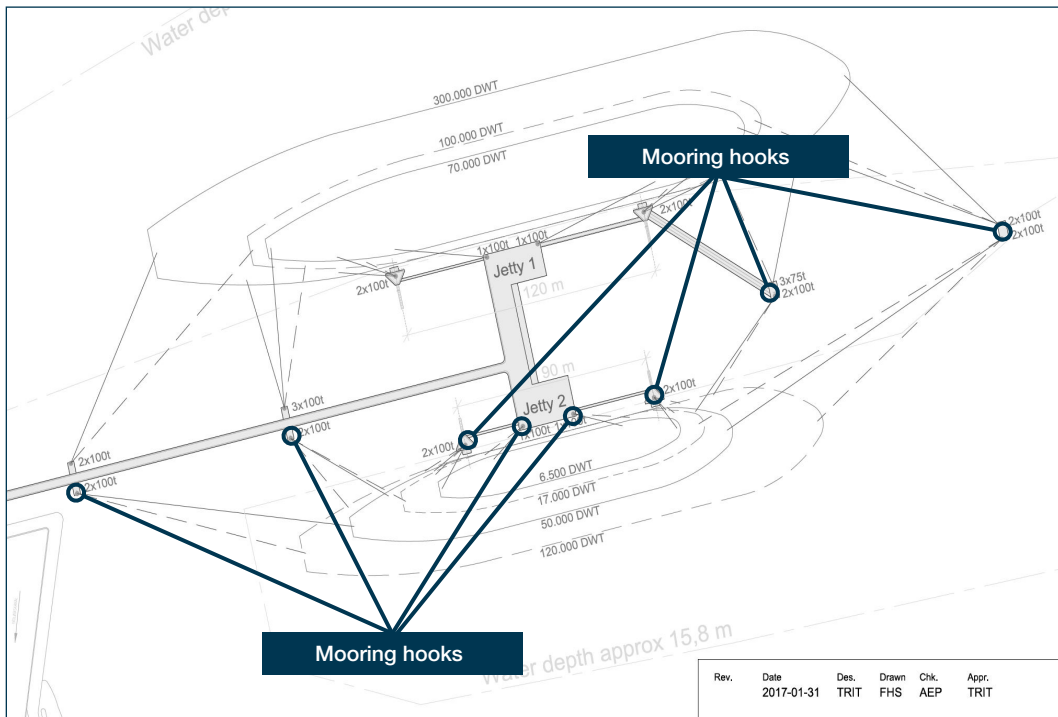
Figure 20: Ensted Oil Terminal mooring plan  
Source: Inter Terminals Denmark EOT Aps / DMAIB

Ensted Oil Terminal is located in Aabenraa fjord. The terminal and the jetties were built in 1979 to accommodate tankers and bulk carriers up to 300,000 tons. The terminal was projected in a south-westerly and north-easterly direction. The terminal has two jetties (figure 20). Jetty 1 faces north and was designed to accommodate vessels from 70,000-300,000 DWT. Jetty 2 faces south and was designed to accommodate vessels from 6,500 to 120,000 DWT. The two jetties are connected to land via a service road. A terminal control room is located at the loading platform at jetty 2. Terminal operators monitored the loading from the control room on the jetty. Due to the geographic location with coastal open structure jetties, the jetties were exposed to weather forces, especially wind.

Due to the ship's size, STONE I berthed at Jetty 2. Jetty 2 had 14 mooring hooks (figure 20, next page). Jetty 2 was fitted with two loading arms. When berthing the ship, the jetty's loading arms determined the position of the ship, as these needed to be aligned with the ship's manifolds. When the loading arms and manifolds were aligned, the possibilities for mooring the ship depended on the interface between the ship and the jetty and their available mooring equipment.

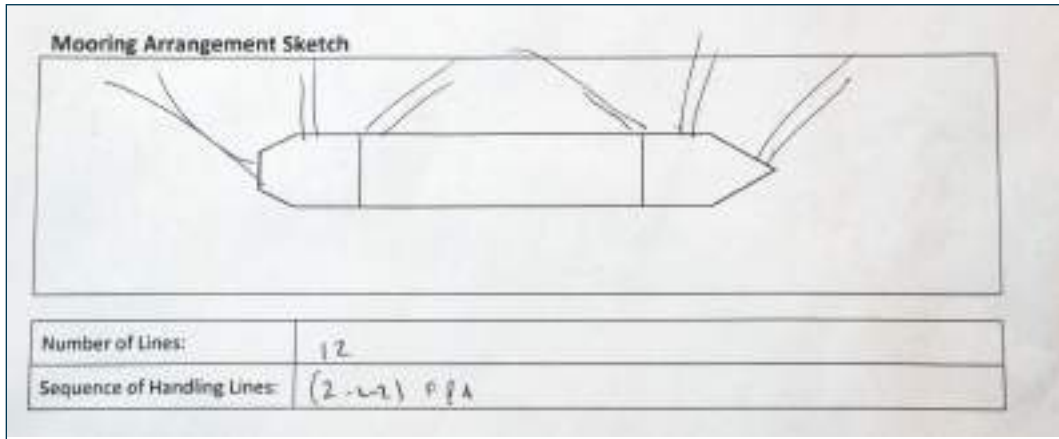
Figure 21: Mooring philosophy according to the mooring management plan  
 Source: Zenith Gemi Isletmeciligi AS / DMAIB

Prior to arrival at Ensted, the master and pilot planned the mooring configuration. The plan was documented in a form from the ship's safety management manual (Master Pilot Information Exchange, figure 21)

The agreed mooring configuration was similar to the typical mooring pattern in the ship's mooring management plan. However, during berthing, the master was informed that the jetty's bollards and hooks were not aligned to direct the breast lines in an optimal angle. The master assessed the situation and decided to accept the mooring configuration as this seemed to be the only feasible option. STONE I was thus moored with four lines on the forecandle, four lines on the main deck and four lines on the aft (figure 22).
