# Loss of containers overboard involving *APL England*

46 NM south-east of Sydney, New South Wales, on 24 May 2020

**ATSB Transport Safety Report**

351-MO-2020-002

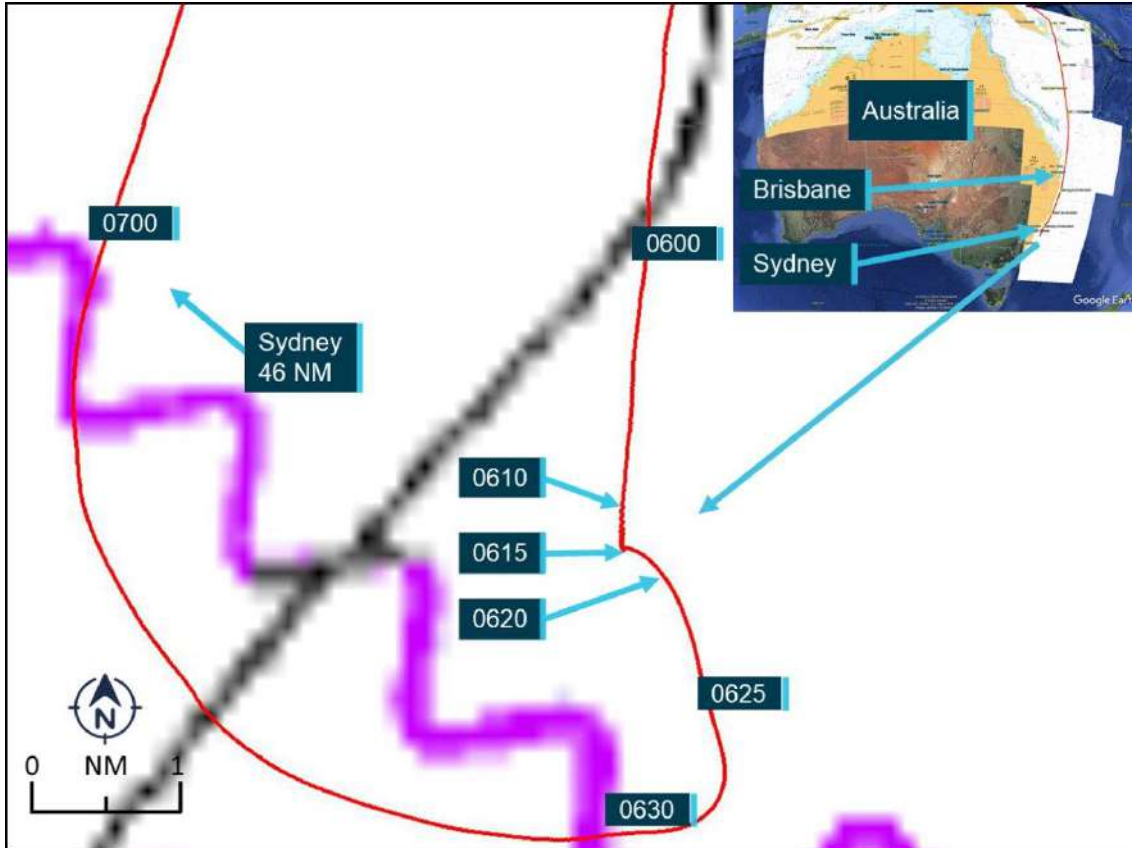
**Figure 2: APL England track and incident location**

Just after 0600, the ship was on hand steering and maintaining its southerly course at about 7 knots (Figure 2). Conditions remained unchanged with the ship pitching and periodically rolling more noticeably in high seas and gale force winds.
