SAFER SEAS DIGEST

2019

Lessons Learned *from* Marine
Accident Investigations

NTSB | National
Transportation
Safety Board

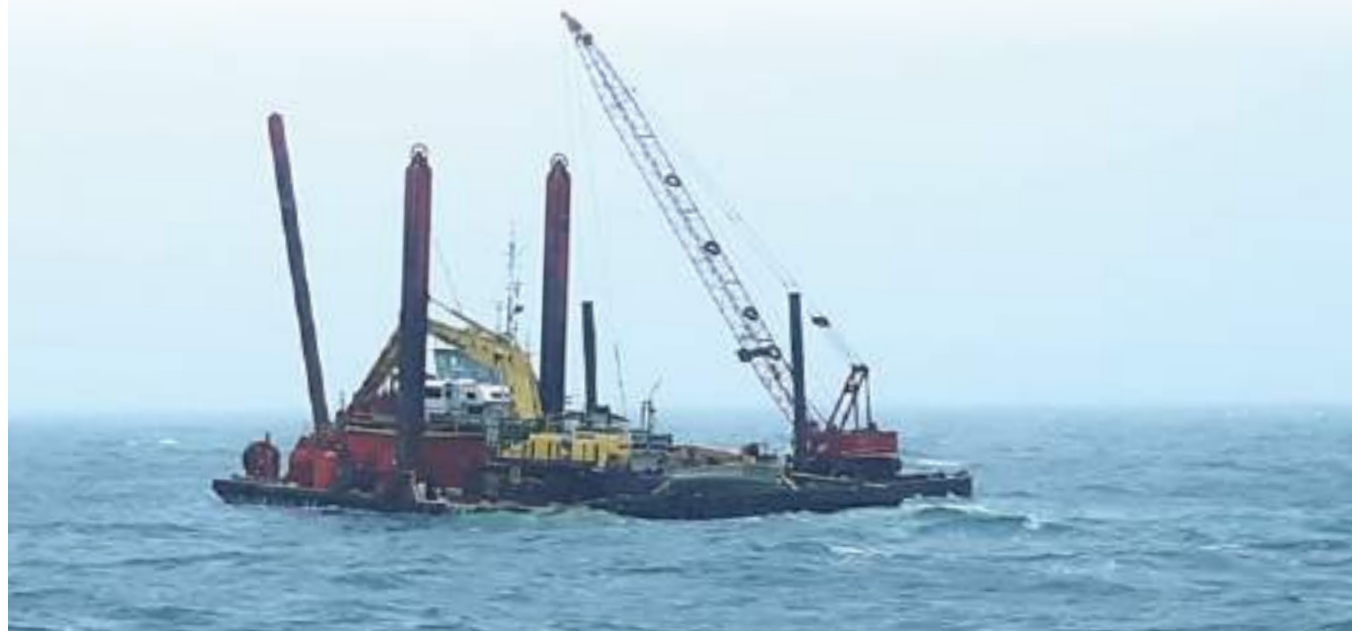
Figure 2. The *Big Jake*'s tow with the *Dredge200* in the foreground during the accident.

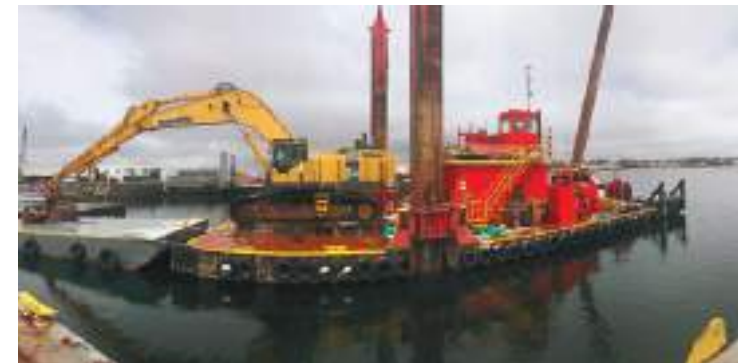
The probable cause of the capsizing and sinking of the *Dredge200* and the *R.E. Pierson 2* was the decision by the tow captain and owner to attempt a transit in forecasted wind and waves that exceeded their original plan for the voyage.

Figure 6. *Dredge200* with excavator boom extended.

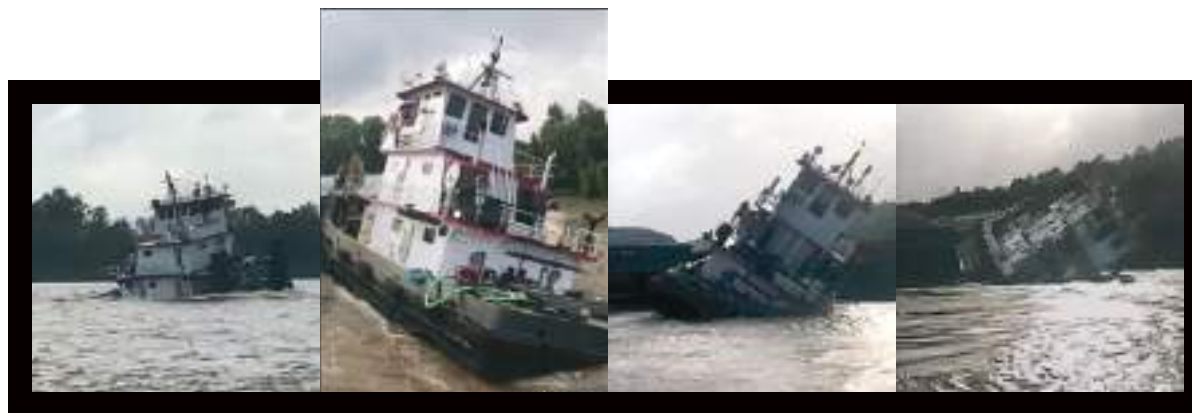
Figure 8. Sequence of events as the *Miss Roslyn* headed toward moored barges with a heavy list to starboard and eventually capsized. Left to right: (1) About 1650, the *Miss Roslyn* began crossing the Mississippi River with a noticeable list to starboard. As the vessel crossed the river, water increased on deck, and the vessel sank lower into the water. (2) The deckhands evacuate the *Miss Roslyn*. (3) About 1658, the vessel's list increases rapidly to starboard. (4) About 1659, the vessel lists further to about 90 degrees. SOURCE: CLAY HEBERT, ITV KRISTY DUTSCH

The probable cause of the capsizing of the *Miss Roslyn* was the company's lack of effective hull inspection and maintenance program, which resulted in flooding into a steering void through multiple wastage holes in the hull.

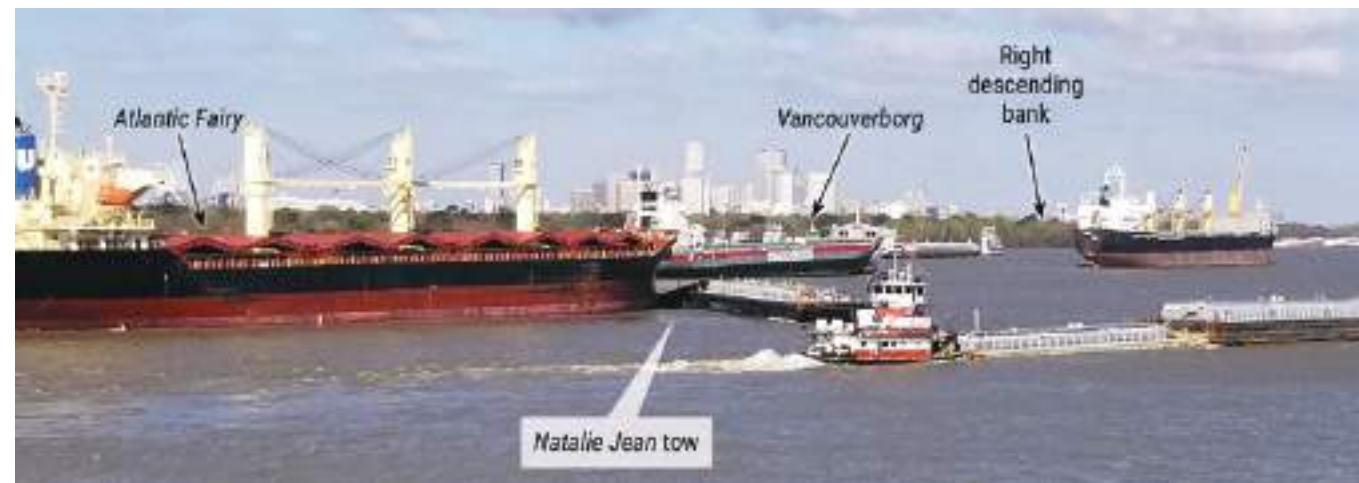
The probable cause of the capsizing and sinking of the *Natalie Jean* was the company's decision to place an inadequately vetted pilot on board the vessel who did not have previous experience operating the *Natalie Jean*.

Figure 14. Photo (looking upriver) of the *Natalie Jean* tow perpendicular to the *Atlantic Fairy*. The towboat has capsized and is sinking. SOURCE: MORAN TOWING

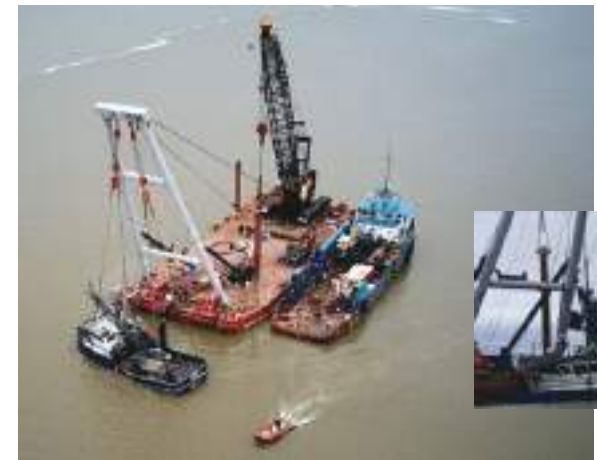
The last stability assessment of the *Pacific Knight* was conducted in 1996 and would not have included any vessel modifications completed since then. The weight and placement of the two cranes that the captain added to the *Pacific Knight* about a month before the sinking likely increased the vessel's vertical center of gravity. Though not required, once the vessel was substantially modified by removing and adding equipment, a revised stability assessment should have been conducted to give the captain the necessary information to safely load the vessel.

Figure 18. *Pacific Knight* while it was salvaged, with its crane positions visible in the inset.

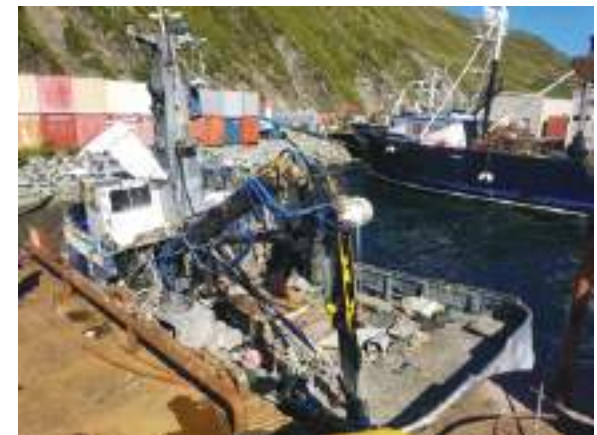
Figure 19. *Pacific Knight* postsalvage.

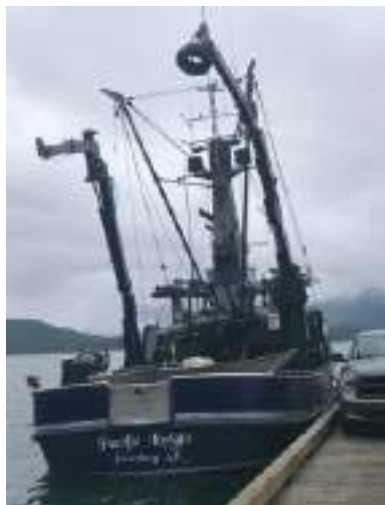
Figure 17. Left: the *Pacific Knight* while moored alongside a dock on June 10, 2018, with the two added cranes. Below: undated photo of the *Pacific Knight* (then named the *Lone Fisherman*) with the aft deckhouse that was removed (highlighted in yellow). SOURCE: LONE FISHERMAN, LLC

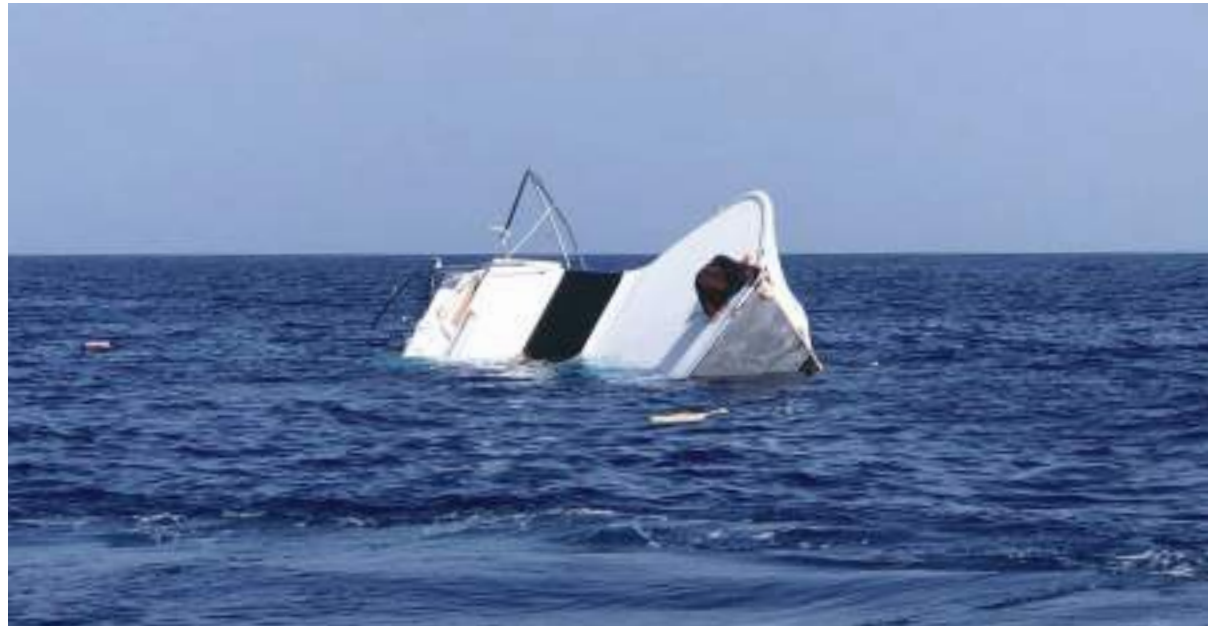
Figure 21. *Got 'M On*, shortly after the collision.

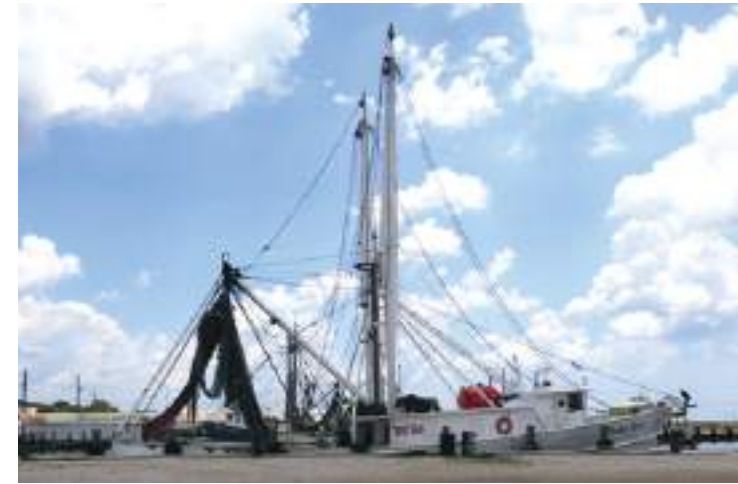
Figure 23. *Lady Toni* dockside, postaccident.

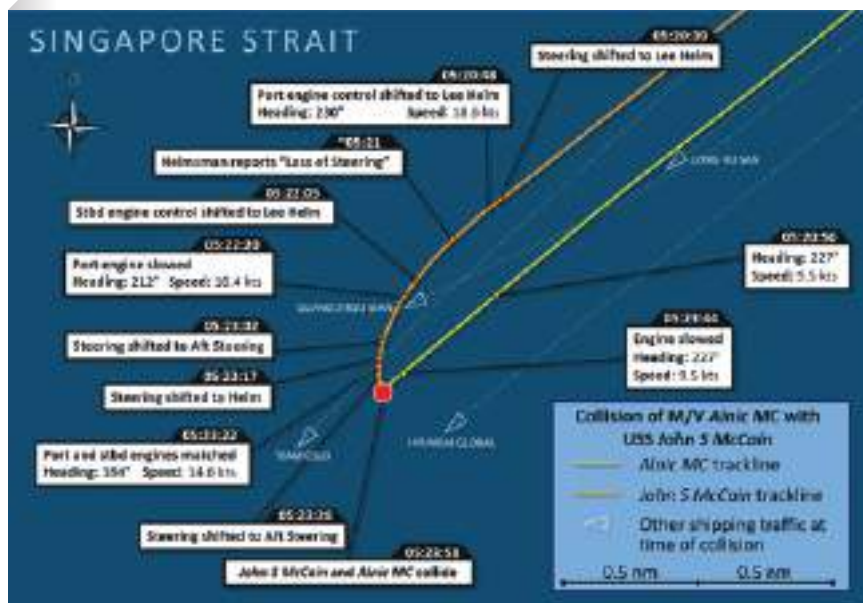
Figure 27. Vessel tracks and accident events.

Once control of the *John S McCain*'s steering was reestablished in aft steering, the rudders were moved to 15 degrees to starboard. However, this action and the action of the *Alnic MC* master to slow his vessel were not enough to prevent a collision, and, at 05:23:58, the bow of the tanker struck the port side of the destroyer.

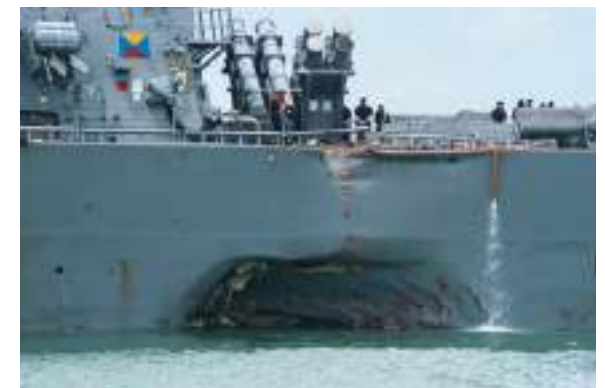
Figure 28. Portside damage to *John S McCain* caused by the bow of *Alnic MC*. SOURCE: US NAVY

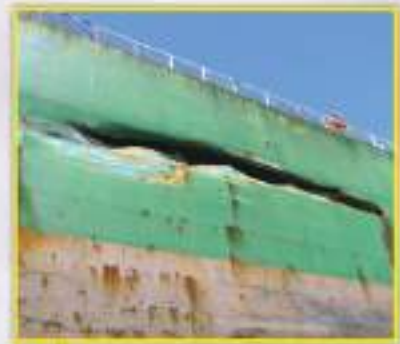
Figure 29. Main damage area of hull of *Tofteviken*.

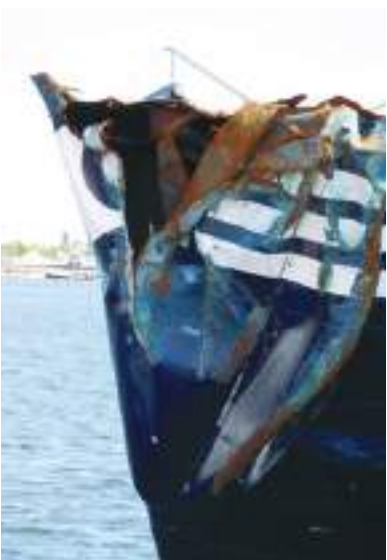
On board the *Polaris*, the mate said he was cleaning when he heard a sound and turned around to see "a wall of green" in front of him. He attempted to turn the vessel to starboard, but the bow of the *Polaris* struck the port side of the tanker. The *Polaris* mate said that he had been monitoring channels 16 and 22A but did not hear any calls or any sound signals from the *Tofteviken*. He last looked out the windows and at both the radars about 15 minutes before the collision. After the collision, the master of the *Tofteviken* and the captain on the *Polaris* assessed damage and reported the collision to the Coast Guard.

Figure 31. Area of greatest damage to hull of *Polaris*.

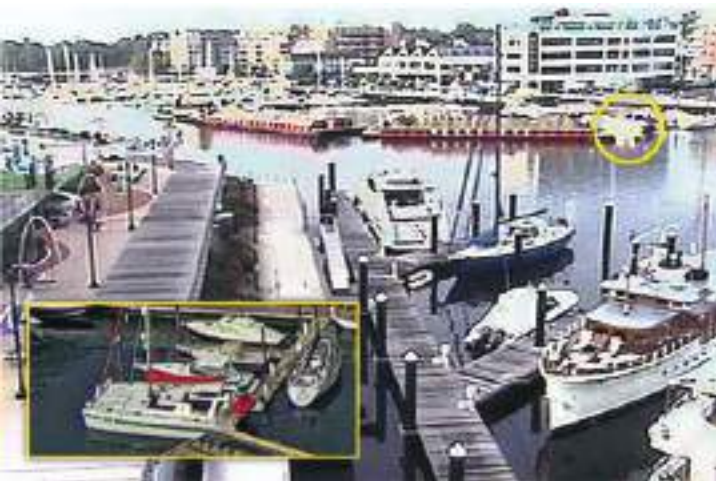
At 0835, less than 2 minutes after the mate ordered the lines let go, the port bow of **Weeks 207** swung to port, striking the port side of the **Sea Jay** at its stern and damaging the fiberglass hull. The impact pressed the **Sea Jay** against the dock on the sailboat's starboard side, causing movement of the floating pier, its finger piers, and four vessels moored to the dock. As the **Seeley** continued moving ahead, the barge came away from the **Sea Jay** and continued swinging to port.

Figure 36. Surveillance footage of (top) **Seeley** with **Weeks 213** and the separated **Weeks 207** angled and moving toward the **Sea Jay** (circled). Inset: Port forward corner of **Weeks 207** at the moment it falls away from the **Sea Jay**. SOURCE: COAST GUARD

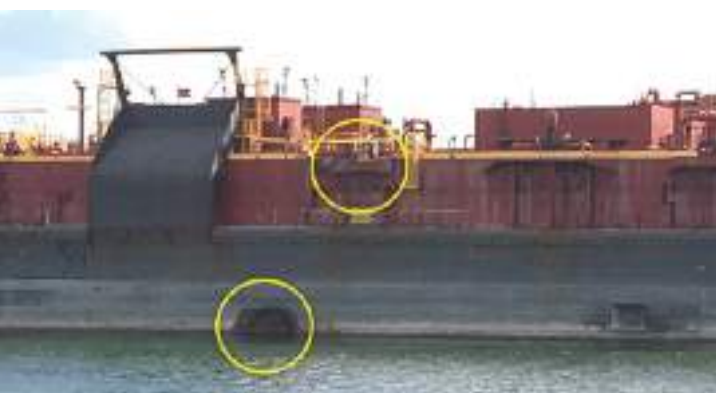
Figure 39. Damage to *OSG 243*, port side. Yellow circles identify, at top, cantilever deck damaged by *Yochow*'s bow rake and, at bottom, side shell at waterline in no. 5P ballast tank penetrated by bulk carrier's bulbous bow.

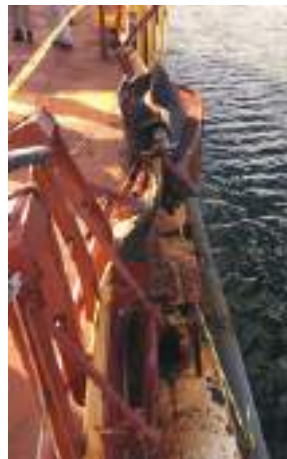
Figure 41. Left: *OSG 243*'s port side damage and facility's pedestrian bridge damage.

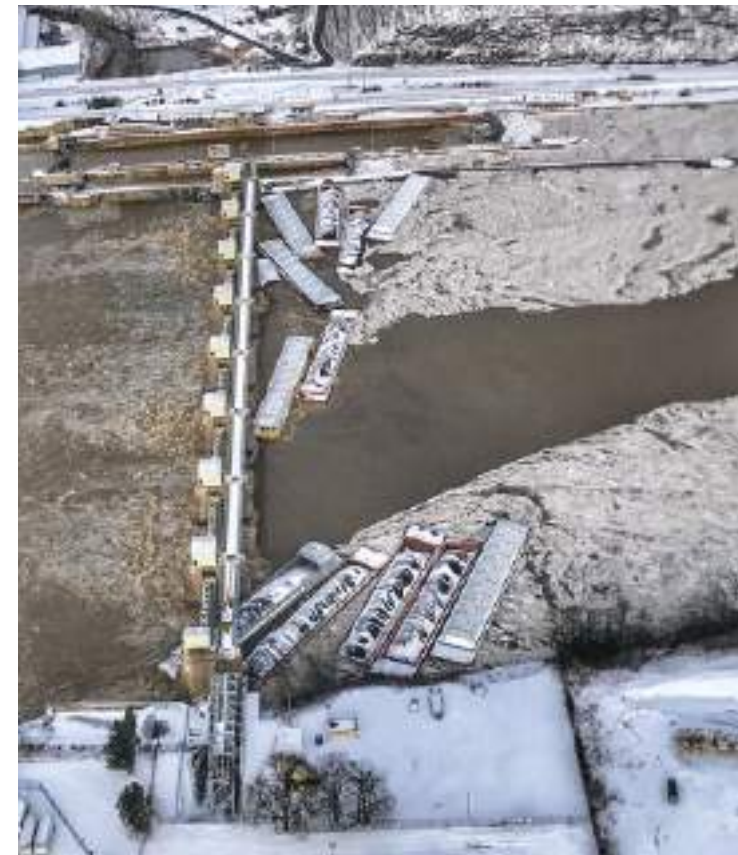
Figure 48. Aerial photo of Emsworth Locks and Dam with breakaway barges. SOURCE: COAST GUARD

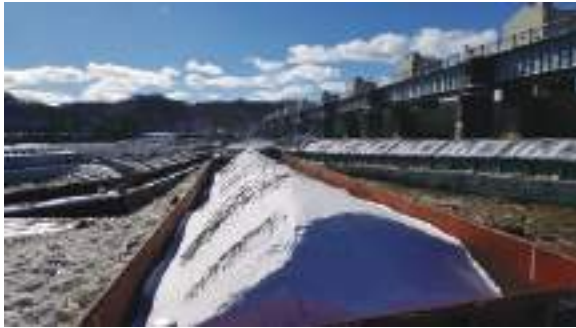
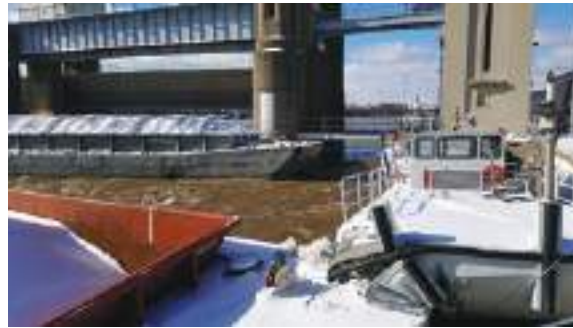
Figure 49. Left to right: Hopper barges after striking the main channel dam. Stern of barge C508 after colliding with Corps of Engineers workboats *Emsworth* (foreground) and *Dashields* (background). SOURCE: COAST GUARD

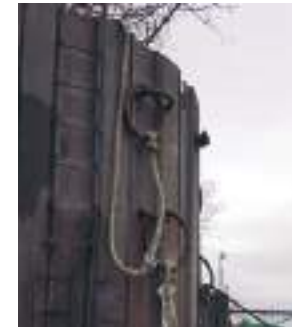
In addition to the rising water and increasing current, floating ice building up at the head of the barge flotilla significantly strained the barge moorings at Jacks Run. After the accident, the mooring ring on a forward cell was found missing, a ring on another cell was misshapen and broken mooring lines and cables remained attached to the cells. The breakaway occurred when the force of the river current acting on the extensive ice buildup at the front of the barge flotilla exceeded the capacity of the fleeting area's mooring cell fittings and the barge mooring wires.

Figure 51. Below, the forward piling at Jacks Run with a broken mooring ring anchor point and missing ring.

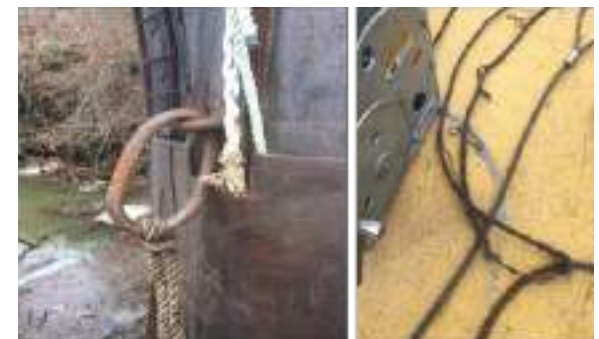
Figure 52. At left, a deformed anchor ring on third piling back from the forward piling at Jacks Run. At right, parted and frayed mooring wires from the lead shore-side barge during the accident.

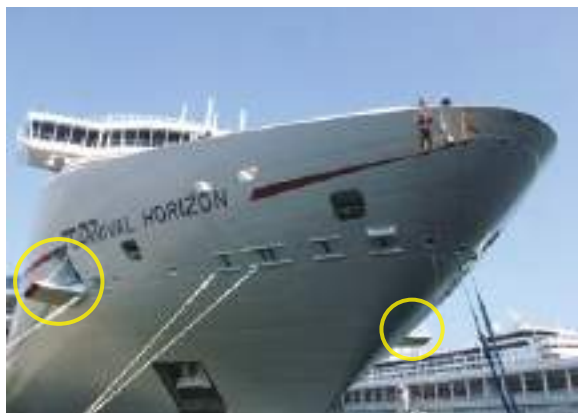
Figure 53. *Carnival Horizon*'s bow after the accident. The forward mooring platforms where the lookout was stationed (about a 100 feet aft from the tip of the bow) are circled in yellow. SOURCE: COAST GUARD

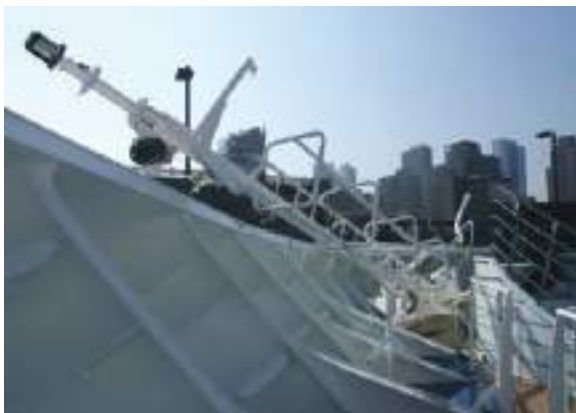
Figure 55. *Carnival Horizon's* damaged forward mast and support structure.

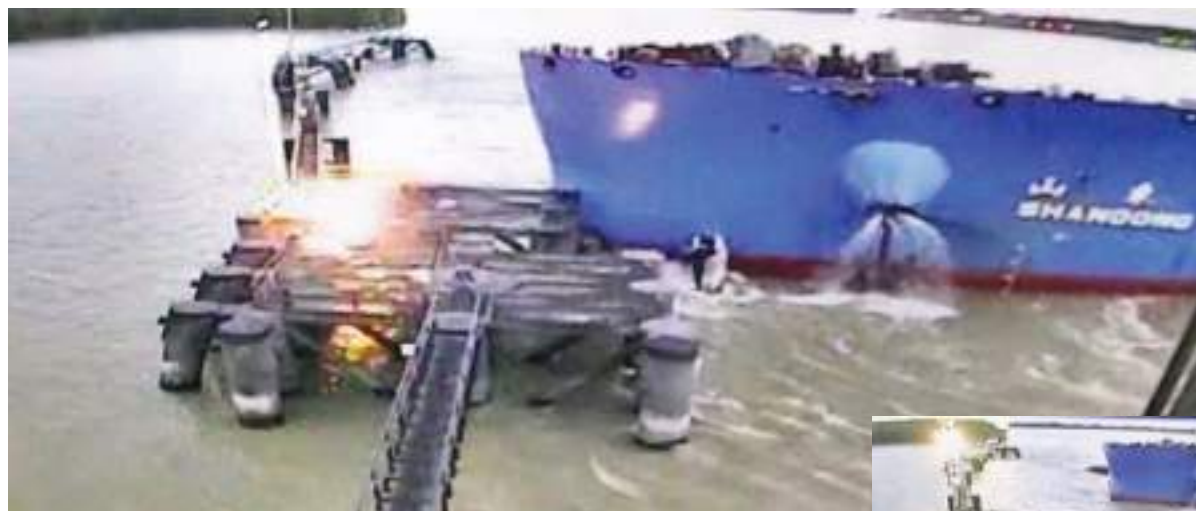
Figure 65. Initial impact of the *Shandong Fu En* bow swinging into the Ergon-St. James Terminal wharf at 0637:08. At right: Screenshot of the *Shandong Fu En* 20 seconds earlier. A crack and three other holes were found in the bulk carrier's shell plate below the waterline. SOURCE: ERGON-ST. JAMES TERMINAL

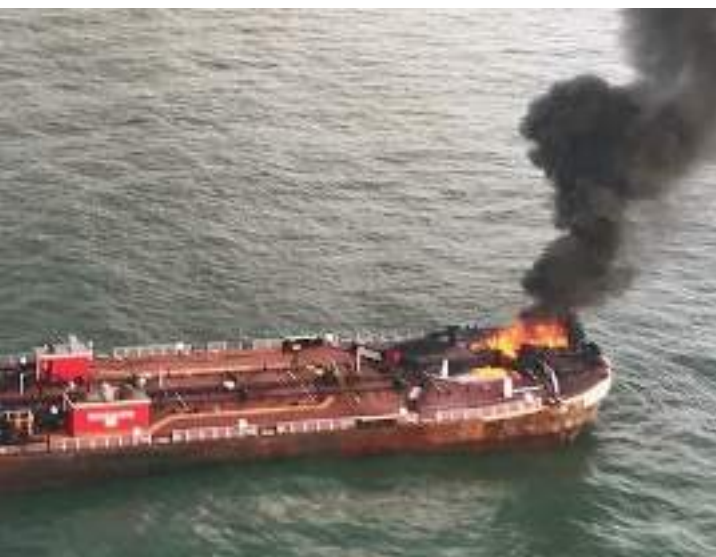
Figure 72. *B. No. 255* bow on fire following an explosion.
SOURCE: COAST GUARD

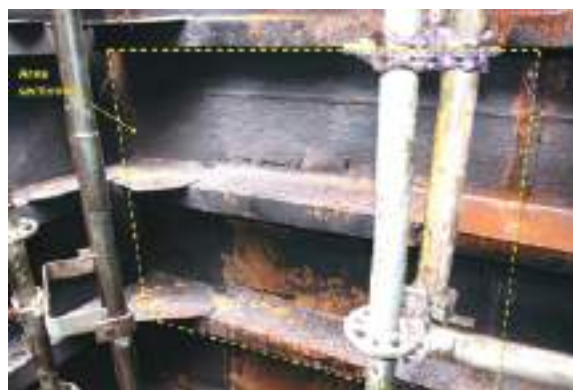
The majority of the damage to the **B. No. 255** was found in the forepeak of the barge, and photographs showed the fire in the same location, indicating the initial explosion originated in the forepeak. During postaccident examination of the bulkhead separating the no. 1 port tank from the forepeak, through-cracks were found in the area of the original bulkhead that had not been previously repaired; the steel around the cracks was pock-marked and pitted. Examination of the through-cracks indicated that this corrosion was present before the accident explosion, thereby compromising the integrity of the cargo containment in the no. 1 port tank.

The no. 1 port cargo tank was 90 percent filled, placing the level of crude oil above the cracks. The oil seeped through the openings in the bulkhead and collected inside the forepeak, increasing the crude oil vapor content. While raising the anchor, the wiring in the forepeak was energized and could have been a source of ignition. In addition, an exposed electrical wire on an energized circuit on the cargo deck could have created an electrical arc capable of igniting fuel vapor.

Figure 75. Cracks in bulkhead separating the forepeak from the port no. 1 cargo tank. The dashed section was removed and sent to the NTSB Materials Laboratory for analysis. SOURCE: COAST GUARD

The probable cause of the explosion aboard the barge **B. No. 255** was the lack of effective maintenance and safety management of the barge by Bouchard Transportation, which resulted in crude oil cargo leaking through a corroded bulkhead into the forepeak void space, forming vapor, and igniting. Contributing to the accident were the ineffective inspections and surveys by the Coast Guard and the American Bureau of Shipping.

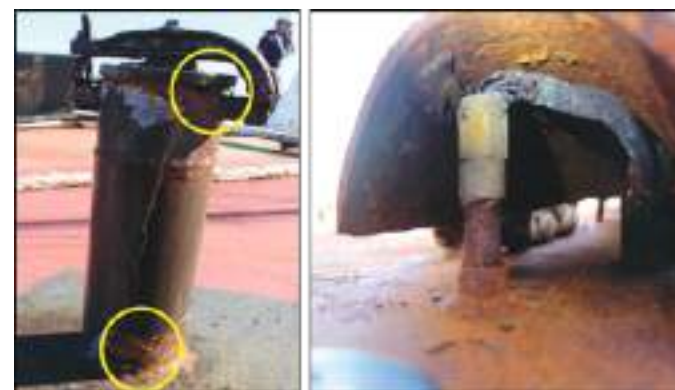
Bouchard Transportation had fully implemented an SMS; however, inspection and survey records indicated that the overall condition of the barge was historically poor and never improved. Postaccident inspections of other Bouchard Transportation barges resulted in 251 deficiencies and operational controls placed on 10 barges, indicating that the SMS and maintenance processes failed to ensure proper maintenance of the company's fleet of barges.

Figure 77. Postaccident photos of corroded no. 1 starboard cargo tank ullage tube (left) and wasted armored protected electrical cable with exposed wiring (right). SOURCE: COAST GUARD

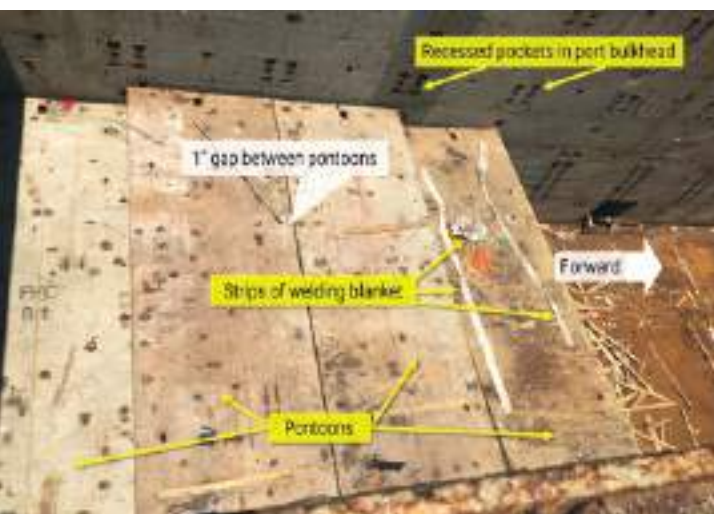
Figure 81. *Chipolbrok Moon* pontoon decks in cargo hold. A gap between the pontoons is labeled.

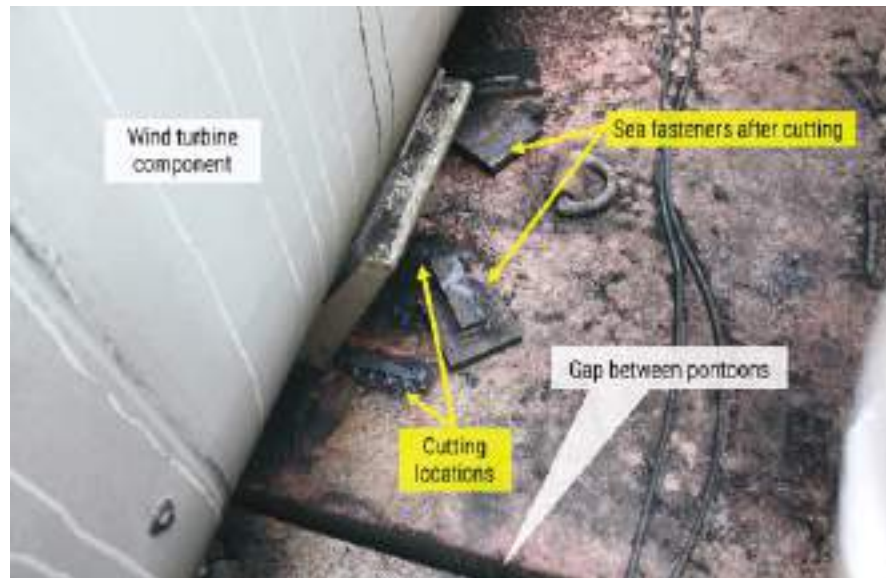
The fitter and the fire watch removed the steel tabs on the upper tween deck level, moved to the lower hold and cut away the tabs from the deck that had been installed to secure the cargo, then proceeded to the lower tween deck and cut the tabs off from that deck. They waited for about 25 minutes in the port cargo hold after completing hot work and then proceeded to the starboard cargo hold, where the oiler smelled smoke. About the same time, the fire alarm sounded throughout the ship, and the smoke detection system panel indicated an alarm in cargo hold no. 3. The crew closed the access manholes, and the third mate released CO₂ from the vessel's fixed fire-extinguishing system into cargo hold no. 3. The crew monitored the bulkhead temperatures in cargo hold no. 3 for the next 8 hours. The captain called and emailed the company offices in Houston and China but did not make any other notifications to the port or the Coast Guard, nor did he make any radio broadcasts during or after the fire, even though the vessel's response plan required doing so.

Figure 83. Left: Steel sea fasteners cut from deck in the portside no. 3 hold aboard *Chipolbrok Moon*, identified with yellow arrows. The gap between pontoons is also identified. SOURCE: HARRIS COUNTY FIRE MARSHAL

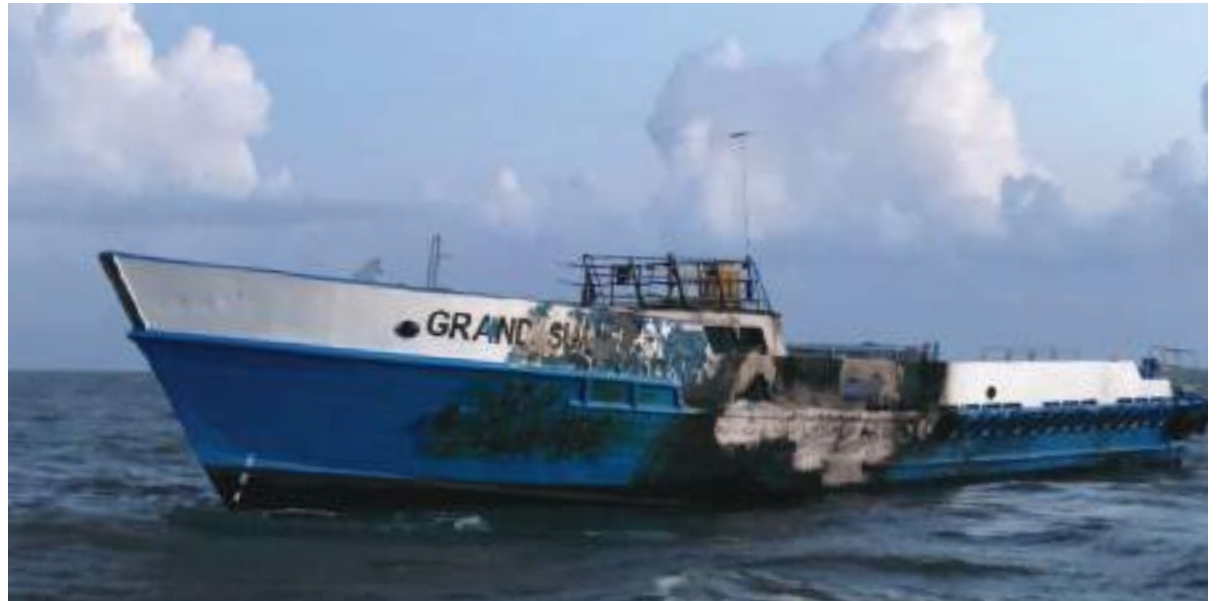
Figure 86. The *Grand Sun* post-fire.

The fire consumed the vessel's entire superstructure, including the interior main deck and wheelhouse, and the aluminum hull was nearly burned to the waterline amidships. Based on fire damage in the wheelhouse and the interior main deck, the likely origin of the fire was in the upper passenger compartment, due to the overheating of electrical wiring either in the chest freezer or in the bulkhead at the receptacle powering it.

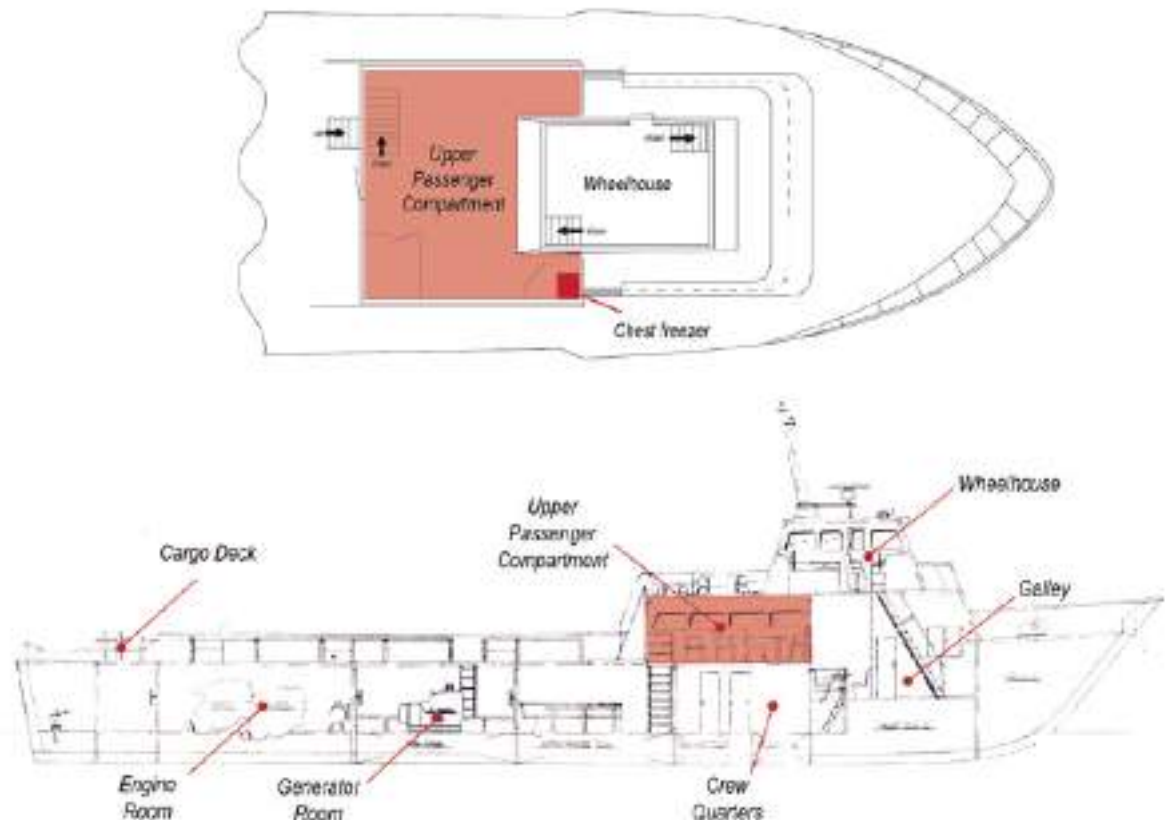
About 0215, on his fourth round searching for the source of the odor, the on-watch deckhand discovered a pile of work vests on fire atop a chest freezer behind the door leading to the wheelhouse from the upper passenger compartment. He woke the first captain and off-duty deckhand. The crew started the fire pump and headed to the compartment, where they found thick smoke. The flames appeared small, so the first captain used a nearby freshwater "garden hose" to attempt to extinguish the flames. About the same time, the wheelhouse filled with thick smoke, forcing the second captain out of the wheelhouse before he could make a mayday call by VHF radio. When he opened the wheelhouse door, the fire expanded rapidly into the wheelhouse.

Figure 88. Vessel plans modified to show the wheelhouse, upper passenger compartment, galley, and crew quarters. The passenger compartment where the fire was discovered is highlighted in red, and the chest freezer is marked as a red square. SOURCE: Y&S MARINE INC , ANNOTATED BY NTSB

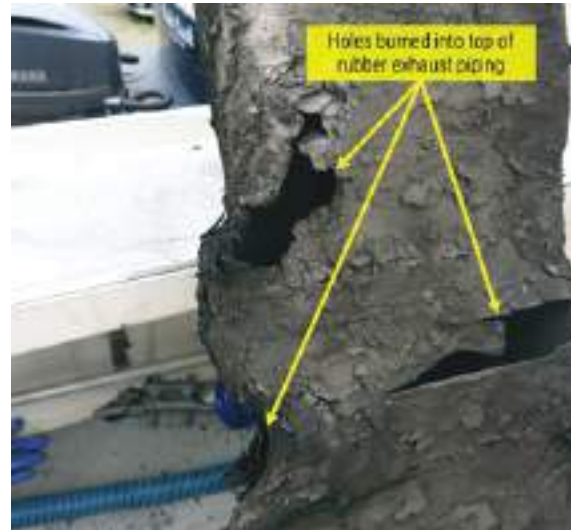
Figure 91. Damage to the engine as seen from above. Right: Damaged exhaust tubing after removal from engine room.

The vessel sank because of water used in suppression efforts and holes burned through the wet-exhaust hose from the heat of the fire, which allowed seawater to flood the engine compartment from the exhaust outlet on the port side of the vessel.

The probable cause of the fire aboard fishing vessel *Hit List* was the failure of a hydraulic hose fitting that sprayed pressurized hydraulic oil onto the engine, eventually causing the oil to ignite. Contributing to the sinking was water applied during firefighting efforts and flooding through the rubber engine exhaust tubing, which the fire burned through.

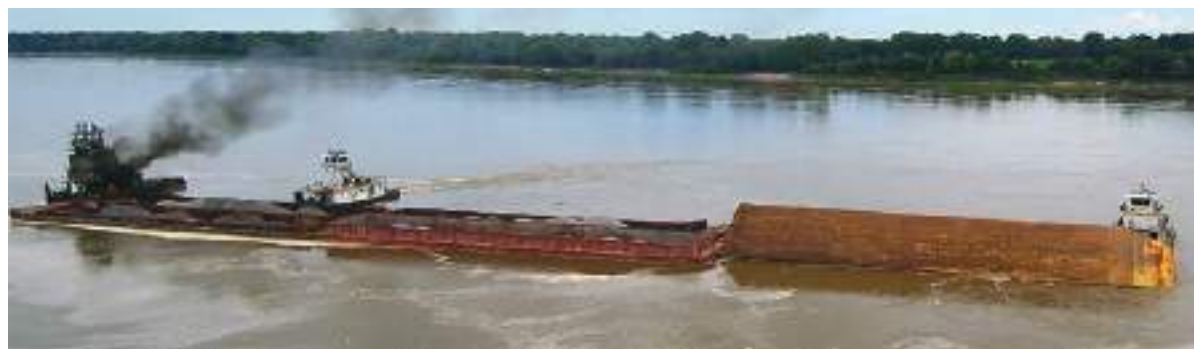
Figure 94. Two towing vessels push the remaining barges of the tow as the *Jacob Kyle Rusthoven* burns. The center head barge, which had turned over, sits on top of the port head barge. SOURCE: COAST GUARD

The stern of the *Jacob Kyle Rusthoven* hit the bank, and the tow wires started to part. The center head deck barge flipped over and lost its load of limestone. Three of the barges in the starboard string broke out of the tow. Towing vessels assisted in gathering the towboat and its barges. Firefighters extinguished the fire later in the evening, at 1913. The *Jacob Kyle Rusthoven* was towed to a shipyard for examination and disposal.

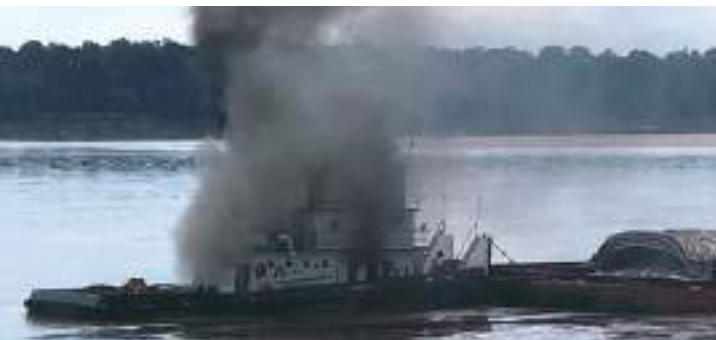
The captain of the *Bill Atkinson*, a towboat traveling northbound, radioed to agree to a passing arrangement, and, about 0919, pushed up on the west bank at mile 673.6. As the *Jacob Kyle Rusthoven* passed, the captain of the *Bill Atkinson* noticed smoke coming from the open starboard-side engine room door of the *Jacob Kyle Rusthoven*. The captain of the *Jacob Kyle Rusthoven* then broadcasted on the radio that his vessel was on fire and adrift.

Figure 96. Smoke emanating from the open starboard-side and aft engine room doors on the main deck.

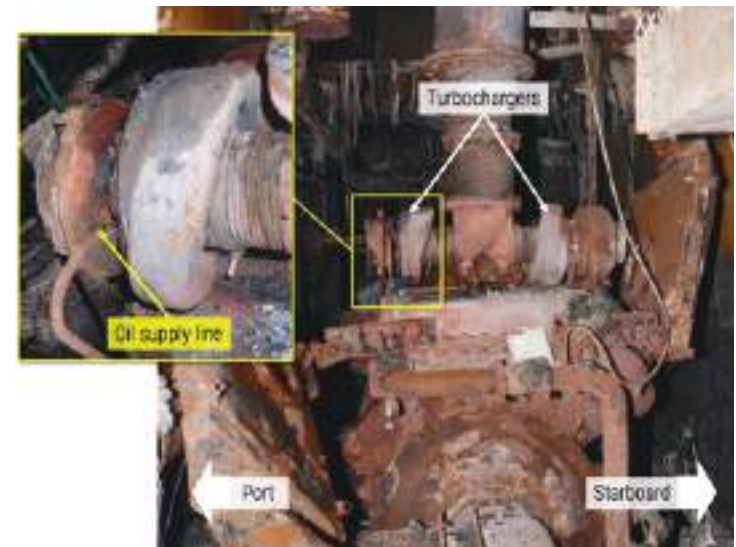
The fire was determined to have originated at or near the inboard turbocharger on the starboard-side main engine based on the heat damage at that location. A commercial forensics science firm found that a loose fitting on the lube oil supply line was a likely fuel source. Considering witness accounts of the captain operating the vessel at full power, it was likely that when smoke first appeared, the lube oil in the line to the turbocharger was at or near its maximum operating pressure. The pressurized lube oil could have atomized from the loosened fitting and consequently come into contact with a hot surface on the starboard engine near the turbocharger. The atomized oil would have likely ignited and eventually spread the fire to adjacent combustible materials in the engine compartment, before spreading upward.

Figure 97. Fire-damaged starboard main engine, while looking forward. The yellow box highlights the inboard turbocharger with its casing and compressor missing due to the damage. The inset shows the lube oil supply line fitting that was found to be loose.

The probable cause of the engine room fire on board the towing vessel *Jacob Kyle Rusthoven* was an engine lube oil leak that ignited off a hot surface near the starboard main engine turbocharger. Contributing to the severity of the fire was the lack of crew measures to activate the engine fuel supply shutoffs and secure open doors ventilating the engine room.

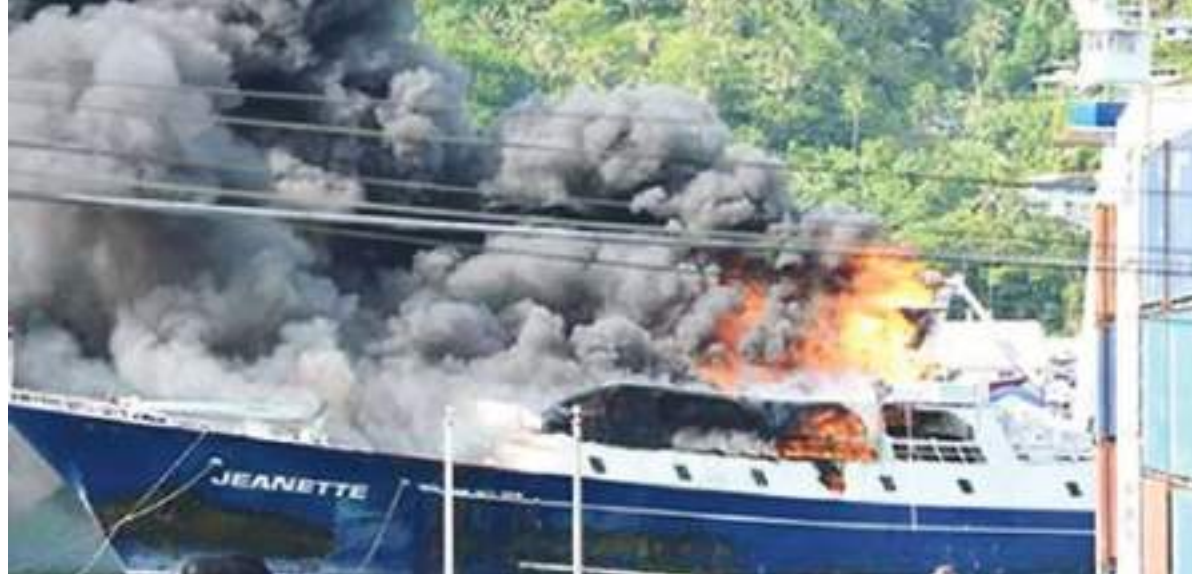
Figure 100. The bridge of the *Jeanette* engulfed in fire.

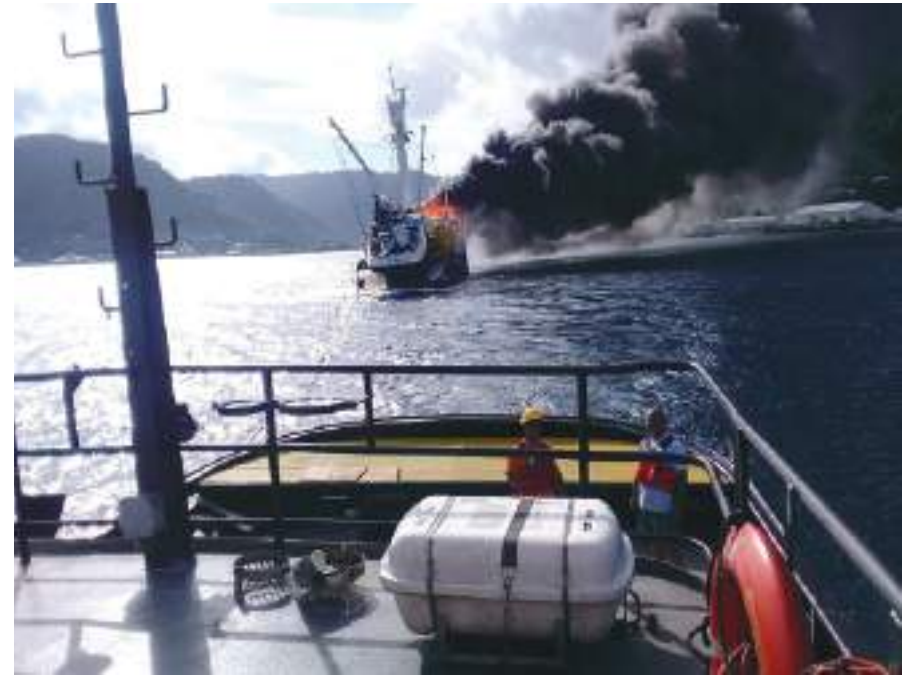
As a result of firefighting efforts, the *Jeanette's* wet deck began to flood, and the vessel began to list slightly to port. The vessel continued to burn, so at 1552, it was towed south into the Pacific Ocean. On December 6, at 1039, the vessel sank in open water about 15 miles offshore.

Figure 101. The fishing vessel *Jeanette* being towed by the tugboat *Iseula* while on fire.

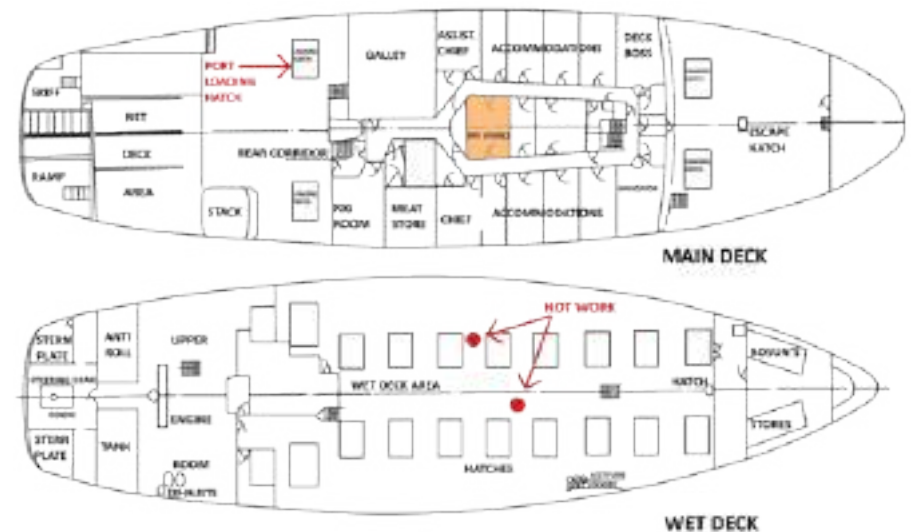
Figure 102. Vessel deck plans modified for clarity and to show the location where the hot work occurred on the wet deck (represented by red circles) and the location of the dry stores locker where the fire was discovered on the main deck above (shaded in orange). Note the port loading hatch on the main deck, where water entered and caused listing.

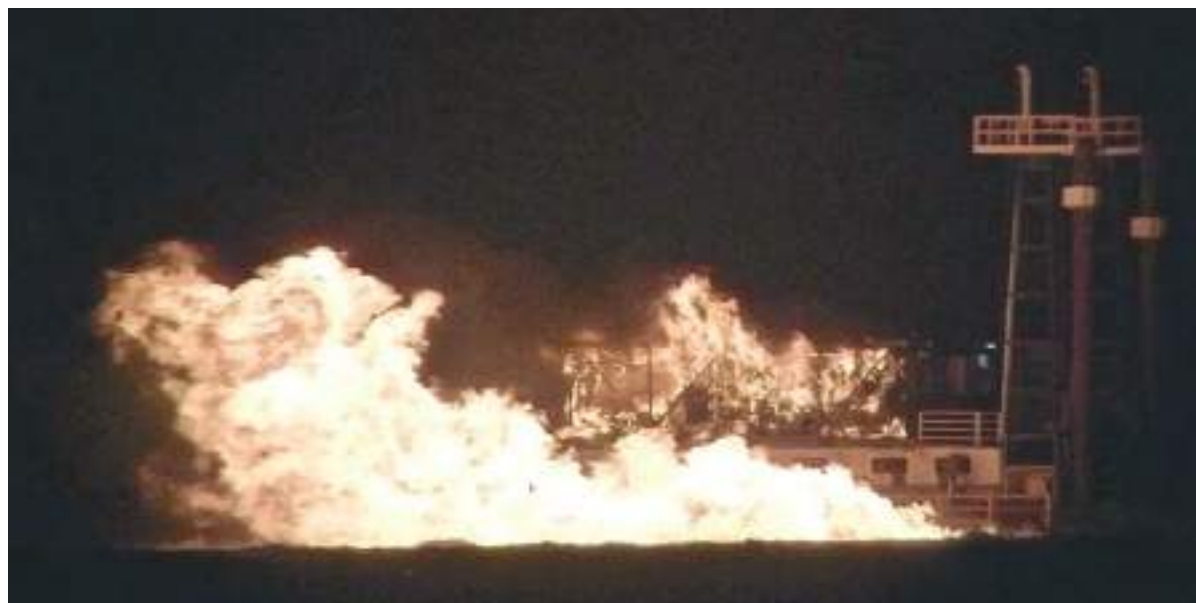
Figure 104. *Jonathon King Boyd* burns after striking a submarine gas pipeline.

On the evening of April 17, 2018, the cutter suction dredge *Jonathon King Boyd* punctured a submarine natural gas pipeline with a spud during dredging operations in Matagorda Bay, Texas. A gas plume ignited and engulfed the dredge and its accompanying towboat, the *Bayou Chevron*. All 10 crewmembers abandoned the vessels uninjured. Damage to the pipeline was estimated at \$1.7 million. The *Jonathon King Boyd* and the *Bayou Chevron* were constructive total losses, valued at \$5.5 million and \$125,000 respectively.

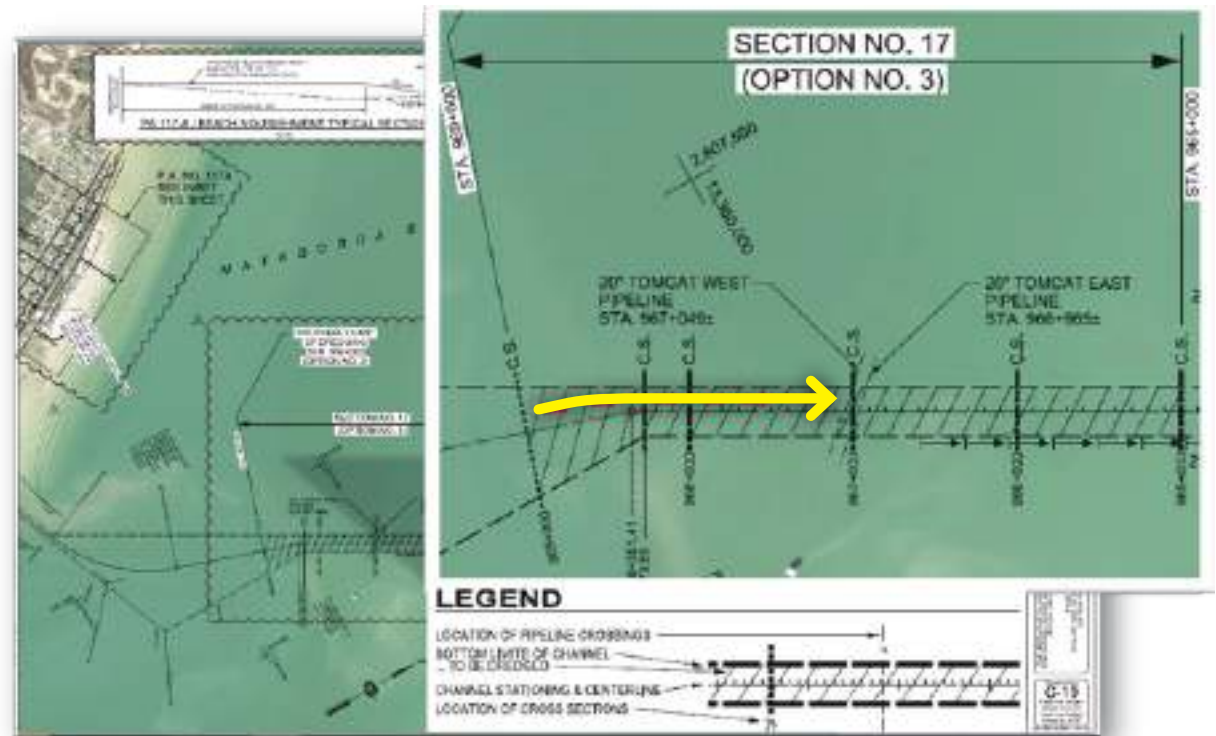
Figure 105. Extracts from Corps of Engineers Drawing No. C-19 depicting the dredging plan for Option No. 3, Section No. 17 for the Gulf Intracoastal Waterway. The yellow arrow displays *Jonathon King Boyd*'s easterly dredging trajectory, commencing at the southern section (STA. 969+000).

Pipeline positions could, and as per company policy should, have been entered into the HYPACK software, but according to the crew, the positions were not displayed in the software they had. According to the company, the production engineer was responsible for entering the location of utilities and that information was typically provided to them at the beginning of the project. RLB Contracting relied on a single shoreside individual (the production engineer) to carry out appropriate notifications and to input the data for the vessel software, which, in this instance, led to a single-point failure.

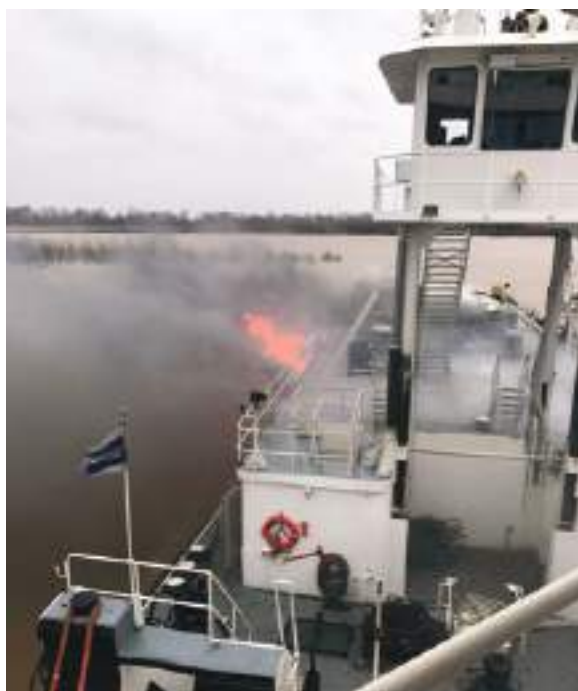
Figure 106. Fire on starboard side of vessel.
