SAFER SEAS DIGEST

2019

Lessons Learned *from* Marine
Accident Investigations

NTSB | National
Transportation
Safety Board

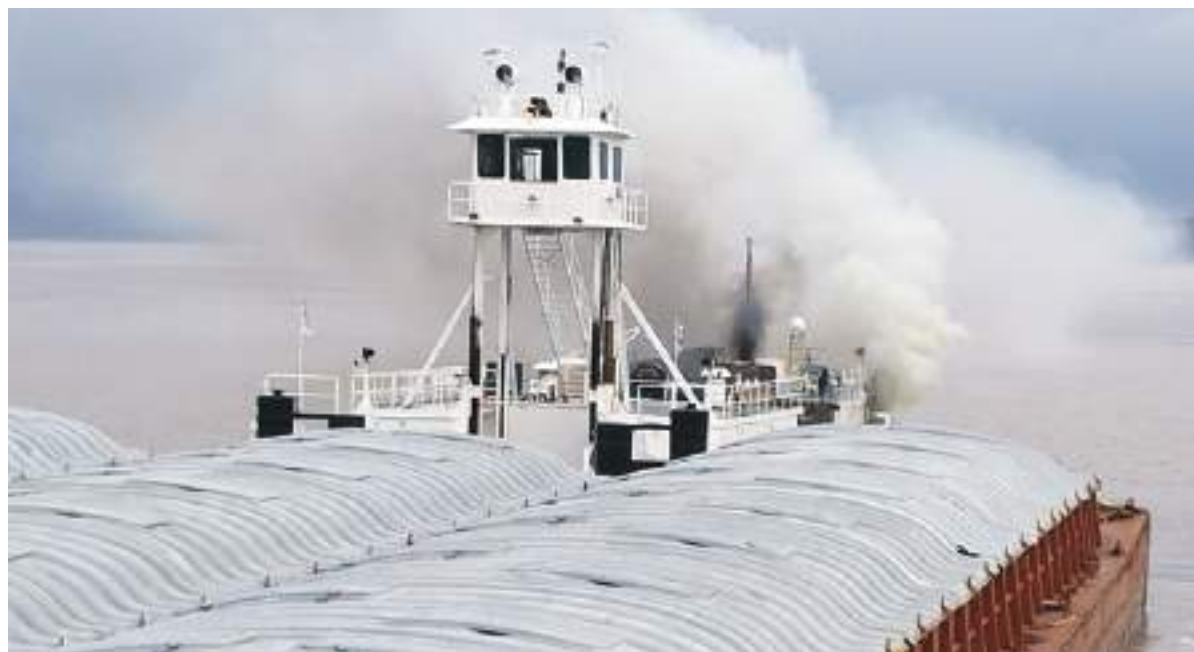
Figure 107. *Leland Speakes* on fire after abandonment.

The probable cause of the engine room fire on board the *Leland Speakes* was a catastrophic failure and crankcase breach of the port main engine resulting from failure of the caps that secured two piston connecting rods to the crankshaft. Contributing to the severity of the fire was the vessel's lack of a fixed fire-extinguishing system for the engine room and lack of redundant fire pumps.

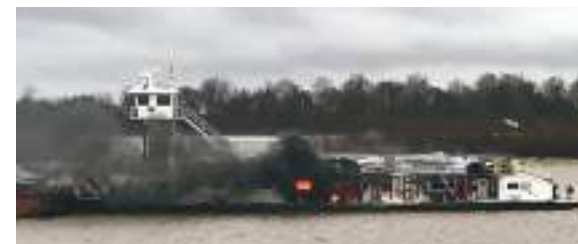
Figure 110. *Leland Speakes* on fire and abandoned at 1249.
SOURCE: LESLIE JENKINS, JANTRAN INC.

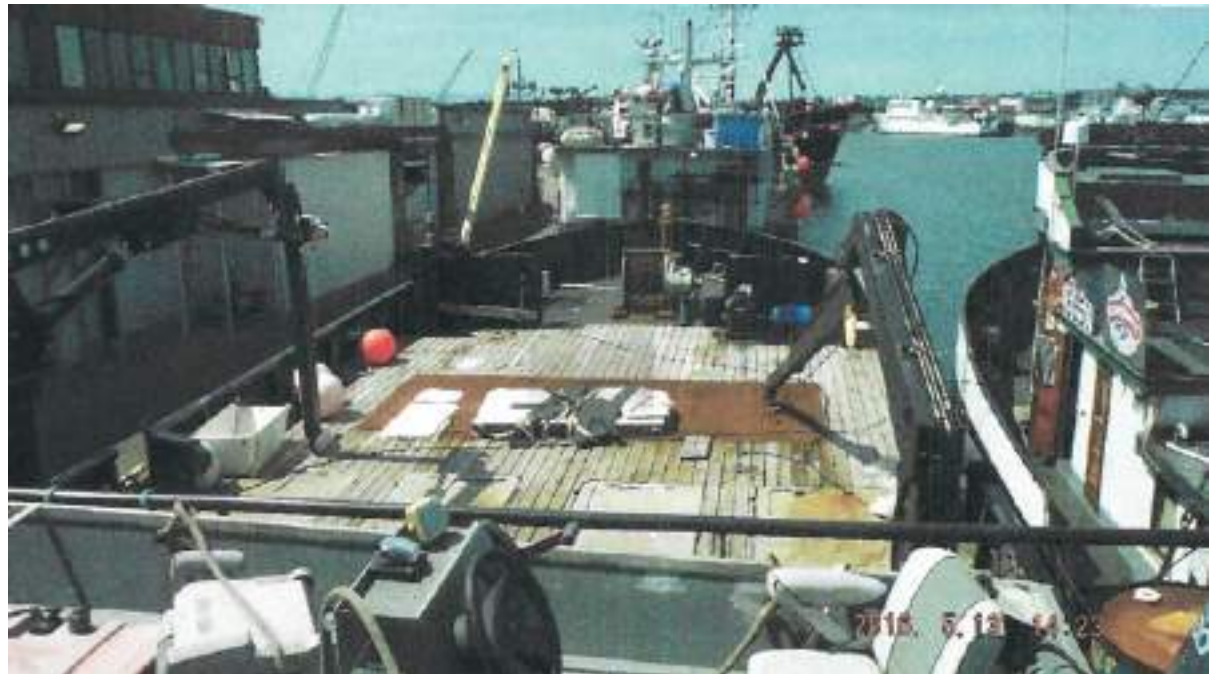
Figure 112. Photo from a 2016 survey report documenting the condition of *Logger* shows wooden deck boards on the main deck, from where the captain saw smoke emanating.

The captain surmised that the fire may have been started by wiring that led to the forepeak for the fish hold pumps, based on the smoke he saw emanating from the main deck and the wooden planks on the main deck, which indicated to him that there may have been a fire below the deck. He noted that the fire had to be substantial in size for smoke to penetrate the deck. However, he stated that the fire spread so rapidly that he could not confirm this possibility with certainty.

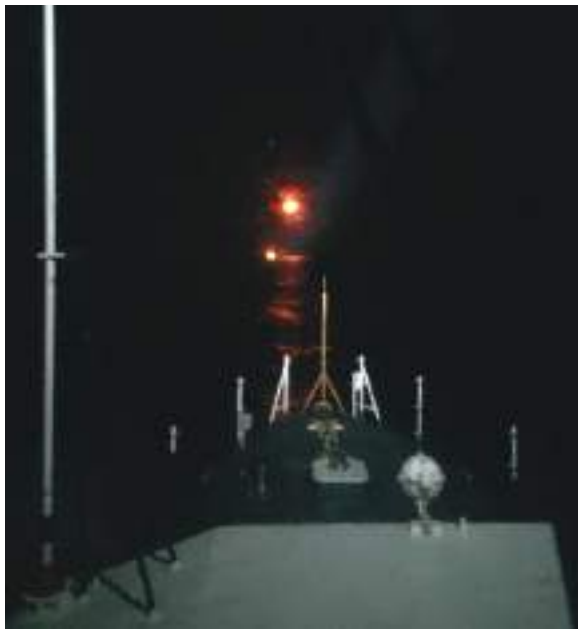
Figure 113. Red parachute flare above the *Master D* seen by the Coast Guard cutter. SOURCE: COAST GUARD

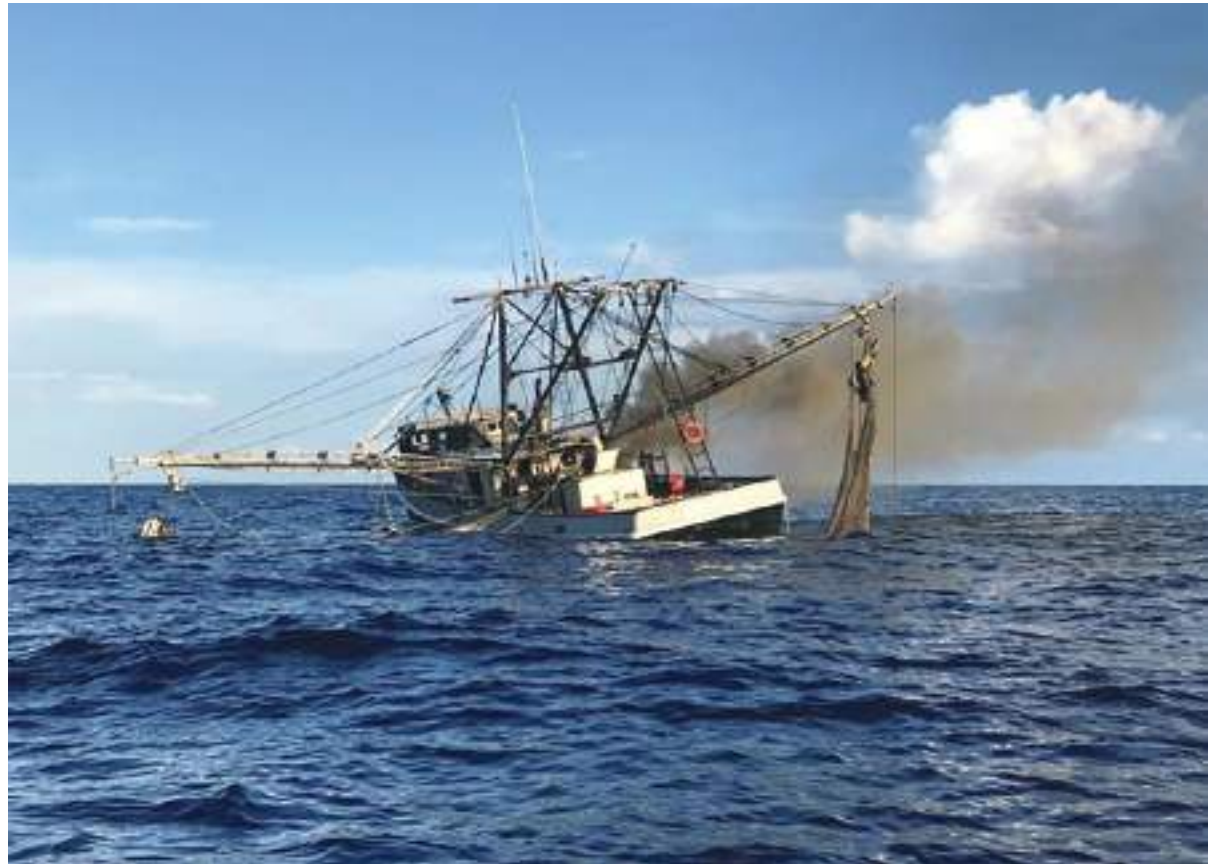
Figure 114. *Master D* burning on the day after the crew rescue. SOURCE: COAST GUARD

Based on the location of the flames seen by the captain, along with the intensity of the fire and smoke when it was discovered shortly after the power went out on the bridge, the fire most likely started at the generator. As noted by the captain, the generator had a lube oil leak, which was not properly repaired prior to the accident voyage. Although the source of the ignition could not be determined, there would have been several hot surfaces around both the operating main engine and the generator to ignite a fuel or lube oil leak from either engine. The final loss of power was most likely a result of fire damage to the generator and/or the electrical distribution system near it.

The probable cause of the fire aboard the fishing vessel *Master D* was leaking lube oil from the diesel generator that contacted a hot engine surface and ignited. Contributing to the eventual sinking was the failure of fire-damaged nonmetallic hoses connected to through-hull fittings below the waterline.

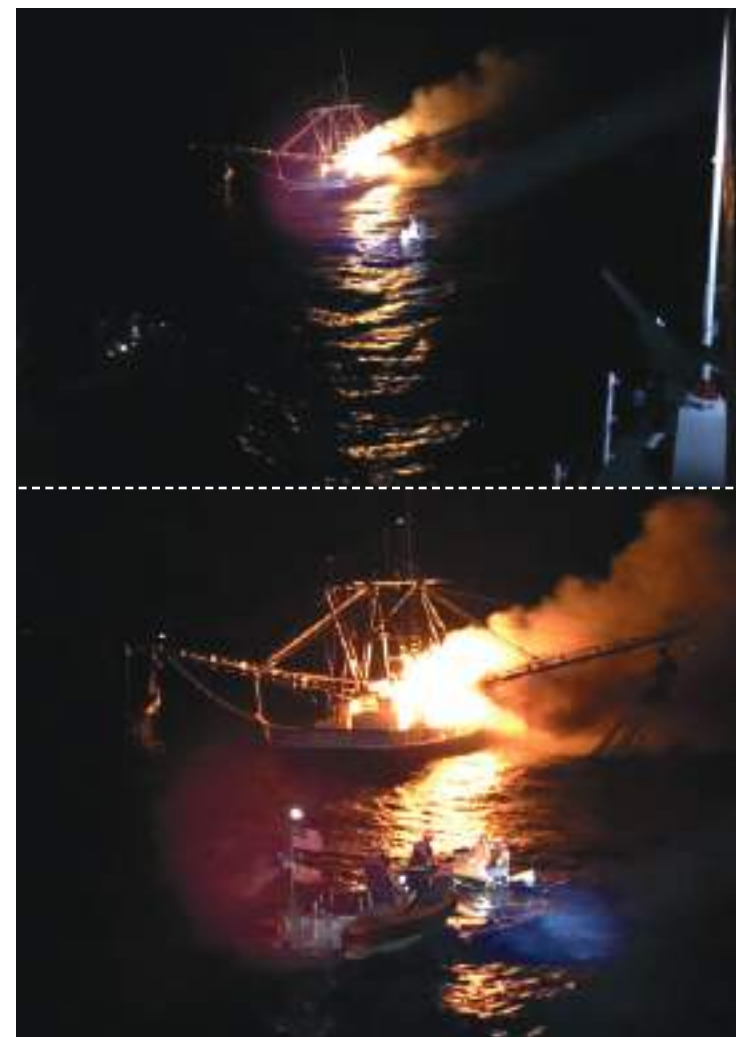
Figure 115. *Master D* on fire while the crew is rescued by the Coast Guard. SOURCE: COAST GUARD

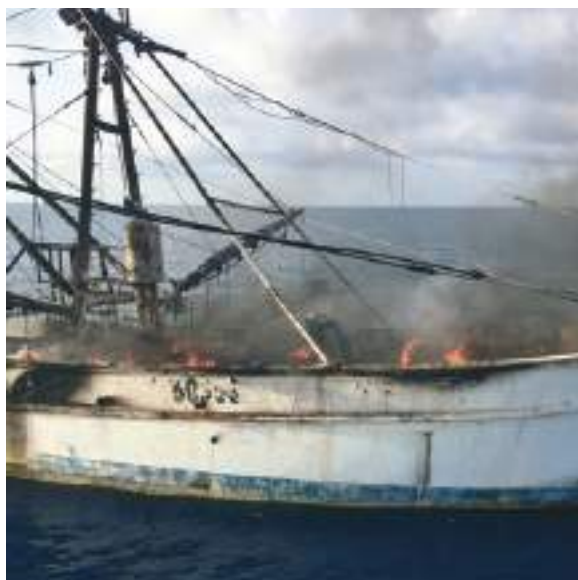
Figure 116. Burning hull of *Ole Betts Sea*.
SOURCE: TRICO SEAFOOD, INC.

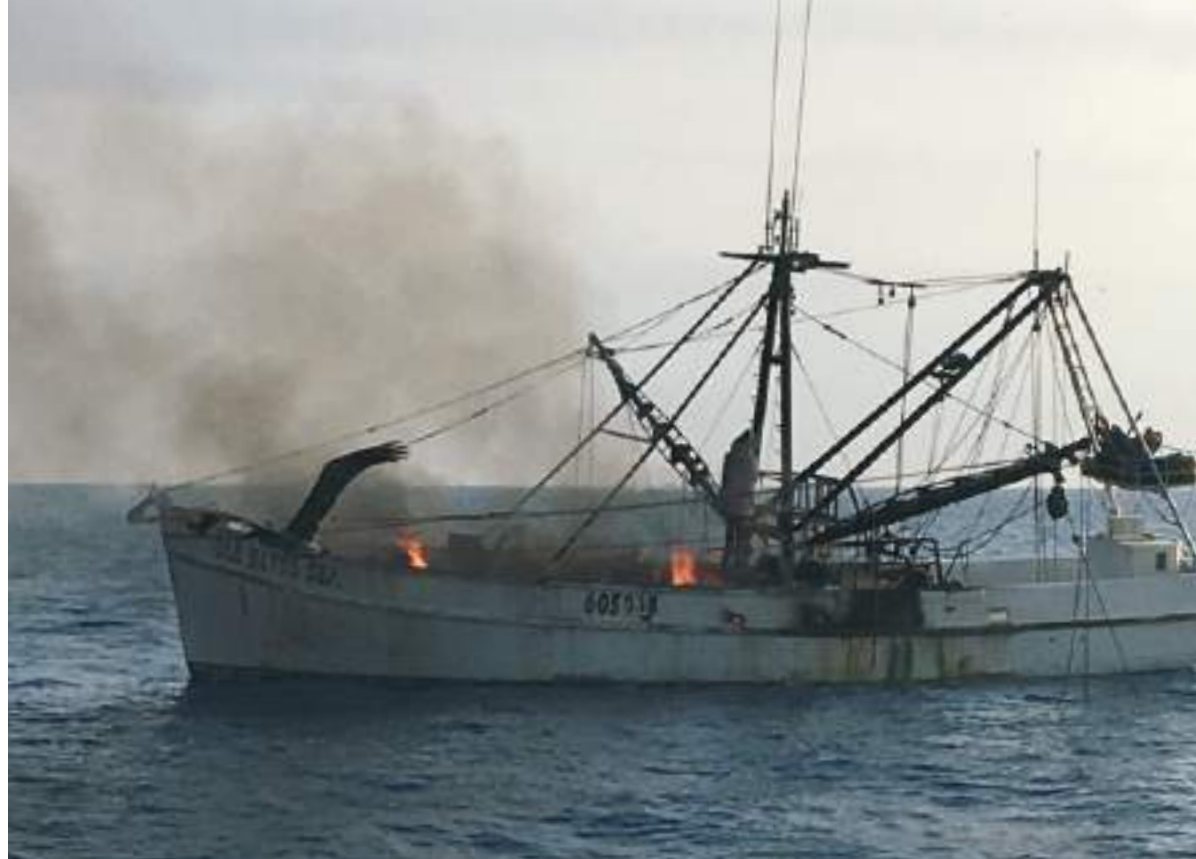
Figure 117. Burning hull of *Ole Betts Sea*. SOURCE: TRICO SEAFOOD, INC.

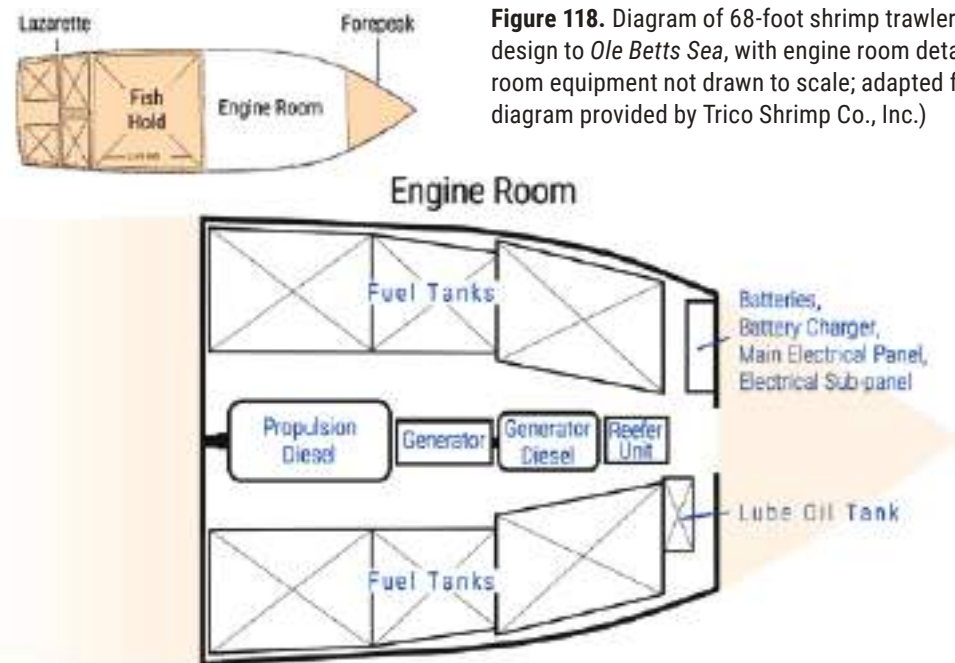
Figure 118. Diagram of 68-foot shrimp trawler of similar design to *Ole Betts Sea*, with engine room detail. (Engine room equipment not drawn to scale; adapted from hull diagram provided by Trico Shrimp Co., Inc.)

The fire was likely fed by diesel oil from a failed fuel line to the propulsion or generator diesel engines. Investigators noted that there was no way for the crew to shut off the fuel flow to the diesel engines, such as a remote quick-closing (cut-off) valve, outside of the engine compartment. Depriving the fire of fuel, especially during the early stages of the incident, could have prevented further ignition of flammable materials and increased the likelihood of saving the vessel.

The probable cause of the fire and sinking of fishing vessel *Ole Betts Sea* was a mechanical failure of the generator's diesel engine, which led to a fuel-fed fire that burned out of control.

Following the initiation of an engine room fire, it is imperative to remove the source of available fuel to the fire found in the fuel oil and lube oil systems. In this accident, the vessel had no remote emergency cut-off valves for fuel and lube oil systems outside the engine room, and thus fuel to the fire could not be stopped and the vessel was eventually consumed by the flames. Vessel designers, builders, owners, and operators are encouraged to install, regularly test, and have emergency drills that incorporate remote cut-off valves for fuel and lube oil lines.

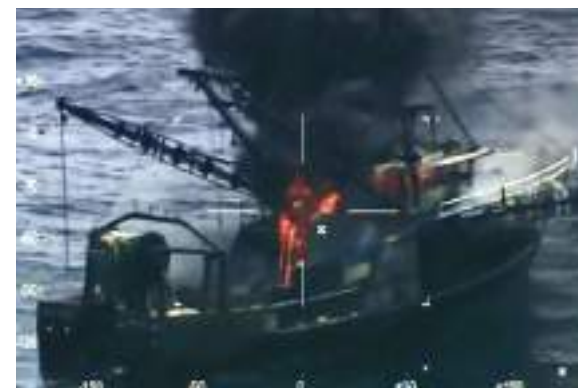
Figure 120. Video screenshot of the *Rose Marie* from the Coast Guard's aircraft, which had been dispatched to the fire. The camera's crosshairs capture the flames consuming the net on the drum. SOURCE: COAST GUARD

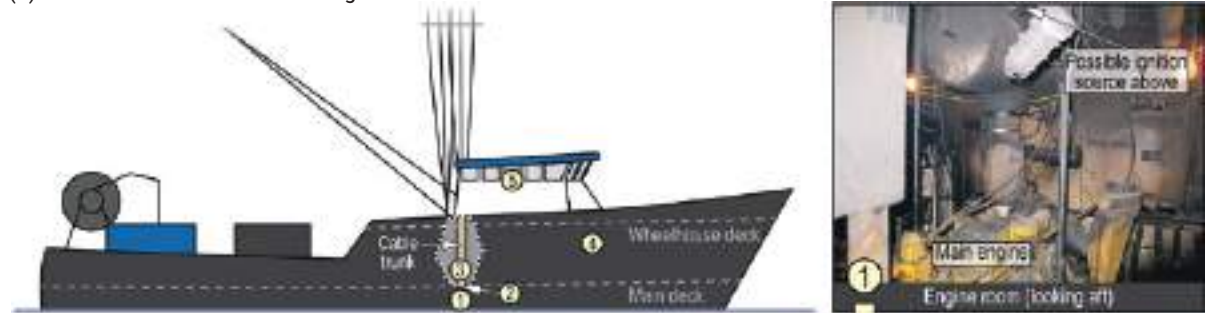
Flames cannot spread easily through insulated steel decks or bulkheads. The deck between the accommodation space and the wheelhouse was steel, but the cable trunk running through it was constructed of uninsulated flammable material (wood). Had the trunk opening been sealed and its surrounding structure insulated with fire-retardant materials, the fire would not have been able to rapidly spread, and damage may have been limited to the engine room.

The probable cause of the fire aboard the fishing vessel *Rose Marie* was arcing of an electrical wire in the engine room overhead igniting a wooden cable trunk. Contributing to the severity of the damage was the installation of a trunk that compromised the steel boundary of the engine room, allowing the flames to spread to the combustible materials in the upper decks.

Figure 121. The sequence of the fire's path can be traced in these images as flames (1) began above the main engine in the engine room, (2) traveled through the wooden cable trunk opening overhead, (3) entered the accommodation space through the cable trunk opening, (4) spread through the galley and throughout the accommodation space, and (5) entered the wheelhouse through the cable trunk and ladder access.

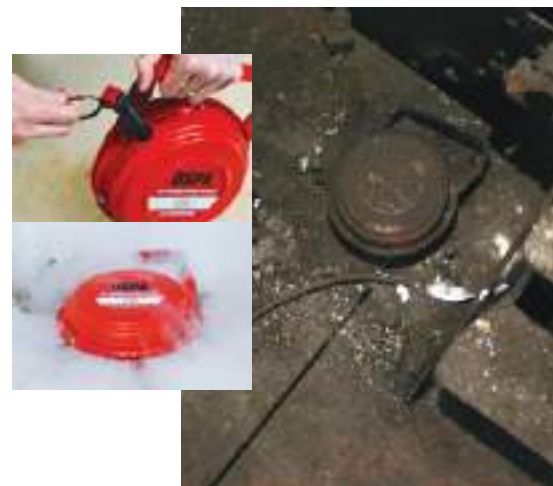
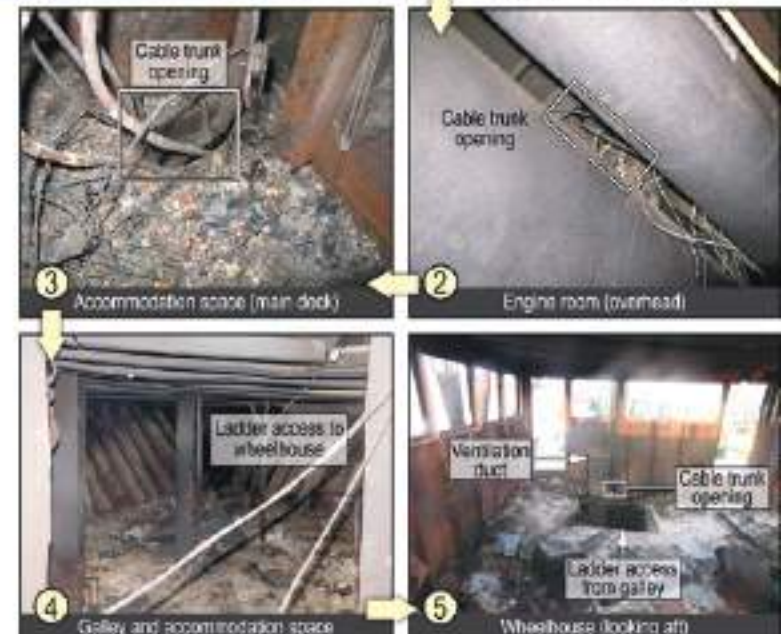
Crewmembers attempted to fight the fire using a grenade-type aerosol extinguisher rated for spaces up to 5,300 cubic feet in volume. The manufacturer recommended that spaces be sealed completely when using the handheld aerosol grenade, yet the engine room door and vents remained open throughout the fire, rendering the extinguisher ineffective.

Figure 122. Below: grenade-type aerosol fire extinguisher used initially to combat the fire sits on the deck of the engine room near the entrance ladder. Inset: two photos from the manufacturer's website demonstrate how the device activates.

Grenade-type aerosol fire extinguishers were used to fight engine room fires in this accident and an earlier fire on the fishing vessel *Logger*—but did not extinguish the fire in either accident. In both cases, the crews did not close all openings, such as engine room doors and other ventilation, thus reducing the effectiveness of the extinguisher. When using such devices or designing any vessel space for the prevention of fires, vessel owners and operators should identify openings, provide means to ensure they can be properly secured in order to contain a fire, and train crewmembers on how to secure them during a fire emergency.

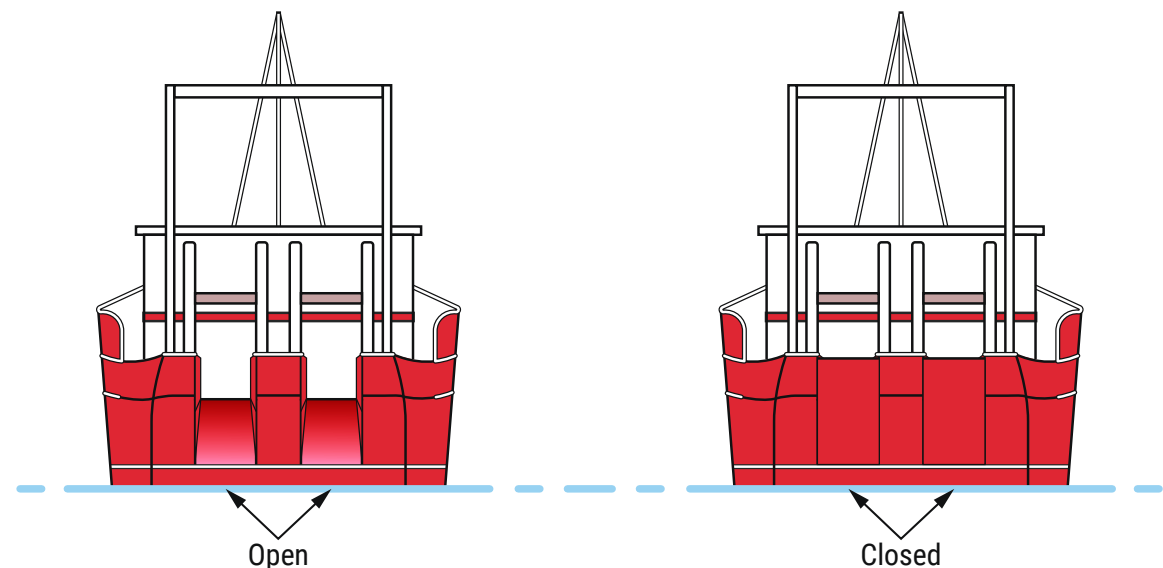
Figure 126. A diagram of the stern ramp gates in the open (at left) and closed (at right) positions.

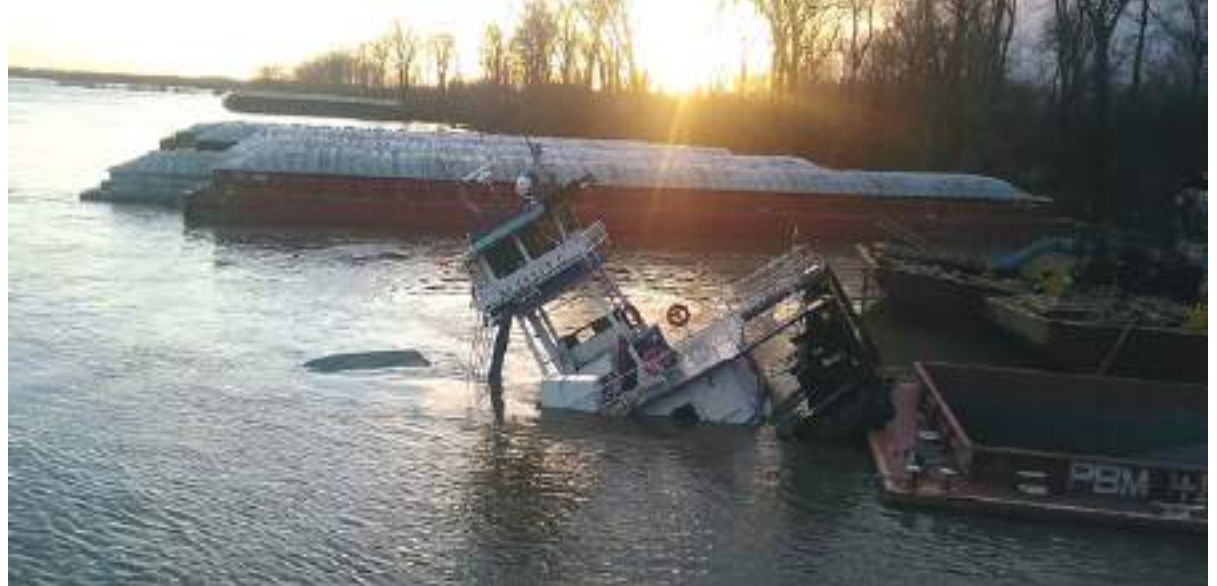
Figure 128. Postaccident photo of *Ms Nancy C*.

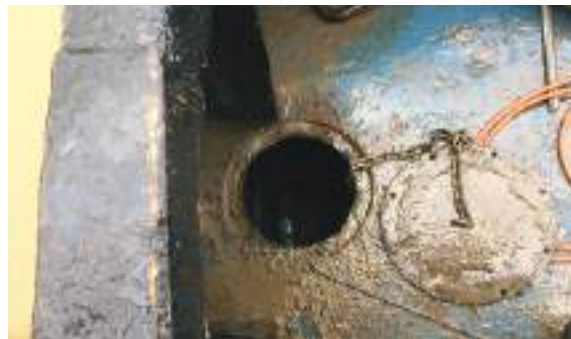
The amount of water entering the vessel exceeded the capability of the two portable pumps. This quantity of water increased the stern trim and decreased the aft freeboard so that water was able to freely enter the three open access covers to the stern voids, as well as through several other loose access hatches and poorly fitted doubler plates. As the vessel sank further, water would then have entered the engine room through wastage on the aft side of the deckhouse and over the sills of the open engine room doors.

The probable cause of the flooding and sinking of the towing vessel *Ms Nancy C* was inadequate maintenance of the vessel by Chocktaw Transportation Company, resulting in corrosion and the loss of watertight integrity on the main deck, which allowed uncontrolled water ingress into the vessel's stern voids.

Figure 130. Starboard deck access to aft stern void found open during salvage, with broken and missing access cover screws.

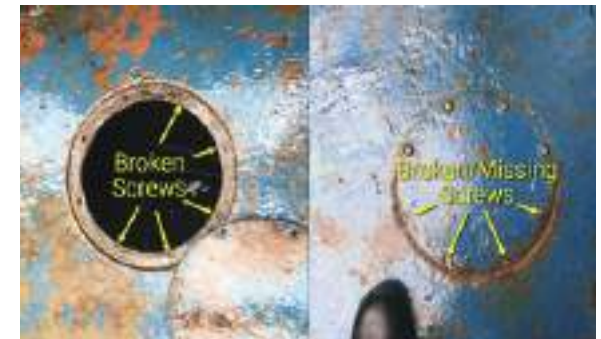
Figure 132. Starboard deck access to forward stern void found open during salvage. At right, port deck access to aft stern void, with broken and missing access cover screws.

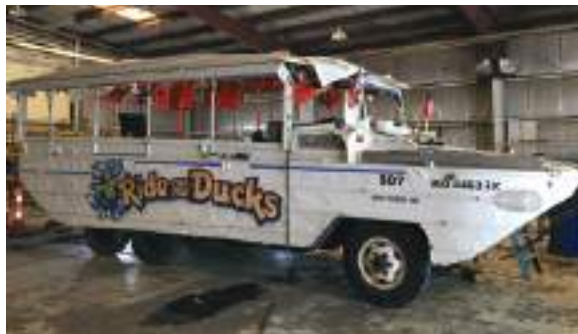
Figure 139. *Stretch Duck 7* after being recovered from Table Rock Lake following the sinking.

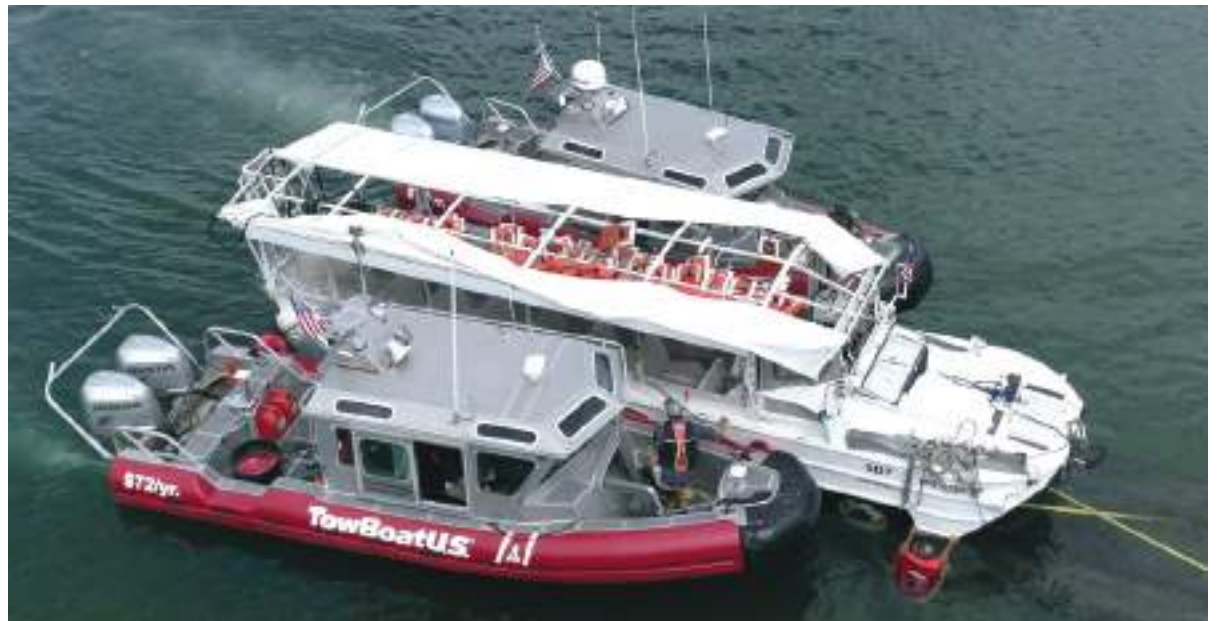
Figure 140. Torn canopy on the *Stretch Duck 7* during recovery at Table Rock Lake.

Emergency egress. Several passengers stated that the vessel's canopy obstructed their egress. The 1/32-inch-thick vinyl canopy, designed for protection against inclement weather, extended over the entire passenger compartment and the captain's station. In addition, two 1/32-inch-thick clear vinyl curtains were installed on the

Stretch Duck 7 as a protective measure, one on each side of the vessel, and controlled by a switch at the captain's station. On recovery of the vessel, investigators found the starboard-side curtain was closed and the portside curtain had been released. The NTSB had recommended that the Coast Guard require the removal of canopies for waterborne operations or installation of an approved canopy that does not restrict passenger escape following the *Miss Majestic* accident. Yet, believing its Navigation and Vessel Inspection Circular 1-01 guidance was "sufficient," the Coast Guard did not take action, which consequently may have increased the number of fatalities in the *Stretch Duck 7* accident.

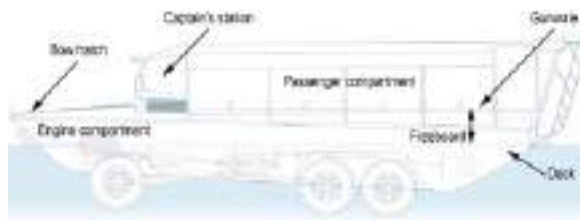
Engine compartment openings. As wind-driven waves washed over the **Stretch Duck 7**'s bow several times, water likely entered the vessel through the air intake hatch located on the forwardmost point of the bow. The

purpose of the hatch, when opened, was to allow air in the engine compartment for cooling the space during normal operations. Waves likely rolled over the bow hatch's spring-loaded damper and intermittently opened it, thereby allowing water into the engine compartment. As the water accumulated in the engine space, the **Stretch Duck 7**'s bow sank lower, and as relatively higher waves rolled across the hatch, the rate of flooding would have increased.

Figure 144. Profile drawing of *Stretch Duck 7* also showing engine, drive train, and propeller.

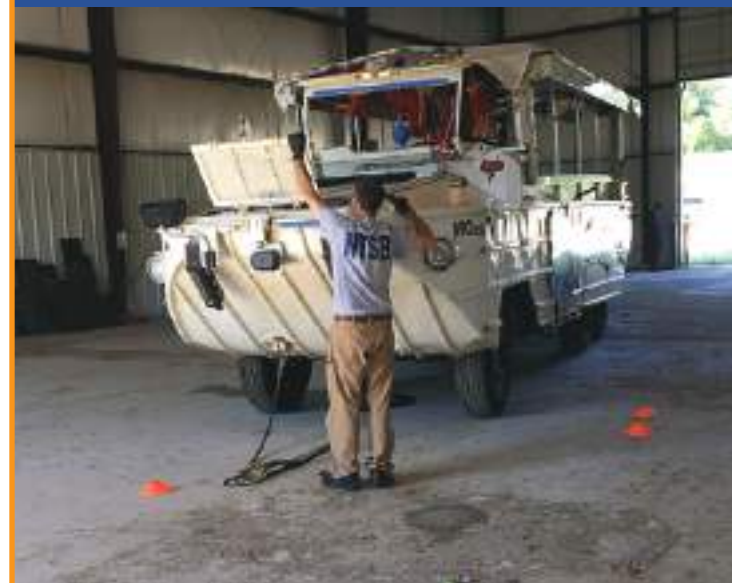
Figure 146. NTSB investigator inspecting the accident vessel's bow hatch.

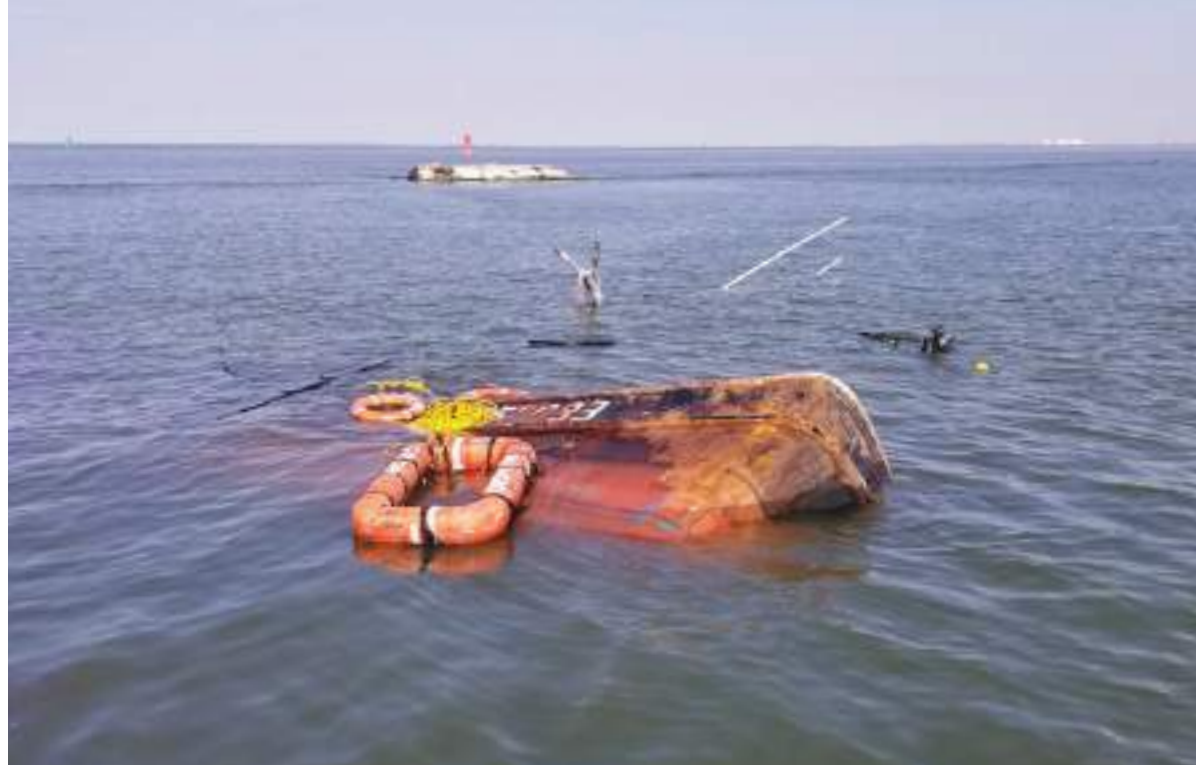
Figure 148. Starboard quarter of the *Capt. M&M* wreckage. Sabine Pass Jetty Channel buoys "19" (green) and "20" (red) appear in the background.

The probable cause of the grounding of the fishing vessel *Capt. M&M* was the failure of the wheelhouse watchstander to keep a proper navigation watch. Contributing to the sinking was a modification to the watertight collision bulkhead that allowed progressive flooding.

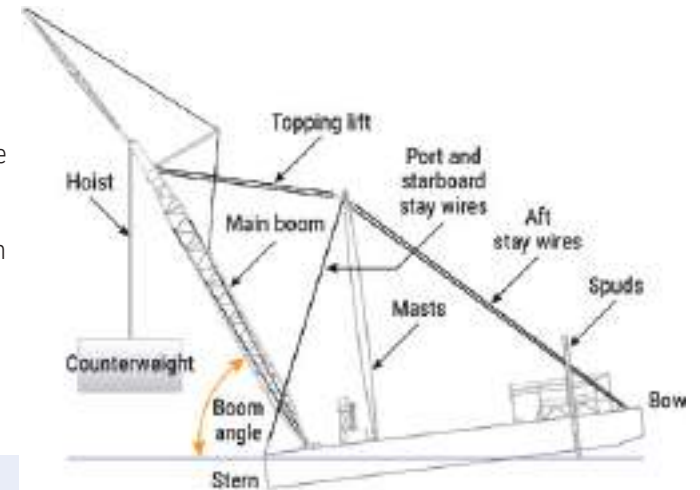
A crane that is not level due to a list causes sideloading of the boom, thus reducing the rated capacity. The crane operator stated that he boomed up to 69 or 70 degrees; the Keppel AmFELS' incident report stated 68 degrees. Therefore, the vessel would have trimmed at least 7 degrees by the stern for the boom angle to read 60.7 degrees when the weight was suspended. At 60.7 degrees of boom angle, the crane's maximum capacity was 645 tons; the actual 671-ton lift exceeded the capacity by 26 tons. The trim likely contributed to the crane being overloaded by reducing the boom angle relative to the water.

Figure 155. Simplified diagram of *Atlantic Giant II* illustrates barge's trim and boom angle relative to sea surface, as crane hoists *TOPS DB1*'s counterweight. (Dimensions and angles not drawn to scale.)

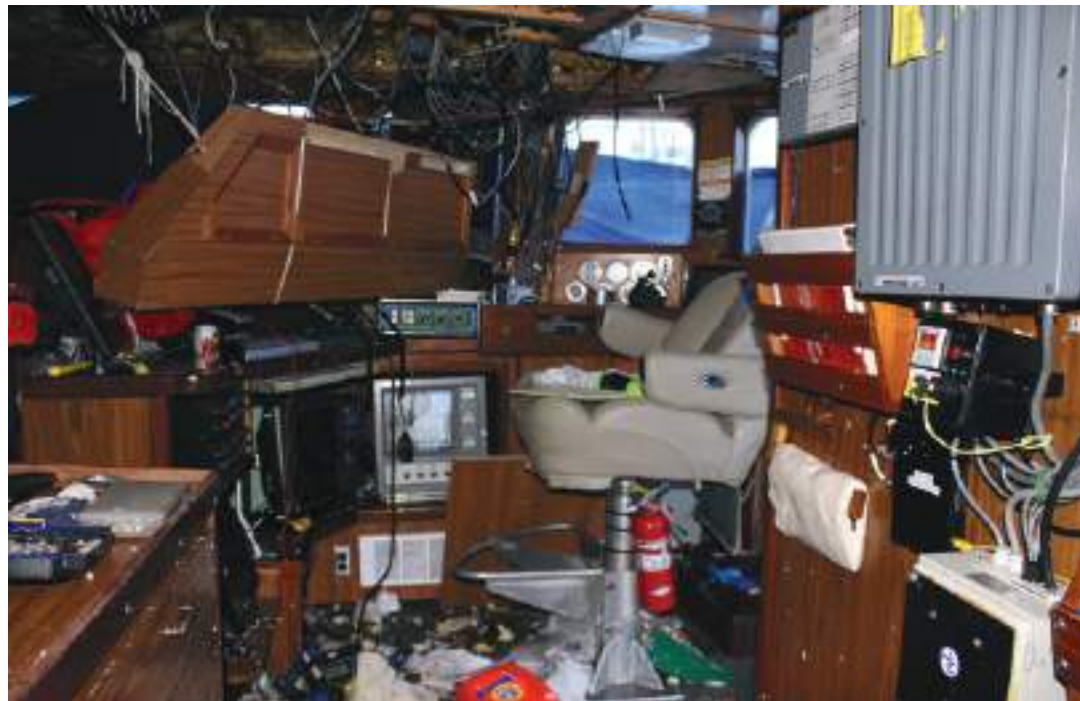
The wheelhouse ceiling “had been ripped off and our radios were torn away,” and there was “a river of water rushing down the [wheelhouse] stairs into the galley.” The crew immediately began to assess and react to the situation to secure the vessel. About 30 minutes after the wave struck the *Progress*, damage control was completed. The crew donned survival suits and then the captain, assessing that the vessel had lost all communications and navigation equipment, decided to activate the EPIRB and shoot flares, hoping vessels would respond. Shortly thereafter, one of the radios was repaired, and the captain called the Coast Guard and nearby vessels. At 0849, the Coast Guard received the EPIRB signals from the *Progress*.

Figure 160. Below: Interior wheelhouse damage.

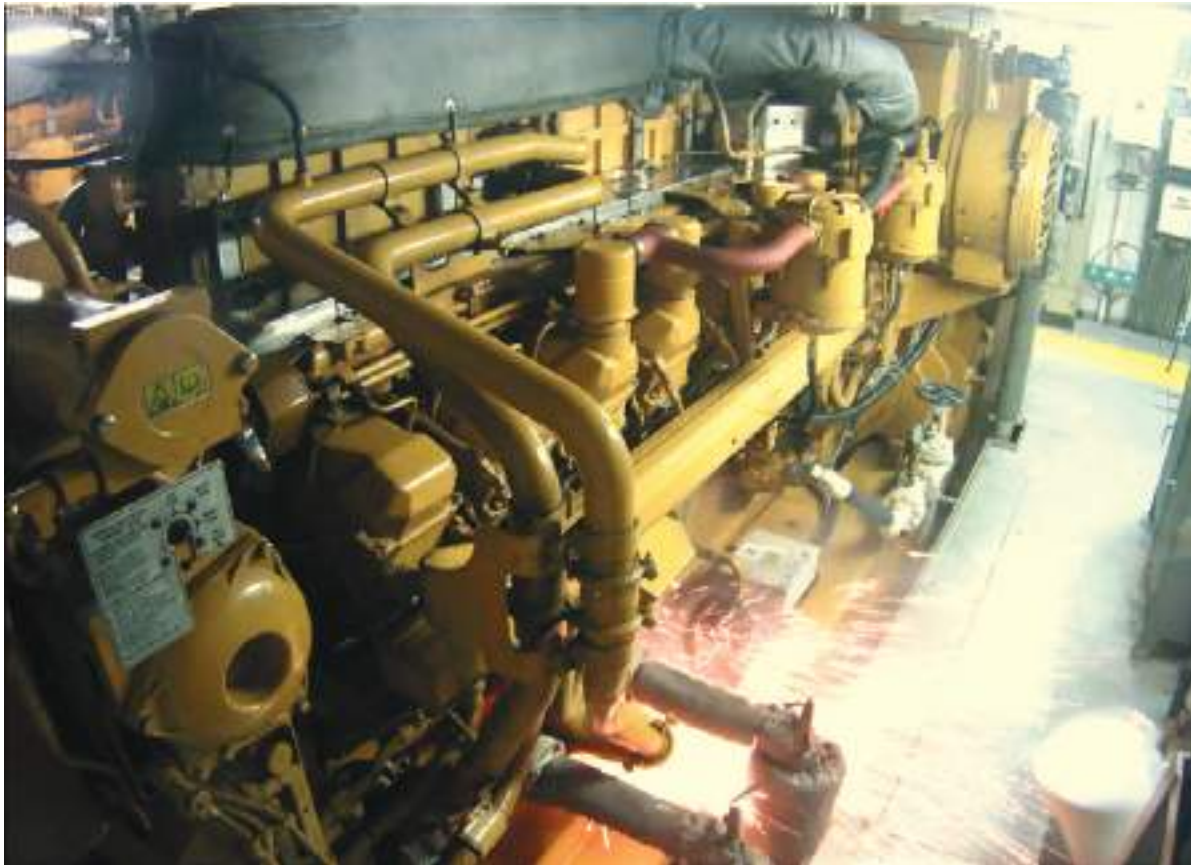
Figure 162. Screenshot from closed-circuit television at the time of the failure, looking aft from the inboard side of MDG no. 2.

During a forensic teardown of MDG no. 2, investigators and technical experts developed an engine failure timeline. They determined that the engine was running at rated speed when the joint between cylinder no. 8's connecting rod and rod cap loosened. The connecting rod cap hinged open and detached from the crankshaft rod journal, impacting the cylinder block and causing massive damage to the engine. The connecting rods on cylinder nos. 7 and 8 disengaged from the crankshaft and collided with the rotating assembly. A series of high-energy collisions created secondary damage to the engine.

Based on the forensic teardown of MDG no. 2 and the appearance of cylinder no. 8's connection rod bolts, cap and bearing assembly, investigators determined that one of the four connecting rod bolts on cylinder no. 8 backed out of the internal thread of the connecting rod. Once this bolt backed out, the remaining three bolts became overloaded. It appeared that repetitive impact occurred as the connecting rod cap loosened, resulting in the remaining three bolts shearing off.

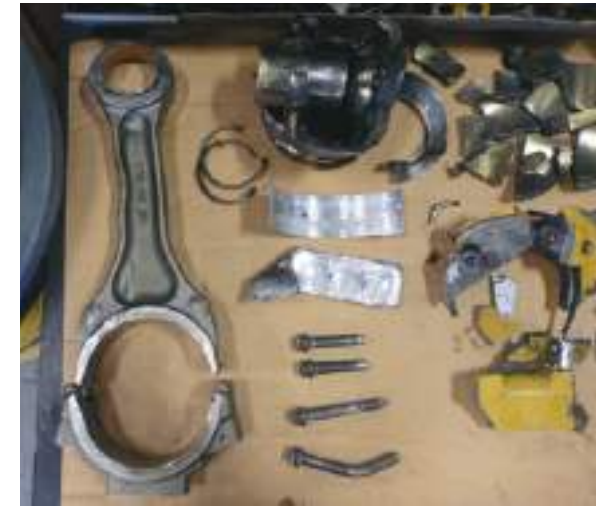
Figure 163. Connecting rod, cap, bolts, and bearing halves of cylinder no. 8.

The two Caterpillar technicians who conducted the overhaul on MDG no. 2 the previous month stated that they followed company procedures and that they tightened the connecting rod bolts using a company-issued and calibrated torque wrench in accordance with the manufacturer's specifications. However, based on the findings of the circumstances pertaining to the rod assembly's failure, the bolts were likely under-torqued during the overhaul.

The probable cause of the mechanical failure on board offshore supply vessel *Red Dawn* was a connecting rod assembly on the no. 2 diesel engine that came loose and separated from the crankshaft due to improper tightening (torqueing) of the connecting rod bolts during the previous engine overhaul.

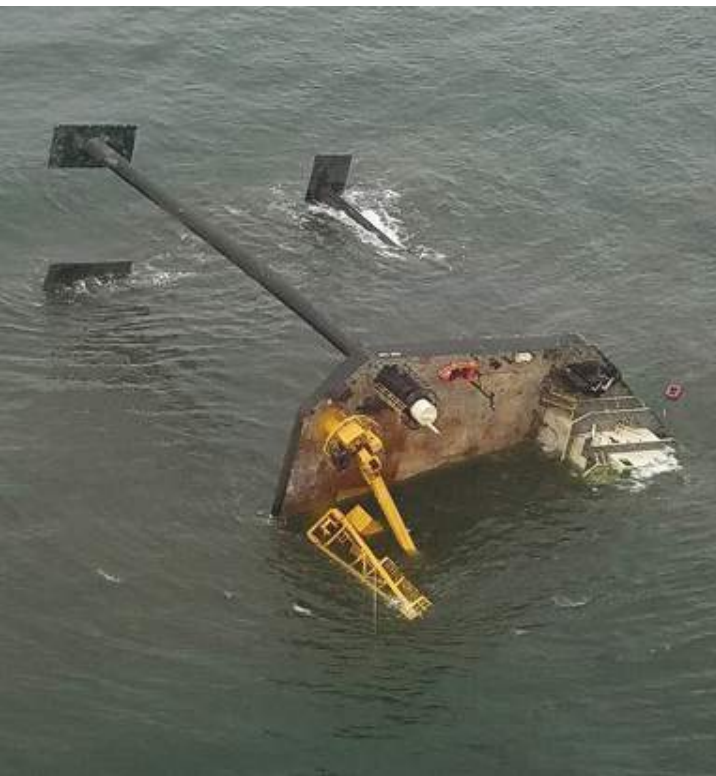
Figure 164. *Ram XVIII* six days after the accident, on November 24. Note the life float adrift astern of the vessel.

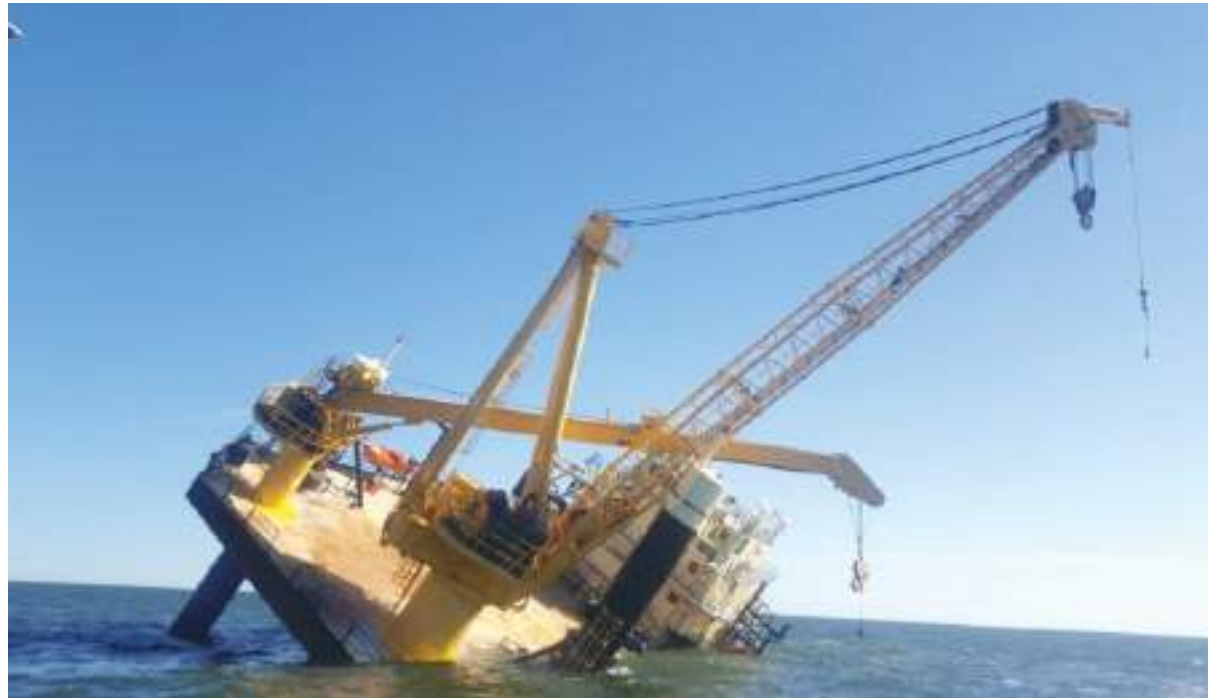
Figure 165. *Ram XVIII* after the vessel was abandoned, showing a significant angle of inclination to port.

The probable cause of the overturning of the elevated liftboat *Ram XVIII* was the industry practice of not regularly providing liftboat operators with adequate information about the seafloor composition, which resulted in the instability of the port leg due to unidentified conditions/hazards in seabed composition near the port leg landing site.

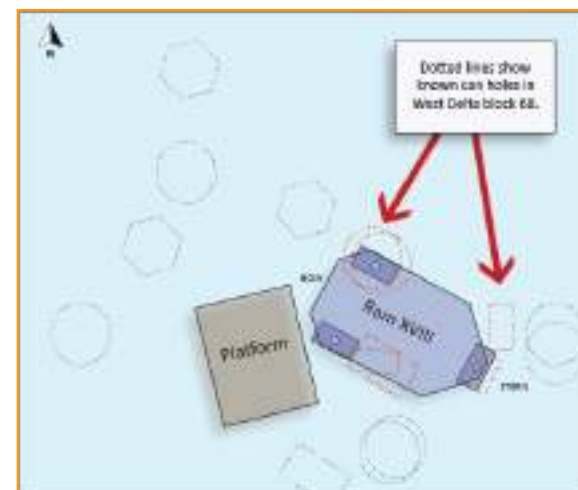
Figure 167. The WD-68-U platform and surrounding seafloor, including outlines of documented can holes. The *Ram XVIII*'s position is shown in relation to the platform, with its starboard leg in a can hole.

Seafloor conditions, including can holes; bottom changes due to storm passages; proximity to major rivers; and soil composition can pose significant hazards to safe liftboat operations. Operators should use all available information in selecting sites to land out legs. Leaseholders should provide and liftboat operators should request all necessary information for safe operations, including, but not limited to, soil analysis, penetration history for the site, and/or core samples, before commencing jack-up operations.
