SAFETY INVESTIGATION REPORT

REPORT NO.: 03/2021

MT VALTAMED **Fatality in the pump room** **at Ceyhan OPL Anchorage, Turkey,** **in position 36° 20.6' N 035° 09.66' E** **03 February 2020**

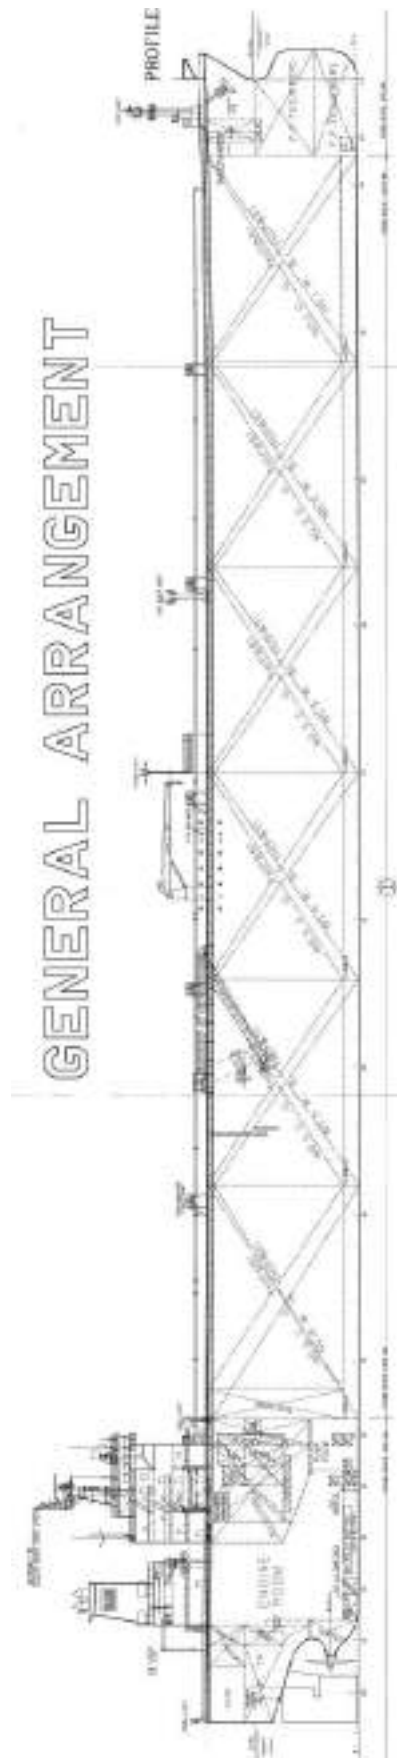
Figure 1: Extract of the General Arrangement Plan – *Valtamed*

Valtamed (Figure 1) was an 83,669 gt, double-hull oil tanker, owned by Vassholmen Shipping Ltd. and managed by Navigazione Montanari S.p.A., Italy. *Valtamed* was built in 2004, by Daewoo Shipbuilding and Marine Engineering Co. Ltd. in the Republic of Korea and was classed with Registro Italiano Navale (RINA).

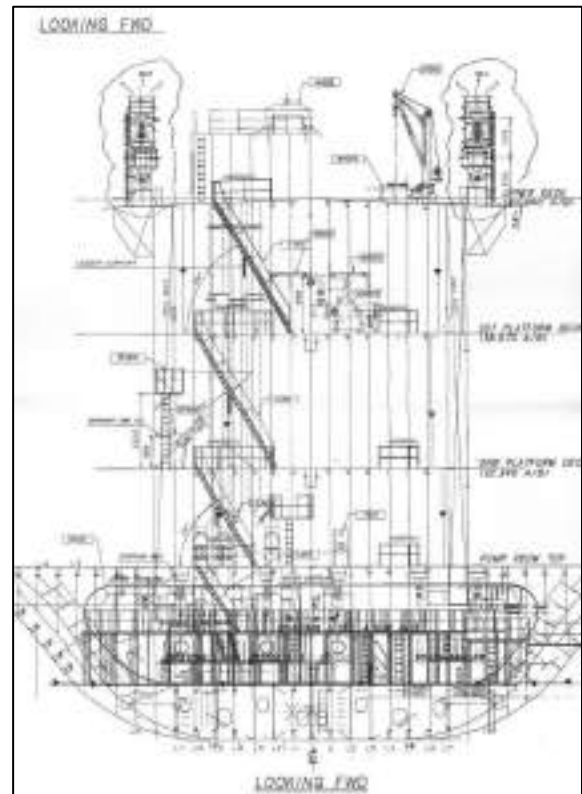
Figure 2: Pump Room Arrangement Plan

The vessel was fitted with a pump room (Figure 2). The vessel's cargo and ballast pumps and fittings extended down from the main deck to the keel. The vessel was fitted with three cargo pumps and two ballast pumps. All cargo pumps were located on the port side of the vessel's centre line, with cargo pump no. 1 lying closer to the centre line and cargo pump no. 3 lying closer to the port side. The pump room was located just forward of the accommodation block.

The starboard side sensor was located within a more confined area. This area was surrounded by the pump room's bottom floor above, the keel below, and strengthening structural members, in the form of steel plates with lightening holes which allowed access through them, on its sides (Figure 2).

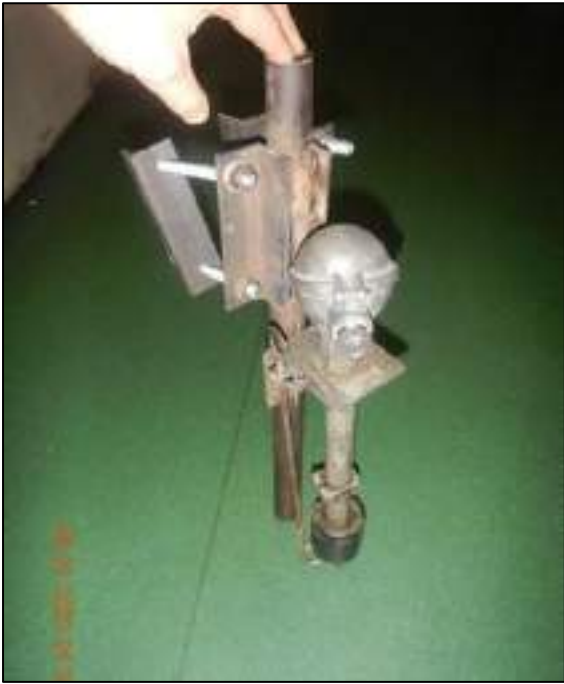
Figure 3: Bilge alarm sensor (representative photograph)

The pump room was fitted with two bilge alarm sensors of the float type (Figure 3), located on the port and starboard sides of pump room bottom.

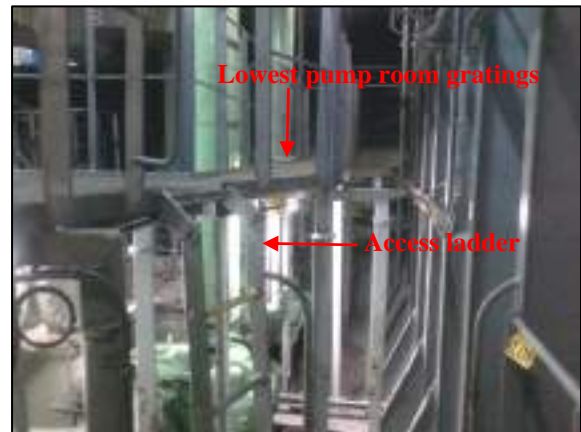
Figure 5: Access towards starboard side bilge alarm sensor

To access the starboard sensor, crew members had to go down below the lowest gratings (Figures 5), access a manhole (Figures 6a and 6b) of about 2.0 m depth and

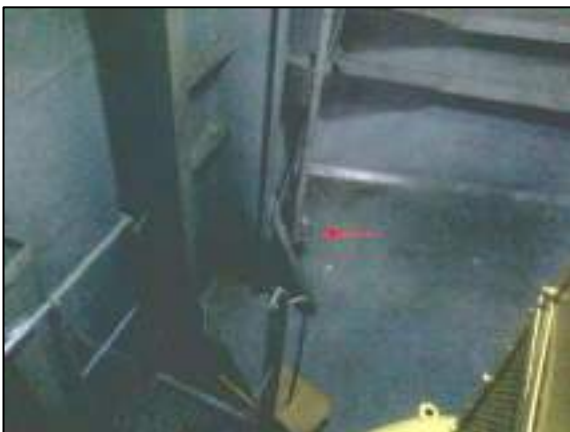
Figure 4: Port side bilge alarm sensor (red arrow), as seen from the lowest pump room gratings

The port side bilge alarm sensor was readily visible and accessible from the lowest level gratings of the pump room (Figure 4).

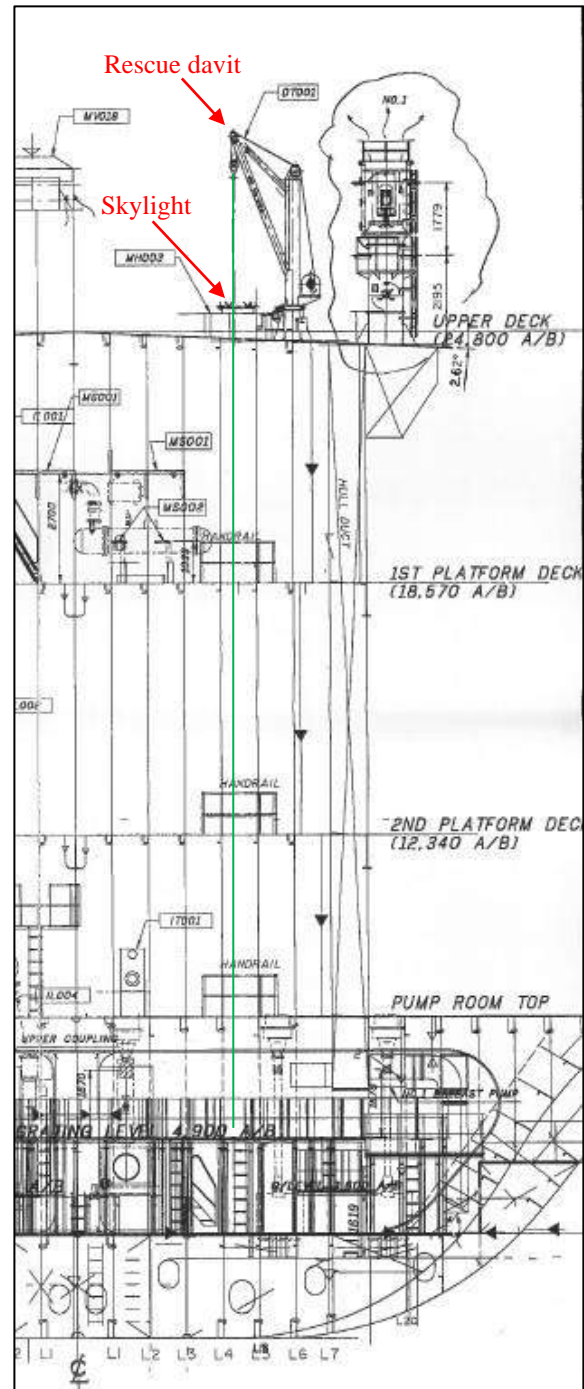
Figure 8: Rescue davit (green line indicates direction through which its wire passes)

For emergency cases, say, when recovery of a person would be necessary, the pump room was fitted with a rescue davit at the top, the hook and wire of which could be passed through a skylight vertically down to the lowermost gratings (Figure 8).

Reportedly, a stretcher and a harness were placed on the lowermost gratings of the pump room, at the evacuation area.

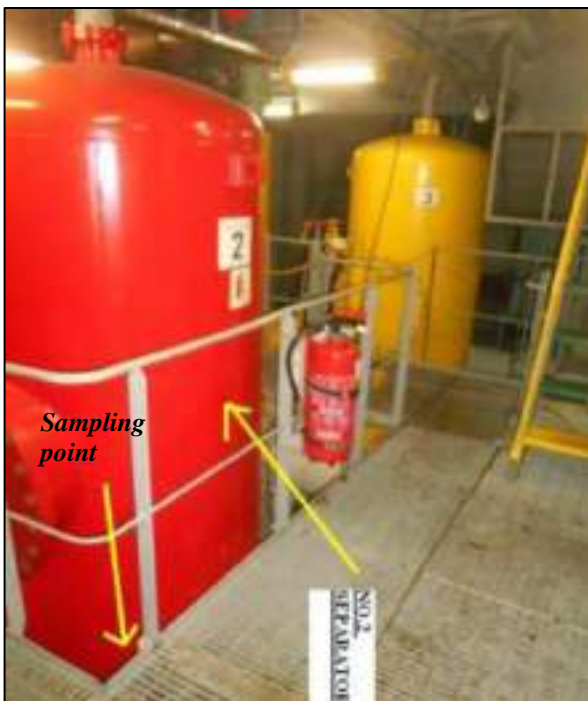
Figure 9: Location of LEL and O₂ sampling point

- one in each of the exhaust vent ducts to measure the LEL;
- on either side above the lowest gratings to measure the LEL;
- at the pump room's bottom, in way of the separator of cargo pump no. 2, to measure the LEL and O₂ (Figure 9); and
- at the pump room's bottom, in way of the separator of cargo pump no. 1, to measure the LEL and H₂S (Figure 10).

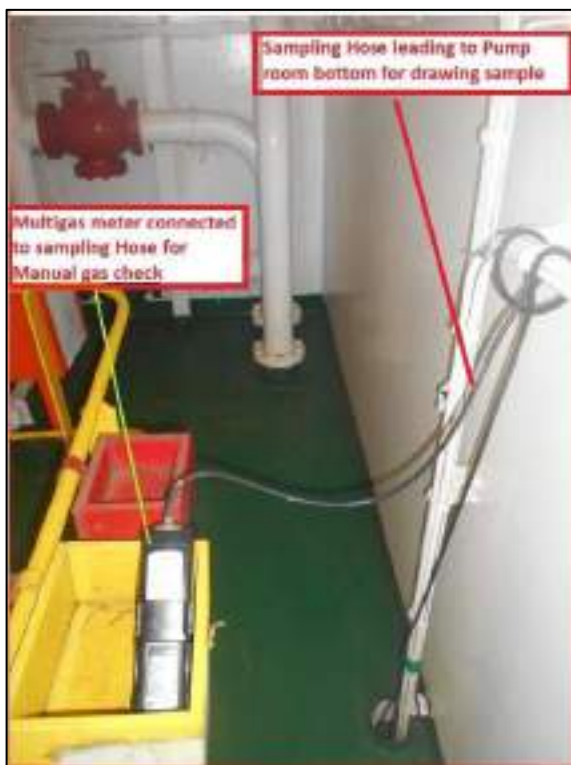
Figure 12: Personal multi gas detector placed at the pump room's entrance

In addition to the fixed gas detection system, a personal multi gas detector (Figure 12) was placed at the entrance to the pump room, with its sampling tube extending down to the bottom of the pump room.

This gas detector was designed to measure the O₂ and LEL in percentages, as well as H₂S and Carbon Monoxide (CO) in ppm. This gas detector was last calibrated by a

manufacturer's representative on 20 September 2019 and was last tested on board the vessel on 11 December 2019.

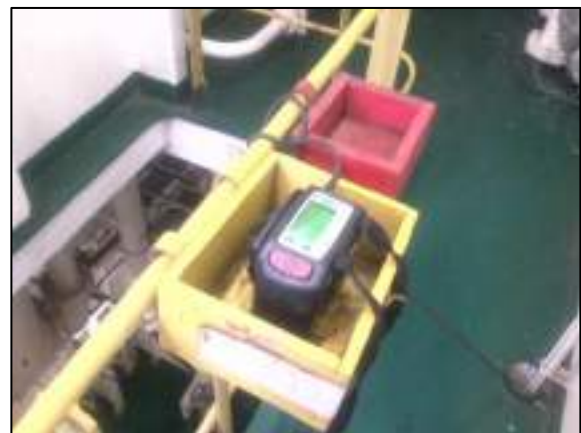
Figure 13: Portable gas detector replacing the personal multi gas detector

In line with on board procedures, after the initial checks of the pump room atmosphere from above, the person entering the pump room would carry the personal multi gas detector and replace it with a portable gas detector (Figure 13) capable of measuring O₂ and Hydrocarbons / LEL in percentages.

Thereafter, two able deck seafarers (AB 1 and AB 2) checked the atmosphere of the pump room using the portable gas detector, which was placed at its entrance (Figure 13). The meter read 20.9% O₂ and 0% LEL and so they entered the pump room wearing self-contained breathing apparatus (SCBA) sets. They also carried personal multi gas detectors and portable radios.
