SAFETY INVESTIGATION REPORT

REPORT NO.: 07/2021

MV CROATIA
Cargo explosion
in position 03° 38.7' N 105° 37.7' E
23 February 2020

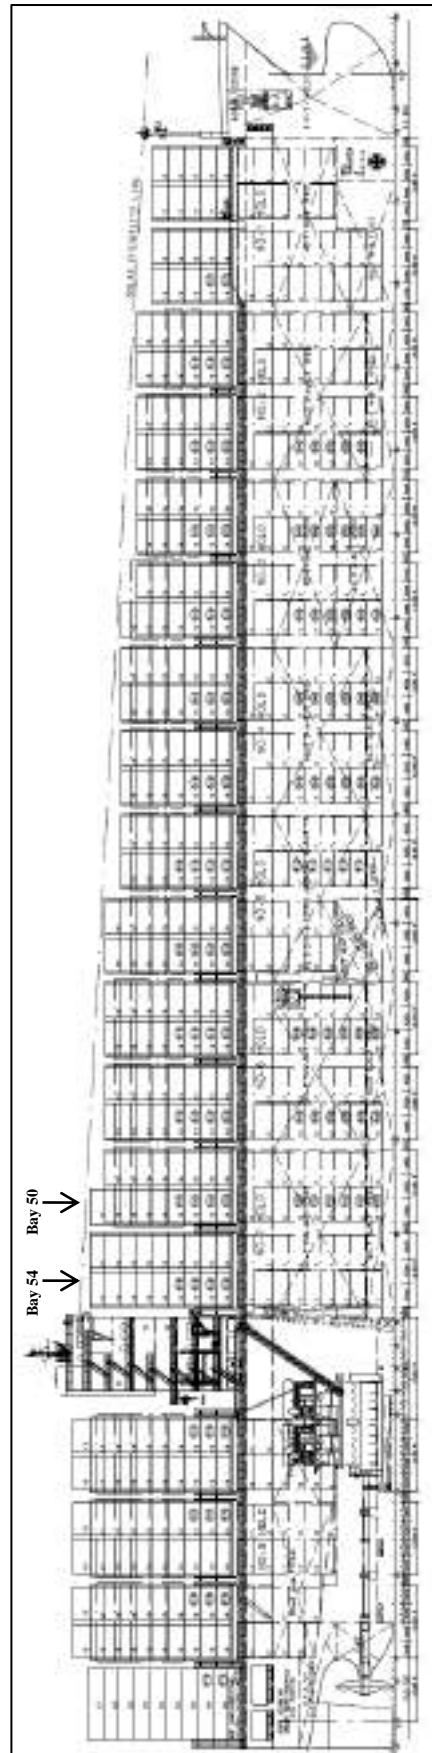
Figure 1: Extract from the general arrangement plan

Croatia (Figure 1) was a 94,684 gt, Maltese registered container vessel, built by Hanjin Heavy Industries & Construction Subic, Philippines, in 2016. The vessel had a length overall of 299.98 m, a moulded breadth of 48.2 m, and a moulded depth of 24.8 m. She had a summer deadweight of 111,530 metric tonnes (mt), corresponding to a summer draught of 14.521 m. *Croatia* was owned by Croatia Maritime Limited, managed by *Ciner Gemi Acente Isletmeleri Sanayi Ve Ticaret A.S.* and classed with the American Bureau of Shipping (ABS).

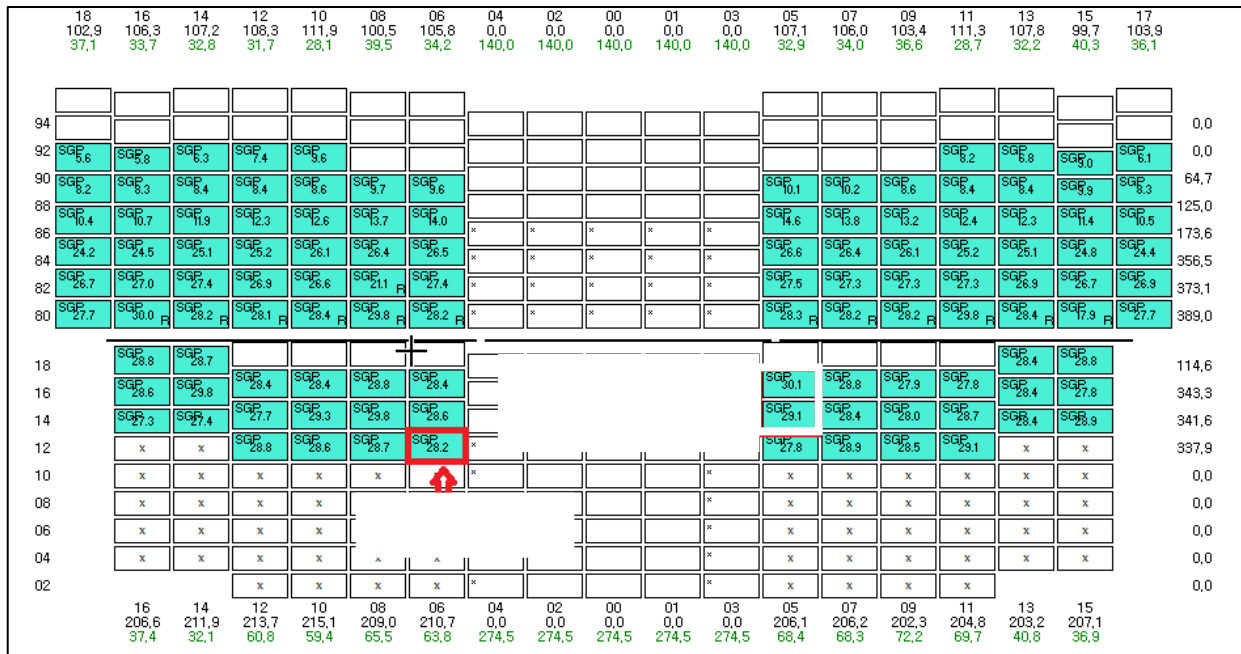
Figure 6: Plan of Bay 50 indicating the location of the exploded container

The container inside which the explosion had happened was in position Bay 50, Row 06, Tier 12 (500612) (Figure 6). As a result of the explosion, the entire right panel and the access door were ripped off, exposing the cargo contents (Figure 7).
