MARINE SAFETY INVESTIGATION REPORT

Safety investigation into the serious occupational accident on board the
Maltese registered heavy lift /pipelay vessel

PIONEERING SPIRIT

MARINE SAFETY INVESTIGATION REPORT NO. 02/2021

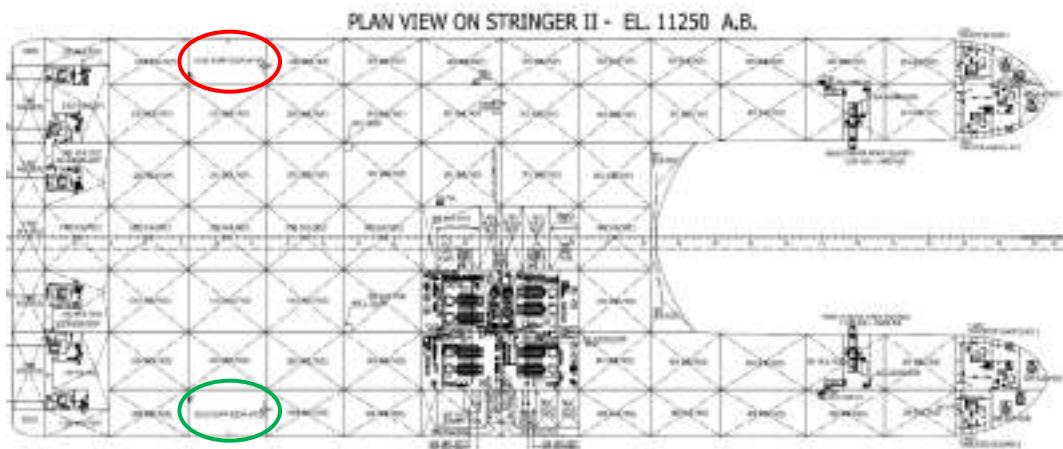
Figure 4: Extract from General Arrangement plan - Position of WBT no. 1006 marked in green and WBT no. 1005 marked in red

During a period of seven weeks, between October and November 2019, while the vessel was in Tenerife, Spain, parts of the new JLS installation had been assembled. New winches and electrical cabinets had been mounted below deck in the adjacent WBTs, at each side of the vessel. Forward of the new winch rooms, in the adjacent WBTs nos. 1005 and 1006 (Figure 4), reinforcement for new block-sheave assemblies for wires had been mounted. After completion of the welding of these assemblies in the tanks, the WBTs were sealed off in preparation for the vessel to depart for Northern Europe. The jobs in these WBTs, were at that time, considered to have been completed.

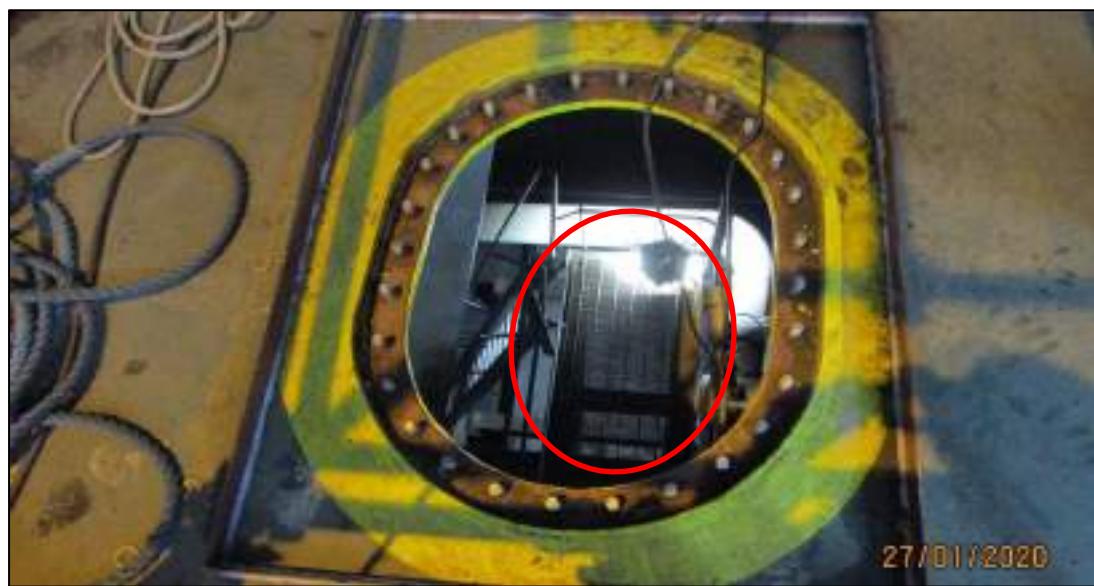
Figure 8: Access to WBT no. 1006 - First level platform with lighting installed marked

The accident happened inside WBT no. 1006, which was classified as an enclosed space. The tank, which was fitted on the vessel's starboard side just aft of the accommodation (with one side forming part of the vessel's outer hull), had a capacity of about 10,500 m³. Access to the WBT was through a manhole on the main deck. On the first platform, lighting had been fitted in preparation for the welding job in the tank, which illuminated the entire upper level of the WBT (Figure 8).

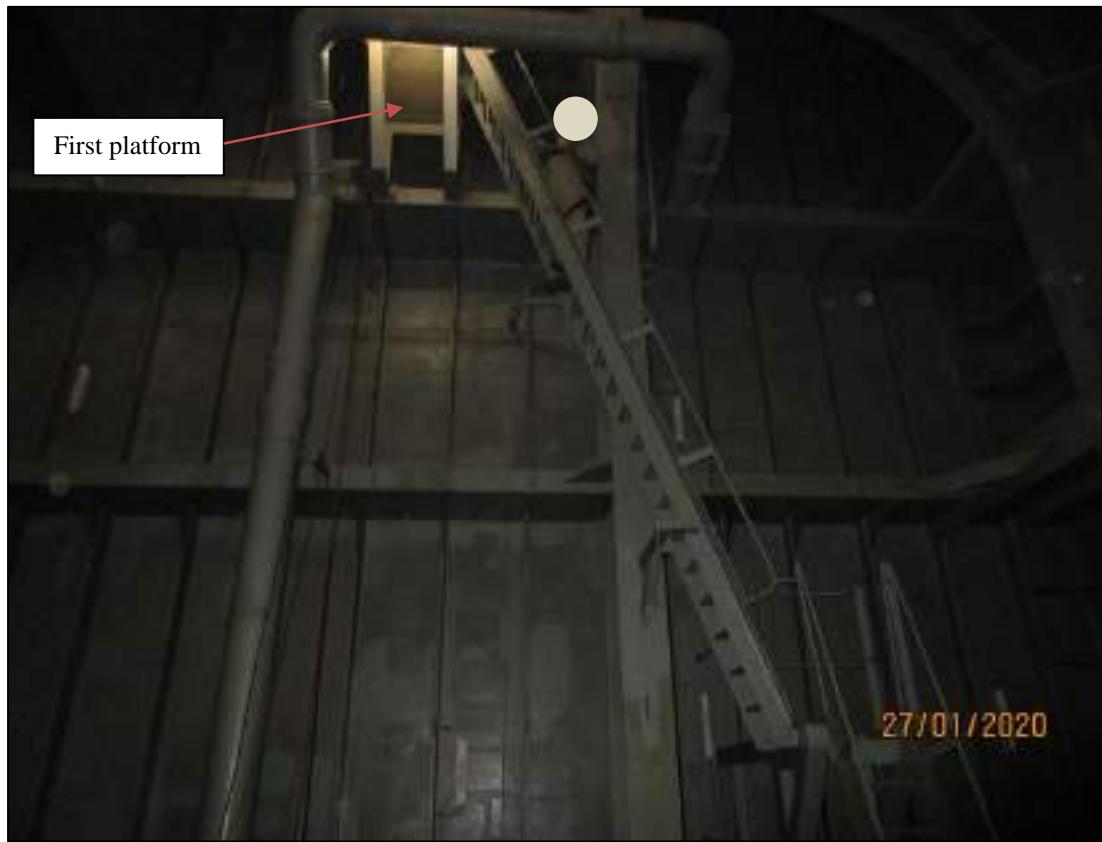
Figure 9: Access ladder inside water WBT no. 1006

Inside the WBT, from the manhole, a vertical ladder led to the first platform, thence an access ladder with relatively steep steps led to the tween deck (Figure 9). The access ladder passed the trunk with approximately one metre of space in between (Figure 10), just before the ladder reached the tween deck. From the bottom of the stairs there was approximately five metres of passageway to an opening in the deck that led to the lower level of the tank (Figure 11), with another access ladder that led all the way to the bottom which was approximately 16 meters below. The five metres of passageway were bounded by a waist high guard rail.

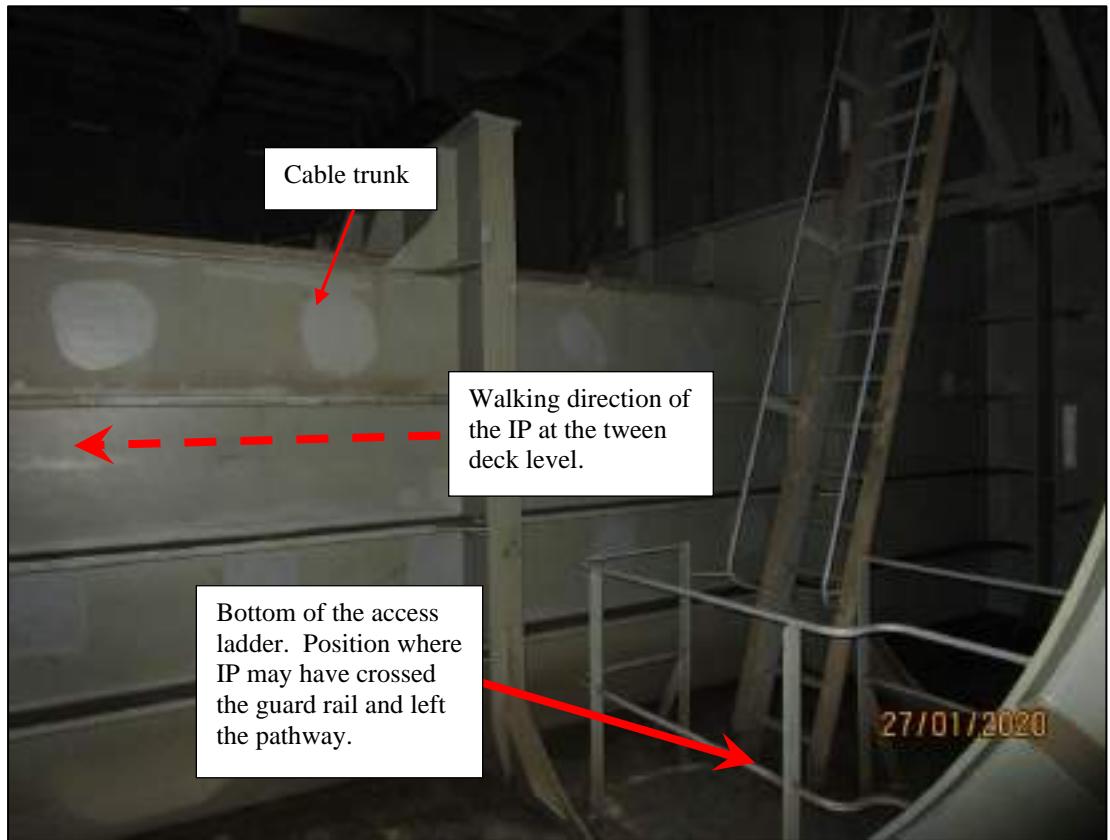
Figure 11: Access ladder ending at the tween deck

The IP deviated from the guided access inside the tank by crossing a guardrail which served as a barrier in between the access ladders and pathway, and the rest of the tank (Figure 11).. The IP fell through the opening in the deck on his way to the work site, landing on the bottom of the tank, a drop of about 16 m (Figure 15). The final location of the IP was slightly offset from the deck opening above, in an aft ward direction. This suggested that the IP was in motion and in the direction of the work site, when he fell through.

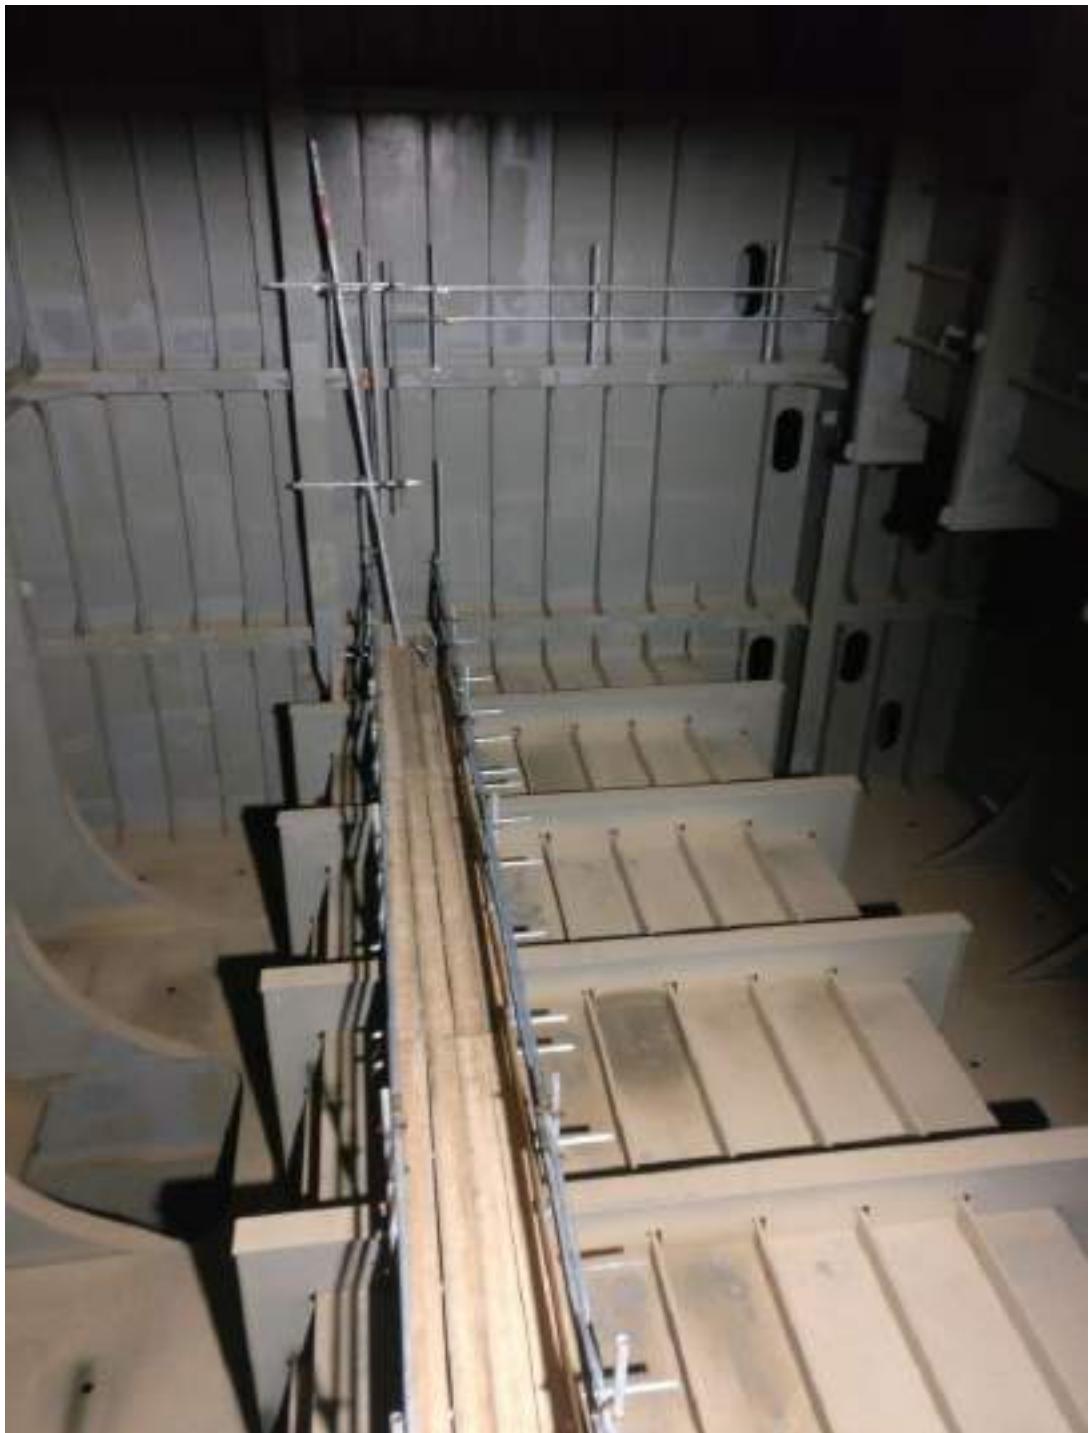
Figure 13: Scaffolding during initial work in tank in October 2018

The previous work done at the work site, was done in Tenerife, during which a scaffolding was set up to provide access to the work site (Figure 13). A scaffolding was not erected for the welding job at the time of the accident, as this was considered to be a small and quick task.
