Report on the investigation of the grounding
and recovery of the container feeder vessel

Thea II

Svitzer Josephine

on 15 December 2018

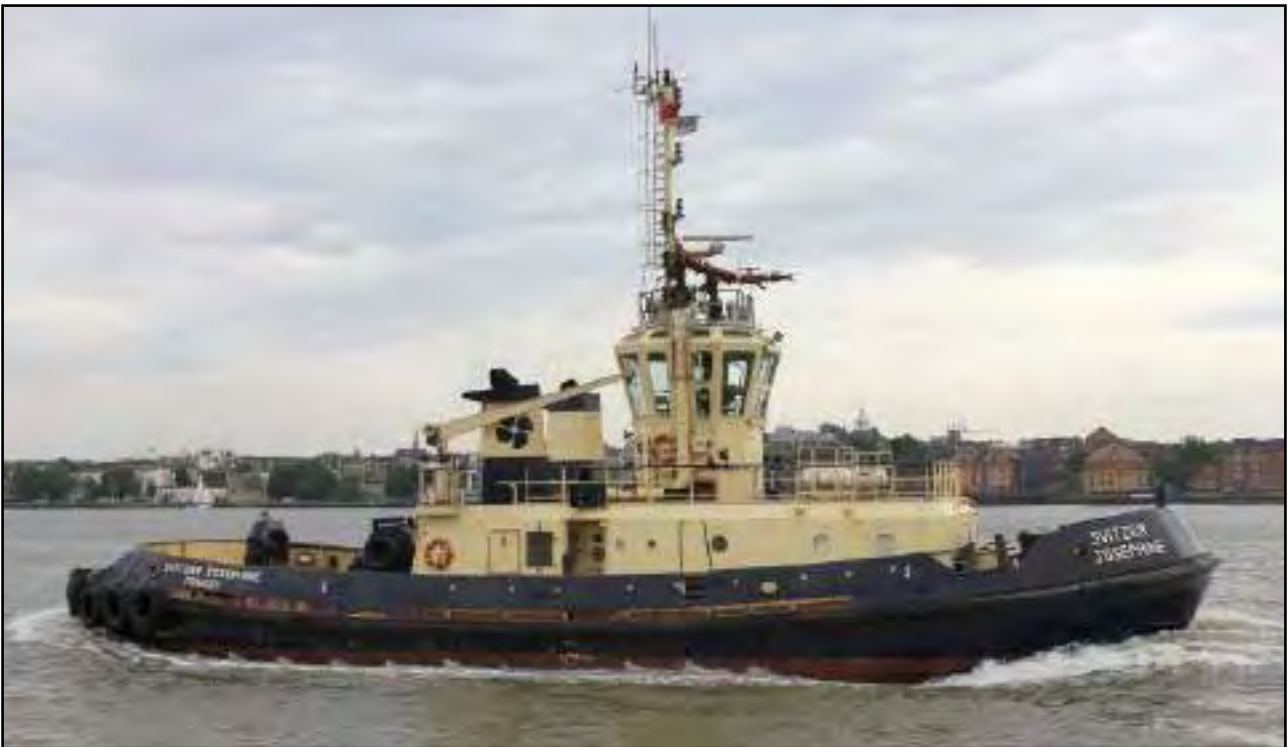
Figure 2: *Svitzer Josephine*

The VTSO then tried to raise the crew of *Svitzer Josephine* (**Figure 2**), Immingham Oil Terminal's (IOT) duty fire tug, on VHF radio, to enquire if they were able to assist *Thea II*. The call went unheard as the tug's bridge was not manned. The VTSO then contacted the IOT duty officer and requested that he activate the duty fire tug alarm. The alarm was heard on board the tug, and *Svitzer Josephine*'s master immediately contacted VTS Humber. The VTSO informed him that the container feeder vessel *Thea II* had broken down, was anchored on the north side of the channel and needed urgent tug assistance. *Svitzer Josephine*'s master agreed to assist. He then asked the VTSO to notify the Svitzer office of their tasking so that they could arrange a replacement fire tug.

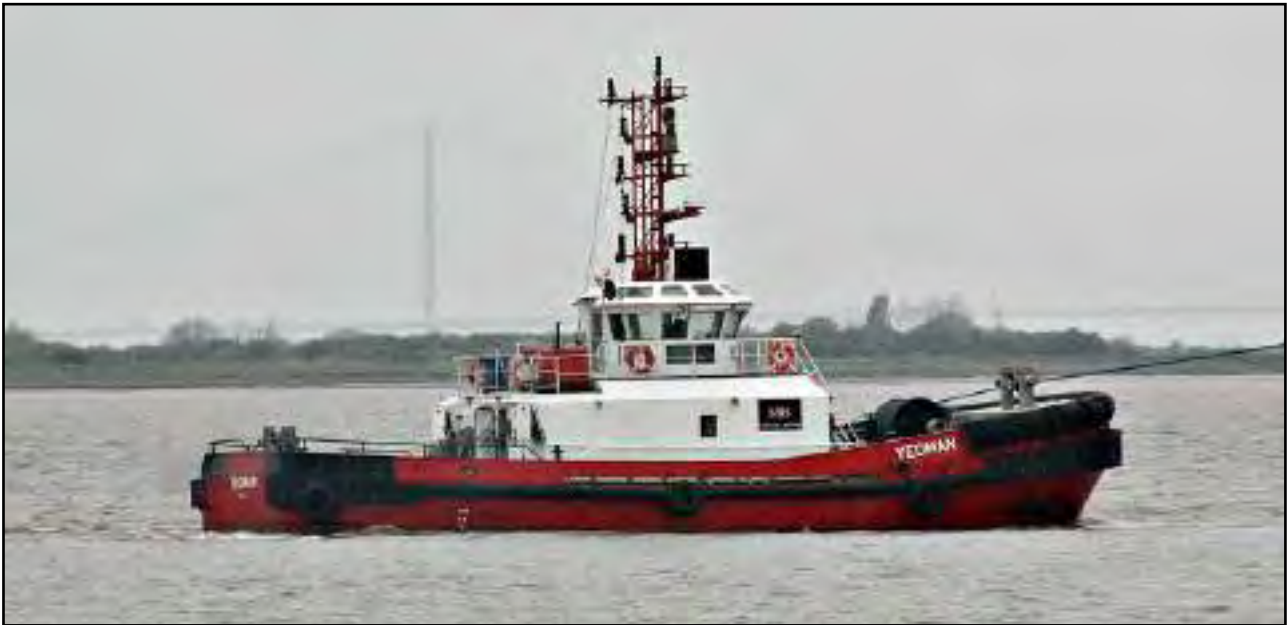
Figure 5: *Yeoman* (Hong Kong class) tug

At 2145, the tugs *Yeoman* and *Irishman* (**Figure 5**) left the main channel to approach *Thea II*. Shortly afterwards, *Yeoman* reported to VTS that the weather conditions were unsuitable to pass towlines.

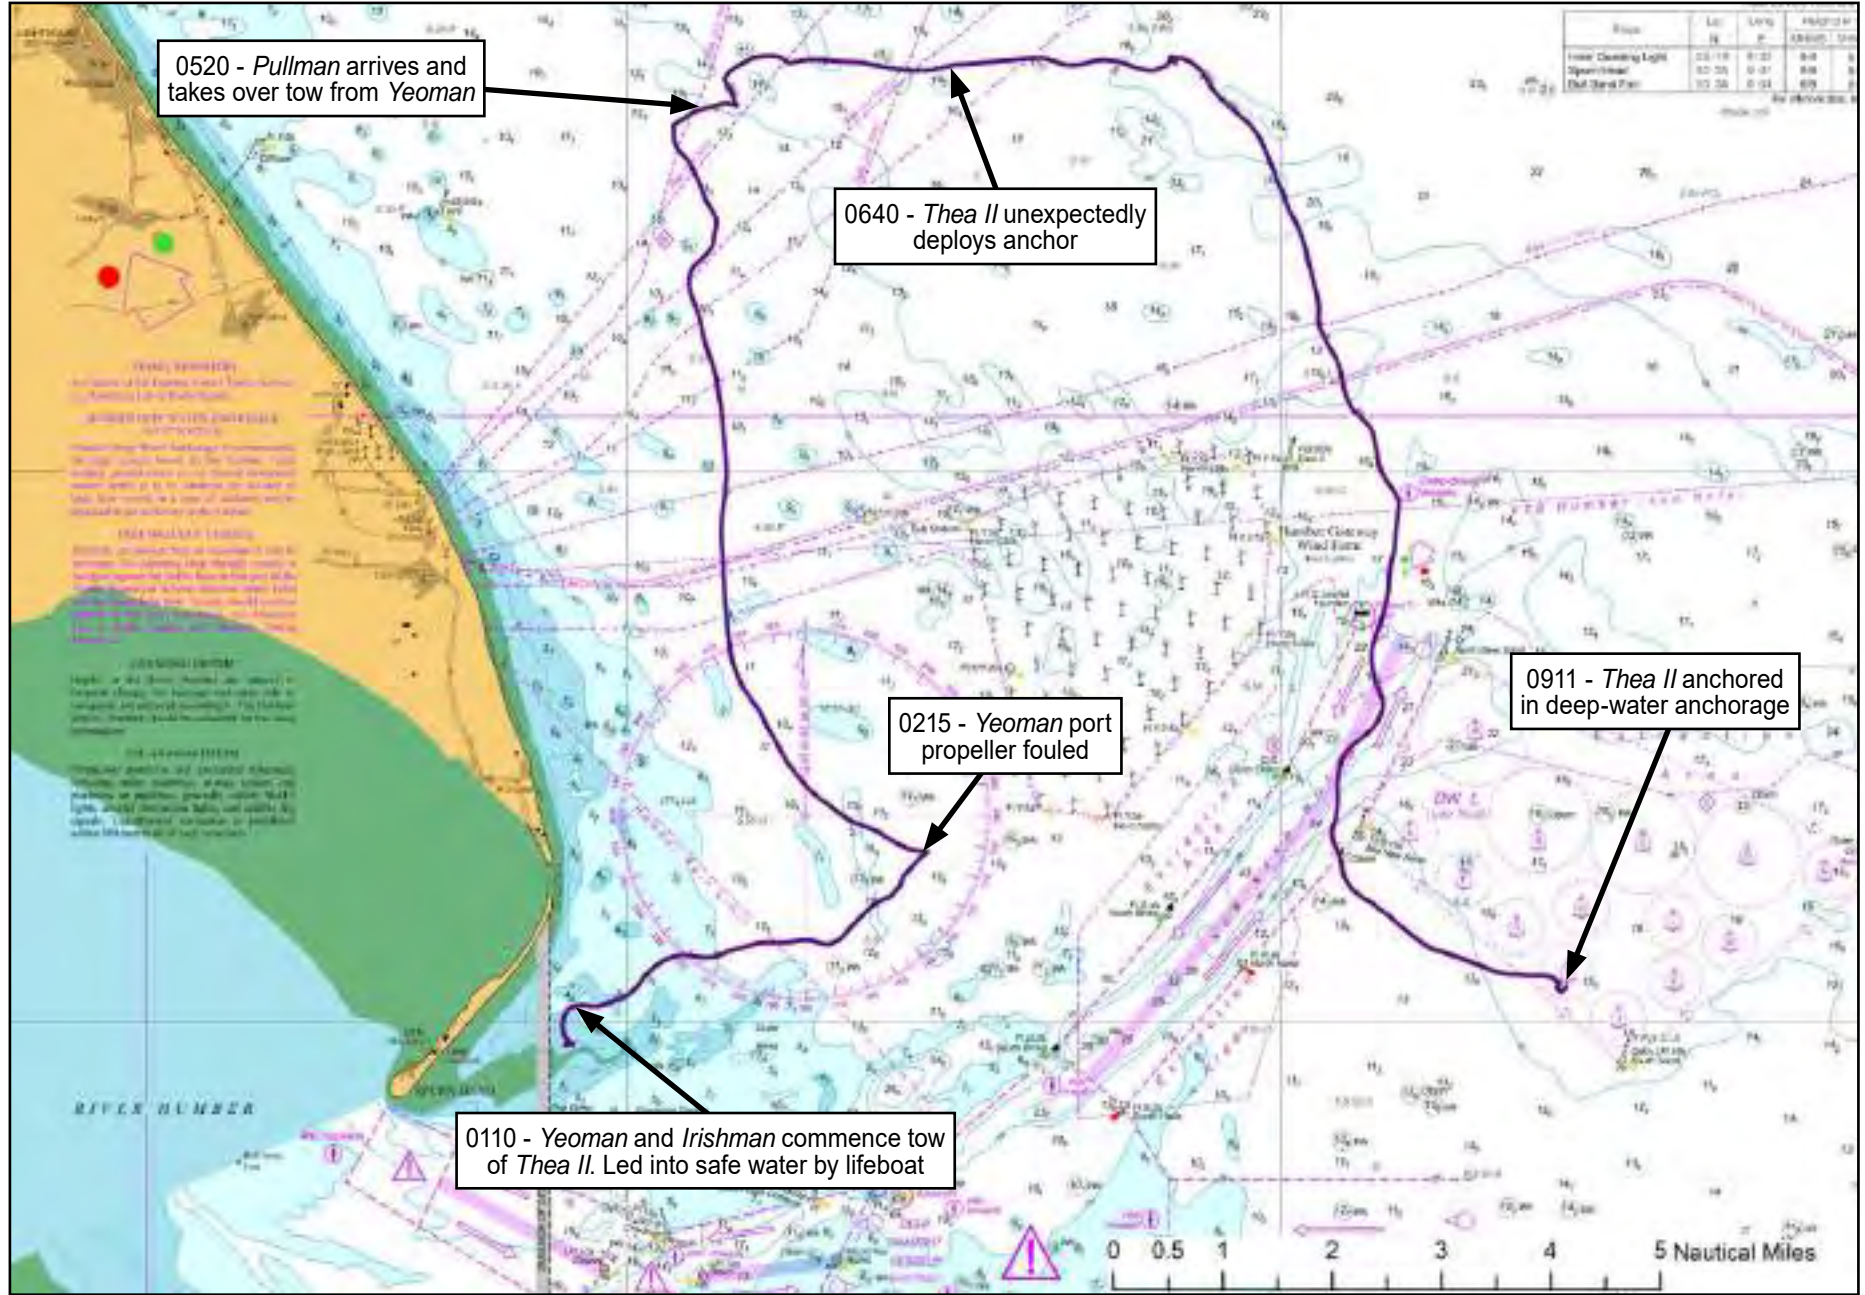
Figure 6: Thea II's passage, under tow, from the Binks shoal to the deep water anchorage

The tugs towed *Thea II* to the north following a passage plan agreed with the harbourmaster (**Figure 6**). This took the vessel down sea, between the mainland and the Humber Gateway windfarm. From there, the plan took *Thea II* east of the windfarm, before taking it south to the port's deep water anchorage. Thereafter, the plan was that *Thea II* would remain at anchor until the weather moderated and the vessel could be safely towed into harbour.

Shortly after 0200 the forward tug, *Yeoman*, unexpectedly lost the use of its starboard azimuth unit. This was quickly followed by the failure of its port azimuth unit at 0215. The remaining tug, *Irishman*, was able to control the tow as the three vessels ran down sea at slow speed. VTS Humber was informed and SMS Towage

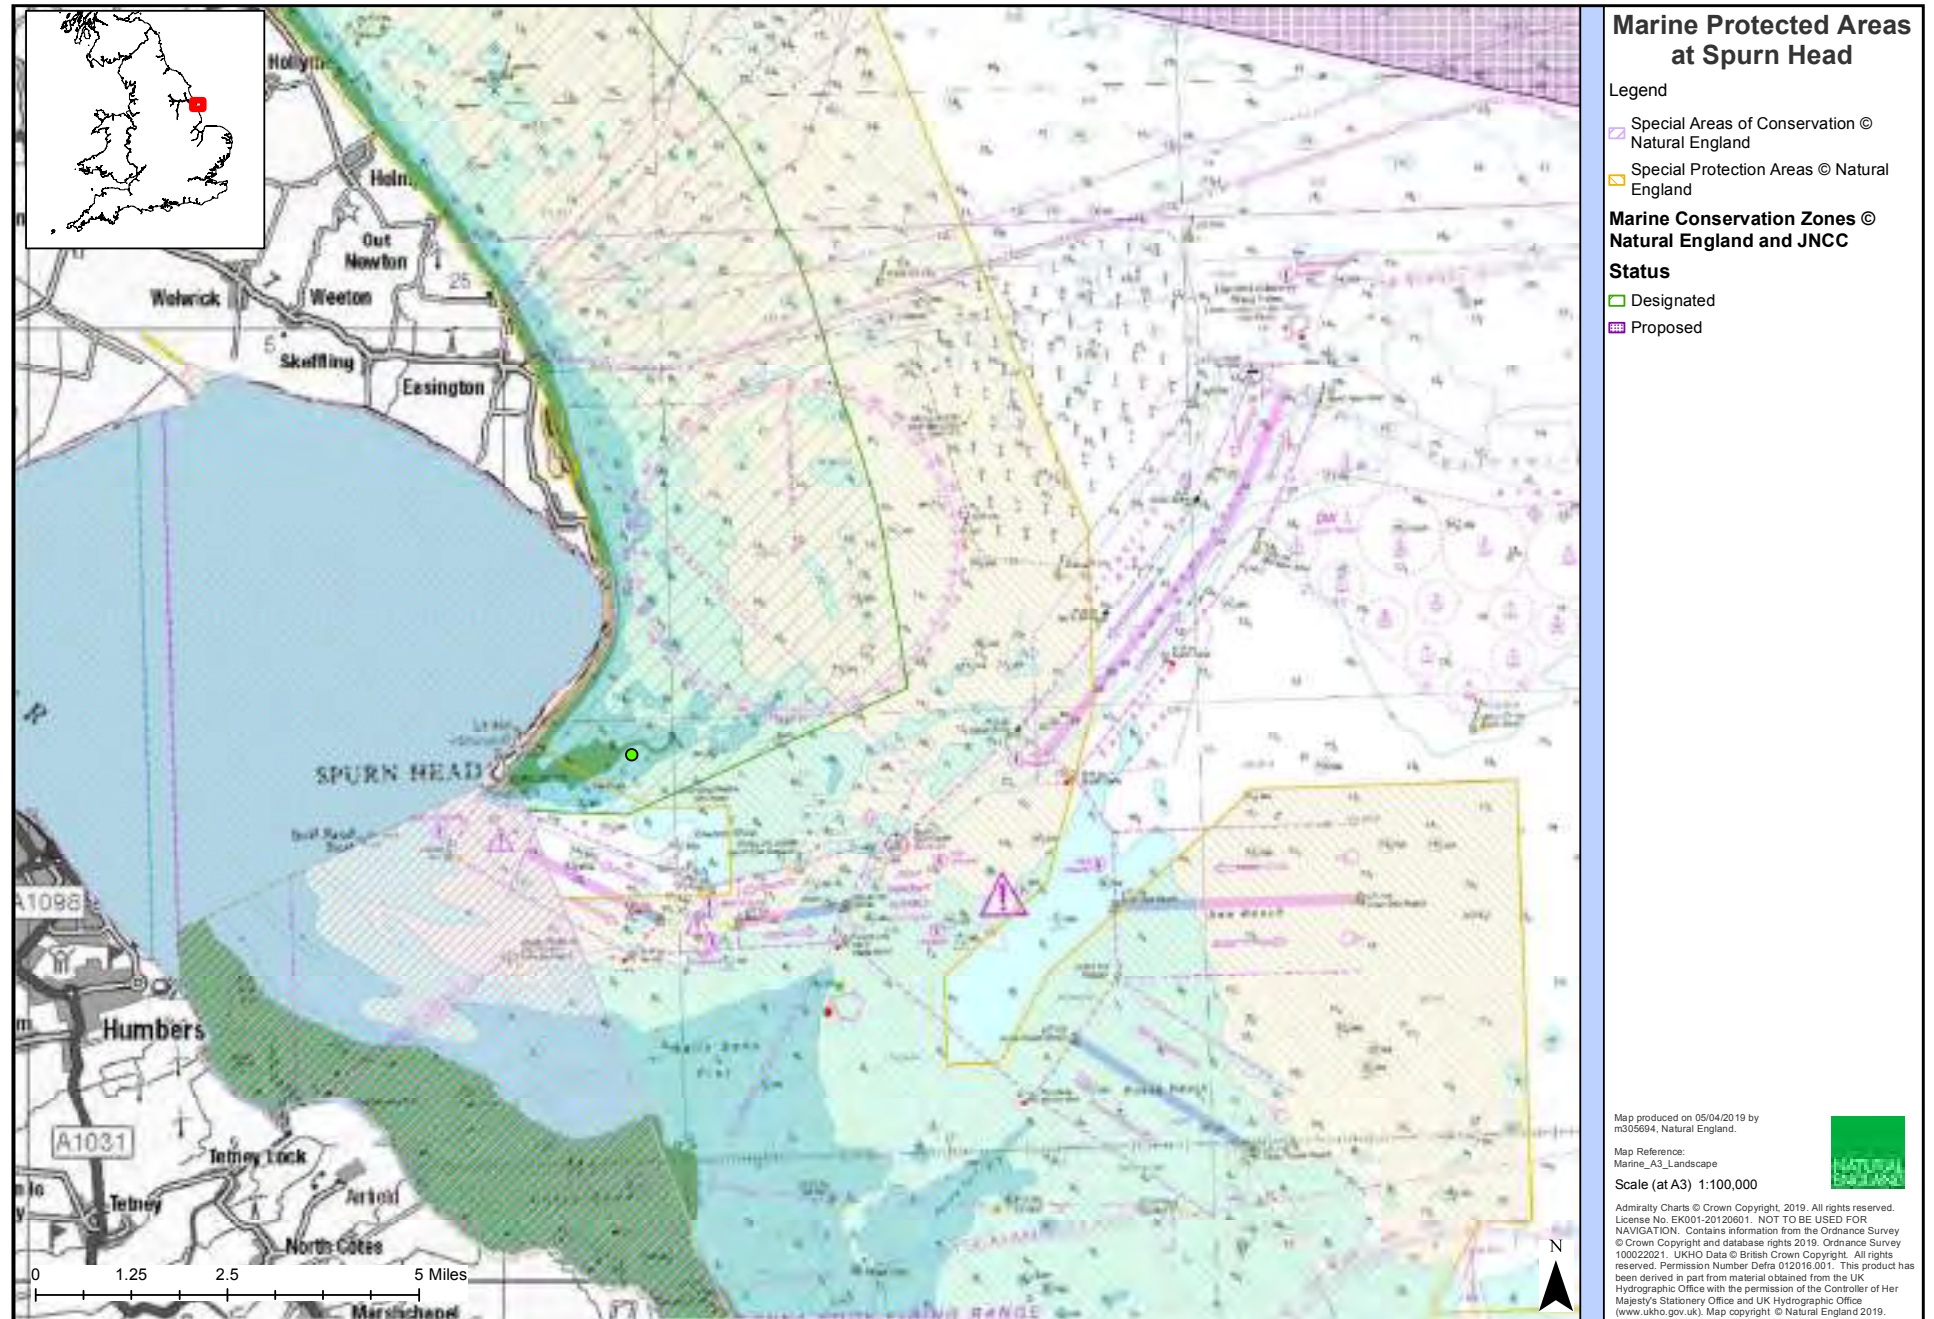
Figure 10: Marine protected areas at Spurn Head

The Humber port area contained several environmentally sensitive sites. *Thea II* and *Svitzer Josephine* grounded in a Marine Conservation Zone³ and Special Protection Area⁴, which were adjacent to a Special Area of Conservation and Ramsar site⁵ (**Figure 10**).

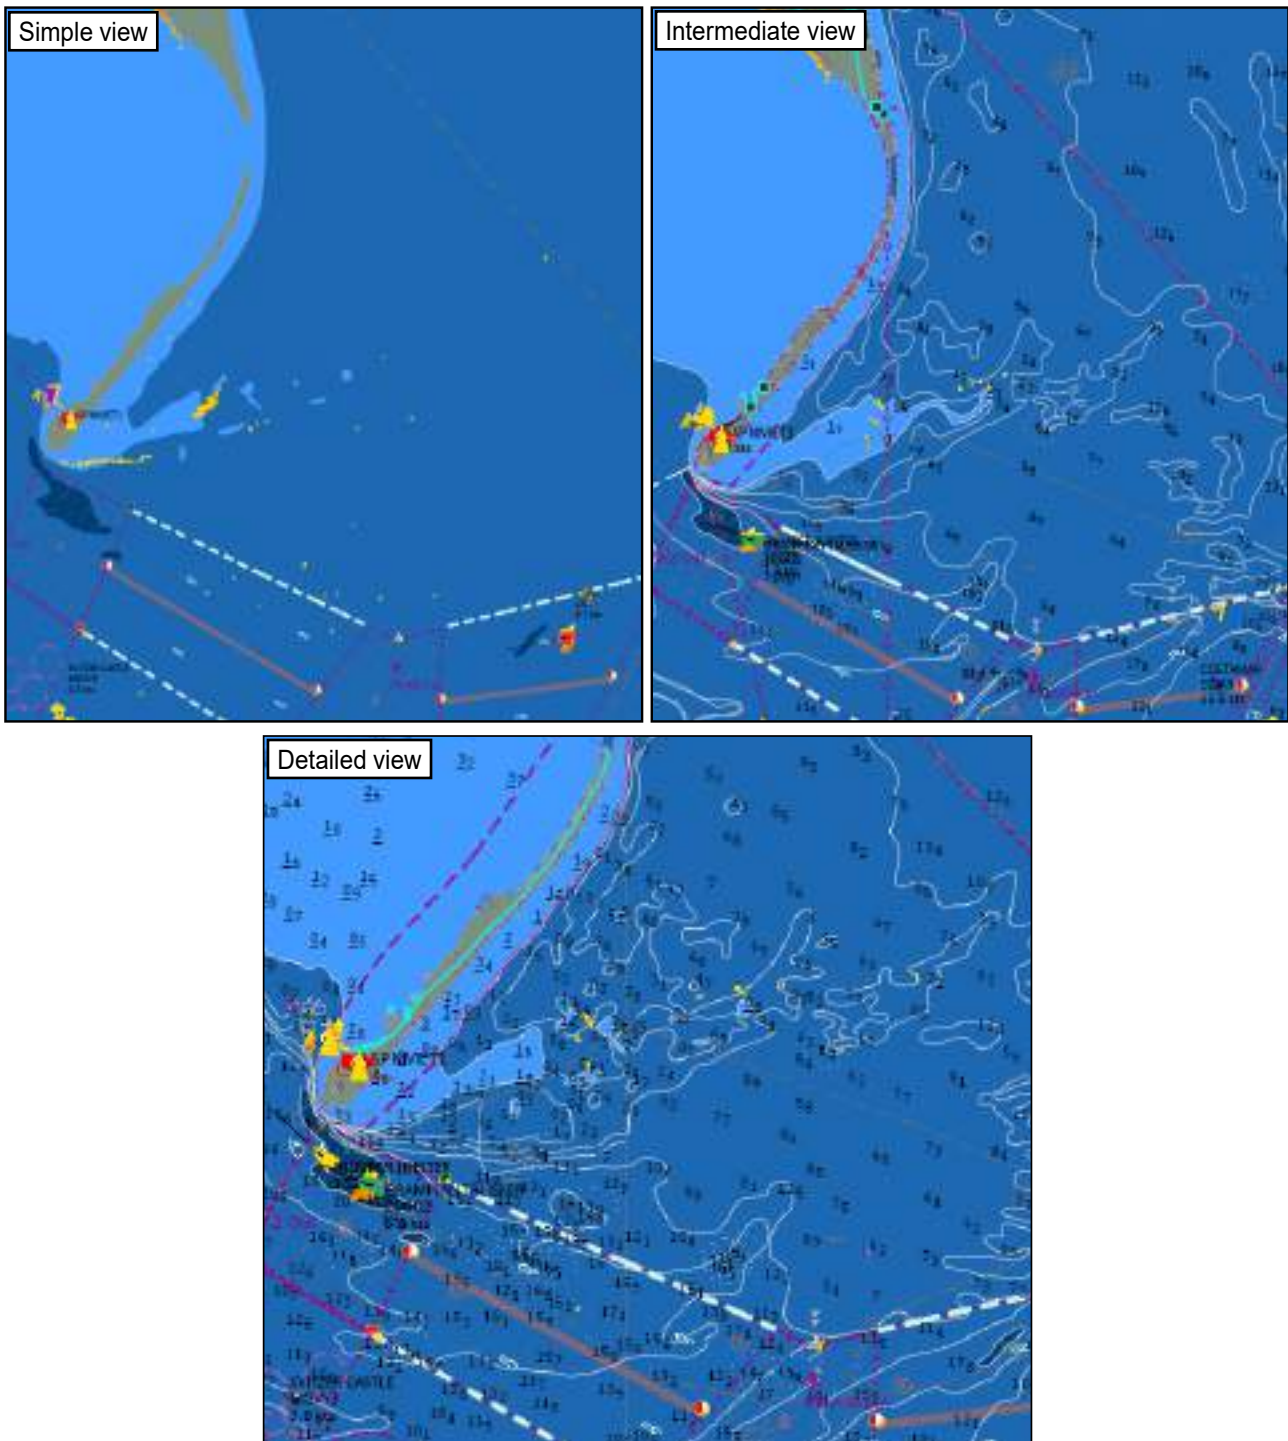
Figure 11: VTS display showing up to date S57 chart data

Charts for the VTS area were available in both electronic and paper form. The electronic chart data could be displayed on the VTSO's computer system in simple, intermediate and detailed views (**Figure 11**). In most cases operators configured their display to use the uncluttered, simple view, so that they could monitor vessel traffic without distraction.

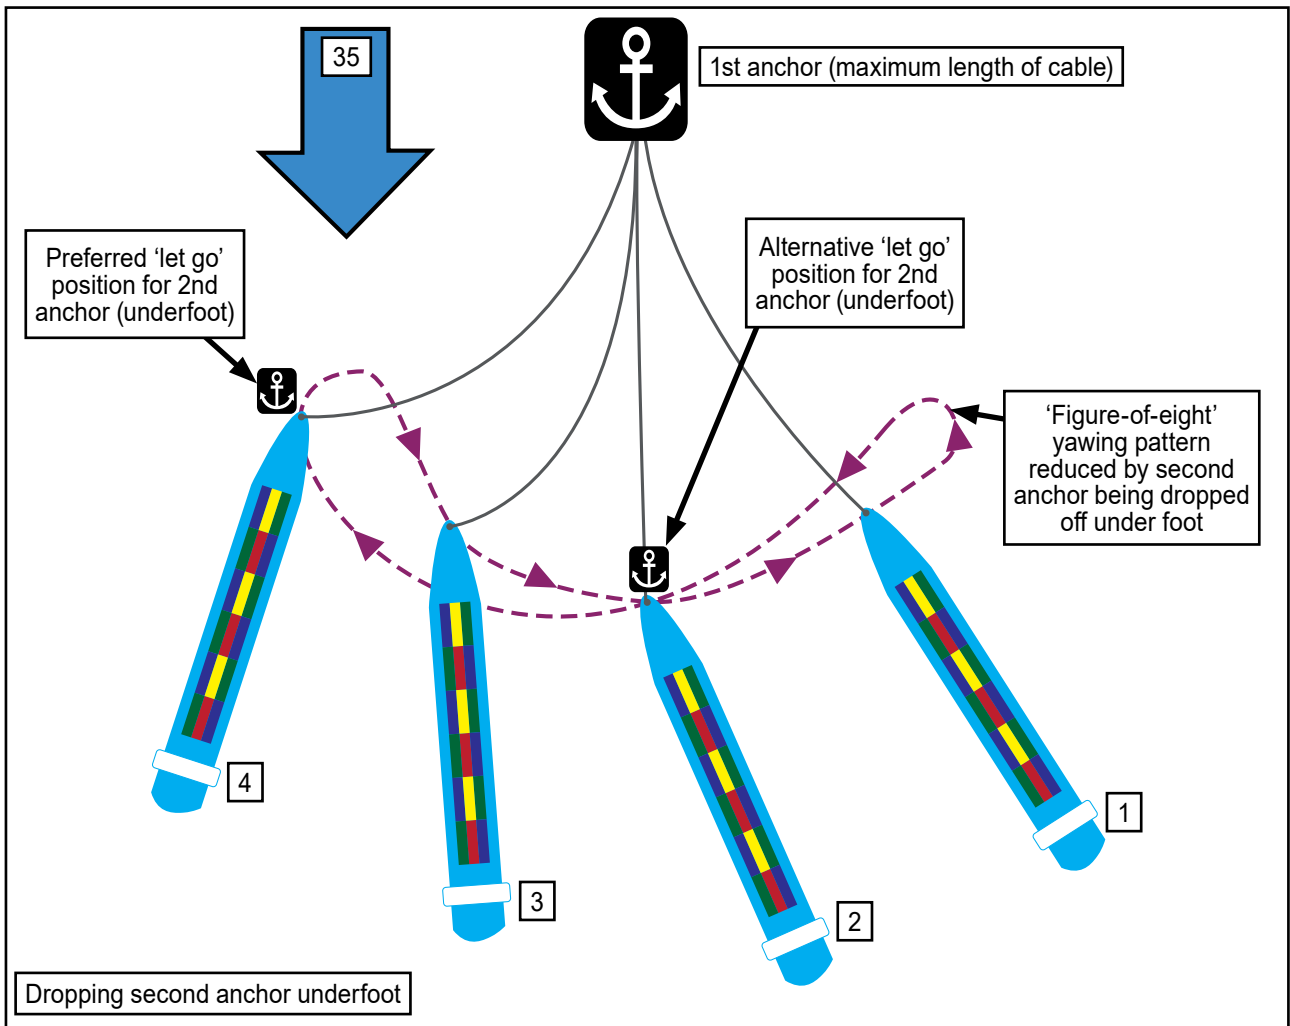
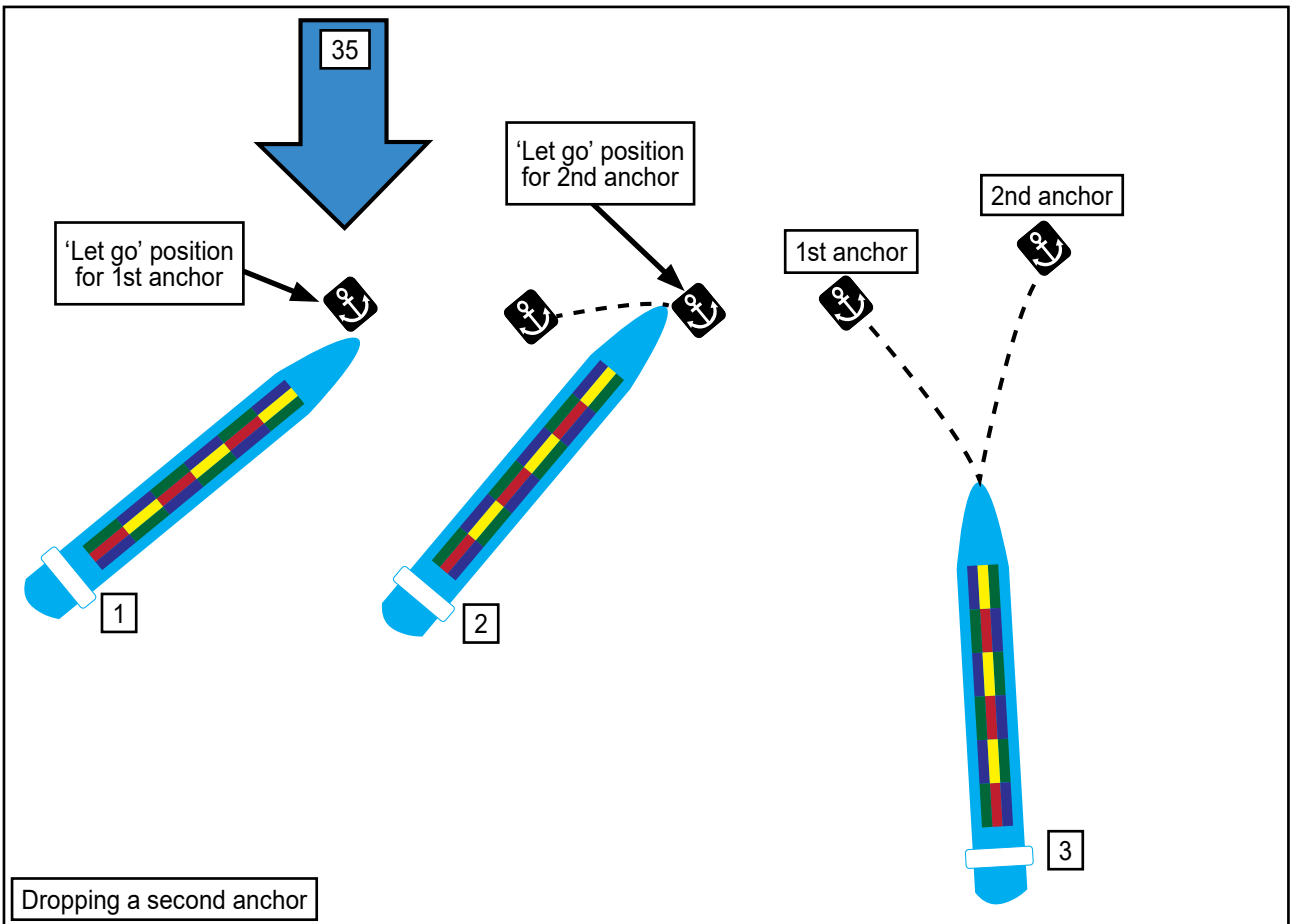
Figure 13: Use of the second anchor

A method to reduce the likelihood of dragging anchor in bad weather is to deploy a second anchor (**Figure 13**)⁶, by either:
