Report on the investigation of the  
failure of the controllable pitch propeller of the cargo ship

***Saffier***

resulting in heavy contact with a berthed tug

25 June 2011

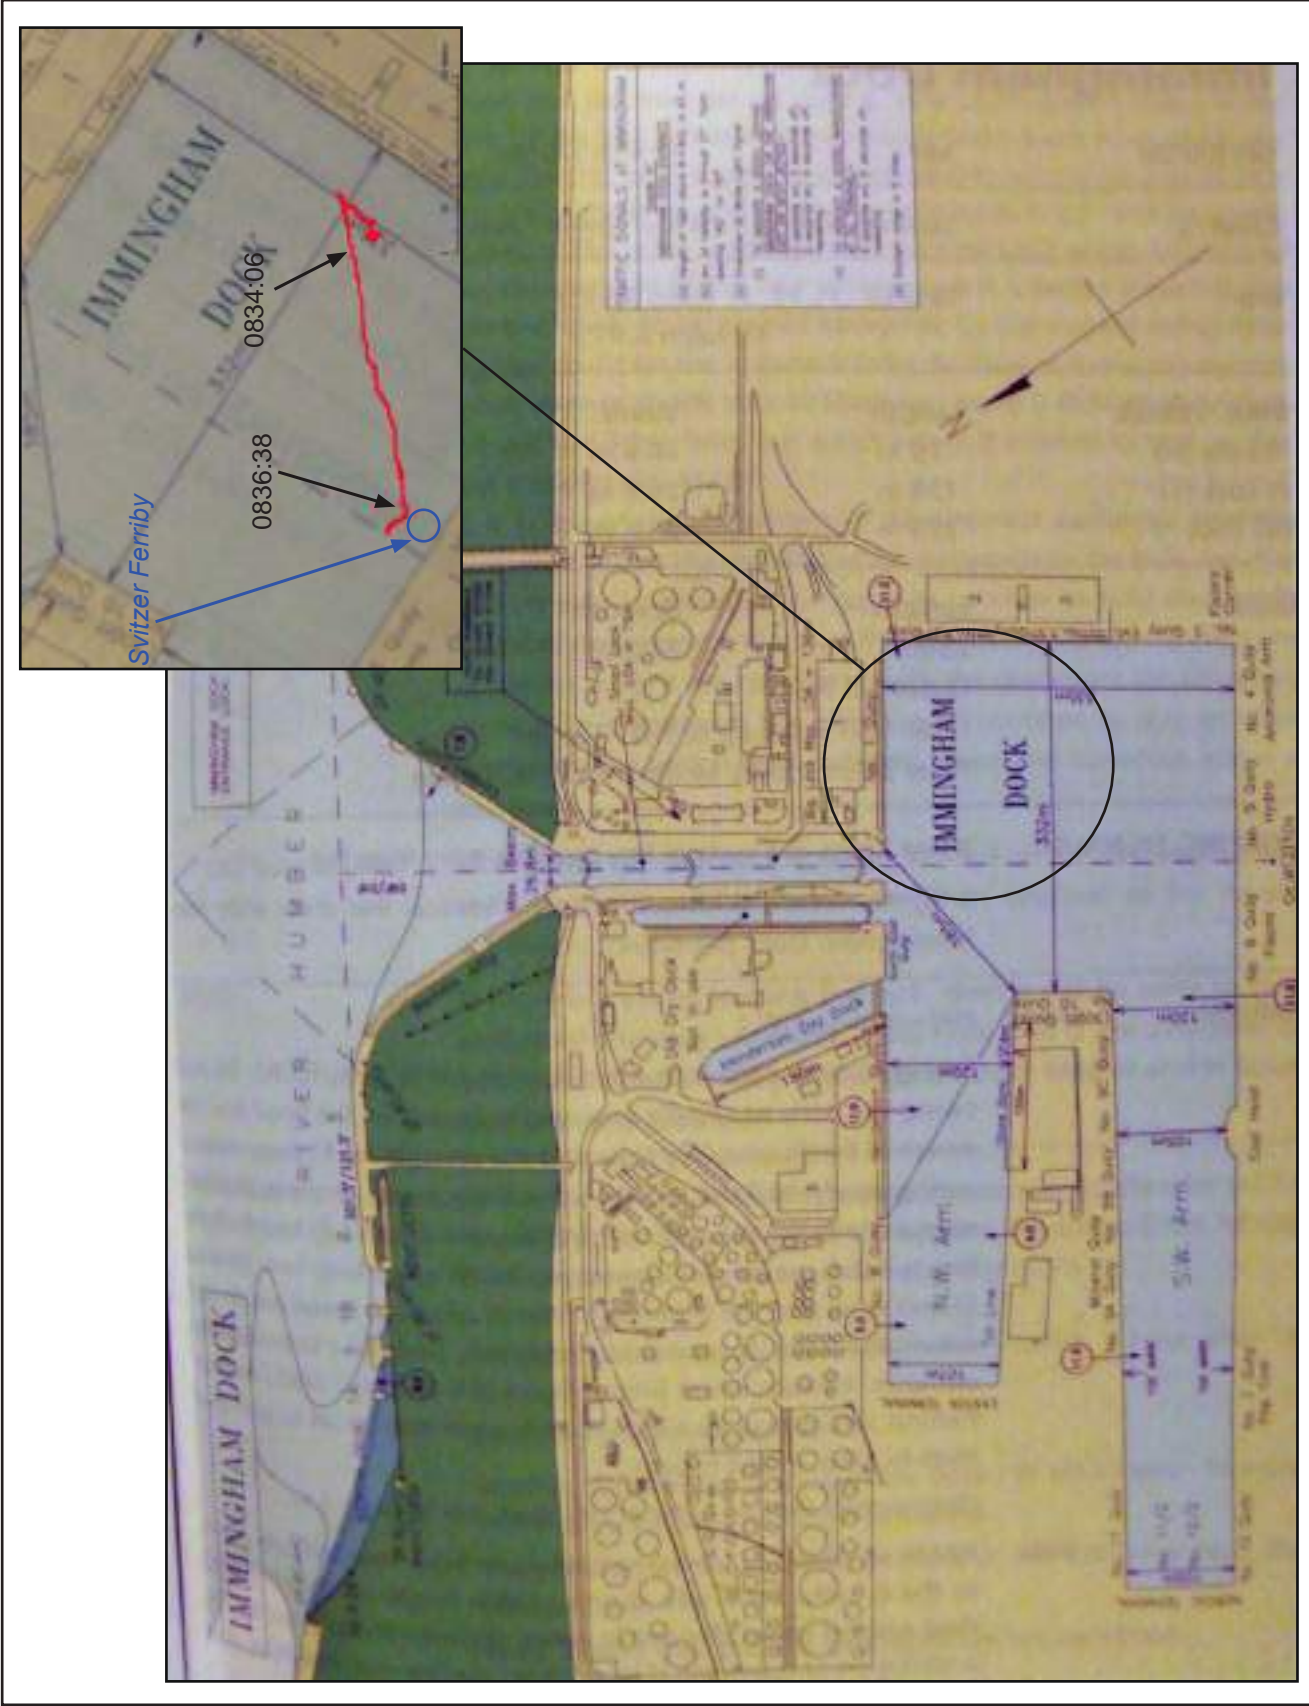
**Figure 1:** Immingham harbour (Inset: movement of Saffier during the incident)

At 0726, prior to *Saffier* entering the harbour lock gate, the master took the conn of the vessel from the pilot, and by 0832 he started the final approaches to berth starboard side alongside at quay 3 (**Figure 1**). The master of the tug *Valiant*, which was secured at the far end of quay 2, offered his tug to assist in berthing, but *Saffier*'s master declined. A forward spring line was secured on the quay and the vessel approached the berth at an angle of approximately 45° with a speed of 0.7 knot.

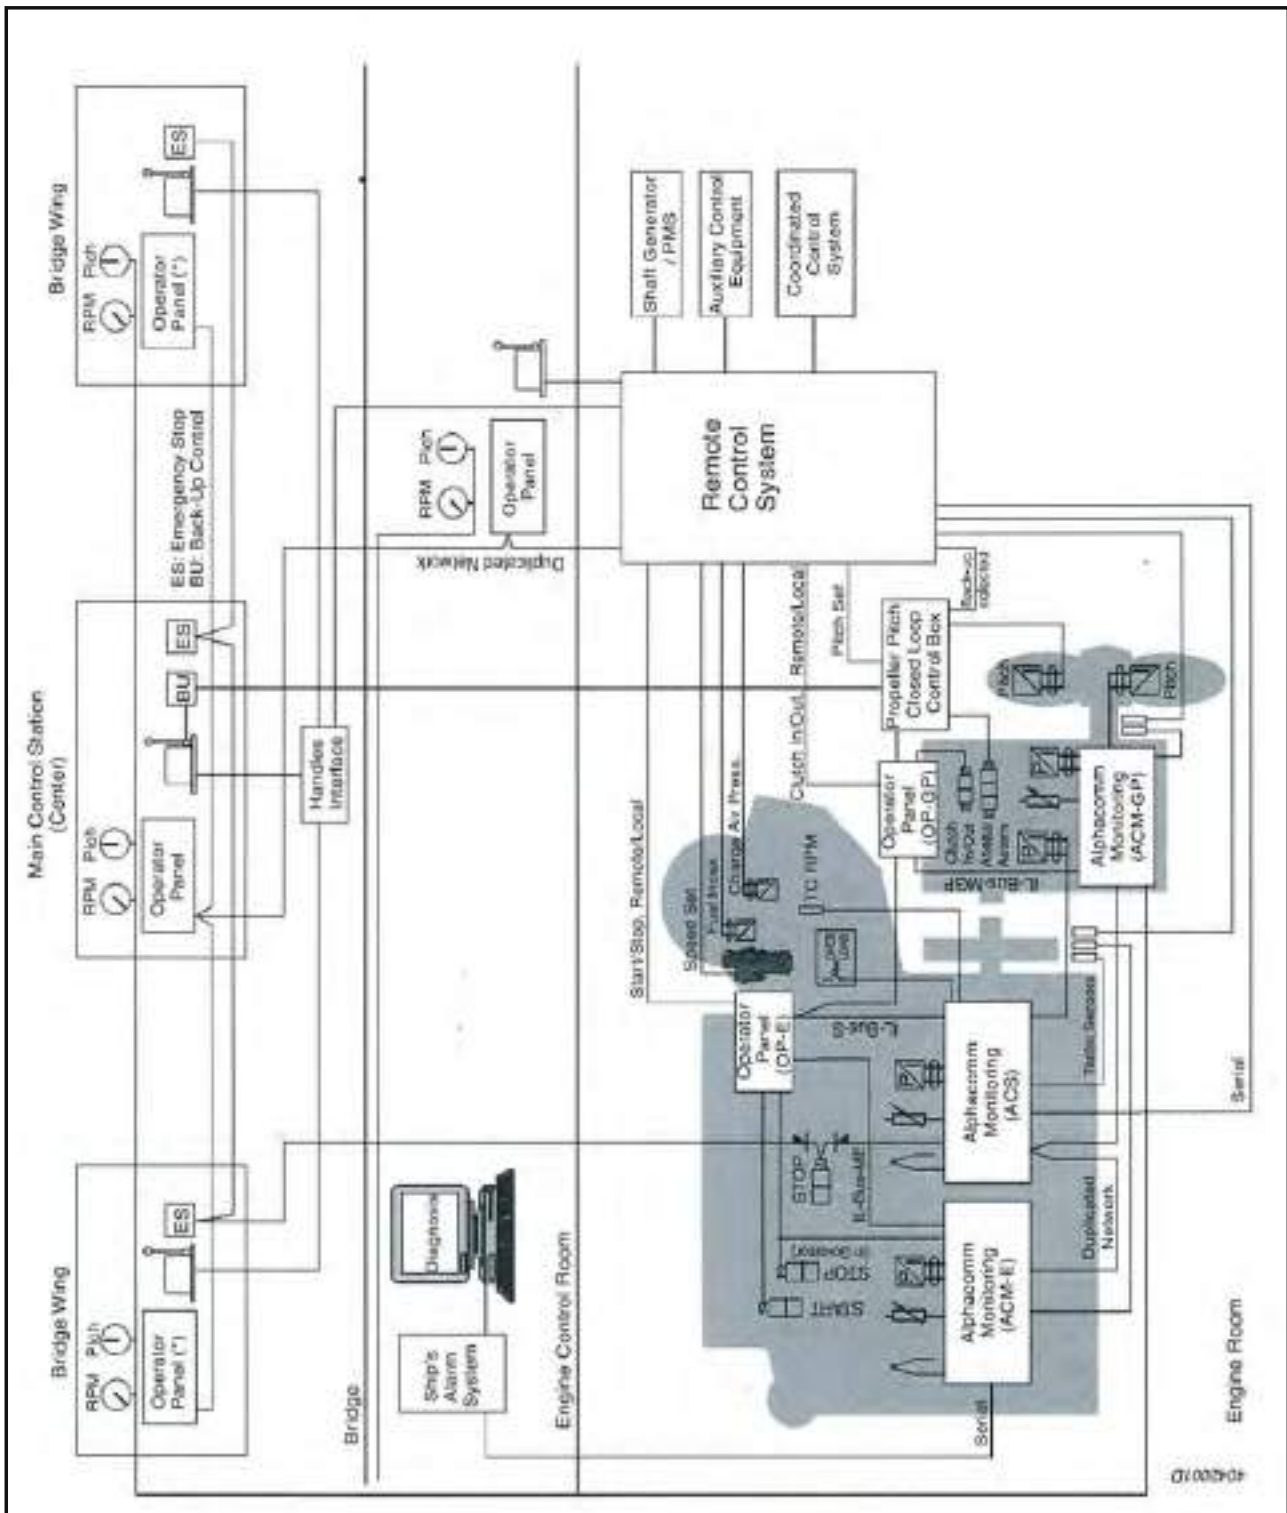
Figure 5: Propulsion control and monitoring system

The ship's propulsion equipment was controlled by MAN's Alphatronic 2000 propulsion control system (AT2000 PCS) (**Figure 5**). It was integrated through a network with systems for engine safety (ACS), engine monitoring (ACM-E), and gearbox and propeller monitoring (ACM-GP). The AT2000 PCS was capable of several functions including: starting and stopping the main engine; operating the propulsion system in three different modes (combinator<sup>2</sup>, constant speed and independent control); main engine load control; transfer of control between engine

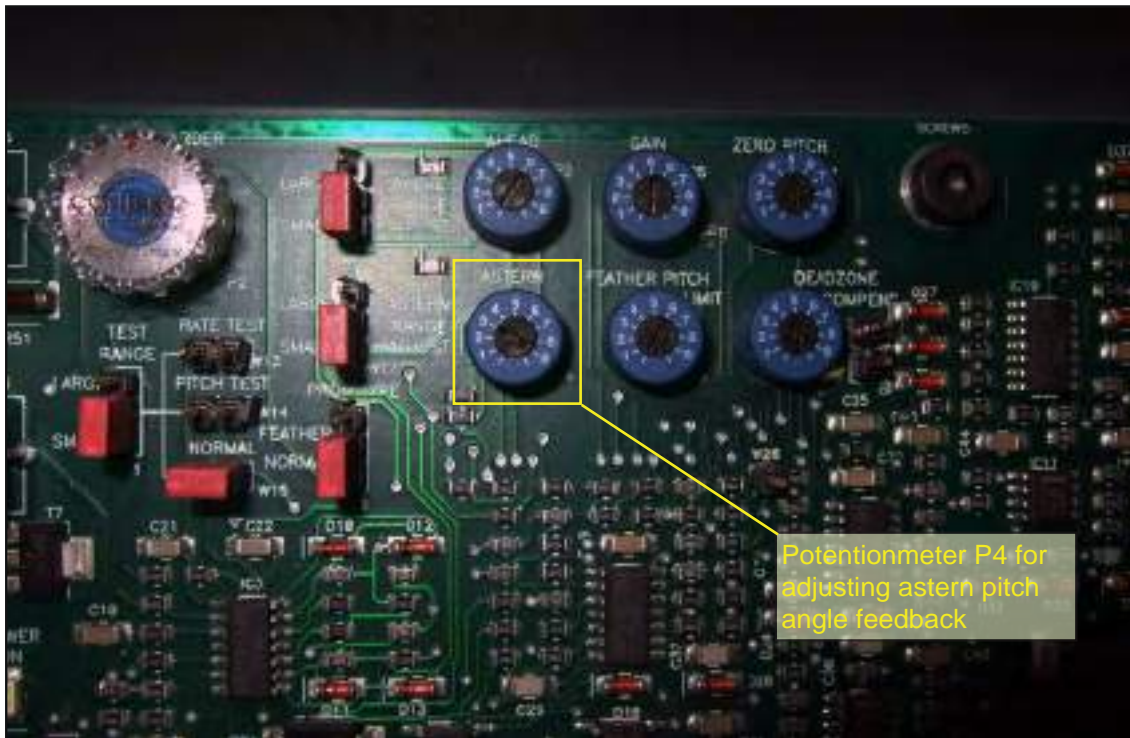
**Figure 6:** Closed loop control system ASP12

The pitch control levers at both the central control console and portable console were connected to potentiometers, which communicated the amount of pitch required by the operator to the AT2000 PCS. A pitch demand signal, of between 4 and 20mA, was generated and fed into the ASP12 unit (**Figure 6**), which then compared the demand and feedback position signals. The feedback signal represented the actual pitch of the propeller blades and was received from one of two position feedback transmitters.

The closed loop control system (the ASP12 unit) was located next to the engine gearcase. It compared the pitch demand signal from the AT2000 PCS with the feedback from the pitch position indicating transmitter. The ASP12 unit contained six potentiometers, P3 to P8 (**Figure 6**), which could be used to calibrate the pitch servo response to the demand and feedback signals. At the time of the accident, the potentiometers on *Saffier* were set to the following values:

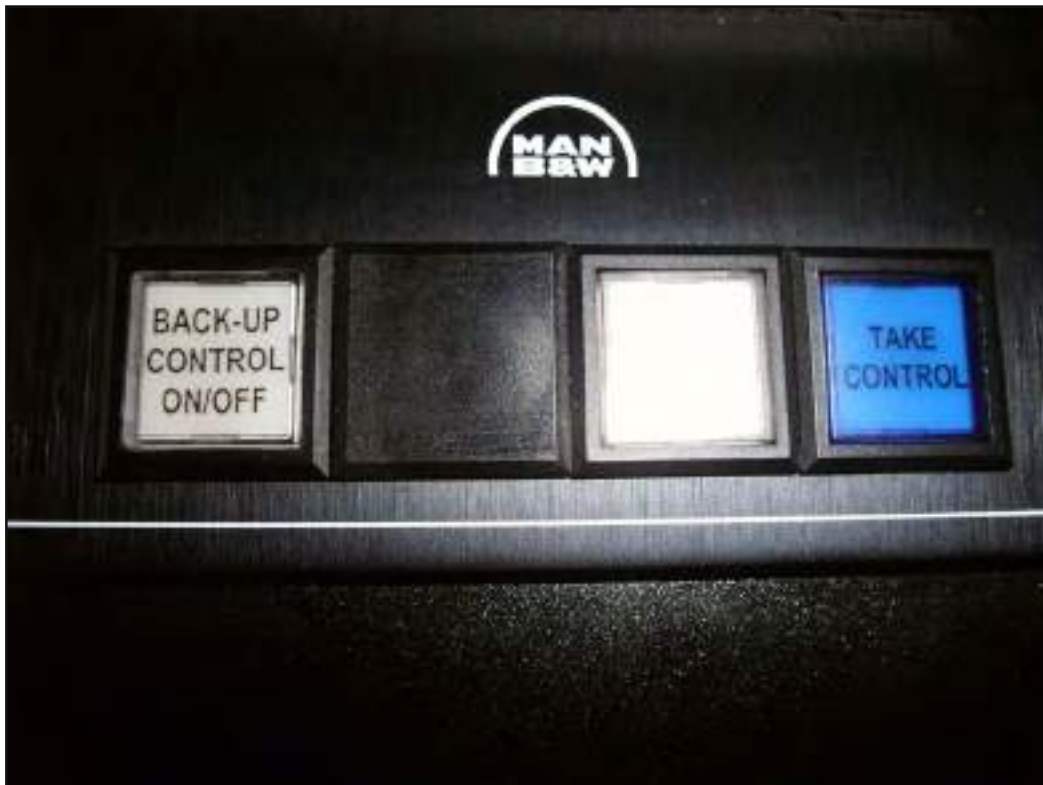
**Figure 7:** Backup control to bypass the AT2000 PCS

It was possible to bypass the AT2000 PCS by pressing a button labelled 'BACK UP CONTROL' (**Figure 7**) at the central control station on the bridge. When backup control was in use, a second potentiometer, also connected to the pitch control lever, was used to control the pitch. The signal was fed directly into the ASP12 unit, bypassing the AT2000 PCS, to control the pitch.

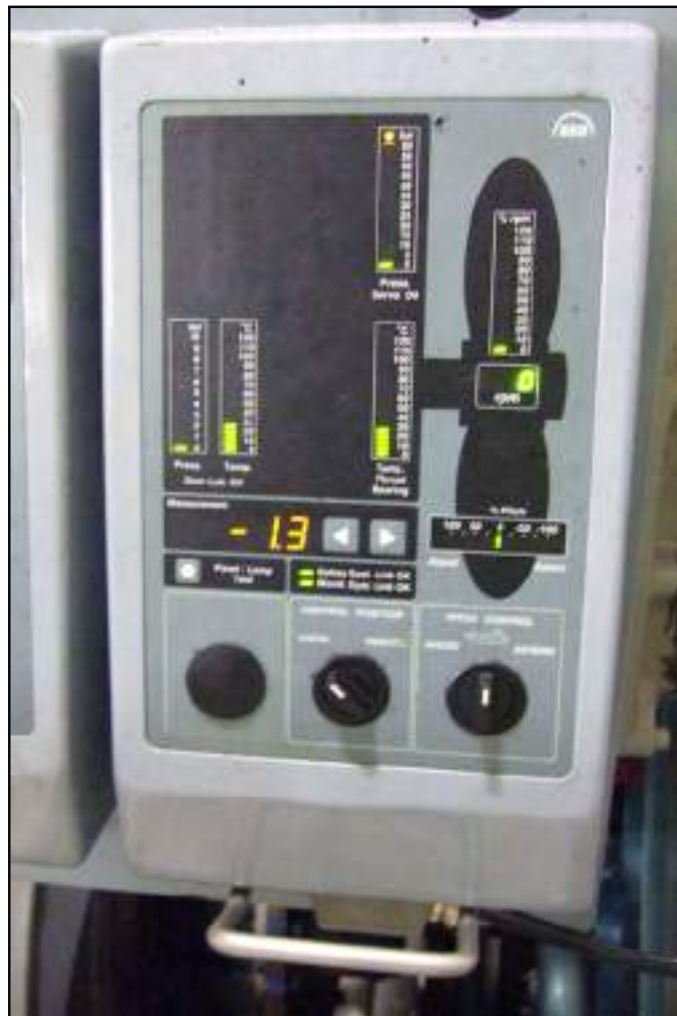
**Figure 8:** Local control for main propulsion system

- setting a switch to the local control position and activating an ahead or astern switch which controlled the solenoid valves directly (**Figure 8**)
- activating the solenoid valves (**Figure 9**) directly using finger pressure.
