Annual Digest
Reports and Insight Articles

2020

Annual Digest of Reports and Insight Articles 2020

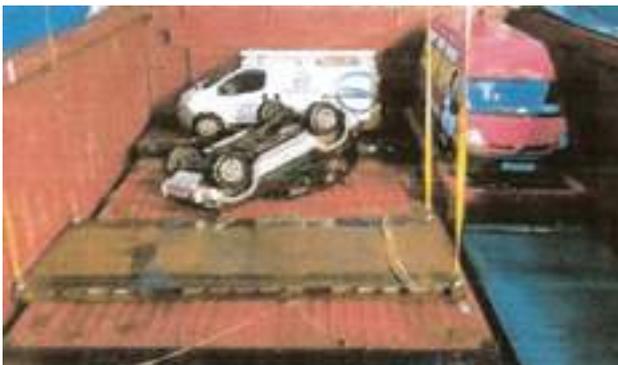
The 4x4 after the incident

The 4x4 vehicle concerned had been placed on the flat and secured using tensioned webbing straps and a standard lifting plan was then used by the stevedores and crane operator. There are normally three lifting options for such a flat bed and light vehicle combination using the shore crane and spreader bar arrangement, these involved a combination of open or safety hooks and chains, side lifting lugs or top lifting lugs with webbing slings.

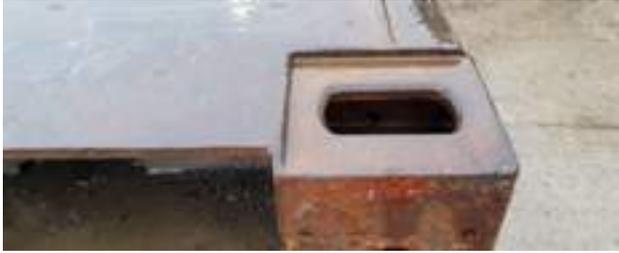
At ≈20mm the top plate thickness was 8mm thinner than more modern "flats" and the current industry standard, ≈28mm

Chamfer on the lifting socket can be clearly seen.

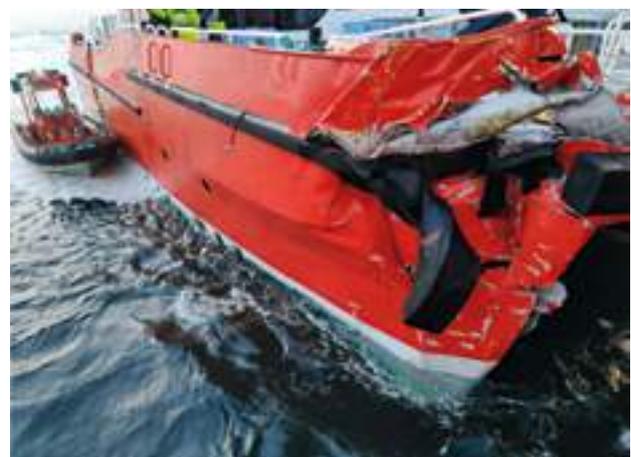
The vessel involved was a service vessel engaged in transferring personnel between a shore base and wind turbines in offshore locations. The only other details initially available were that the hull had been breached at the bow and suffered water ingress, and that three persons on board sustained injury during the allision. The damaged vessel had then been escorted to port by an offshore lifeboat.

The Consequence of distraction.

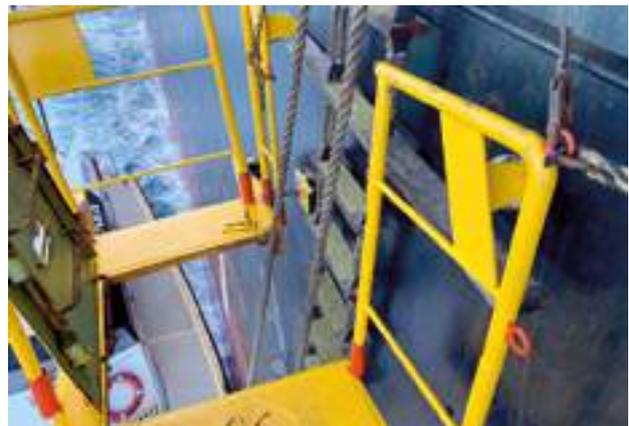
Example of a compliant combination PBA with trap door.

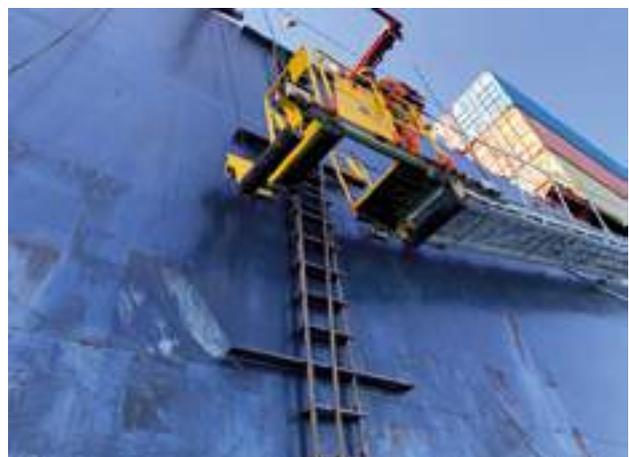
Compliant combination PBA with trap door – pilot ladder and man ropes extend up to and are made fast on vessel's deck

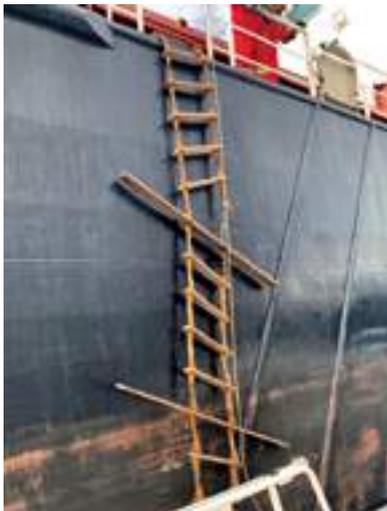
Parted ladder

While boarding the vessel at the pilot exchange station, one of the side ropes snapped. No other pilot ladders were available.

The vessel did not have a suitable replacement ladder.

In addition, the information about the incident was made available to all company vessels and crew. The company was not satisfied with using manila ropes in pilot ladders due to the quality of rope available and weaknesses being difficult to spot. They had started a replacement programme using better quality rope.

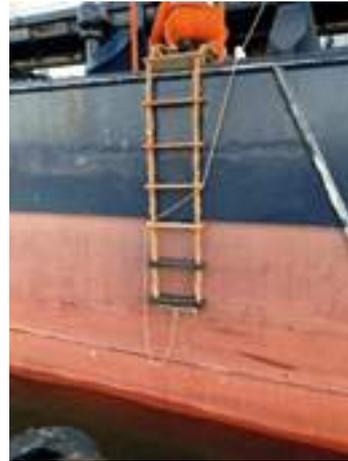
2 metres of ladder with at least 4 non-compliances.

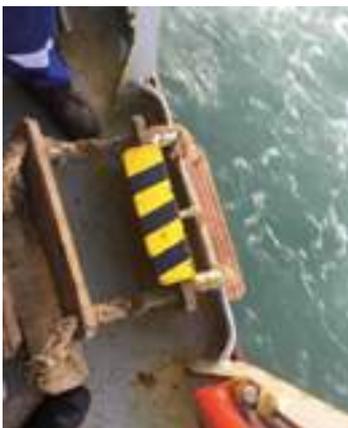
Swell, swinging of the ship or the launch lifting the ladder can also have the dangerous result that the ladder comes loose out of this deck tongue and goes overboard.

Here we see the deck tongue in use holding the ladder, or to put it better, holding one step. Besides all this, the ladder seems rather old and worn. Let's have a look at the regulations to explain why this setup is dangerous.

Deck tongue supporting the ladder.

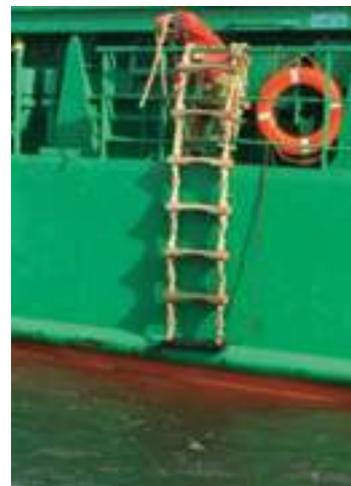
Notorious offender with bulwark setup. It's not even a pilot ladder (at least 6 non compliances).

IMO A.1045(27) states: The side ropes of the pilot ladder should consist of two uncovered ropes not less than 18mm in diameter on each side and should be continuous, with no joints and have a breaking strength of 24 Kilo Newtons per side rope (2.2.1).

We have already seen that the ropes of the ladder can handle almost 5 tonnes on each side, just a question for the reader: are you sure the railing can handle 5 tonnes? We have all seen beaten up and damaged railings in our career, who of you hasn't stepped on a railing piece of steel, and it gave way? We'll never be able to find out who spotwelded the railing in a far away shipyard many years ago. For sure a railing can't handle 2 times 5 tonnes.

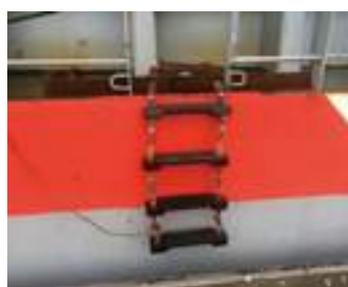
A spreader used for securing the ladder behind a very thin piece of railing.

A spreader is a great invention to prevent a pilot ladder from twisting. Without a spreader you might look at the horizon instead of the ship's side all of a sudden. How would you get back in a safe position if something like that happened? Therefore, every ladder with more than 5 steps must have a spreader (IMO A.1045(27) – Rule 2.1.4).

That is what a spreader is made for and not for keeping a ladder secured to strongpoints on deck. As we know from an earlier statement in the article, steps can handle 880kilos and sideropes 2400 kilos each. That is the main reason you must not secure it this way. One touch of the pilot boat and the ladder will be damaged beyond repair, as will be the poor soul standing on the ladder.

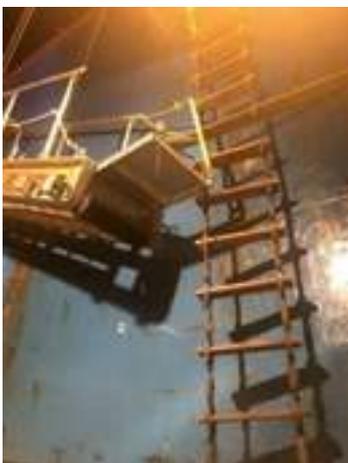
A non-compliant combination arrangement.

SOLAS V.23 clearly states (3.3.1): a pilot ladder requiring a climb of not less than 1.5m and not more than 9m above the surface of the water etc. etc.

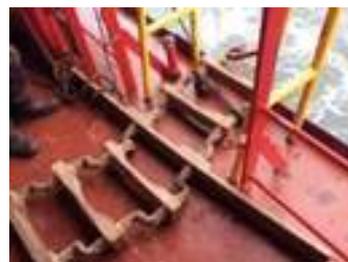
Check the condition of the sideropes.

On the photo we see that the shackles have been used often to keep the ladder in place. The photo shows really well what effect the steel shackles have on the manilla ropes - twisted and beaten up. Just wonder if this ladder will pass the 30-month compulsory strength test (ISO799-1/2019 10.4, for ISO certified vessels).

Shackles are an easy way for the crew to keep a ladder in place, but is it actually securing the sideropes??? No, it’s not - when weight is put on the ladder, the ladder will move freely under the shackles until the next chocks and step has reached the shackles.

Basically, the ladder will be held in place solely by step and chocks. Let’s think back a moment, we have seen that each siderope can handle 2400 kilos and that a step can handle 880 kilos. If or when the pilot launch hits the ladder, it will be ripped to pieces. 880 kilos instead of 4,800 kilos.
