Capsizing of Roll-on/Roll-off
Vehicle Carrier *Golden Ray*
St. Simons Sound, Brunswick River,
near Brunswick, Georgia
September 8, 2019

Marine Accident Report

NTSB/MAR-21/03
PB2021-100930

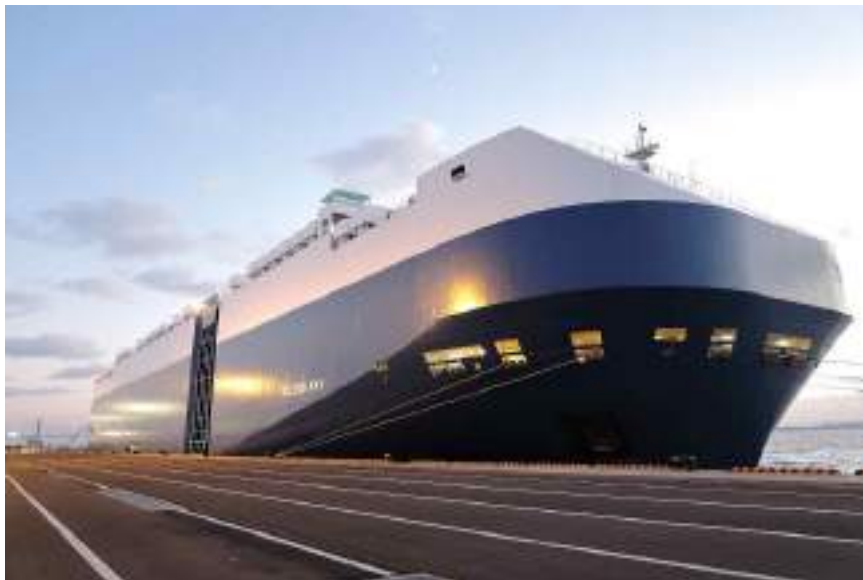
Figure 1. Roll-on/roll-off vehicle carrier *Golden Ray* before the accident.

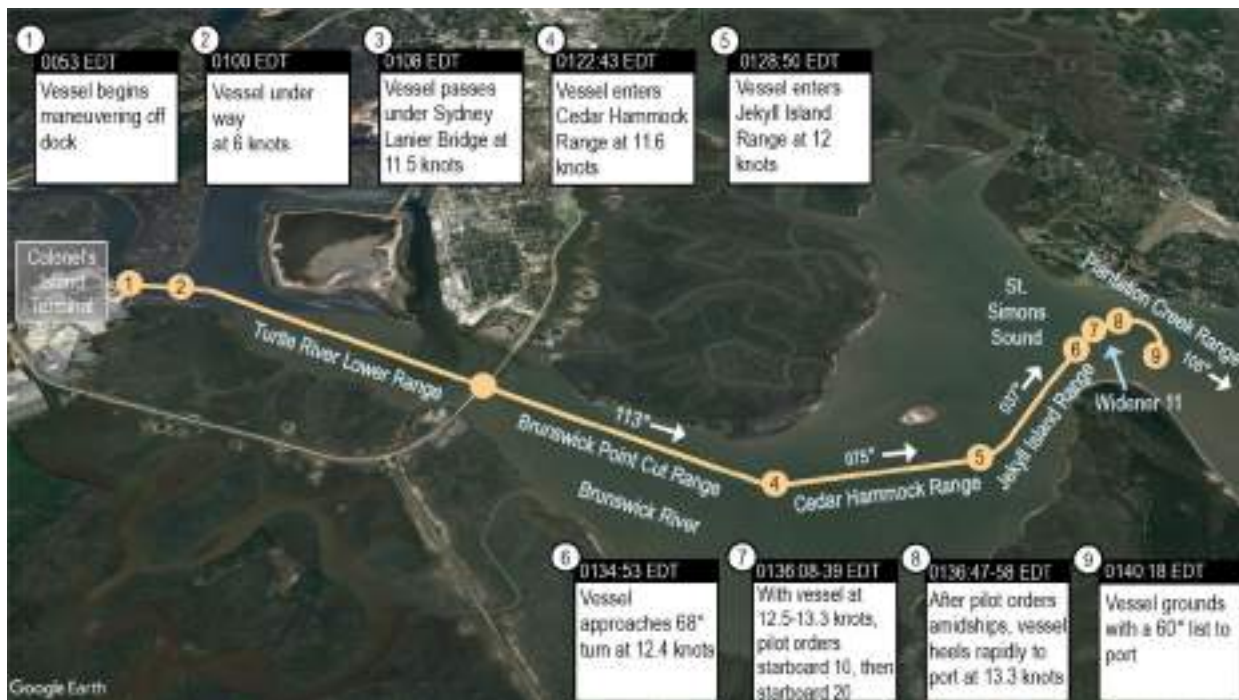
At 0055, the pilot ordered slow ahead. About two minutes later, at 0057:11, the pilot ordered half ahead, and by 0100, the *Golden Ray* was proceeding outbound in the Turtle River Lower Range at 6 knots on a course of 113°. (Figure 2 shows the vessel's transit as it exited the Port of Brunswick.) At 0102:43, the pilot ordered full ahead. The *Dorothy Moran* cast off its line but remained with the *Golden Ray* to provide support as needed. As the vessel transited the channel over the next few minutes, nothing unusual was noted by the pilot or crew of the *Golden Ray* or by the master of the *Dorothy Moran*.

Figure 2. Trackline of the *Golden Ray*'s transit after it departed the Colonel's Island Terminal.

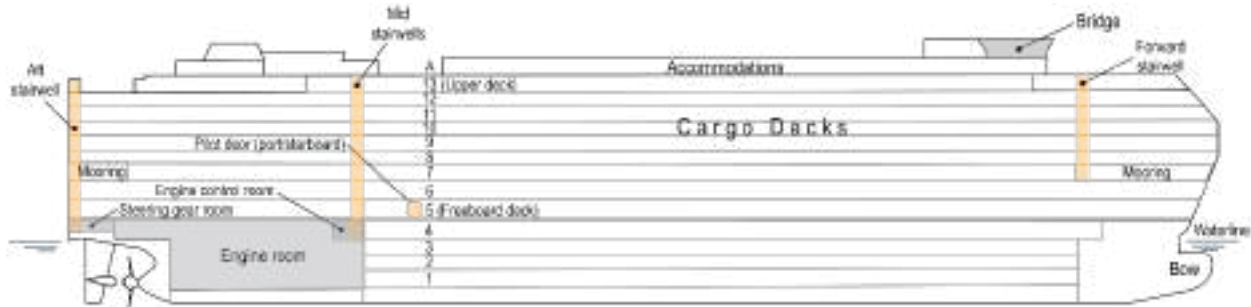
The *Golden Ray* was constructed of steel and had 15 decks, including the cargo decks, bridge, and accommodations (see figure 8). Of the 12 enclosed decks that housed vehicle cargo, 8 were fixed, and 4 were adjustable and could be raised or lowered to accommodate cargo of various sizes. Deck 5 was the vessel's watertight freeboard (or bulkhead) deck.⁸ The ship had two loading

Figure 8. Simplified profile of the *Golden Ray*.

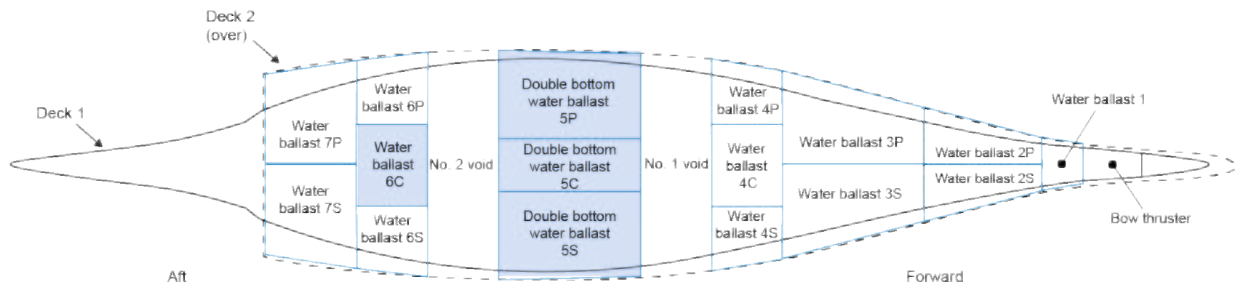
The vessel had 22 ballast tanks, comprised of 18 water ballast tanks, a fore peak tank, and 3 aft peak tanks (see figure 9). The total volume of the tanks was 9,842 cubic meters, and, when the tanks were completely full of salt water, the total capacity was 10,088 MT. Three water ballast tanks did not extend above the lowest cargo deck (deck 1) and were designated double bottom tanks (no. 5 starboard, centerline, and port water ballast tanks). (See [Appendix D](#) for water ballast tank levels at the time of the accident.)

Figure 9. Simplified plan of water ballast tanks on *Golden Ray*. Blue lines show water ballast tanks, and blue highlights show water ballast tanks used to transfer ballast prior to the accident voyage. Note: the solid line is deck 1, and the dashed line shows deck 2 above. Fore and aft peak tanks are not indicated for clarity.

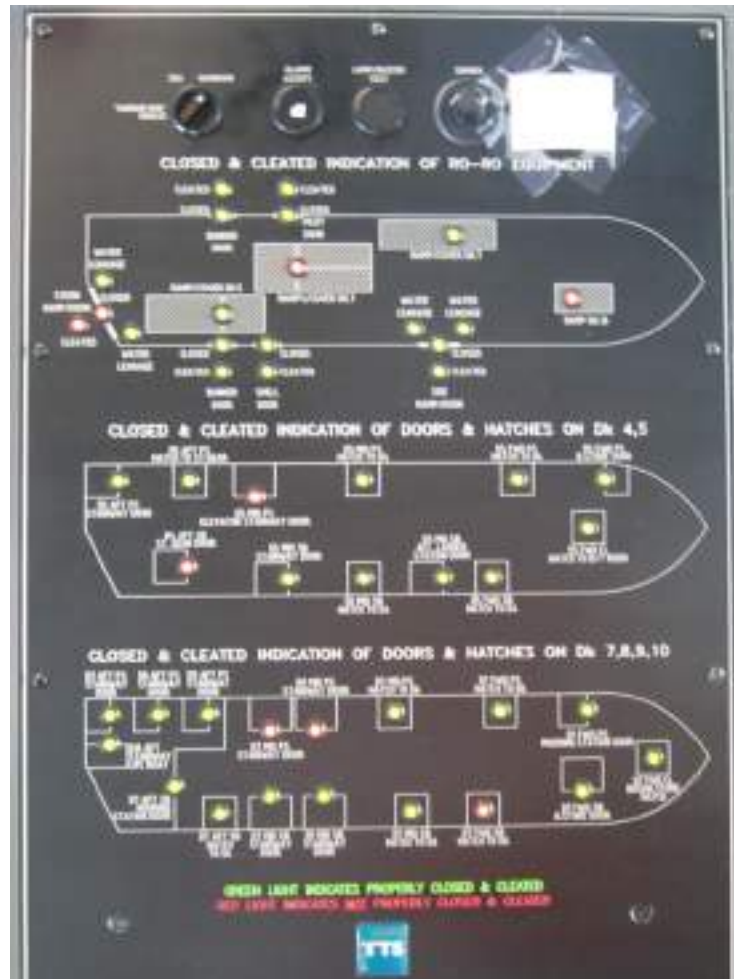
Watertight Doors. In addition to the pilot door, stern ramp, side ramp, and four ramp covers, the *Golden Ray* had 17 watertight doors and 13 watertight hatches that, when shut, maintained the vessel’s watertight integrity. On the vessel’s bridge, there was a watertight door indicator panel that showed whether the watertight doors and hatches were open (red light) or closed (green light) (see figure 10).

Figure 10. Watertight door indicator panel located on the bridge of the *Silver Ray*, a vessel of the same class as the *Golden Ray*.

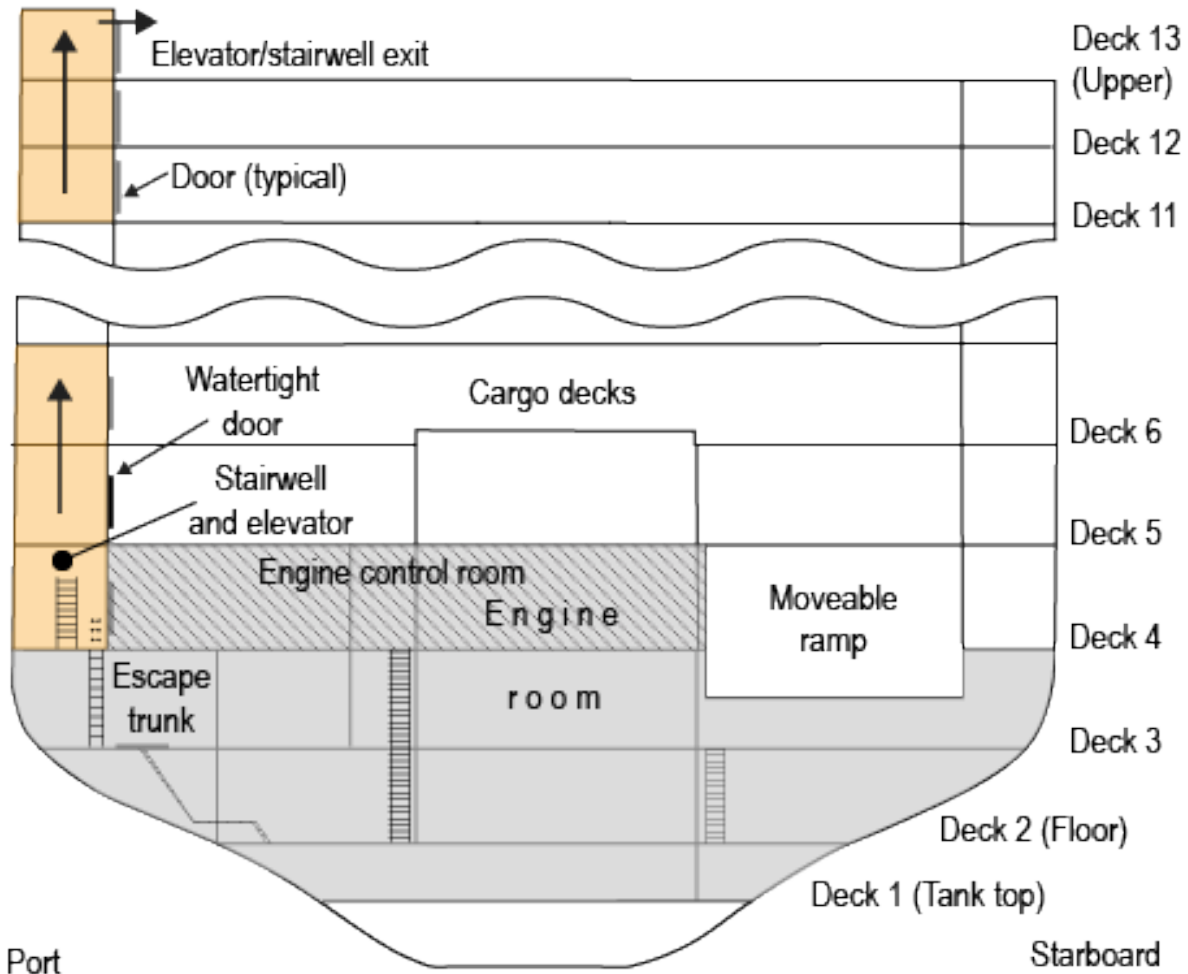
The aft portside stairwell at the stern served as access to the steering gear room on deck 4 (the engine room and steering gear room were separated by a watertight transverse bulkhead and connected to each other on deck 4 by a watertight door). Both the aft and mid stairwells were “towers”—isolated spaces with fire-protected bulkheads that ran vertically up to deck 13, with doors serving car decks in between (see figure 12). On deck 13, the upper deck, the doors allowed exit to the weather deck (outside). There was also an exit from the engine room on the port side from deck 4 by a series of vertical ladders that led up through the engine casing to the upper deck.

Figure 12. Simplified section view of the escape trunk and mid portside stairwell exit from the engine room and engine control room.

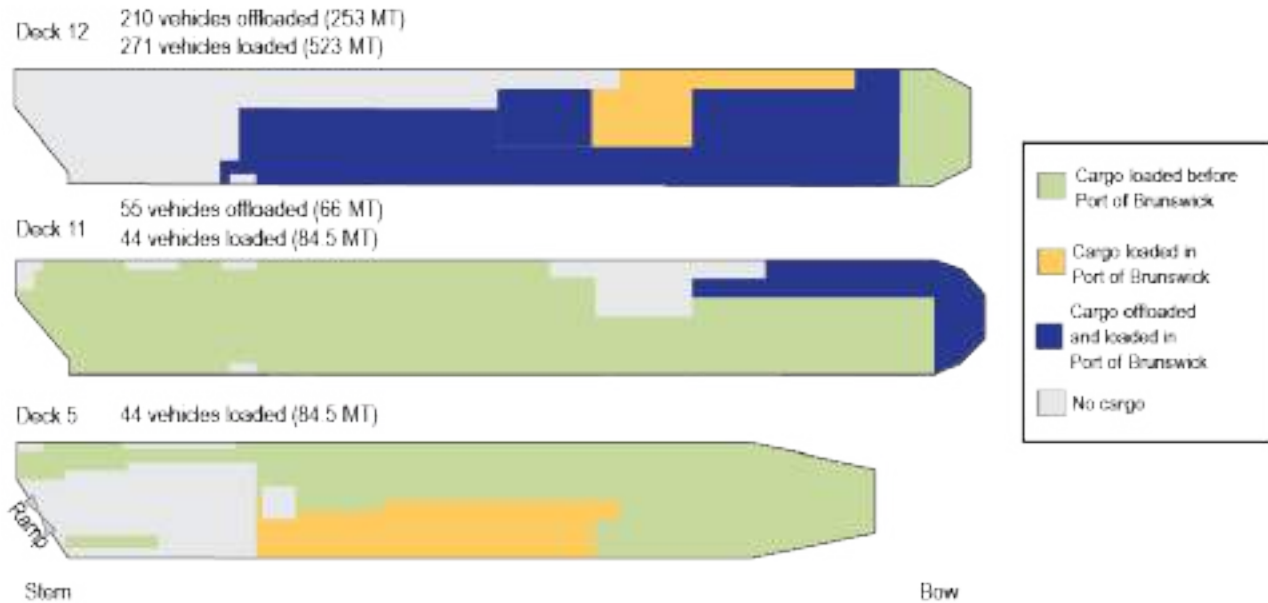
During the voyage to Brunswick, the charterer emailed the preload plan to the *Golden Ray*’s master and chief officer about 30 hours before the vessel was scheduled to arrive at the port, to review and determine if the vessel could accommodate the cargo to be loaded in Brunswick (see figure 13). The preload plan specified that a combination of 265 KIA Forté and Hyundai Accent vehicles from decks 11 and 12 were to be offloaded, and 362 KIA Telluride sport utility vehicles were to be loaded to decks 5, 11, and 12.

Figure 13. Preload plan (top view of decks 5, 12, and 13) for the *Golden Ray* at the Colonel's Island Terminal.

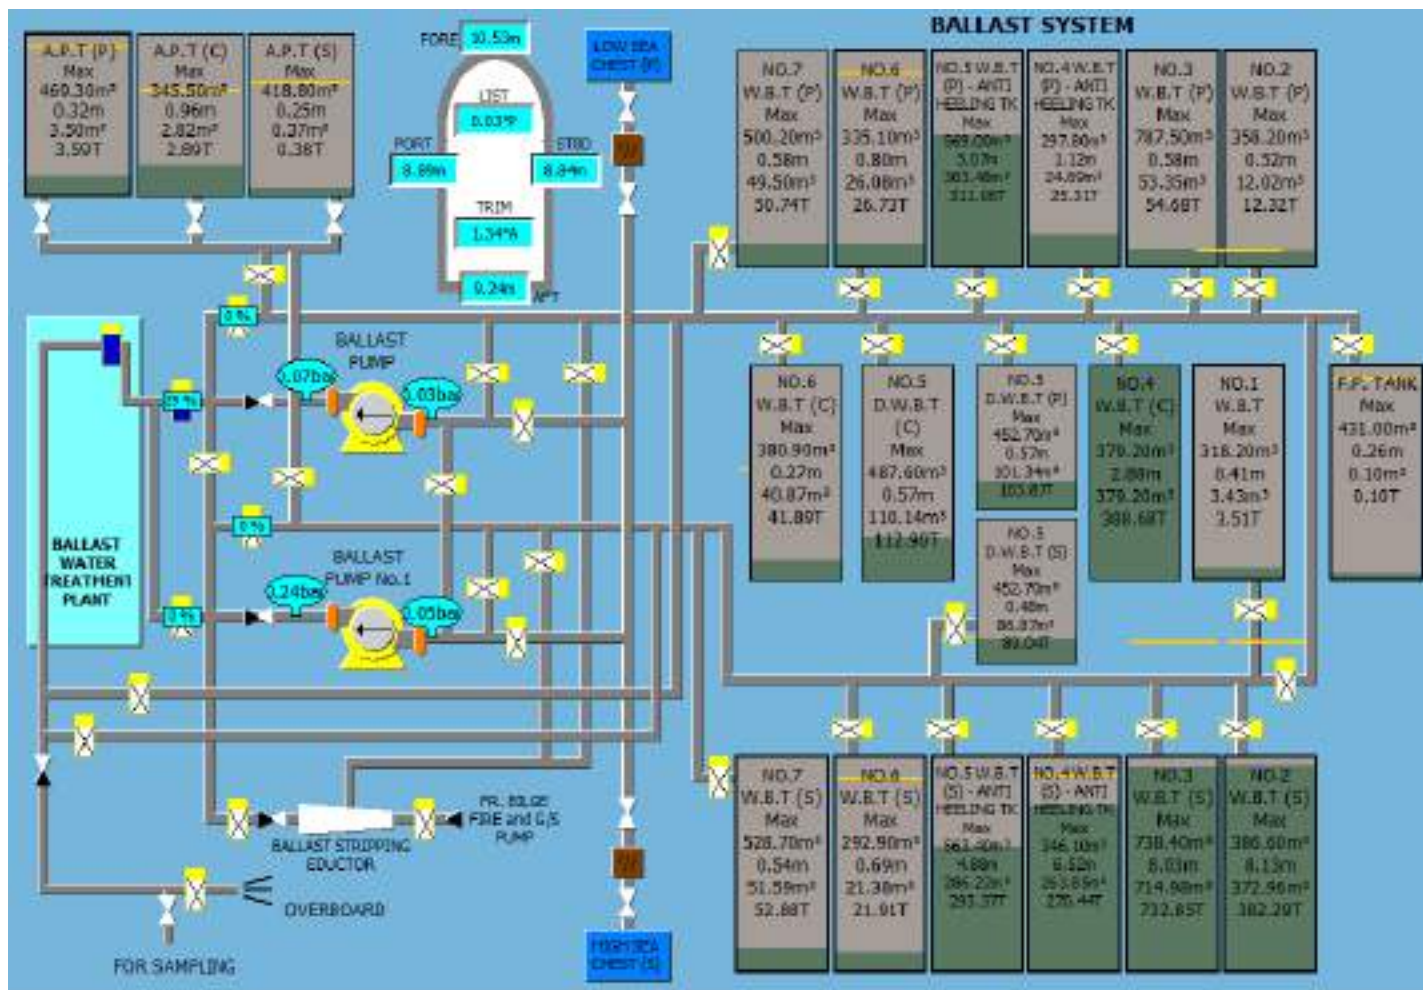
Figure D-1. IMACS water ballast system data before the *Golden Ray's* departure from the Colonel's Island Terminal.
