MARINE ACCIDENT
INVESTIGATION BRANCH

SAFETY DIGEST

**Lessons from Marine
Accident Reports
2/2021**

No 2/2021

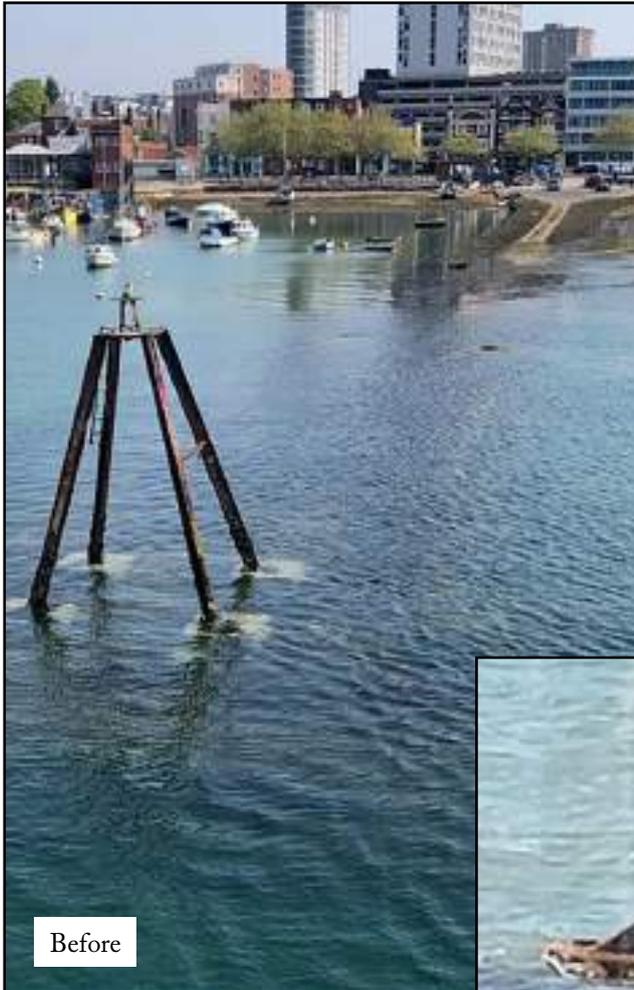
The master and a deckhand who was on the bridge checked the thrusters' digital display, but it was impossible to read because of bright sunlight reflecting off the glass panel display. The deckhand shielded the sunlight with his hand and saw that the aft thruster had been set to astern.

Acting quickly, the deckhand told the master and the thruster was stopped; however, this action came too late to prevent the ferry's stern making heavy contact with a navigation mark at the end of a nearby submerged slipway. The navigation mark was demolished (Figure 1); however, there was only cosmetic damage to the ferry's paintwork.

1. Always check the effect of control system inputs. The ferry operated across a harbour, berthing and unberthing from the same two pontoons many, many times a day, and the master was extremely experienced at handling the vessel. Nevertheless, it's important to check the response to control system inputs, also taking into account the prevailing conditions. The reflecting sunlight was a distraction for the bridge team and vital seconds were lost trying to figure out what was wrong. Simple visual checks on the intended movement and immediate correction of unexpected movement, is necessary in the close confines of a harbour. After the incident, no fault could be found with the control system and the error could not be replicated, so it is probable that the master inadvertently selected astern and not ahead on the aft thruster.

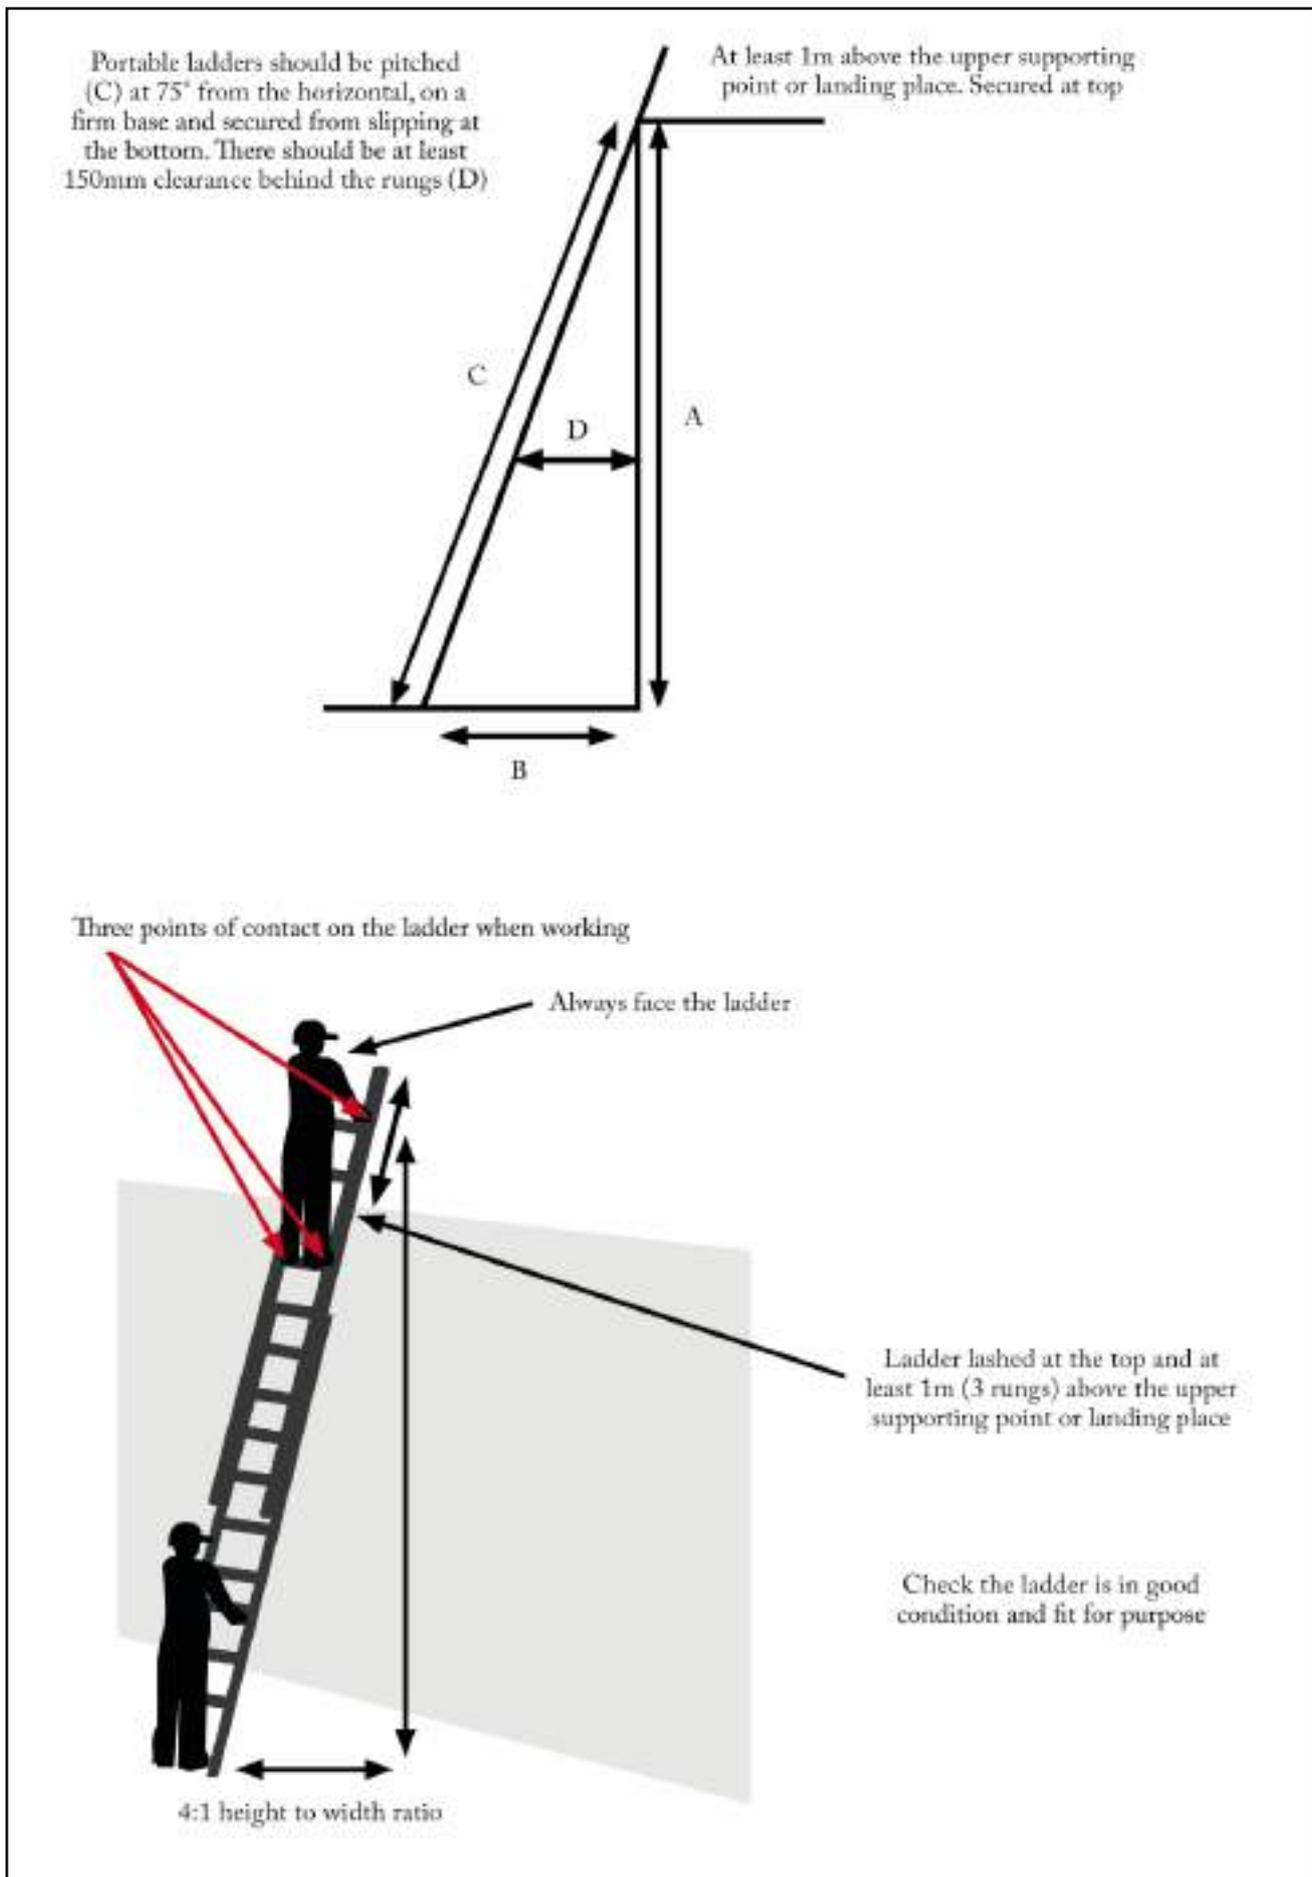
Figure 2: The correct way to rig and secure a portable ladder

1. The use of a portable ladder must be safely supervised and controlled. Advice in the Maritime and Coastguard Agency's *Code of Safe Working Practices for Merchant Seafarers* (COSWP) stated that a portable ladder should only be used as a last resort *where no safer means of access is reasonably practicable*. In this instance, either the approved means of access into the hold should have been unblocked, or guidance

for rigging a portable ladder followed. COSWP's guidance goes on to advise that, where a portable ladder is to be used, it must be properly secured, pitched at 75° from the horizontal with a clearance of at least 150mm behind the rungs and extended at least 1m (3 rungs) above the landing place (Figure 2).

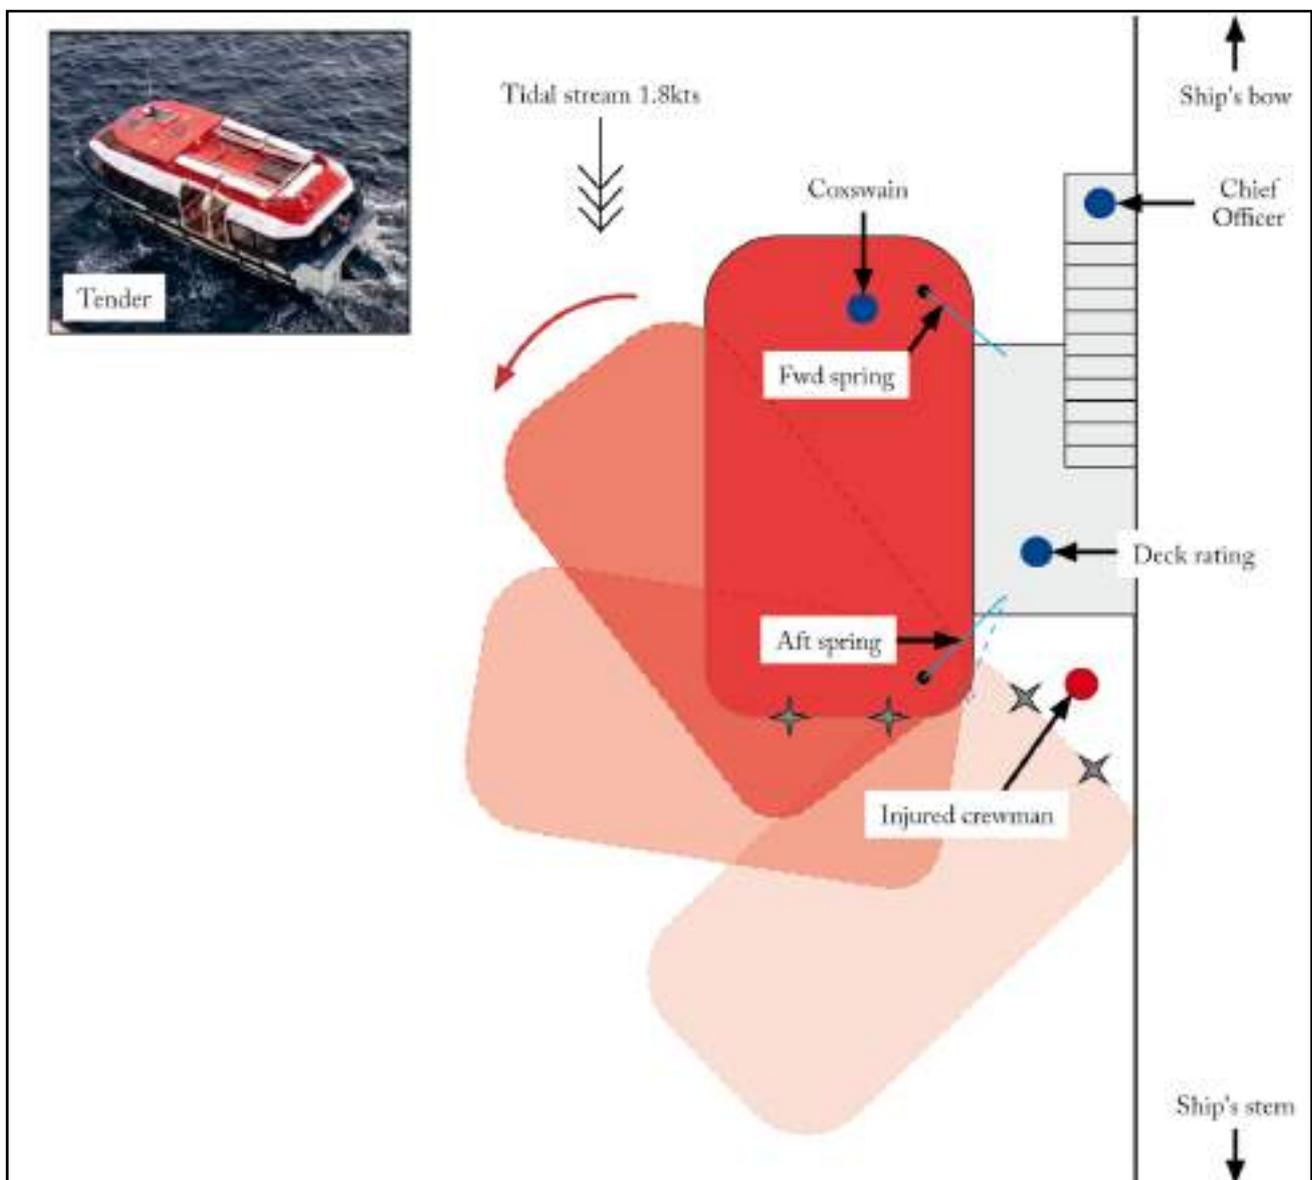
Figure: Tender's movement and contact with the ship's hull

As the parts were being transferred, the tender's forward mooring rope slipped off the cleat. The bow started to swing off the pontoon, with the stern held on by the aft line. As the bow swung away, the coxswain tried to control the situation using the engines, but he was unsuccessful against the strong tidal stream. He then instructed a crewman on the aft deck of the tender to let go of the aft mooring line, hoping to drive away from the pontoon. The attempt to let go the aft line was unsuccessful and the tender's port quarter made heavy contact with the ship's hull (see figure). The impact caused the crewman on the aft deck to lose his balance and fall overboard.

1. Tender operations are hazardous and require careful planning and a comprehensive brief so everyone knows the plan and their role. Planning for a transfer of this nature should, as a minimum, cover the operation, environmental conditions, role of each crewman and emergency procedures. In this case, the tidal stream was a significant factor and, when the bow line slipped off the cleat, a very hazardous situation emerged. Given the tidal stream, the plan could have included using a small amount of ahead propulsion when alongside to ease the tension on the lines.

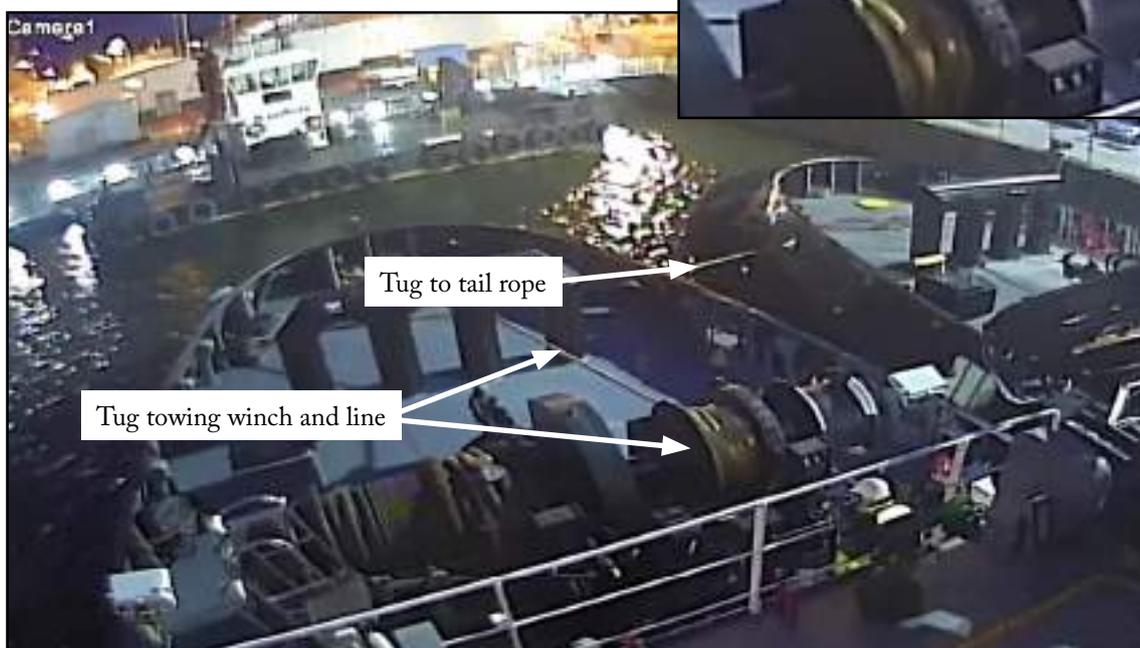
On the first attempt, the rope slipped off the bulwark, so the mate tried again. This time, the rope lay as intended but the mate still needed to flick the remaining tail end of the rope over the bulwark, so he stood on his toes and leant further over the bulwark. The weight of the rope and his own body weight over-balanced

Figure 1: CCTV video still, showing the tugs moored together (inset: mate 'flicking' tail end of the rope over the bulwark)

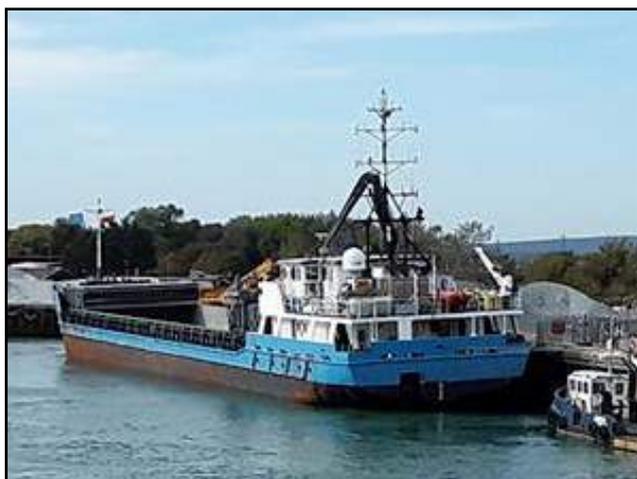
Several of the crew went ashore to buy provisions, leaving four crew members on board. Later that afternoon, as the tide ebbed, the stern settled into the mud, and the vessel took a slight list to port (Figure 1). A short

Figure 1: Vessel alongside as tide drops

2. The pilot had briefed the master on the need to tend lines as the vessel settled, and they had discussed the probability that the vessel would take a slight heel as the tide dropped. Mooring lines should be closely monitored on all berths; this is vitally important where there is a large range of tide, particularly on berths that dry out, as even on the flattest berths there is a chance a vessel will take the ground in one area before another, causing unequal loading on lines.

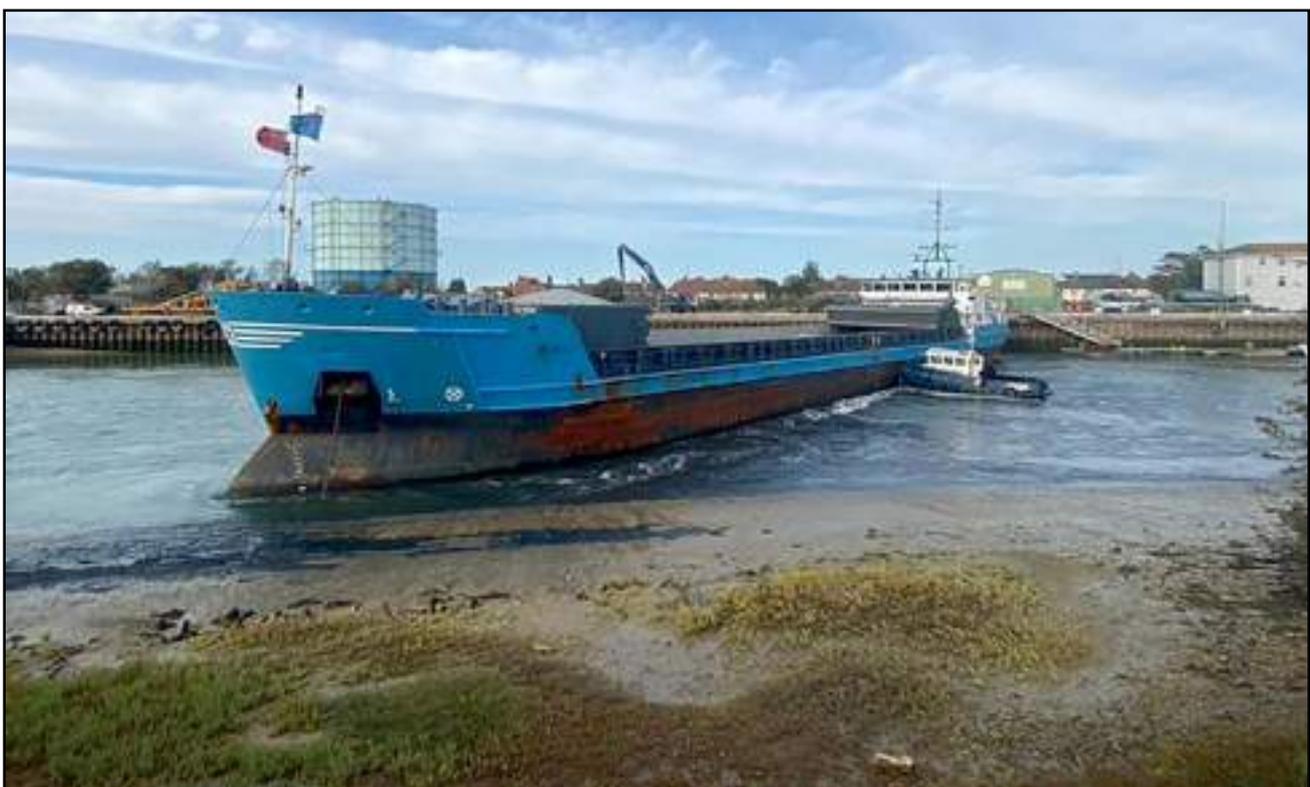
Figure 3: Tug amidships, stabilising vessel against the ebb tide

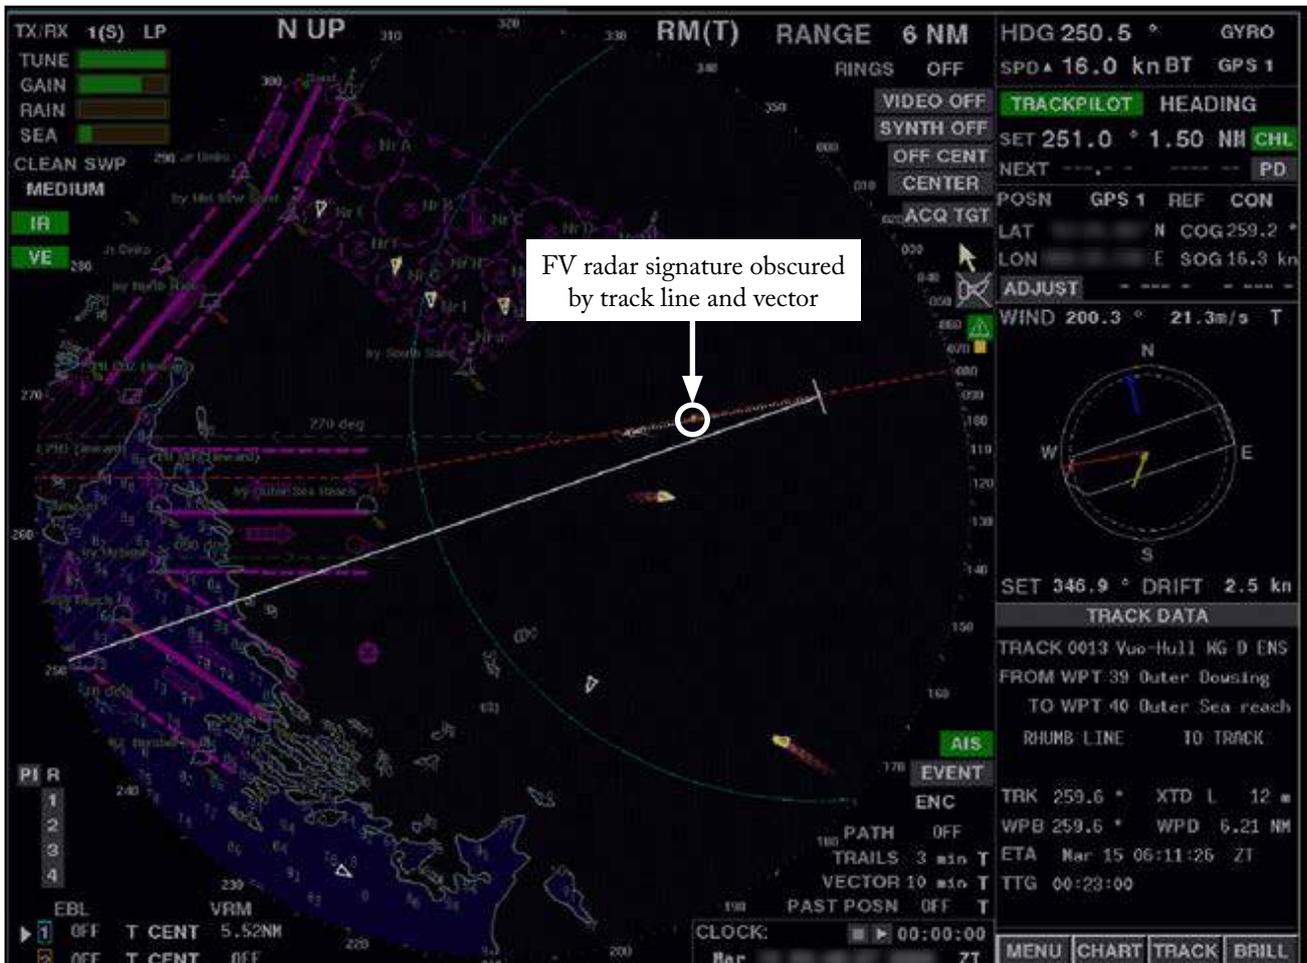
5. Even though contact by mobile phone was eventually made between the fishing vessel and ferry, the initial attempts to contact each other via VHF radio were unsuccessful. After the glancing blow, the ferry’s OOW and master made no assessment of the damage sustained on the fishing vessel and no attempt to slow down or return to the fishing vessel. Had the damage been catastrophic, the immediate deployment of search and rescue assets from the ferry could have been critical in the safe recovery of the fishing vessel’s crew.

Figure: The fishing vessel's radar signature is visible, although obscured by the track line and vector

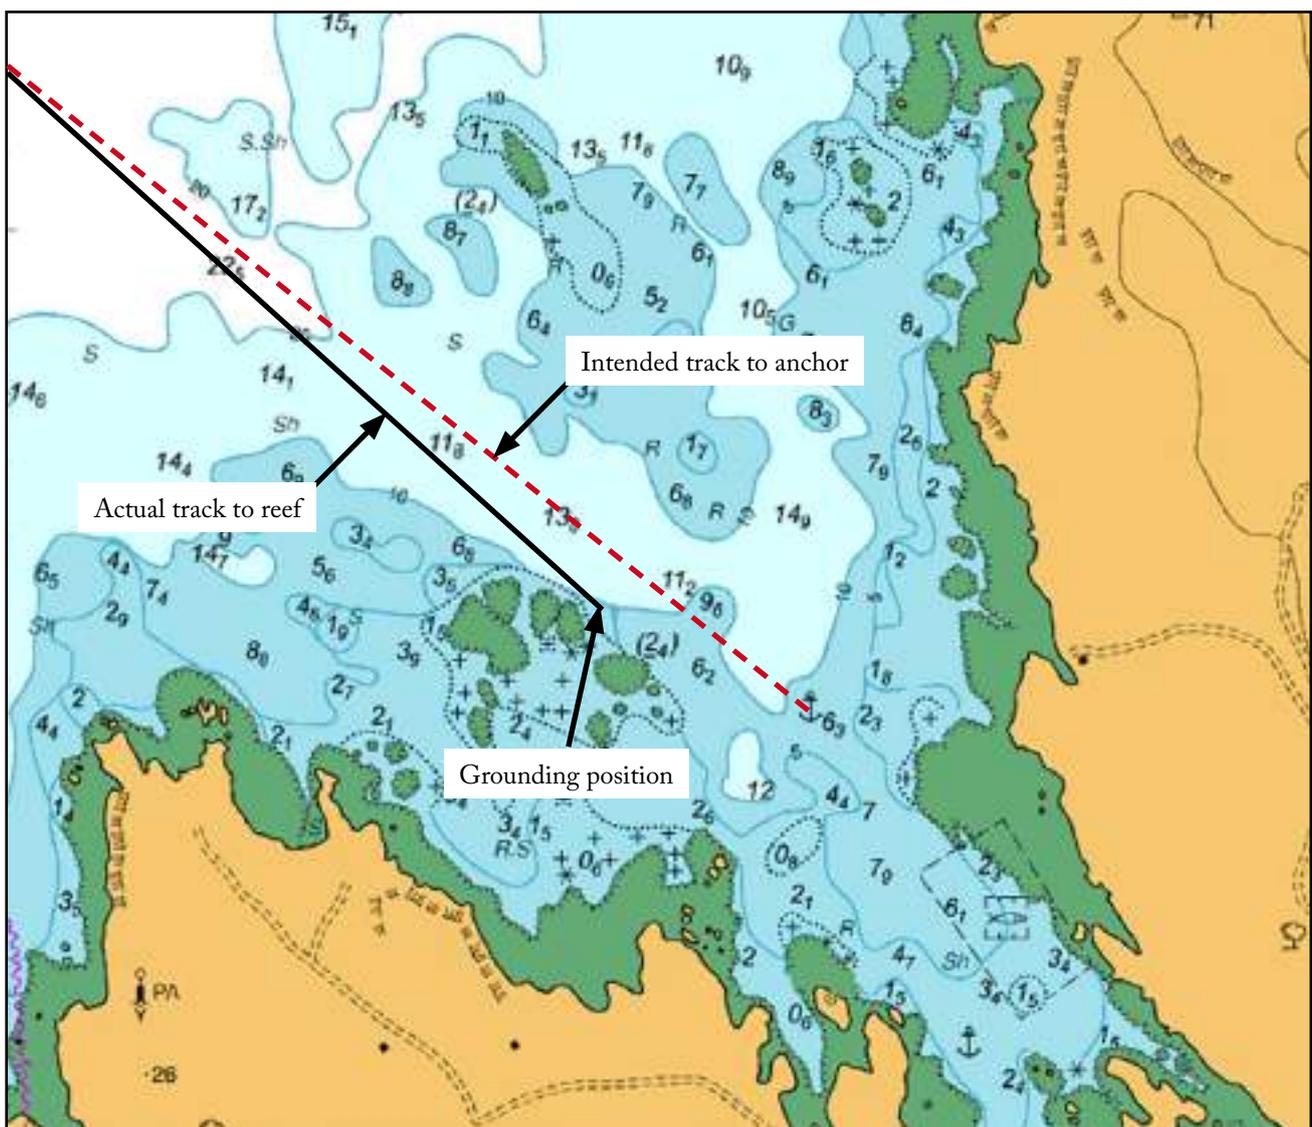
To the south of the planned approach was a shallow reef, exposed at low water, but now covered. While engrossed in his paperwork, the skipper did not notice that the vessel was being set to the south. At around 2120, just before high water, the vessel grounded on the reef at about 5kts.

Figure 1: Fishing vessel intended track compared to actual track

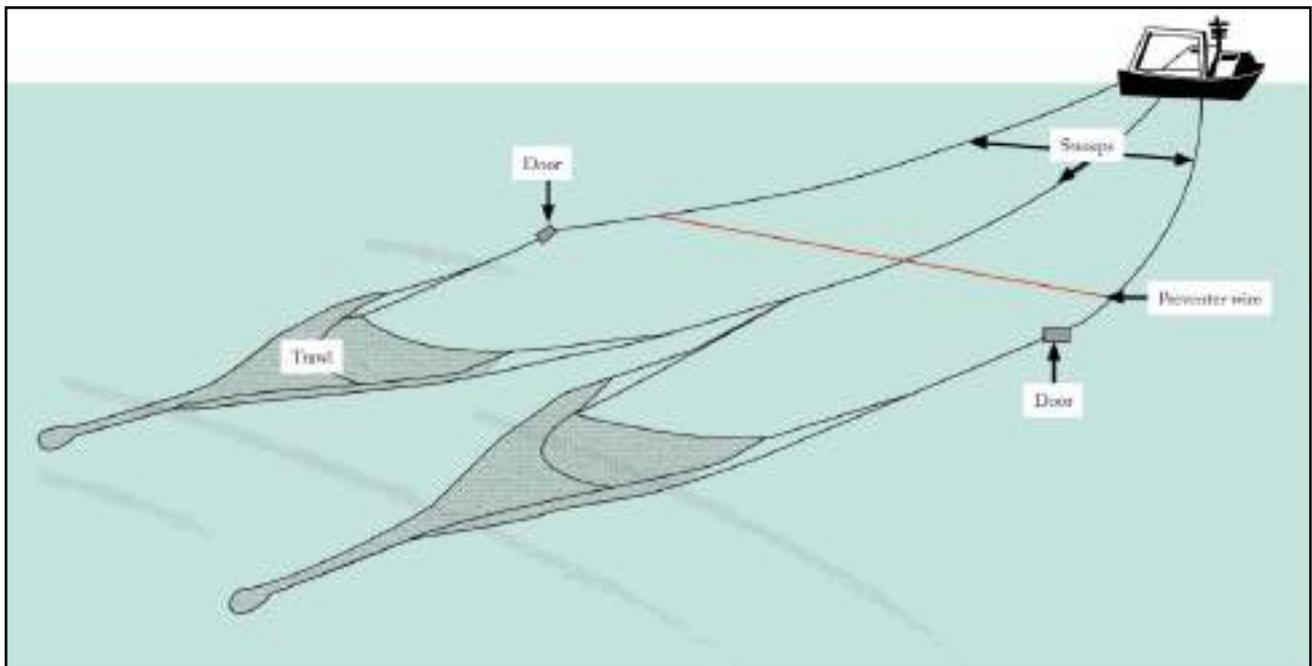
Figure 1: Net configuration

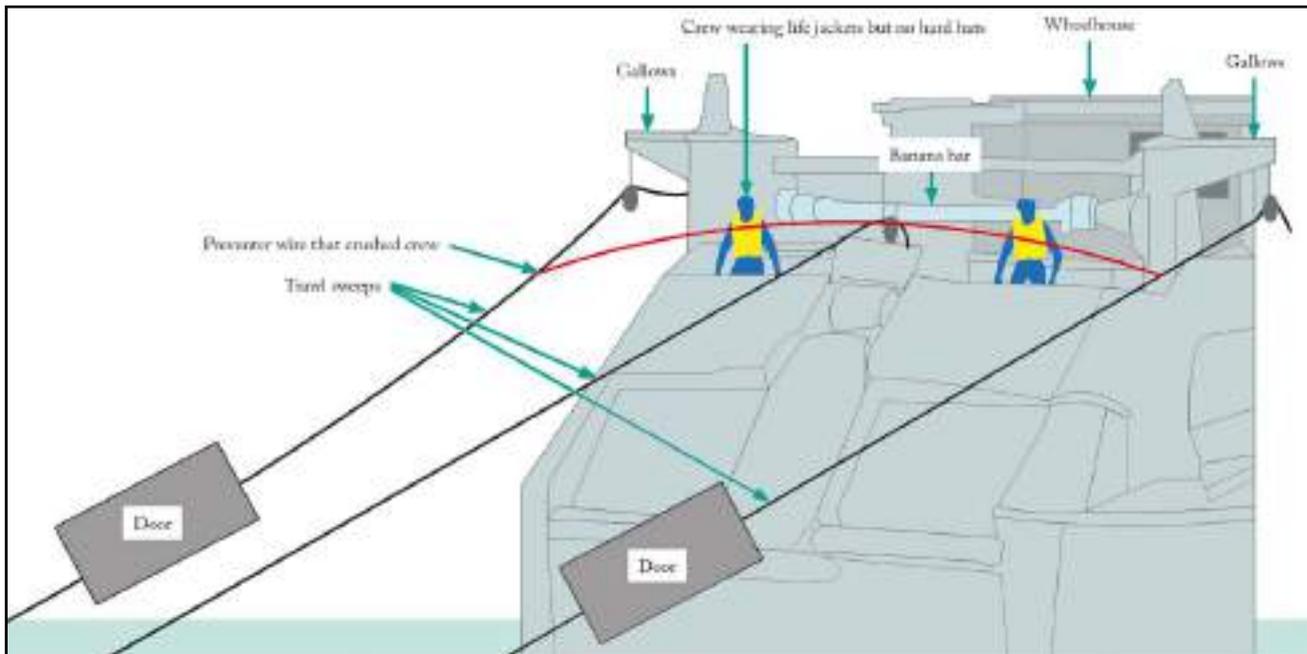
doors came clear of the water, the two crew on the upper deck moved aft, ducking under the banana bar, to reach the doors. Unfortunately, as the gear continued to be hauled in, the two crew members were pinned to the gallows by the preventer wire (Figure 2).

Figure 2: Preventer wire crushes two crew

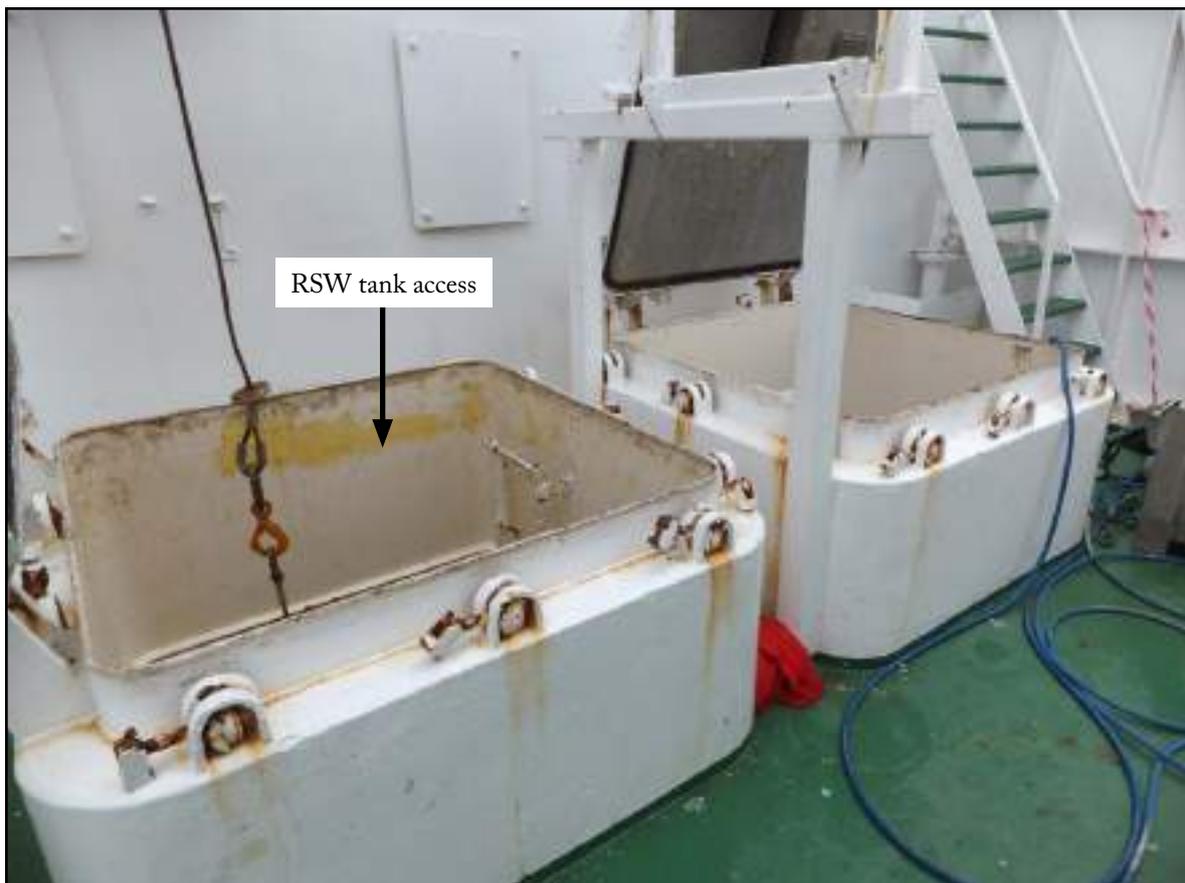
A technical analysis of the refrigeration system after the accident discovered that Freon gas had leaked into the RSW tank through corroded tubes in a heat exchanger. The heavy Freon gas had displaced the air, which meant that the atmosphere in the tank could not support life.

Figure 1: RSW tank access hatch

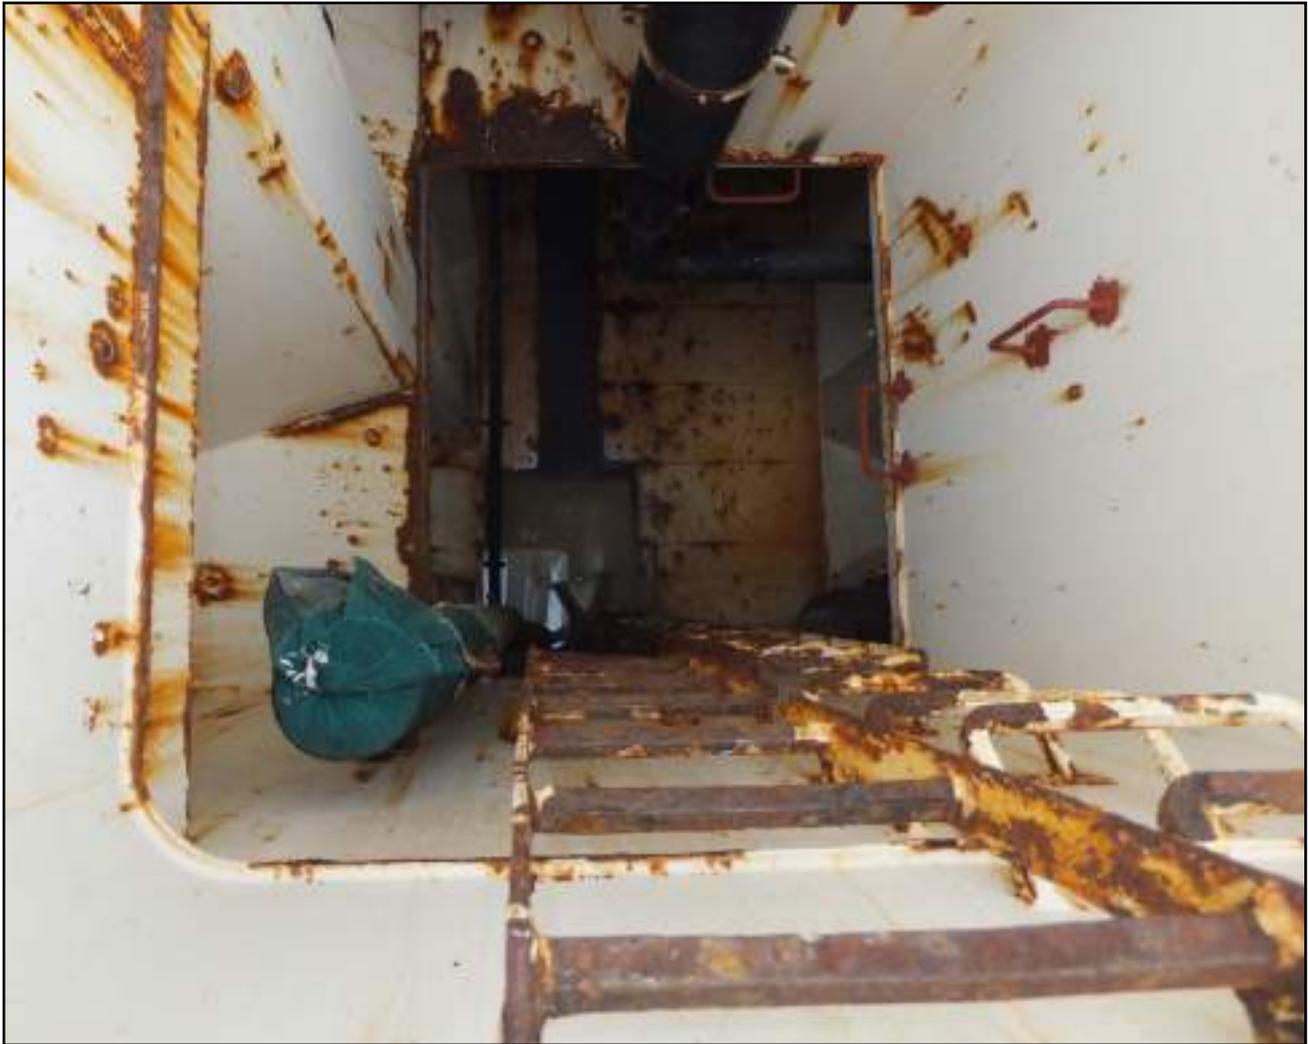
Figure 2: The view down through the access hatch into a pelagic fishing vessel's RSW tank

3. The view into an enclosed space (Figure 2) should cause concern and crew should ask themselves, “*Is this safe and are appropriate precautions in place?*”

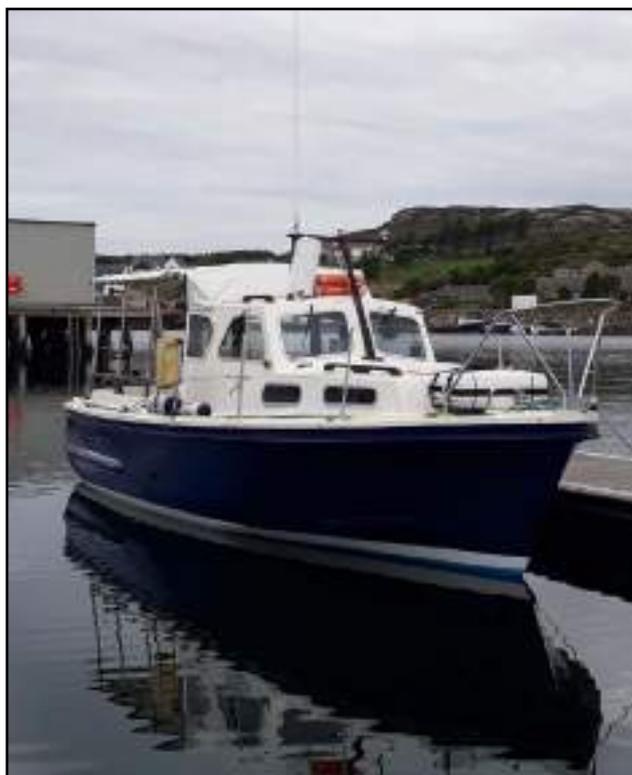
Figure: The fishing vessel before the accident, showing the liferaft on the foredeck – on the day of the accident, the liferaft was stowed inside

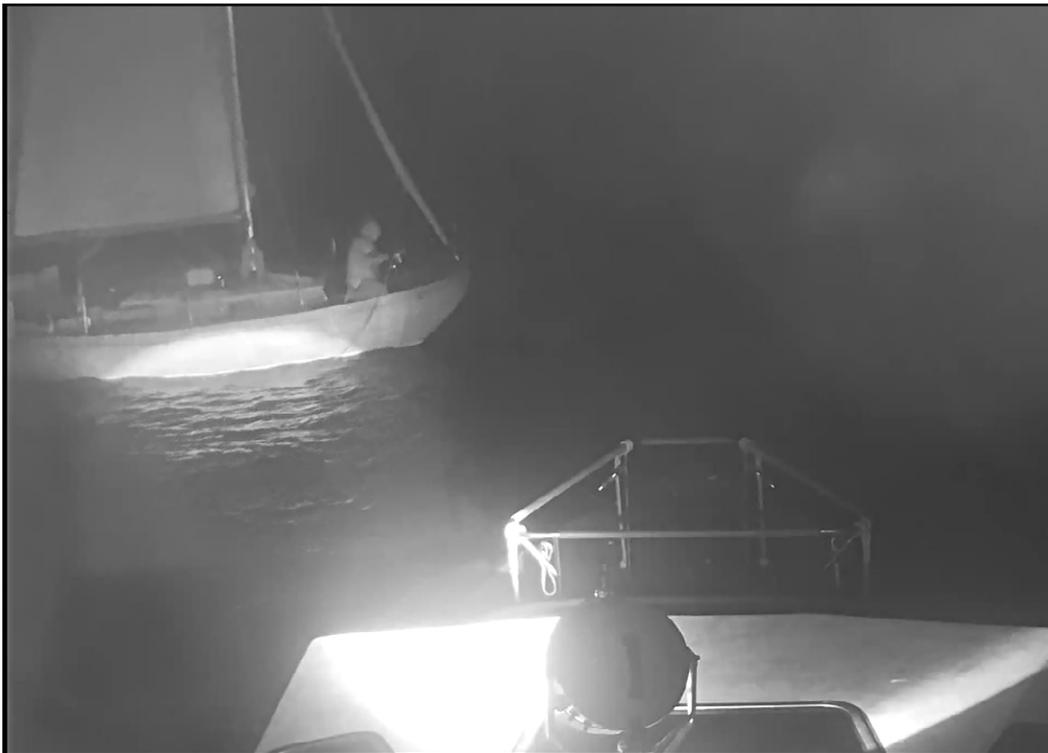
At the same time, a 38000 gross tonne chemical tanker was proceeding outbound at slow speed in the designated area, to disembark its pilot. When the pilot cutter was alongside the tanker, the coxswain saw the yacht's navigation lights close by. As soon as the pilot was safely on board the cutter, the coxswain manoeuvred clear of the tanker and approached the yacht. The cutter's horn was sounded and its searchlight was used to illuminate the yacht to alert the skipper to the risk of collision. The cutter's crew could also see that there was no-one in the yacht's cockpit. Soon after, the skipper emerged from the cabin and saw that a collision was imminent. He immediately put the yacht's engine astern but it was too late and the yacht collided heavily with the side of the tanker (Figure 1). The skipper was not injured and the cutter escorted the damaged yacht safely back to harbour (Figure 2).

Figure 1: A still image from the pilot cutter's external CCTV camera, showing the yacht with the skipper at the bow assessing the damage just after collision
