The Bahamas
Maritime Authority

Marine Safety Investigation Report

into an engine room fire onboard Pride of Hull
on 20 October 2020

Date of Issue: 30 November 2021
Bahamas Maritime Authority
120 Old Broad Street
LONDON
EC2N 1AR
United Kingdom

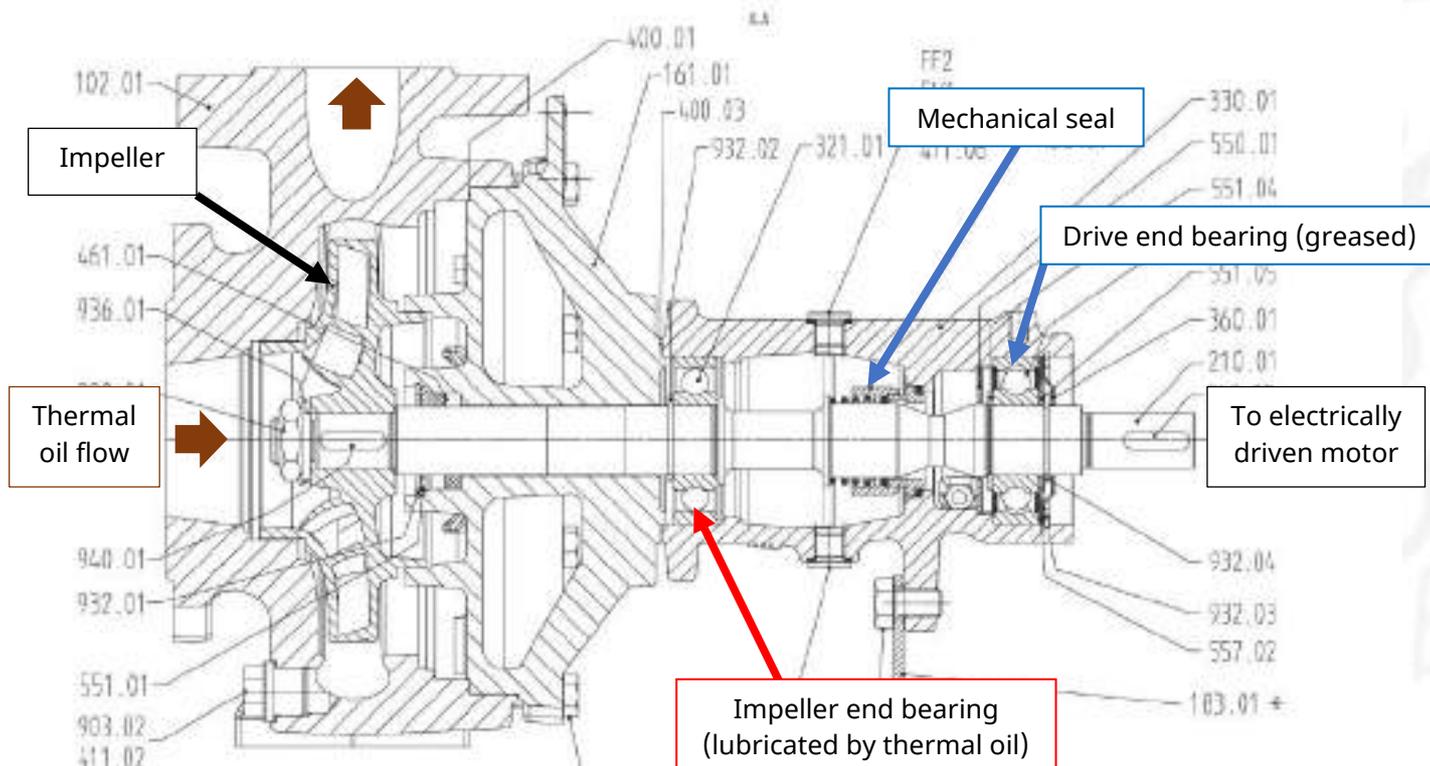
Circulation pump cross-section

The pumps had a single stage centrifugal impeller fitted to a shaft, rotating on two bearings: a grease packed single row ball bearing design at the electric motor (drive) end, and a thermal oil lubricated single row ball bearing design at the impeller end.

Metallurgical examination identified that the damage to the pumps was consistent with a bearing failure and fire originating at pump #1. The pattern of damage to pump #1 indicates that the impeller end bearing failed first and the drive end bearing collapsed shortly afterward. This collapse led to the drive end bearing’s outer race rotating in the bracket housing, which resulted in extreme frictional heating, generating temperatures in the order of 1,200°C - well in excess of the thermal oil’s autoignition temperature. Due to the failure of the mechanical seals and circlips, there was a path for the thermal oil to reach the hot spot internally as well as spray to make contact externally.

The metallurgical examination of the pumps did not conclusively identify the reason for the initial bearing failure. Both the bearings were Allweiler parts, of correct design for application and had failed after a relatively short period of operation. However, it was identified that the surface of the bracket housing in which the impeller end bearing sits was pitted and "possibly slightly" worn. This may have affected the fit of the bearing and potentially led to premature failure.
