Report on the investigation of  
the grounding of the ro-ro freight ferry  
***Arrow***  
in the approach channel of Aberdeen Harbour  
on 25 June 2020

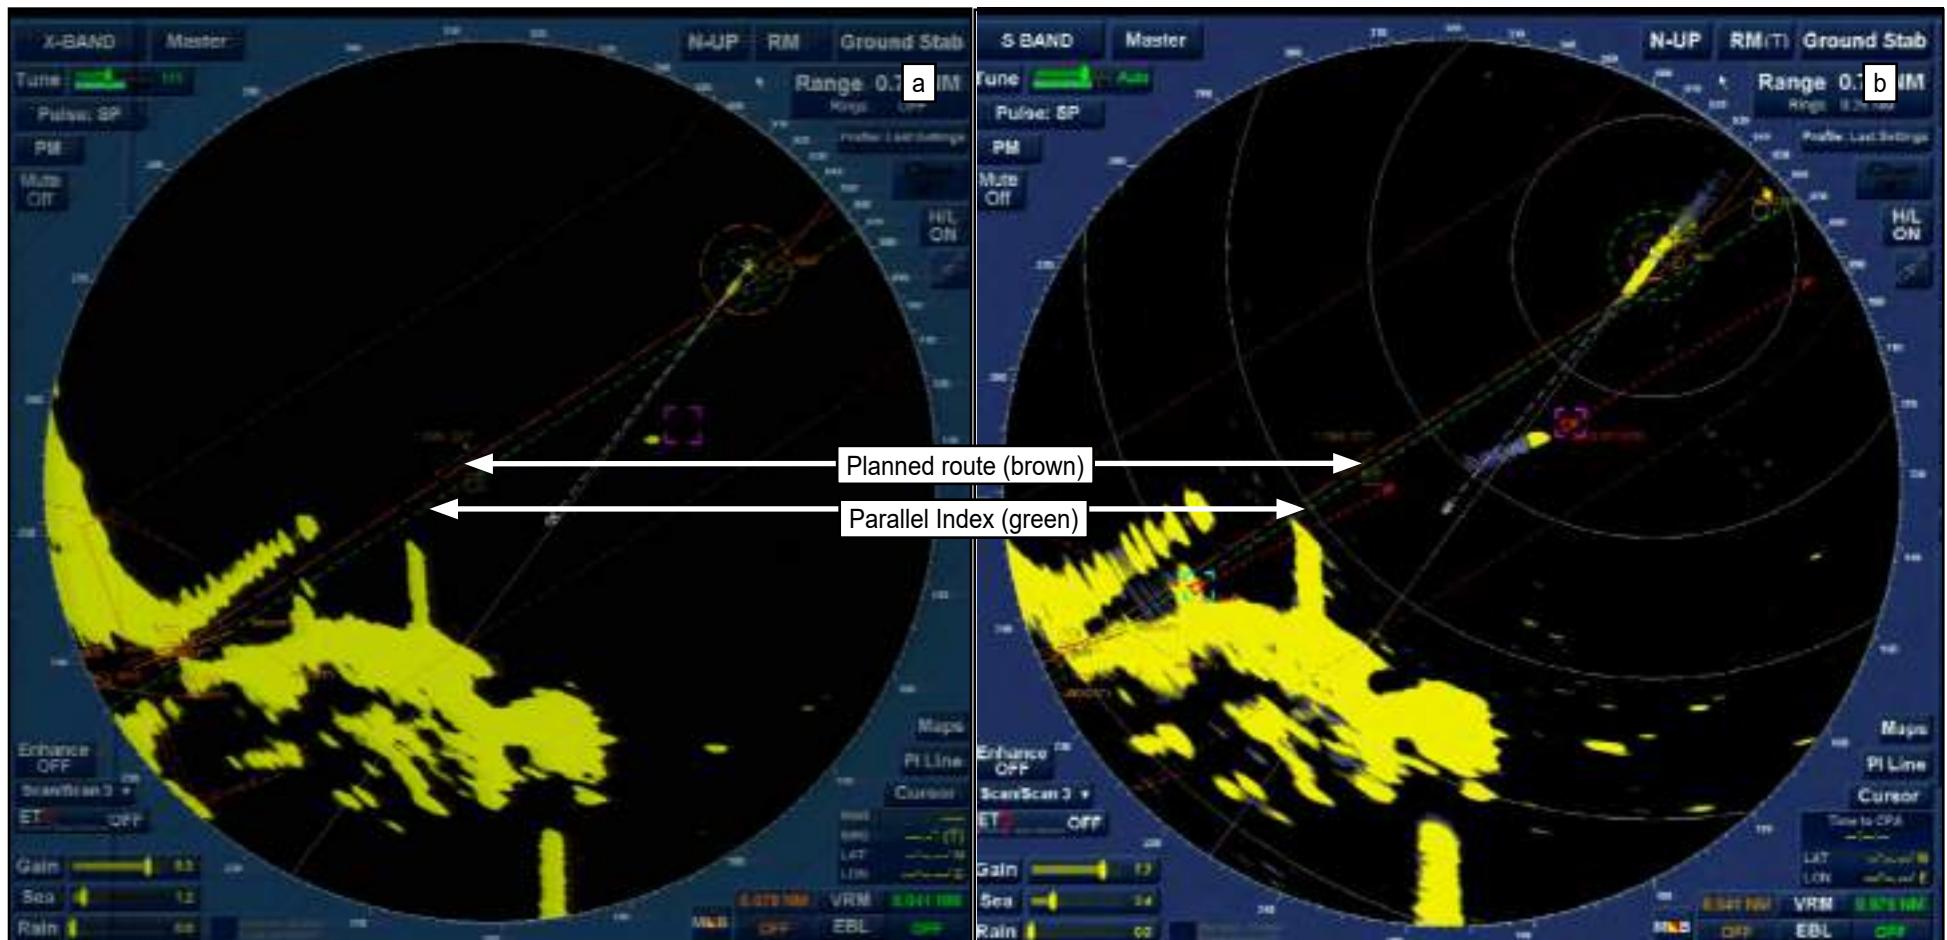
**Figure 3:** Radars set up for entry to Aberdeen. X-Band (a) and S-Band (b)  
(Note: both displays offset to give maximum look ahead)

At 0705, *Arrow*'s 3/O reported to VTS that the vessel was 3nm from the Fairway Buoy. The PEC holder arrived on the bridge and began preparing to take over the conduct of navigation of the vessel (con) for harbour entry. He set up the ferry's S-Band and X-Band navigation radars, inserting a radar parallel index (PI) line on both displays on a course of 237° drawn at 0.05nm to the south to run on the Old South Breakwater (**Figure 3**). After setting up the PI's on the 0.75nm range scale, he set the displays to the 1.5nm range scale, offset both displays to give a more detailed ahead look and set variable range markers (VRM) for the Turning Basin.

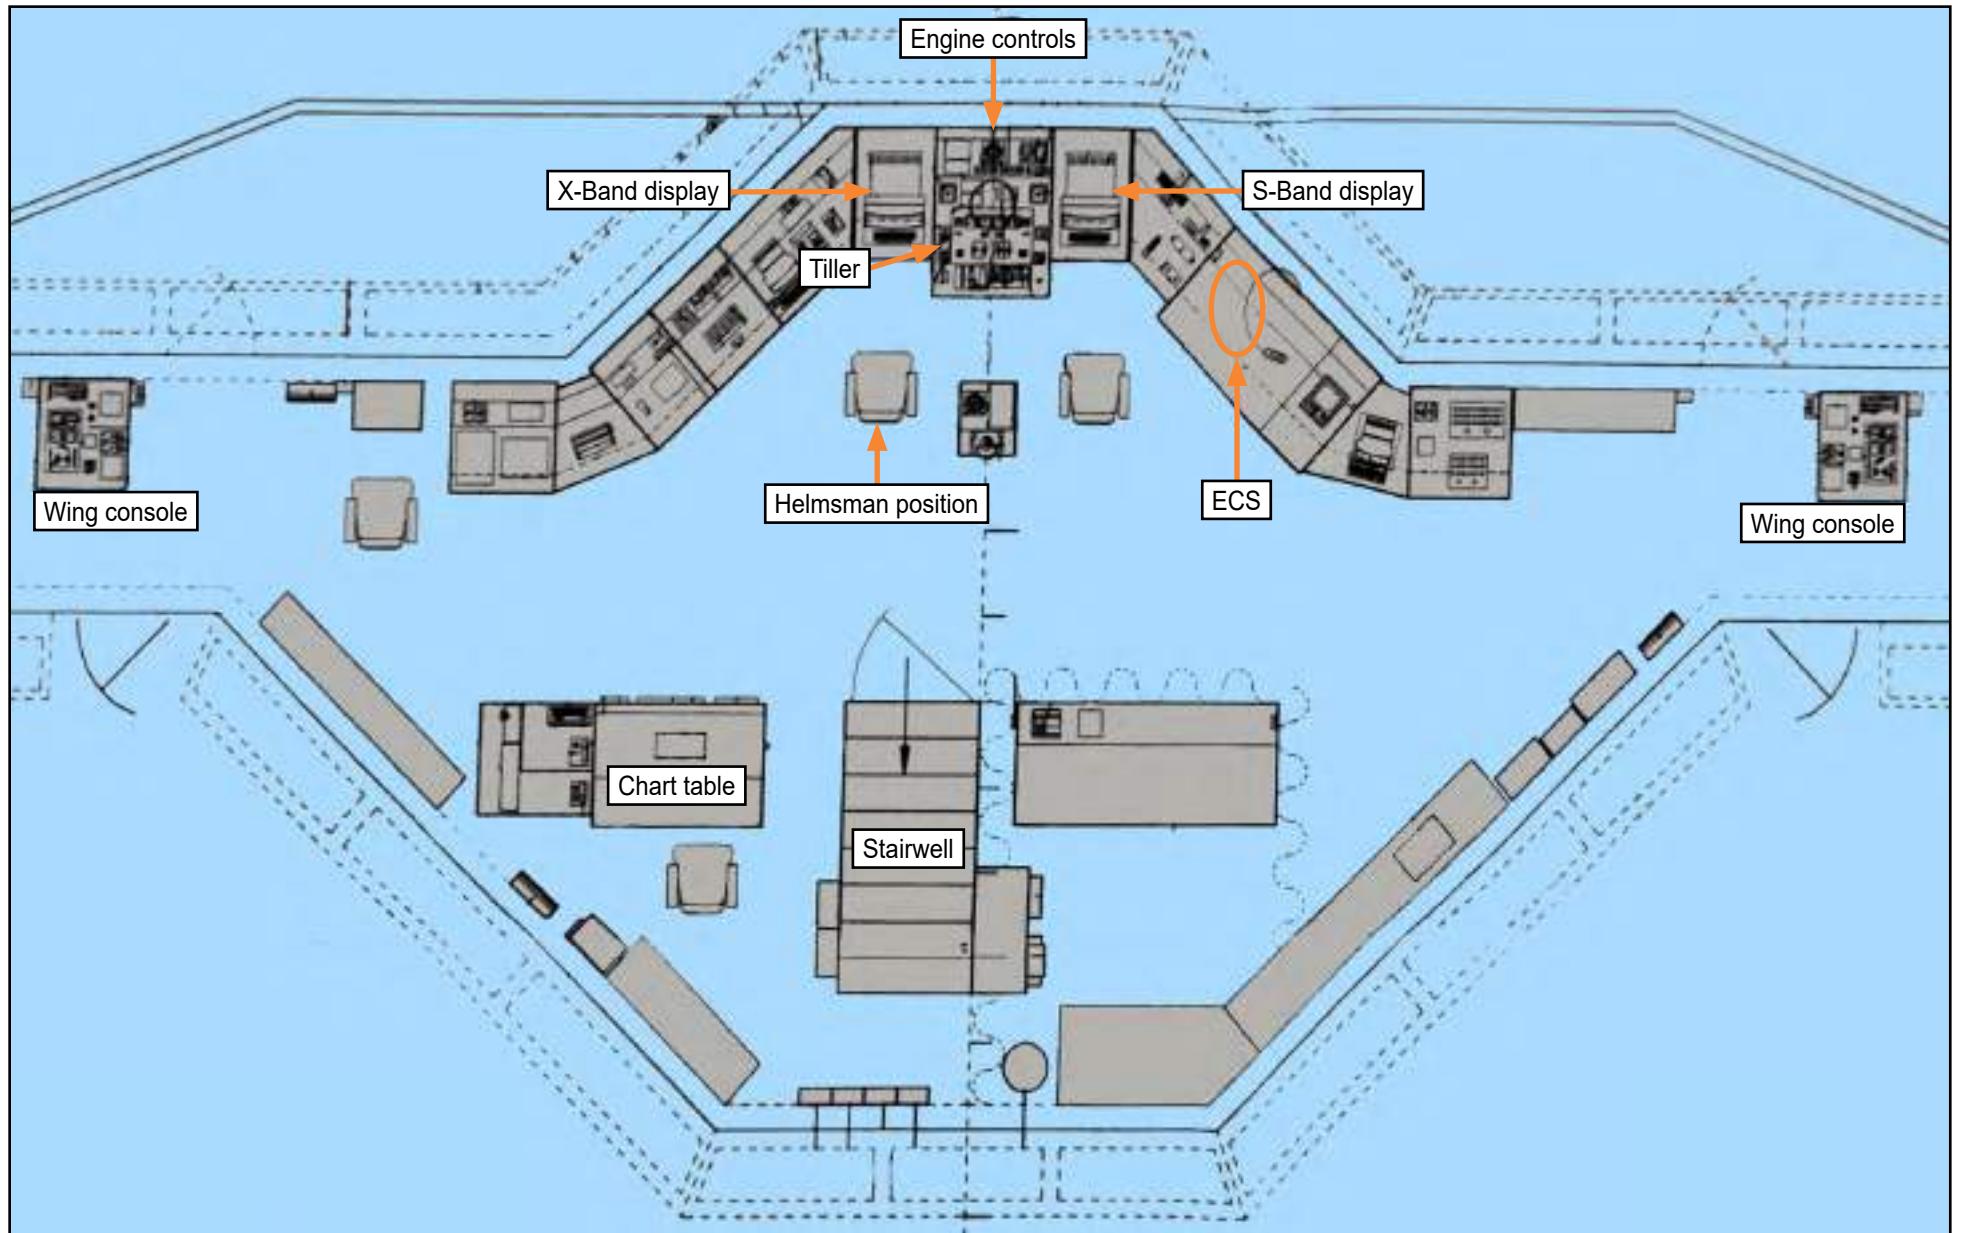
Figure 4: Arrow bridge layout

paper charts as the primary source of chart information, and the ECS was used to improve situational awareness. The ECS was well placed for the master to use but was 2.5m from the PEC holder's conning position (**Figures 4 and 7**) making the display of limited practical use to him.

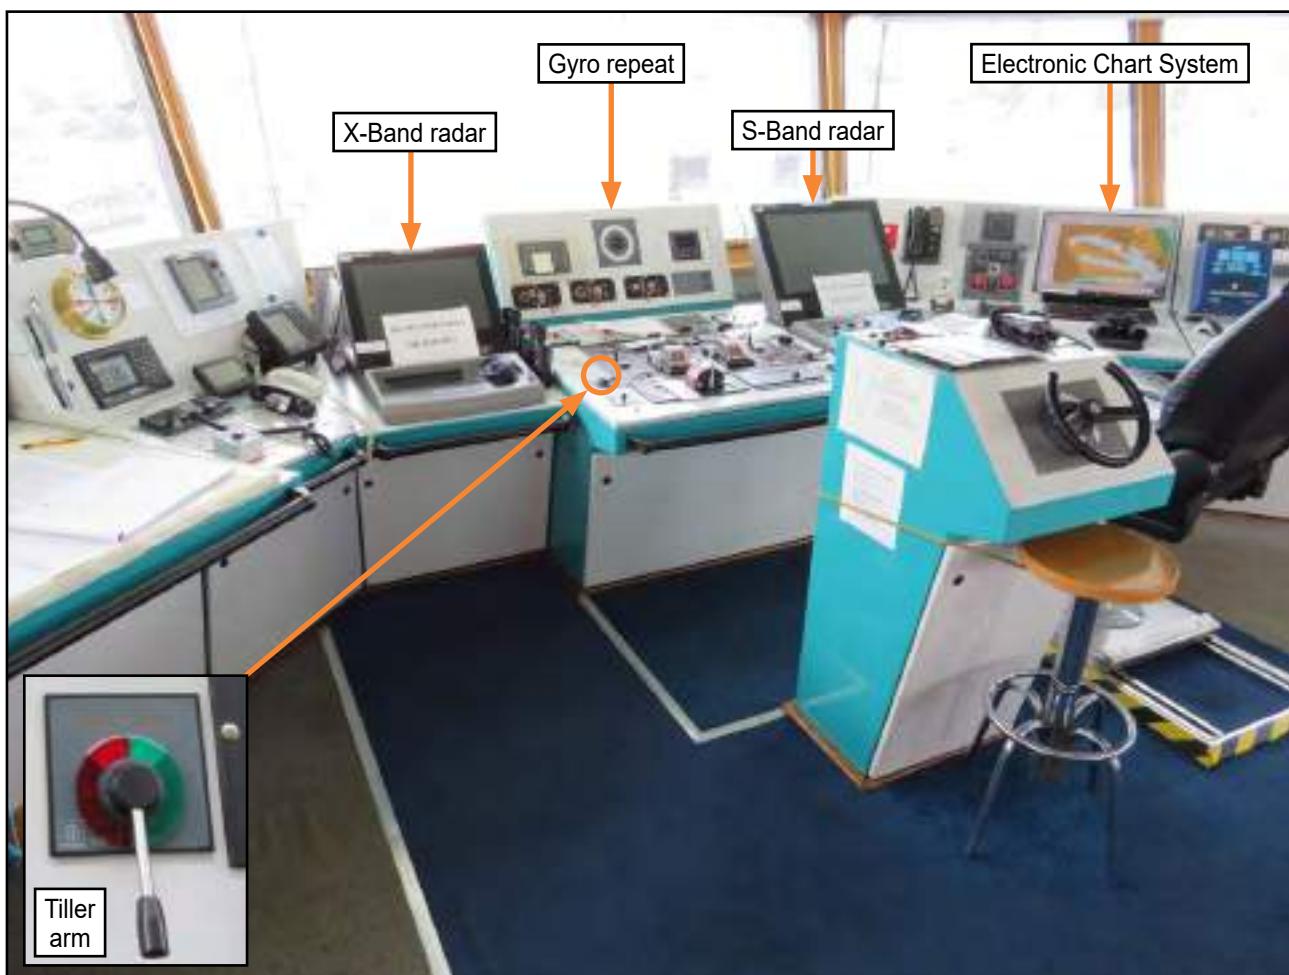
**Figure 7:** Central bridge area layout

It was common practice on *Arrow* for the conning officer to use the X-Band radar and steer the vessel using the tiller arm fitted to the right of the radar display (**Figure 7**). The S-Band radar and ECS were then monitored by either the pilot or PEC holder if the master was conning or the master if the pilot or PEC holder was conning. The ECS display was 2.5m from the X-Band radar display.

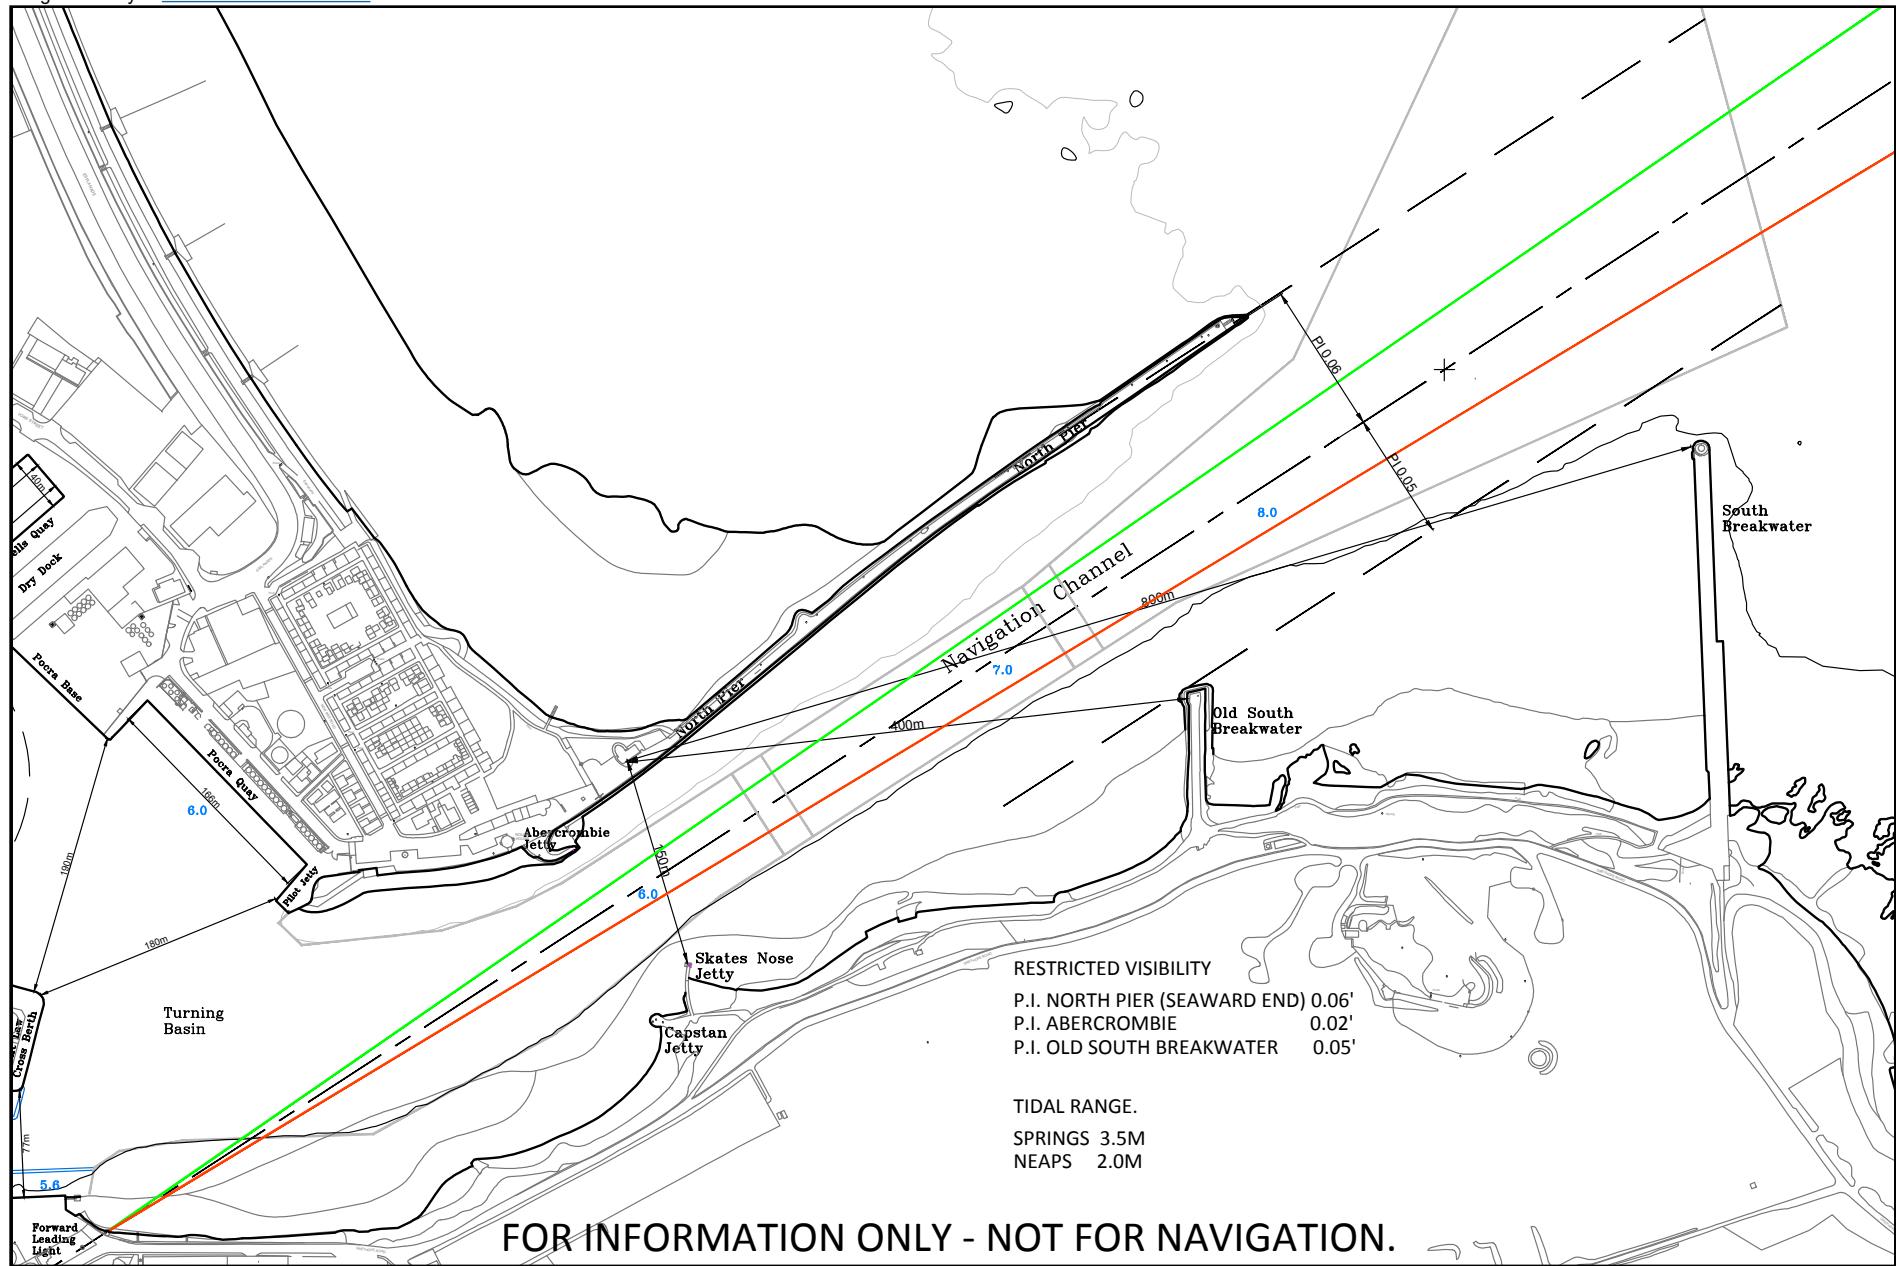
Figure 17: Pilot's handbook – Approach

In clear visibility, the centreline was marked by lit transit marks and a sectored leading light. The port's diagrammatic 'Pilot's Handbook – Approach' (**Figure 17**) gave advice on three PIs – the seaward end of the North Pier at 0.06nm, Abercromby Jetty at 0.02nm and the Old South Breakwater at 0.05nm.

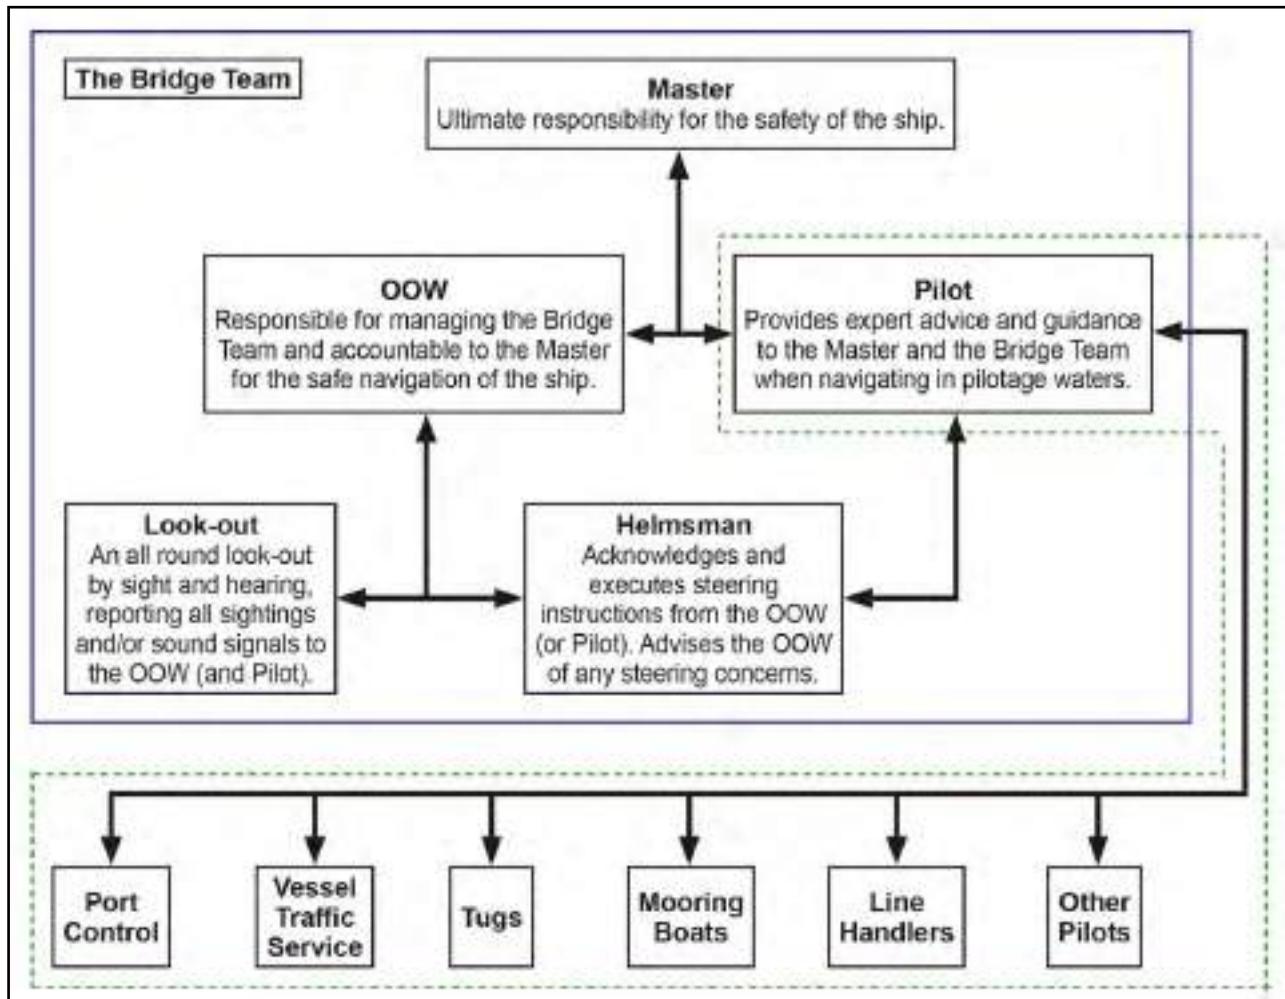
**Figure 18:** *Bridge Procedures Guide* guidance on the roles and responsibilities of the bridge team when a pilot is on board

The *Bridge Procedures Guide* provides a useful diagrammatic representation of how a bridge team should integrate with a pilot and the pilot's place in that team (**Figure 18**). It also makes clear that a PEC holder should act as if they were a pilot. Effectively re-iterating the need for teamwork, the guide states:

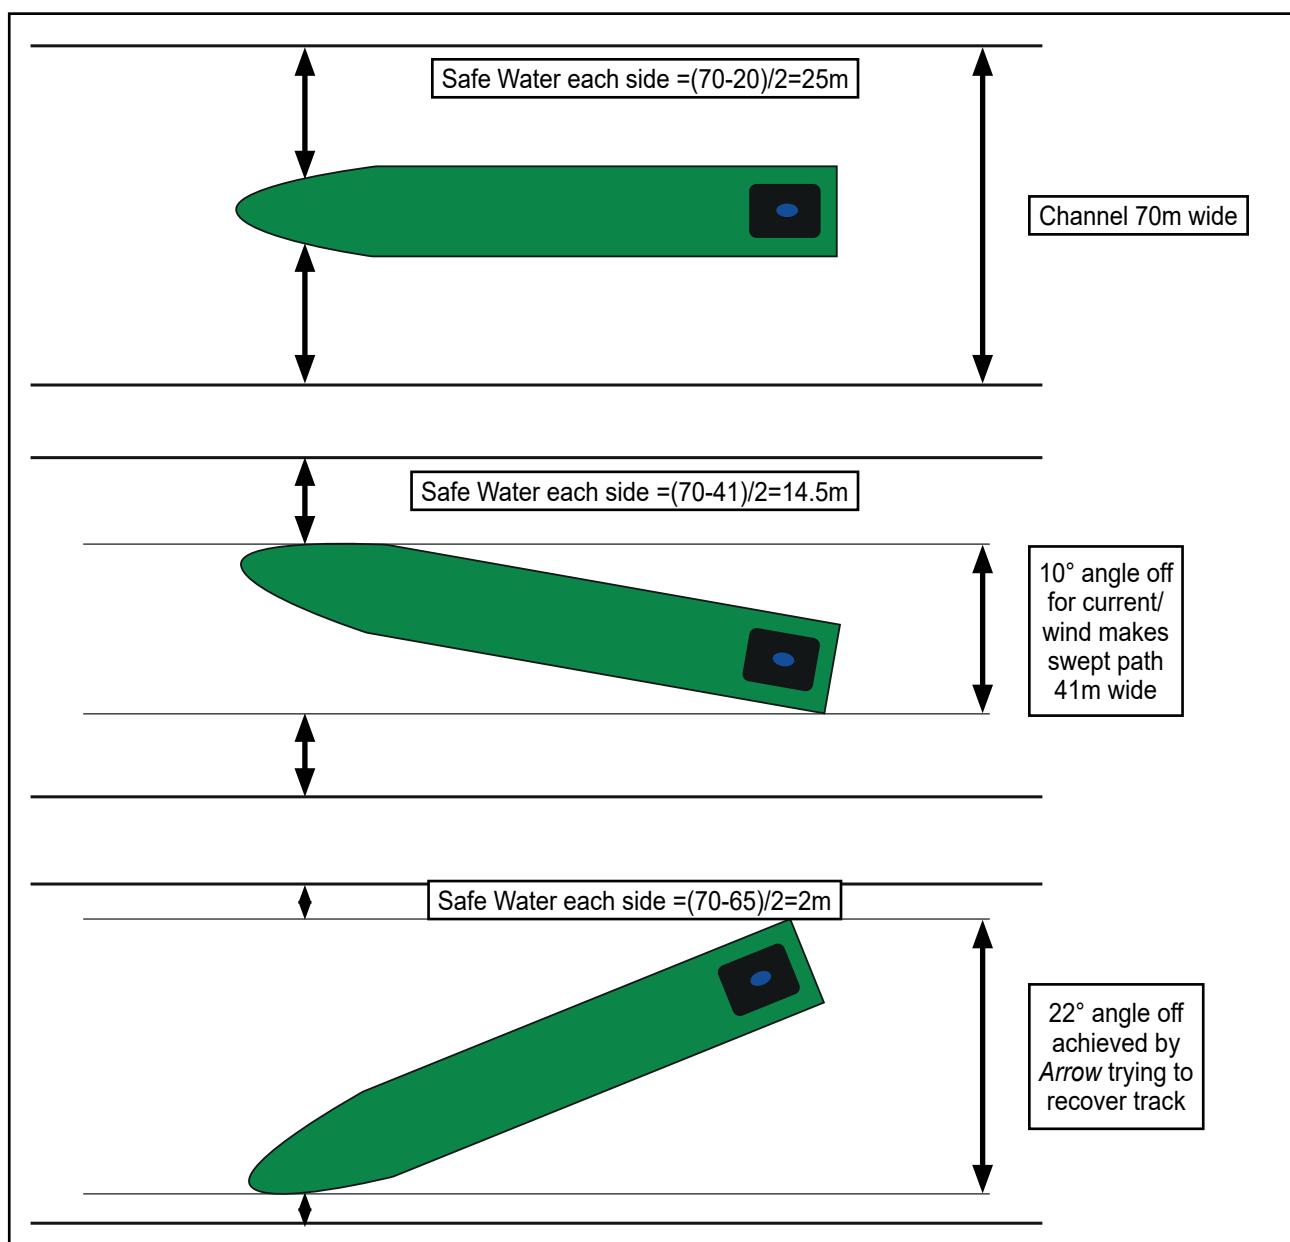
**Figure 19:** Diagrams showing effect on swept path of steering off the base track in a narrow channel

The passage from Lerwick to Aberdeen had been used several times by Arrow on this charter and took the vessel from berth to berth. The ship's paper British Admiralty charts 1446 and 146 (**Figure 10**) had been prepared for the entry, with 'no-go' areas clearly marked. The course marked for the route through the Navigation Channel was '237° – 057°' indicating that the chart was prepared for exits as well as entries. Beyond the 'no-go' areas, there were no clearing bearings or ranges or other safety calculations to indicate how close the vessel could get to danger, nor how far the vessel could be steered off base track and remain safe (**Figure 19**).

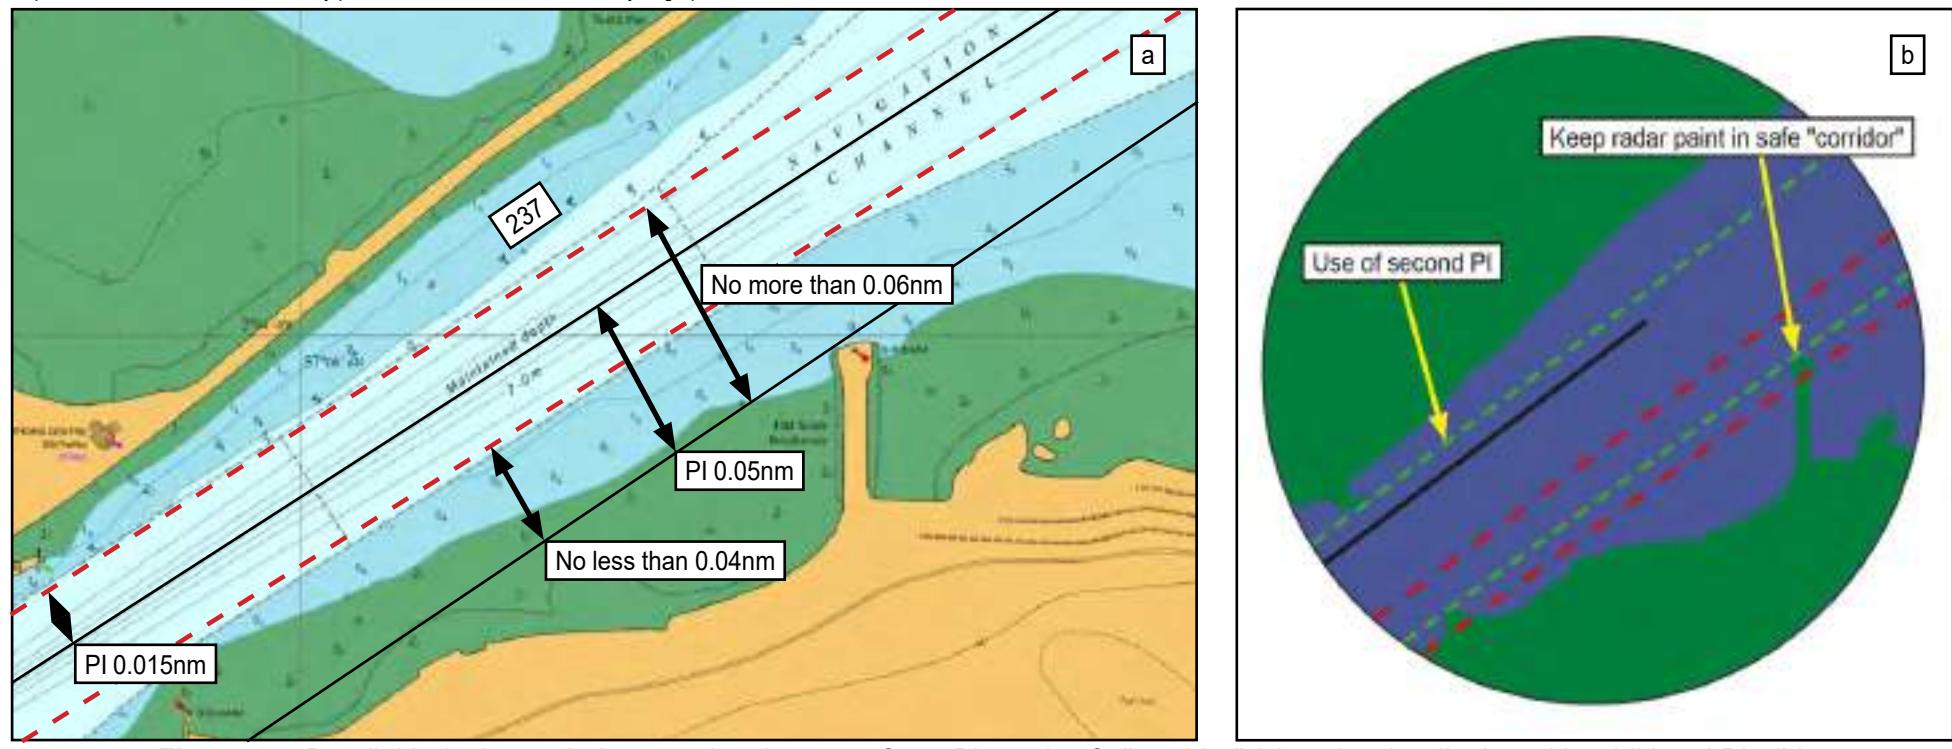
**Figure 20:** Parallel indexing techniques - showing use of two PIs and safe "corridor" (a) and radar display with additional PIs (b)

The use of one PI alone can only accurately give an indication of position if a measuring tool is used to determine distance off track. A more effective use of PIs would be to use multiple PIs to display safety limits, drawing a corridor down which the ship can be safely driven. The use of multiple PIs also allows more than one radar conspicuous mark to be used (**Figure 20**). In this case, Old South Breakwater had disappeared from Arrow's offset radar display (**Figure 21**), which meant that immediately prior to the grounding the PEC holder had no real-time navigational information available. Arrow's radar displays each had the capacity to store four PIs, and with only one track requiring precise navigation, two 'safety corridors' drawn on each display would have provided the bridge team with more information.

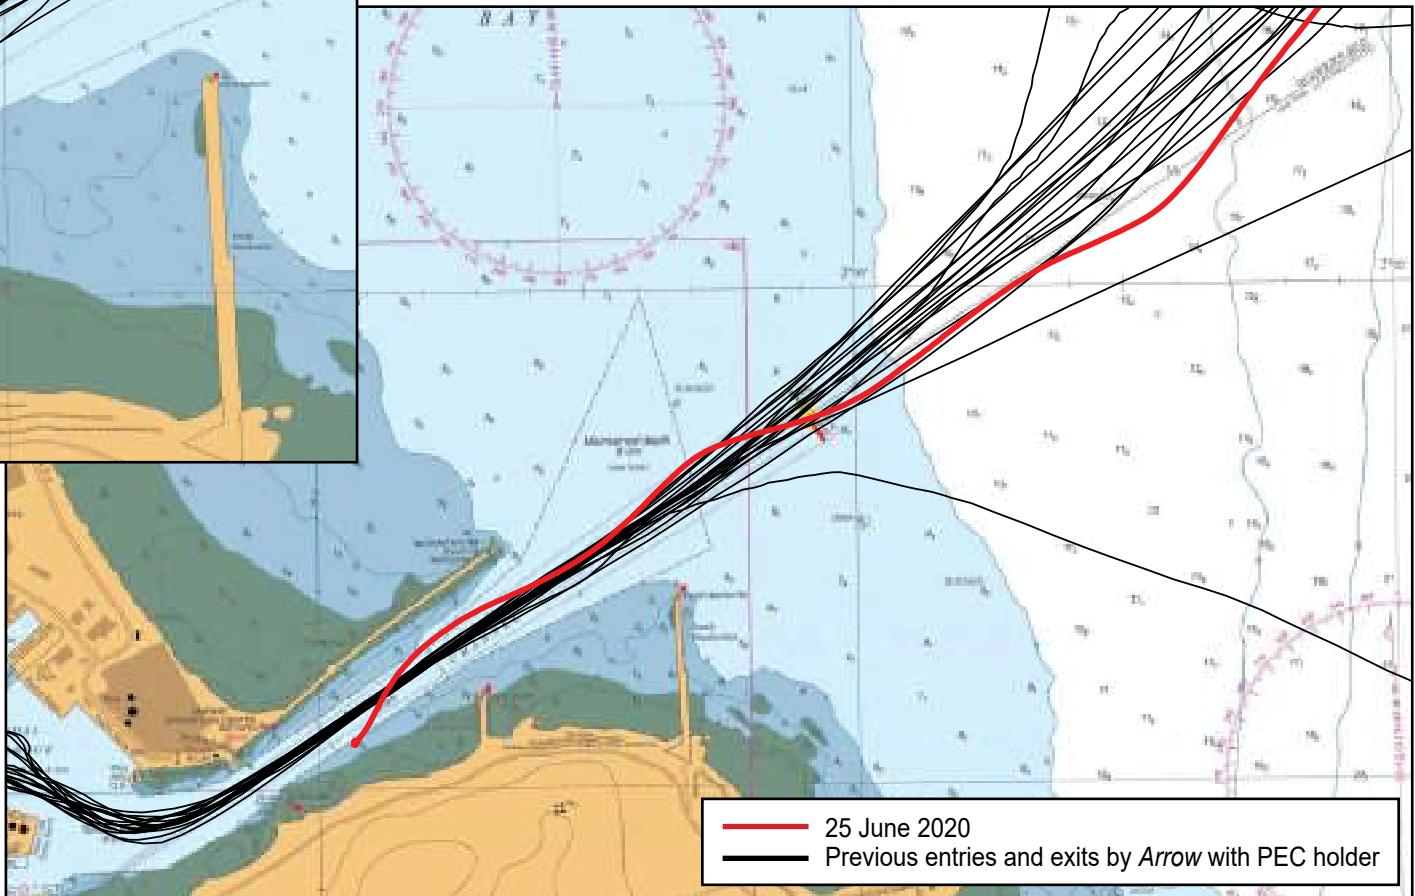
**Figure 22:** Plots of Arrow's tracks into and out of Aberdeen Harbour January to June 2020

Detecting movement trends is much more difficult on a radar display than watching the movement of visual transit marks. Accurate radar navigation requires extremely close attention from the conducting officer. **Figure 22** shows previous entries and exits in good weather, together with the track on 25 June in red. It is highly likely that the PEC holder's ability to simultaneously navigate and steer was degraded to an unsafe level compared to entries and exits conducted in good visibility.
