SAFETY INVESTIGATION REPORT

REPORT NO.: 02/2022

MV FABIO DUO' **Serious injury to a crew member, during crane operations in the port Santa Margherita Ligure, Italy 11 January 2021**

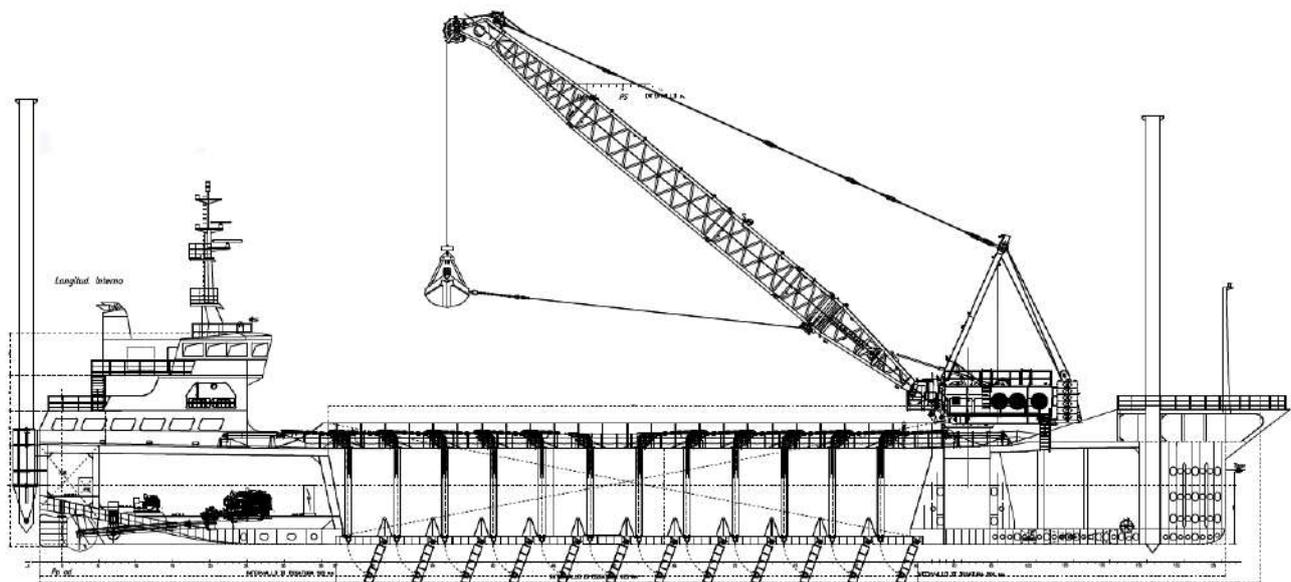
Figure 1: An extract from *Fabio Duo*' GA plan

Fabio Duo (Figure 1) was a general cargo hopper dredger of 2,080 gross tonnage, owned by Intesa Sanpaolo S.P.A. and operated by Monegle Shipping Ltd. of Malta (Company). The vessel was built by Cantiere Navale Vittoria, Adria, Italy, in 2012 and was classed with Registro Italiano Navale (RINA). The vessel had a length overall of 80.90 m, a moulded breadth of 16.00 m and a moulded depth of 5.50 m.

Fabio Duo had a crane on her main deck, capable of lifting a maximum load of 250 metric tonnes, and which was installed forward of her single cargo hold. The vessel's cargo hold measured 40.0 m by 11.0 m by 6.5 m and was not provided with a hatch cover. Access to the cargo hold was via a basket, transferred by the vessel's crane.
