SAFETY INVESTIGATION REPORT

REPORT NO.: 05/2022

March 2022

MT SEASCOUT **Explosion leading to equipment** **and structural damages** **in position 21° 07.1' N 059° 31.9' E** **18 March 2021**

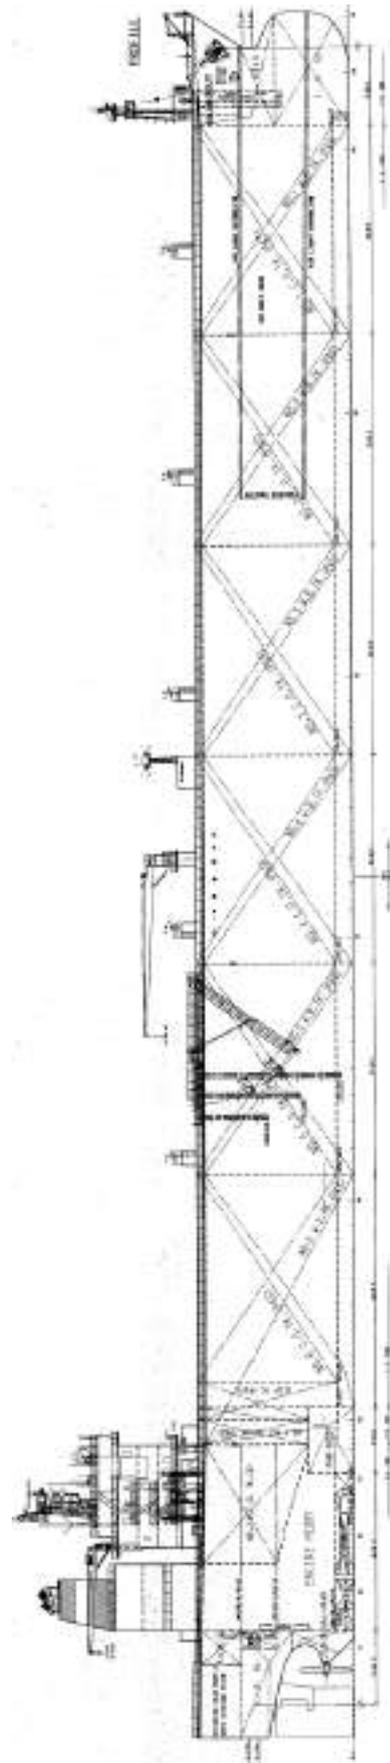
Figure 1: An extract from the vessel's general arrangement plan

Seascout (Figure 1) was a 57,301 gt, double-hull oil tanker, owned by Valiant Sailor Marine Inc. and managed by Thenamaris Ships Management, Greece (the Company). *Seascout* was built in 2004, by Hyundai Samho Heavy Industry Co. Ltd. in the Republic of Korea and was classed with Lloyd's Register of Shipping (LR).

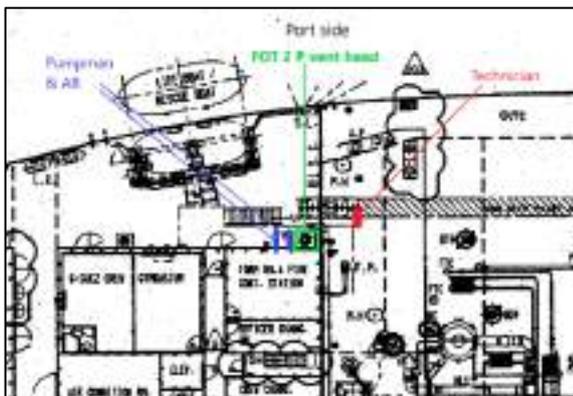
Figure 2: Extract from the General Arrangement plan indicating the location of the crew members and the technician prior to occurrence

The pumpman and the AB, who were close-by on deck (Figure 2), were installing a new isolation valve on the fire line, when they heard the angle grinder running.

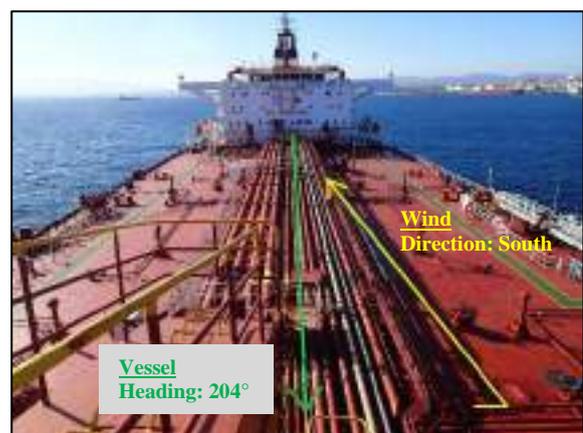
Figure 6: Wind direction relative to the vessel's heading

Two days prior to arrival at the dry-docks, heating of the FOT was gradually increased to 48°C, which was well beyond the recommended storage temperature. The rationale behind this increase was that tank heating would have to be stopped during the vessel's stay in the dry-dock, although the fuel would still need to be kept at the recommended temperature; otherwise, the crew would risk the fuel becoming unpumpable.

Heating up of the fuel closer to its flashpoint must have resulted in an increased generation of gases, which would ultimately be vented to the atmosphere via the tank's vent head. It so happened that for most of 18 March 2021, the vessel was heading on a course of 204° (T), at a speed of about 12 knots. Wind was blowing from the South at a speed of 11 knots (Figure 6). This would have created an apparent wind of around 22 knots approaching the vessel at a close angle on its port side (Figure 7).
