# Fire aboard Roll-on/Roll-off Vehicle Carrier *Höegh Xiamen*

Pier 20, Blount Island

Jacksonville, Florida

June 4, 2020

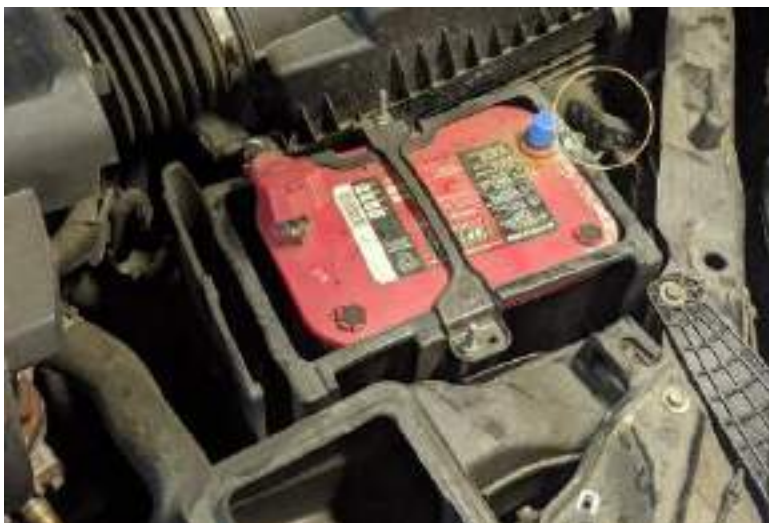
Grimaldi instructed SSA to create a "battery brigade" of ILA longshoremen who would be solely responsible for following behind vehicles as they were loaded and parked in order to disconnect the batteries. The brigade was required to disconnect the negative cable from the battery, tuck the cable away from the battery terminal, and cover the battery post with the battery cap (see figure 12). Once the cable was disconnected and the hood was shut, the brigade would mark the unit with grease marker to identify the vehicle as having a disconnected battery. Before loading, on May 22, 2020, the Grimaldi port captain emailed the company's written procedure to SSA and instructed, "Please note that I can't stress enough the importance of battery disconnect. Please ensure to have battery caps and adequate mechanics ordered to keep up with production."

**Figure 12.** Excerpt from Grimaldi battery disconnect procedure showing a vehicle battery secured with a blue plastic negative terminal cap and disconnected cable (*circled*) tucked inside. (Source: Grimaldi)
