SAFETY DIGEST

Lessons from Marine Accident Reports

1/2022

MARINE ACCIDENT INVESTIGATION BRANCH

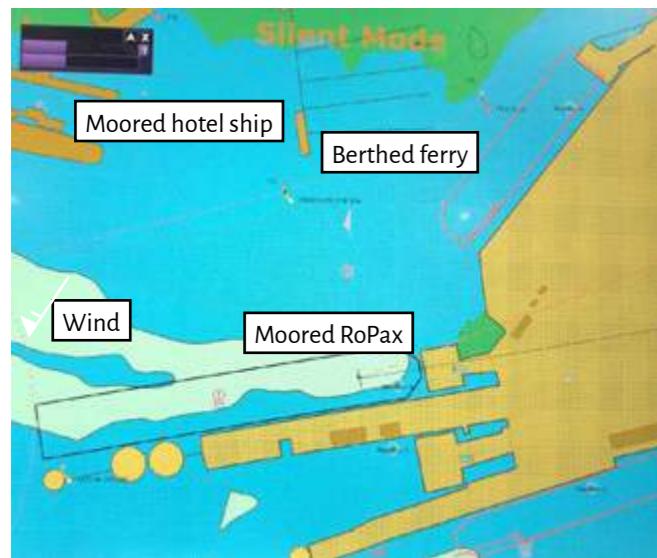
Figure 1: RoPax alongside before the moorings parted

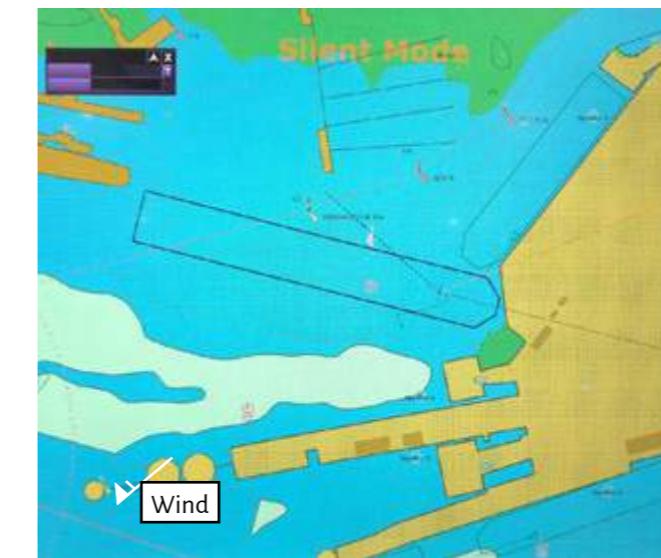
Noticing what was happening, the pilot asked the master to apply more thrust to be told that it was not possible while the engines were being clutched in (Figure 3). Concerned that the bow would contact this moored vessel, the pilot ordered the tugs to stop pulling the stern round and shortly afterwards, with astern momentum already in place, the RoPax made light contact with the moored hotel ship as it drifted downwind (Figure 4).

Figure 3: The point where the pilot was told that the bow thrusters were unavailable

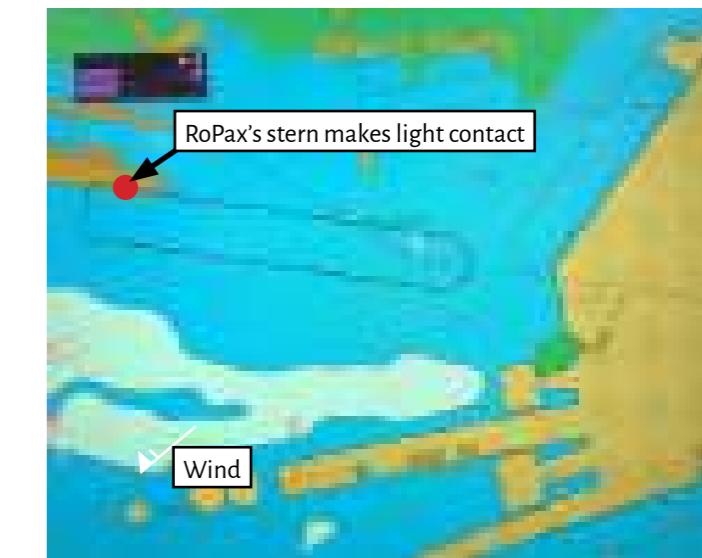
A dive survey and damage assessment concluded that the RoPax had suffered minor damage.

Figure 4: Light contact was made with the hotel ship

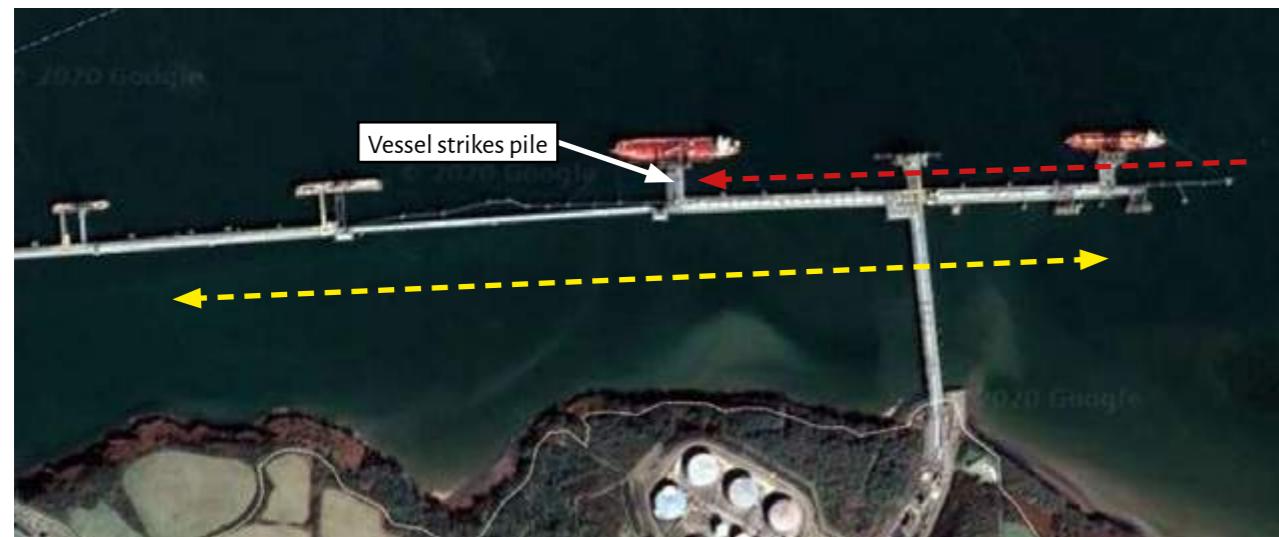
their patrol from the offshore side of the jetty. However, in an attempt to finish it quickly, the coxswain took the workboat under the access roads (Figure 1). The vessel safely passed under the first two access roads in a westerly direction, but when passing under the third it was pushed bodily to starboard by a wave and the port bow made heavy contact with a pile.

Figure 1: Workboat patrol route

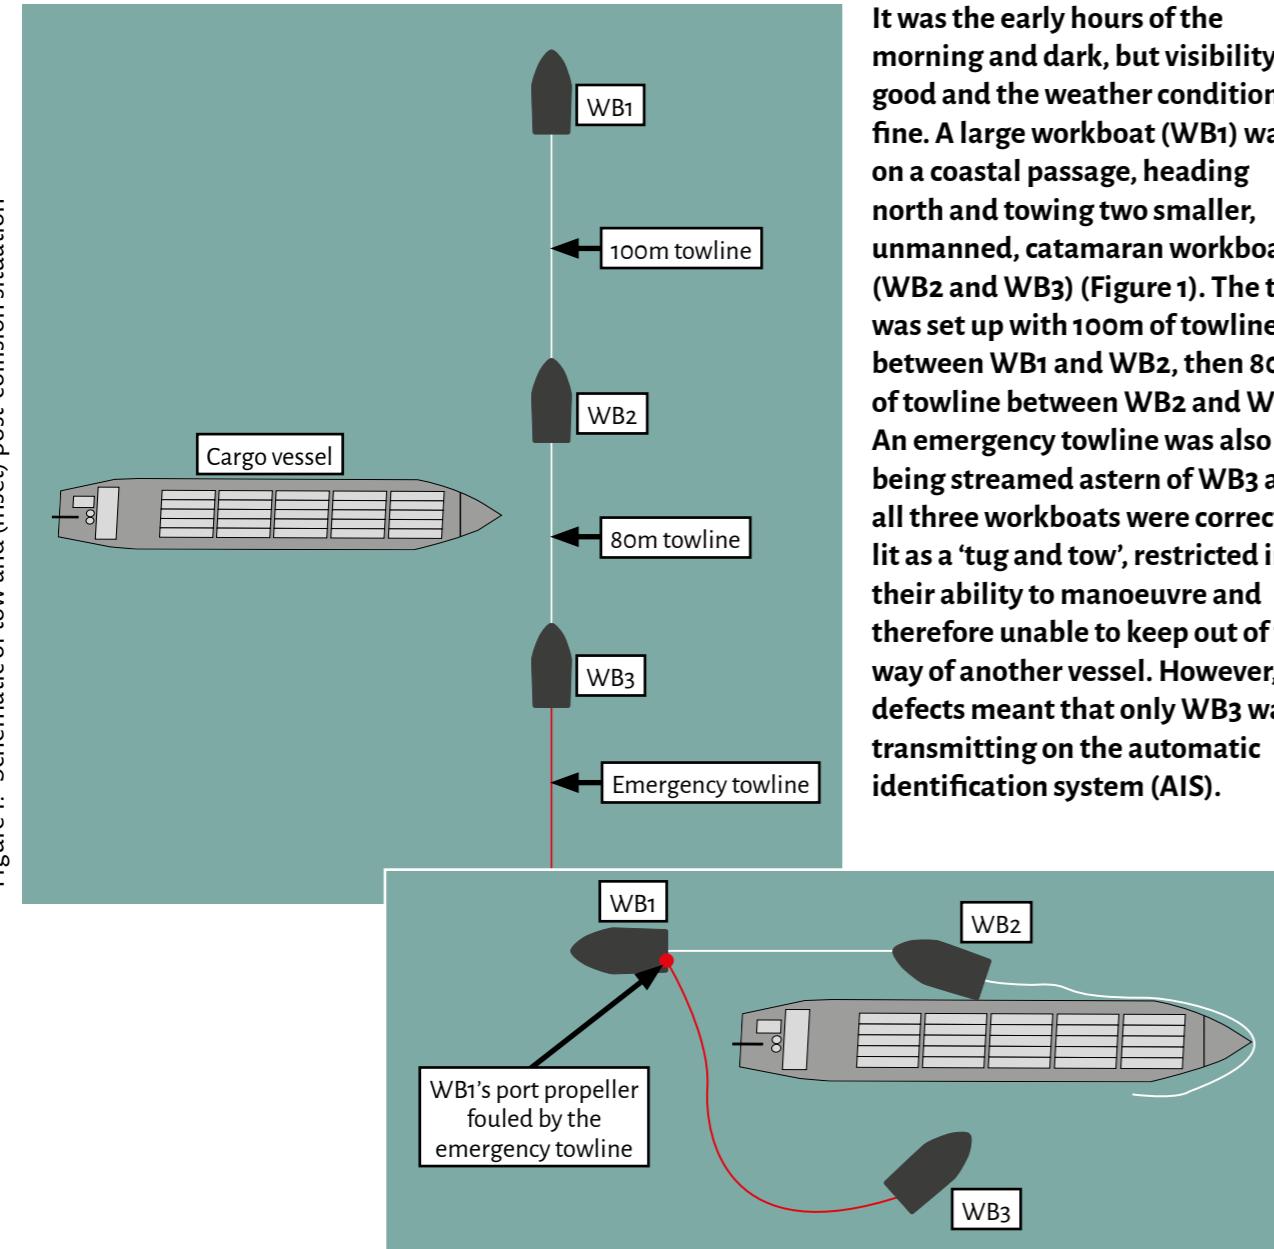
WB1's crew were increasingly concerned about the situation and used a searchlight to try and attract the cargo vessel OOW's attention. WB1's crew also tried hailing the cargo vessel by very high frequency (VHF) radio; this warning came too late and the cargo vessel passed between WB2 and WB3, severing the towline and casting WB3 adrift (Figure 1, inset).

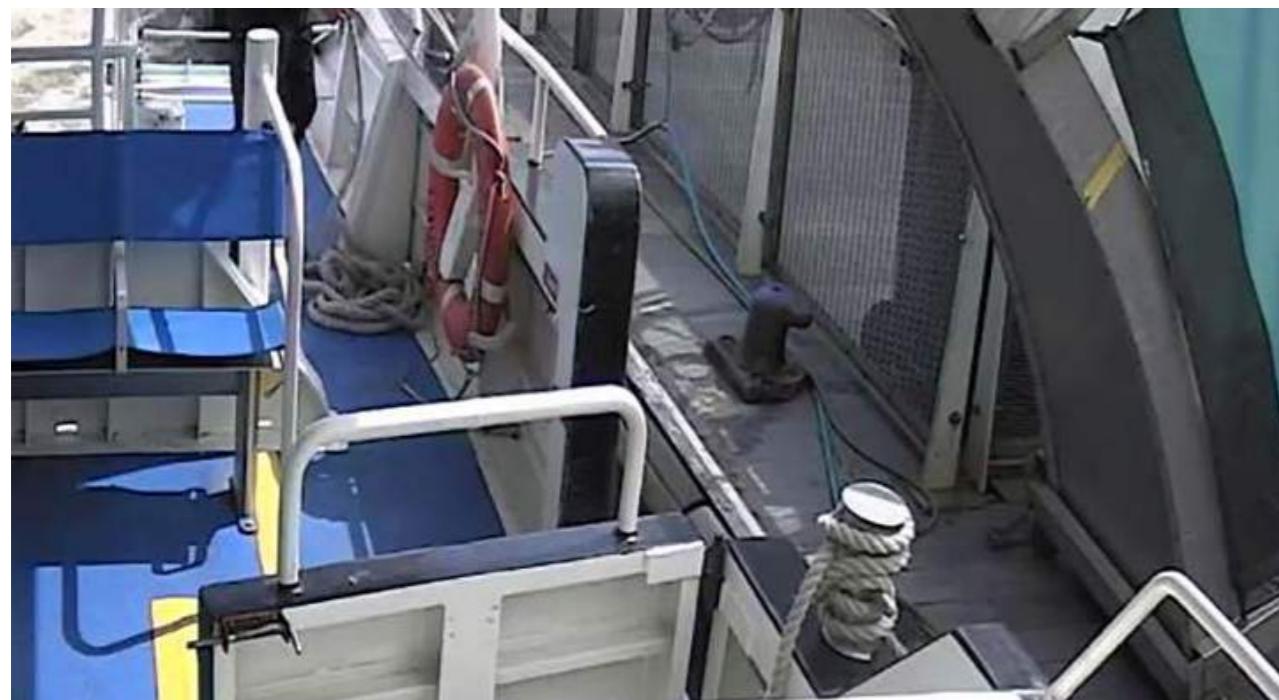
Figure 1: Shore gangway raised, and the stern line cast off

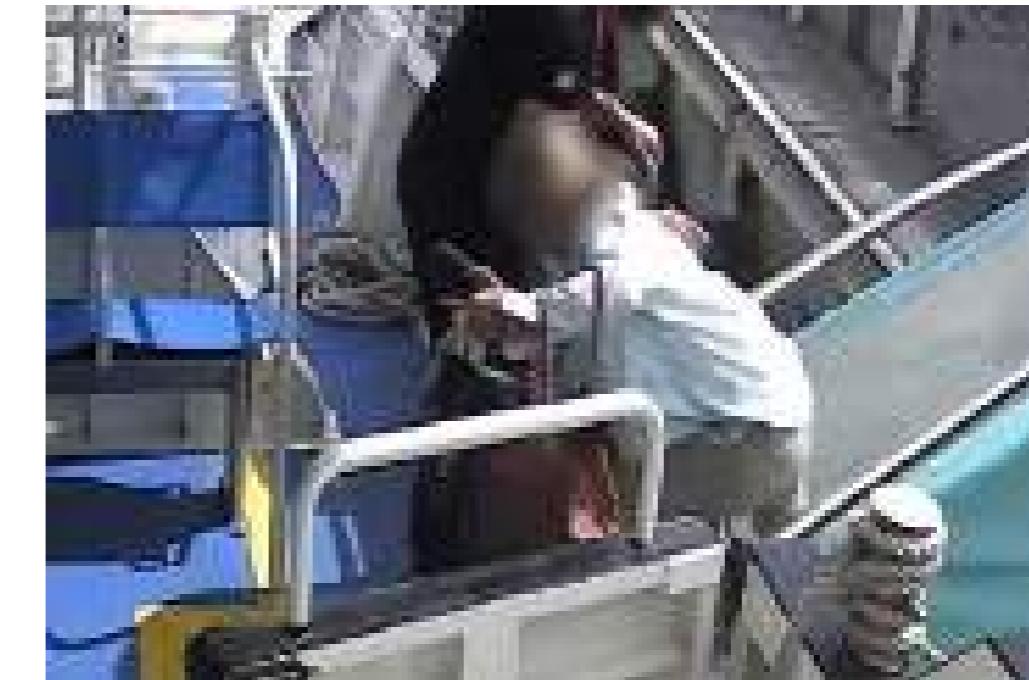
As the final passengers were stepping on board, the second ferry propelled ahead. The second ferry's propeller wash caused the stern to swing out and the gangway fell off the embarkation point. The passenger on the gangway at the time stumbled (Figure 2) and could have fallen into the sea; the crewman realised what was happening and grabbed the passenger, preventing this.

Figure 2: The stumbling passenger as the gangway fell off the ferry's embarkation point

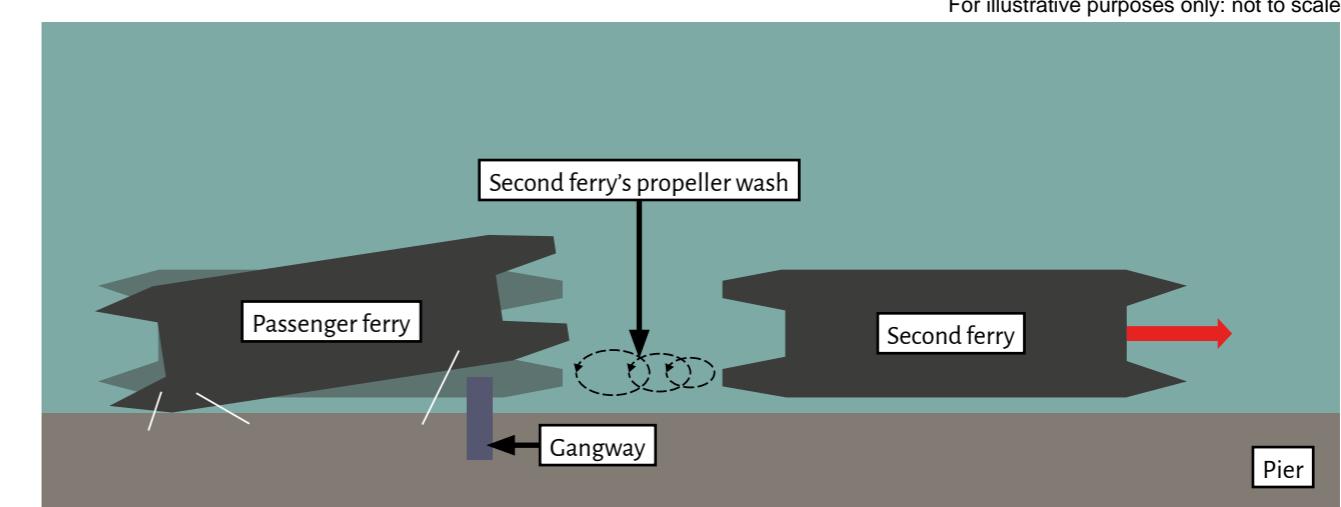
Figure 3: The effect of the second ferry's propeller wash, with no stern line attached

- Observe** → It was unsafe to embark more passengers after the stern line had been released. The ferry was not properly made fast and became vulnerable to the effect of the second ferry's propeller wash (Figure 3). Communication between the bridge and the mooring deck is key to ensuring that crew know and understand the full situation, particularly where such evolutions can be very repetitive. It is also important for bridge teams to monitor the embarkation point closed-circuit television (CCTV), if provided, to maintain a good awareness of passenger movements.

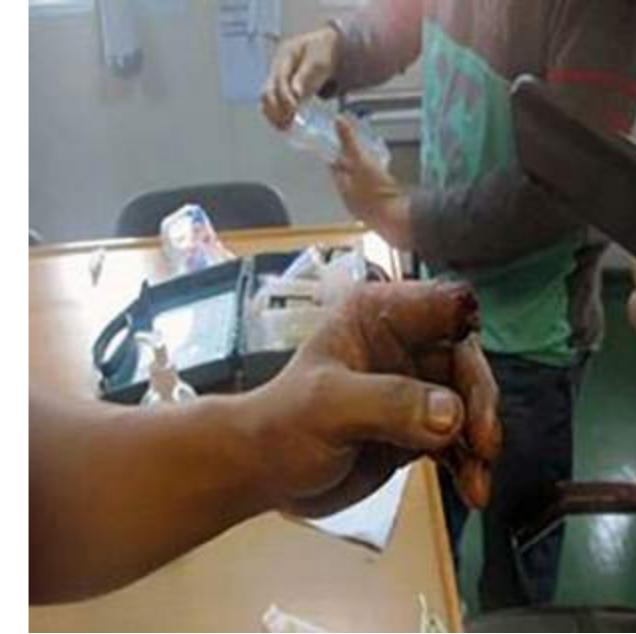
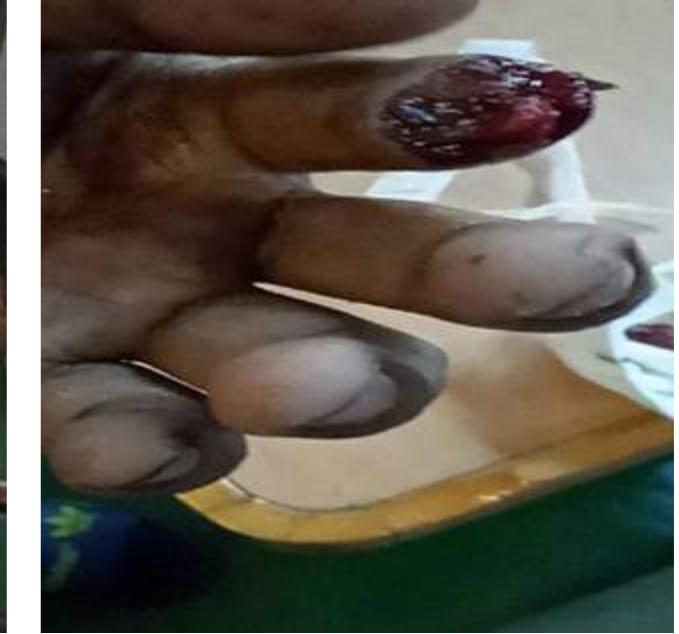
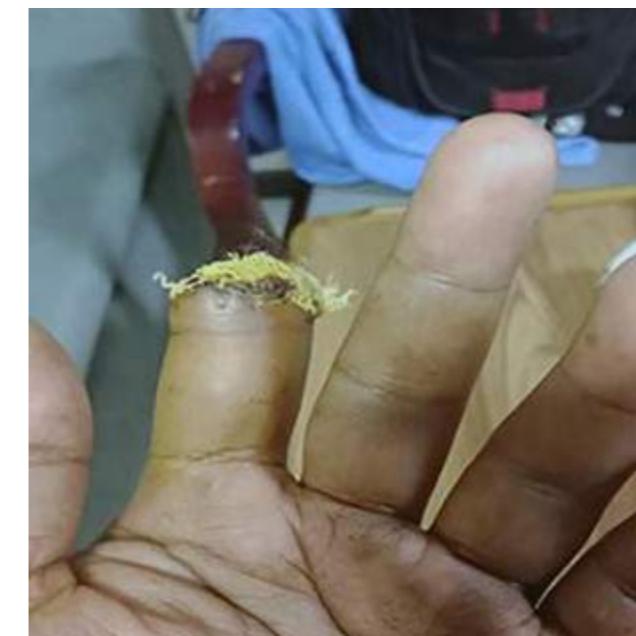
Figure 2: Severed finger at the time of the accident (top) and after hospital treatment (bottom)

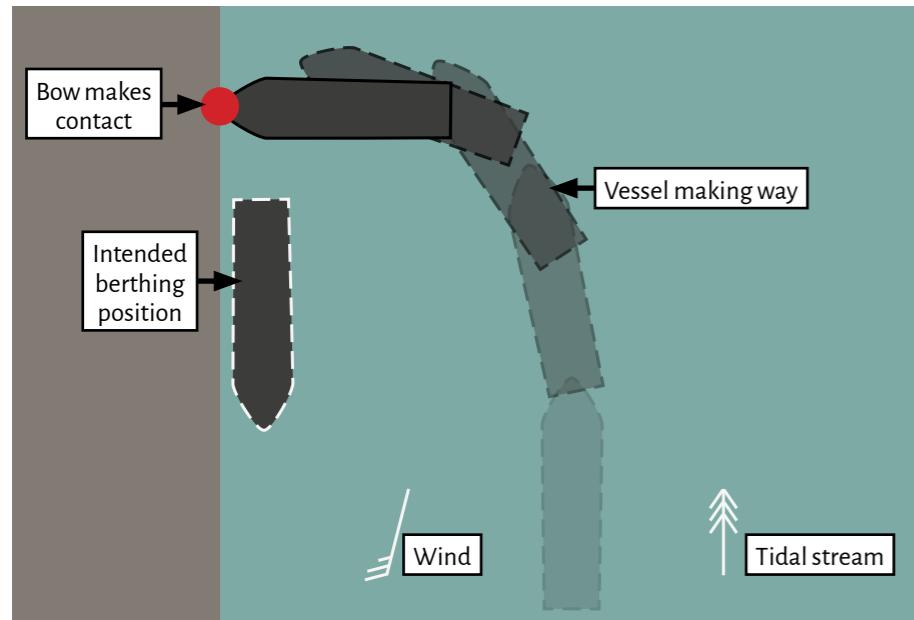
Figure 1: Vessel's track, including environmental effects

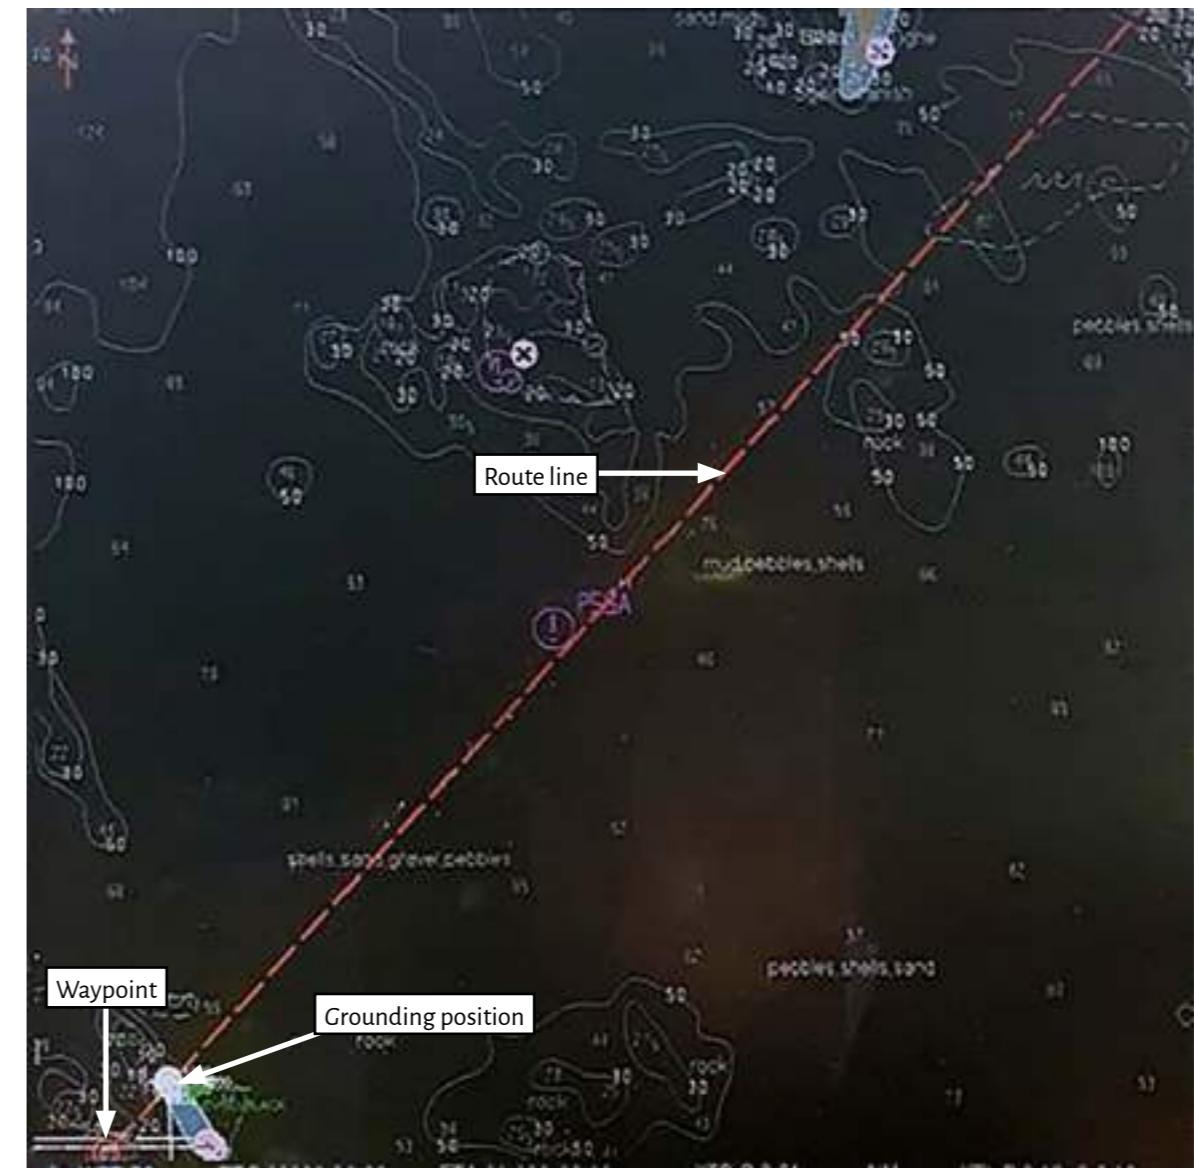
Figure 2: The passage plan took the vessel directly over the shoal

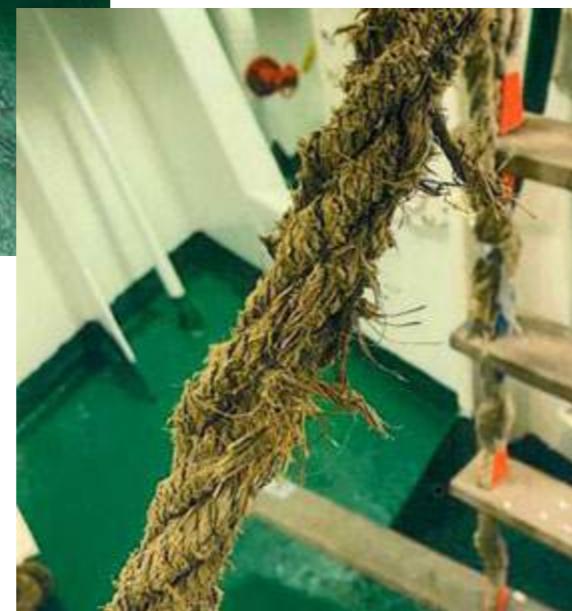
failures were a consequence of the side ropes' poor condition, which a routine visual inspection would almost certainly have detected. If the side ropes are frayed, or in any way degraded, do not use the ladder. Pilot ladders should be less than 30 months old; the year of assembly or reassembly can be found on the identification plate usually located on the lower spreader (Figure 3).

Figure 3: Failed pilot ladder, showing ladder identification plate location

The pilot ladder should be safely rigged. Reported incidents include inappropriate rigging arrangements such as the use of shackles or ladders attached to guardrails. Pilot ladders should be secured to deck strong points by a rope stopper lashed to the ladder's side ropes. When rigged, the steps should be horizontal, clean, in good condition and evenly spaced. There should be a maximum of two replacement steps.

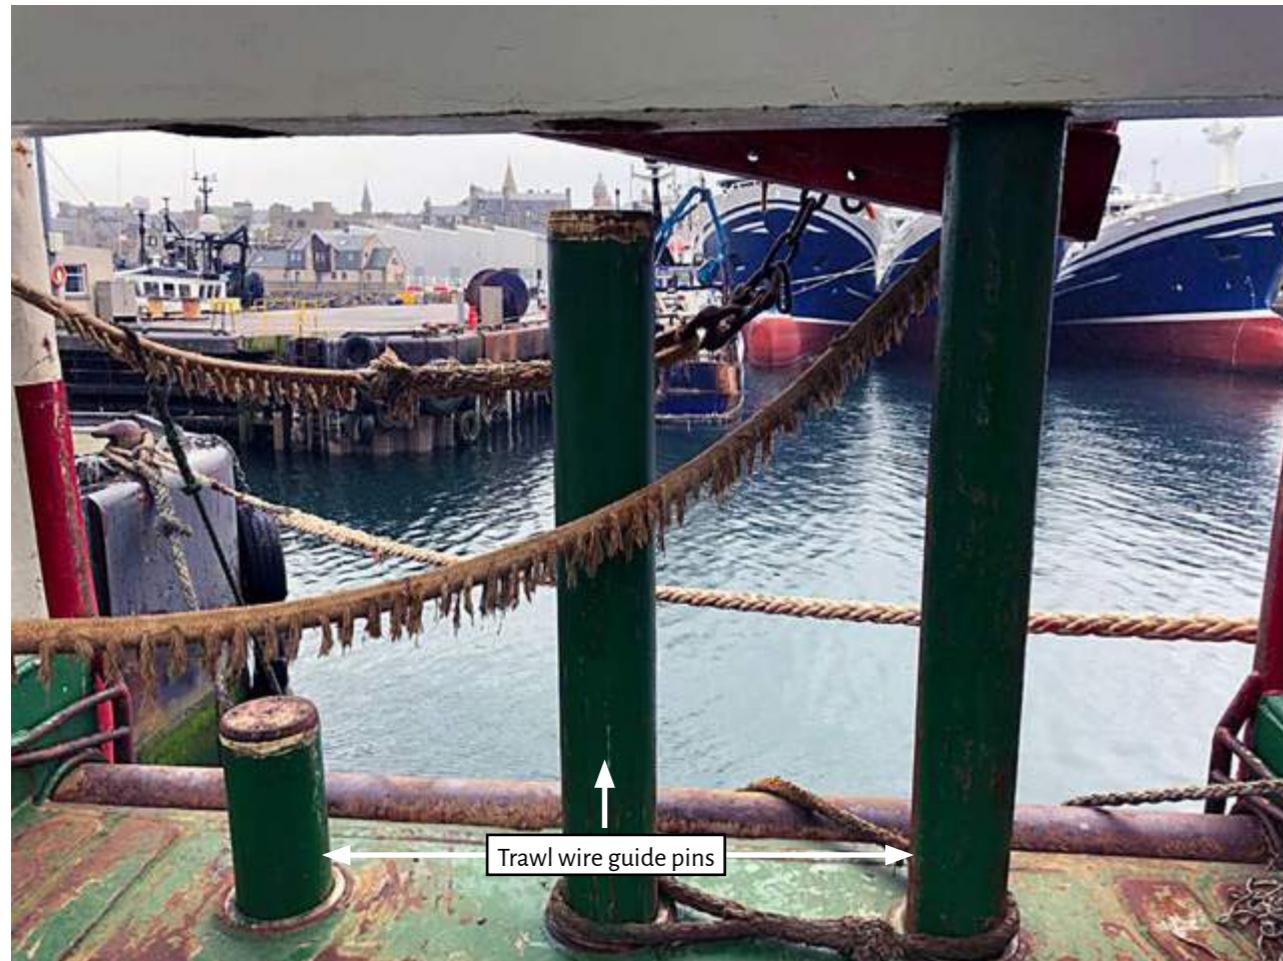
The vessel was fitted with three 15cm diameter pins on each side of the boat. Hydraulically operated, they rose out of the deck and located into sockets in the deckhead (Figure 1).

Figure 1: Hydraulic trawl wire guide pins at stern of vessel

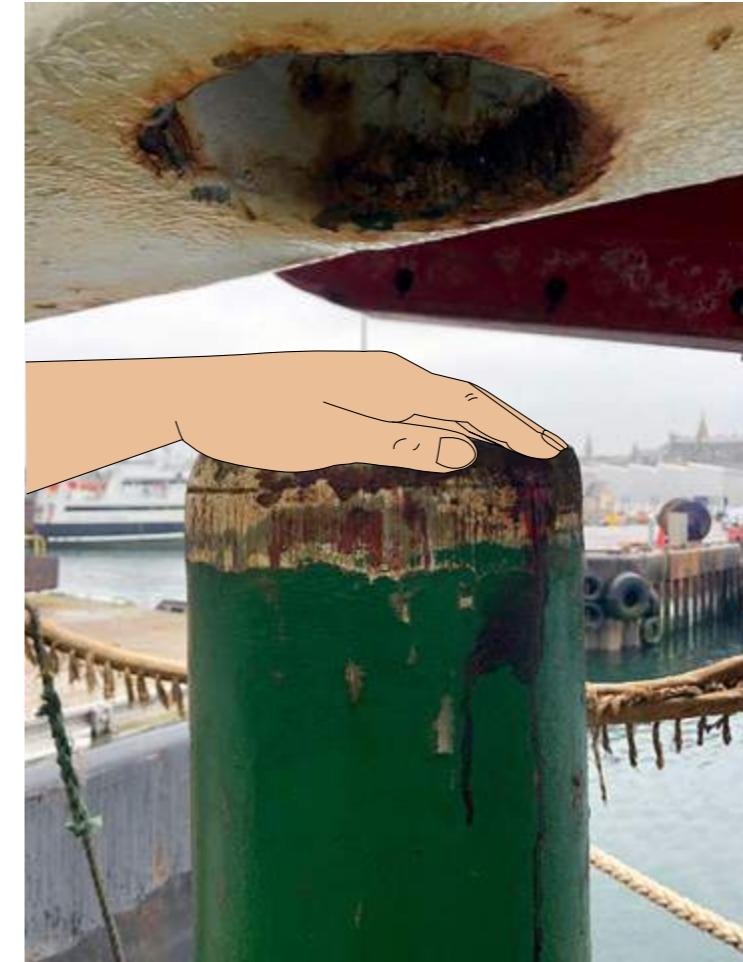
Figure 2: Top of guide pin and deckhead socket

crew member operating the hydraulic controls. His hand was then caught between the pin and the deckhead (Figure 2).

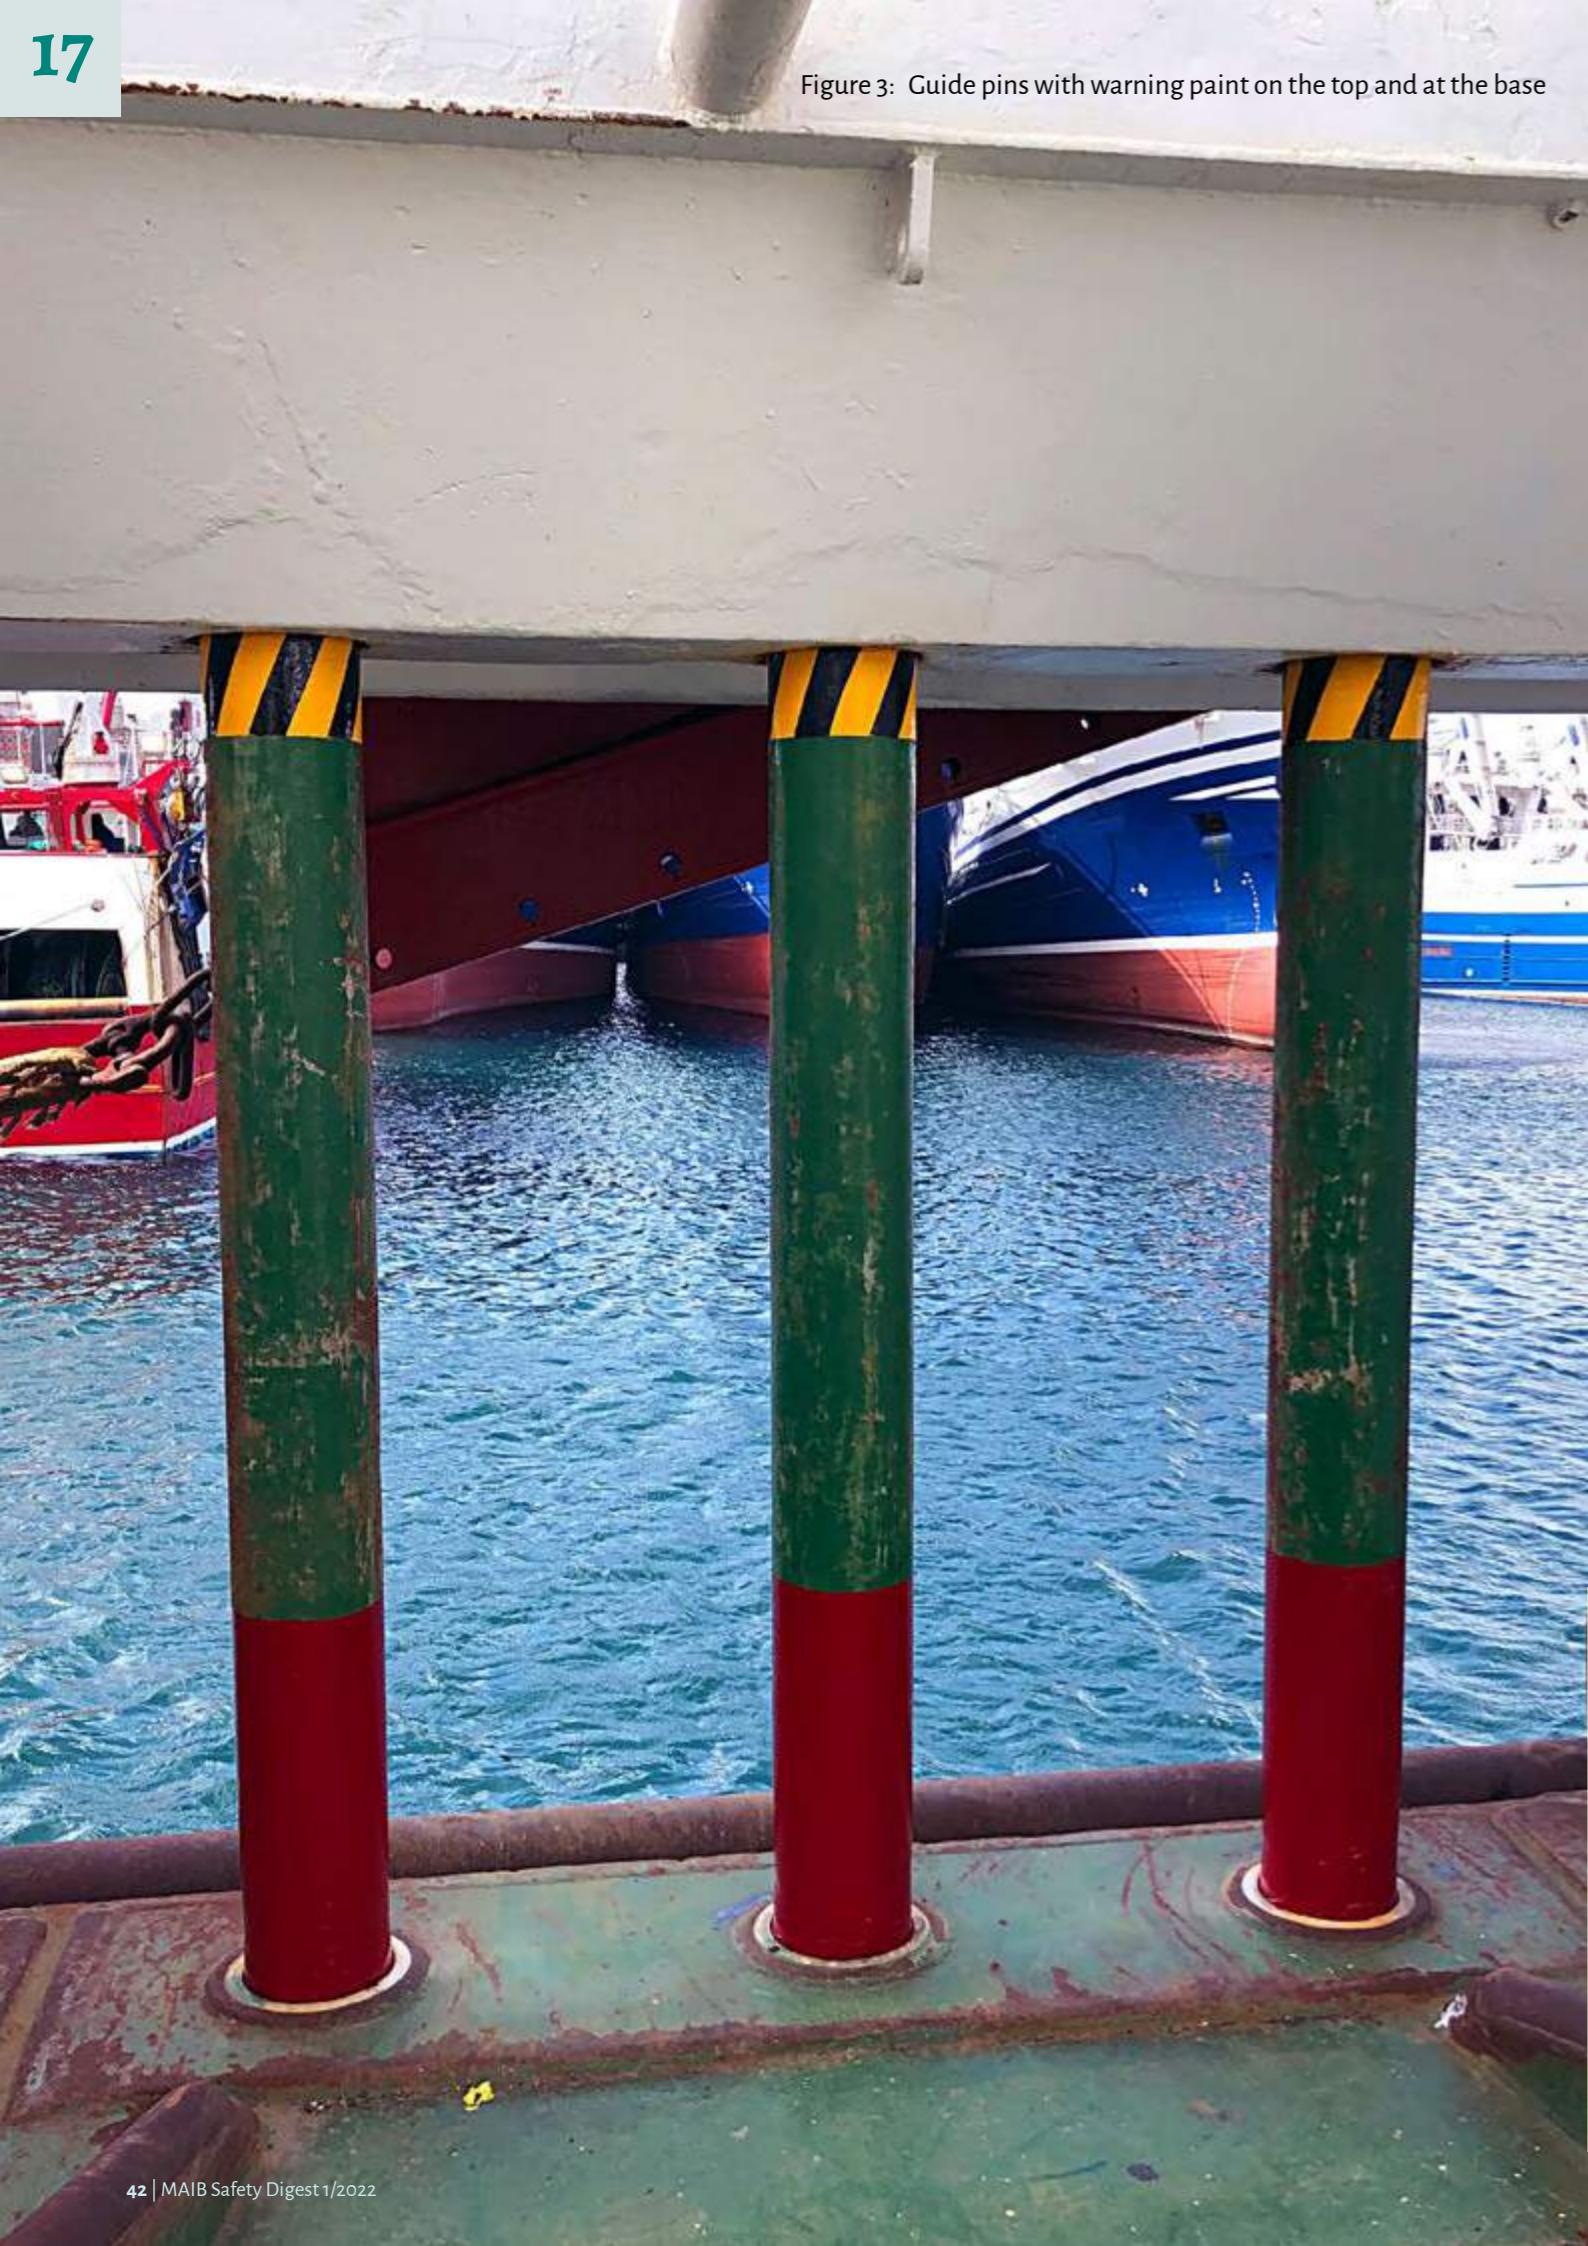
Figure 3: Guide pins with warning paint on the top and at the base

The company that owned the fishing vessel completed an accident investigation and a review of its risk assessments. Among the mitigating measures identified, it undertook to paint warning marks both on the top and bottom of each pin so that the red warning paint on the bottom appeared when the pin was raised (Figure 3).

2. **Hazard** → In this case, the crew member absentmindedly placed his hand into a dangerous location. The company has taken steps to visually highlight the danger zone to remind workers of potential hazards. Emphasising hazards or hazardous areas around a vessel is a simple, cheap and effective means of reducing risks and can become part of onboard training. Getting crew to identify hazards and then to highlight them can be an effective means of safety management engagement on board any vessel.

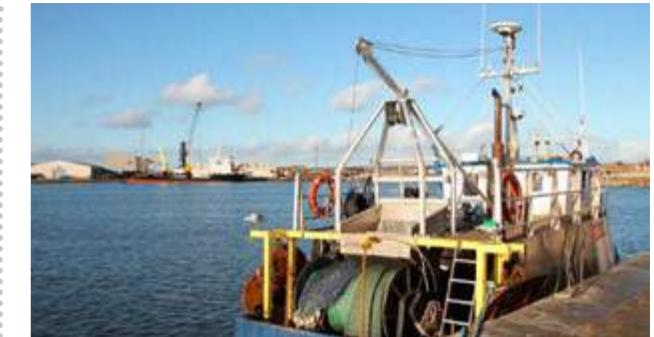
During the early hours of the morning, before daylight, the two crew on board a 10 metre trawler (see figure) were preparing for their second haul of the night. The weather was fine with a slight swell as the skipper and crewman, neither of whom was wearing a personal flotation device (PFD), made their way onto the deck. The boat was underway, steering by autopilot as the nets were hauled to the surface. The skipper was working the winch while the crewman waited for the net to be positioned so that he could release the catch from the cod end into the reception hopper on the shelter deck. However, as the cod end was raised it became caught on the lip of the hopper so the crewman climbed up onto the net drum to pull it into the correct position.

When the crewman pulled on the netting to reposition the net, the section he was pulling suddenly broke and came away in his hand. The crewman lost his balance and fell from the net drum to the deck below; landing upright on his feet he almost sat on the bulwark, but his momentum carried him backwards over the bulwark and into the sea.

Figure: The trawler

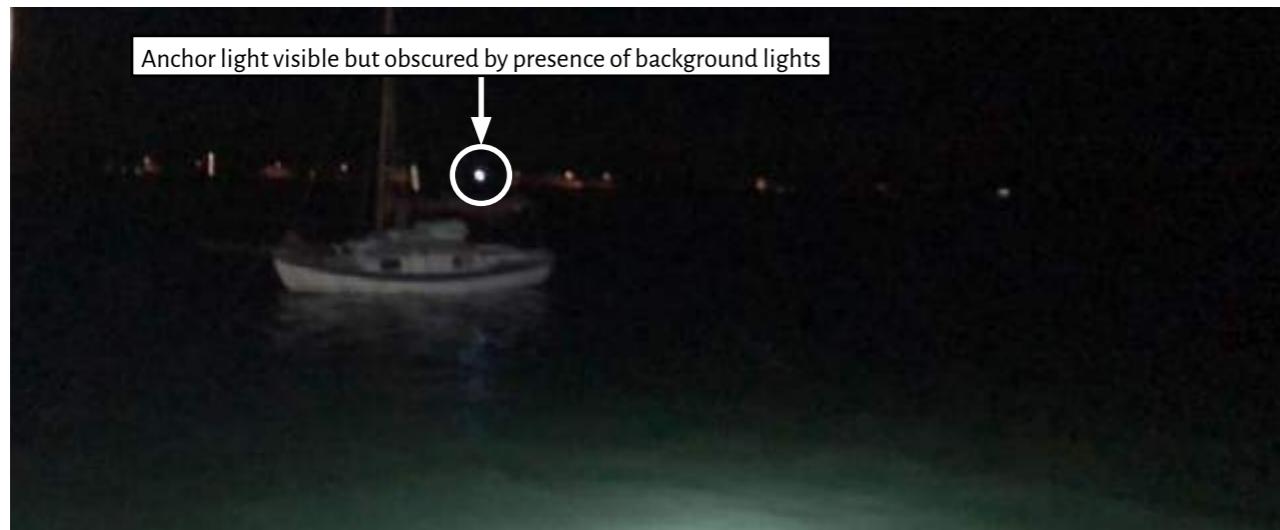
It soon became evident that the fishing vessel had hit a yacht anchored in the bay. The yacht's crew came on deck to see what had happened. Discovering a split in the port side of their yacht, which was now taking on water, the yacht crew agreed to be towed into the nearest harbour. The anchor rope was released and the yacht's crew donned lifejackets and started bailing the flood water out of their vessel. The partner fishing vessel arrived to check on the situation and its skipper remarked that his fishing vessel had earlier passed near the same spot; he had been travelling at 6kts and had not noticed the anchored yacht.

The tow into harbour was uneventful and the yacht was placed on a slipway to assess the damage. The split in the yacht's side was larger than first appreciated and the water ingress had caused some internal damage, but there were no injuries. The fishing vessel was undamaged.

Figure 1: The anchored yacht post-accident against background lights from the shore

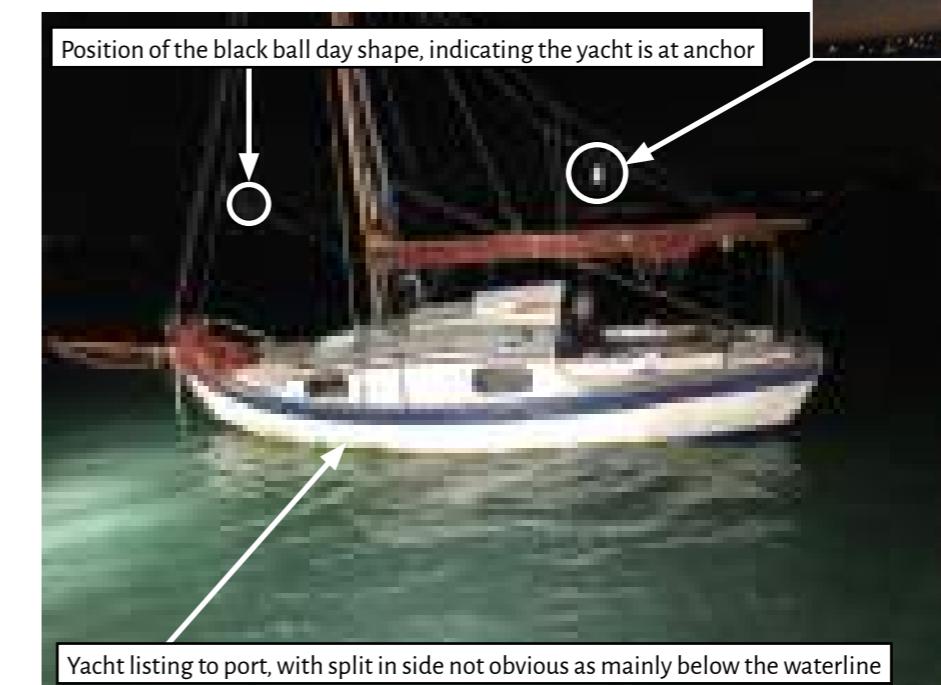
Figure 2: The anchored yacht listing to port, with (inset) the unorthodox anchor light visible

2. **Action** → The yacht was 6.7m in length and anchored close to shore. The yacht was equipped with a radar reflector and had made some efforts to be visible at a reasonable range (Figure 2), but was not transmitting on AIS. When at anchor and without a watch on deck it is prudent to make yourself as visible as possible to other vessels in the vicinity. AIS can improve the visibility of small vessels and yachts to others operating nearby; however, a well-placed all-round anchor light with visibility of at least 2nm should be the minimum action taken to maximise an anchored yacht's chances of being seen.

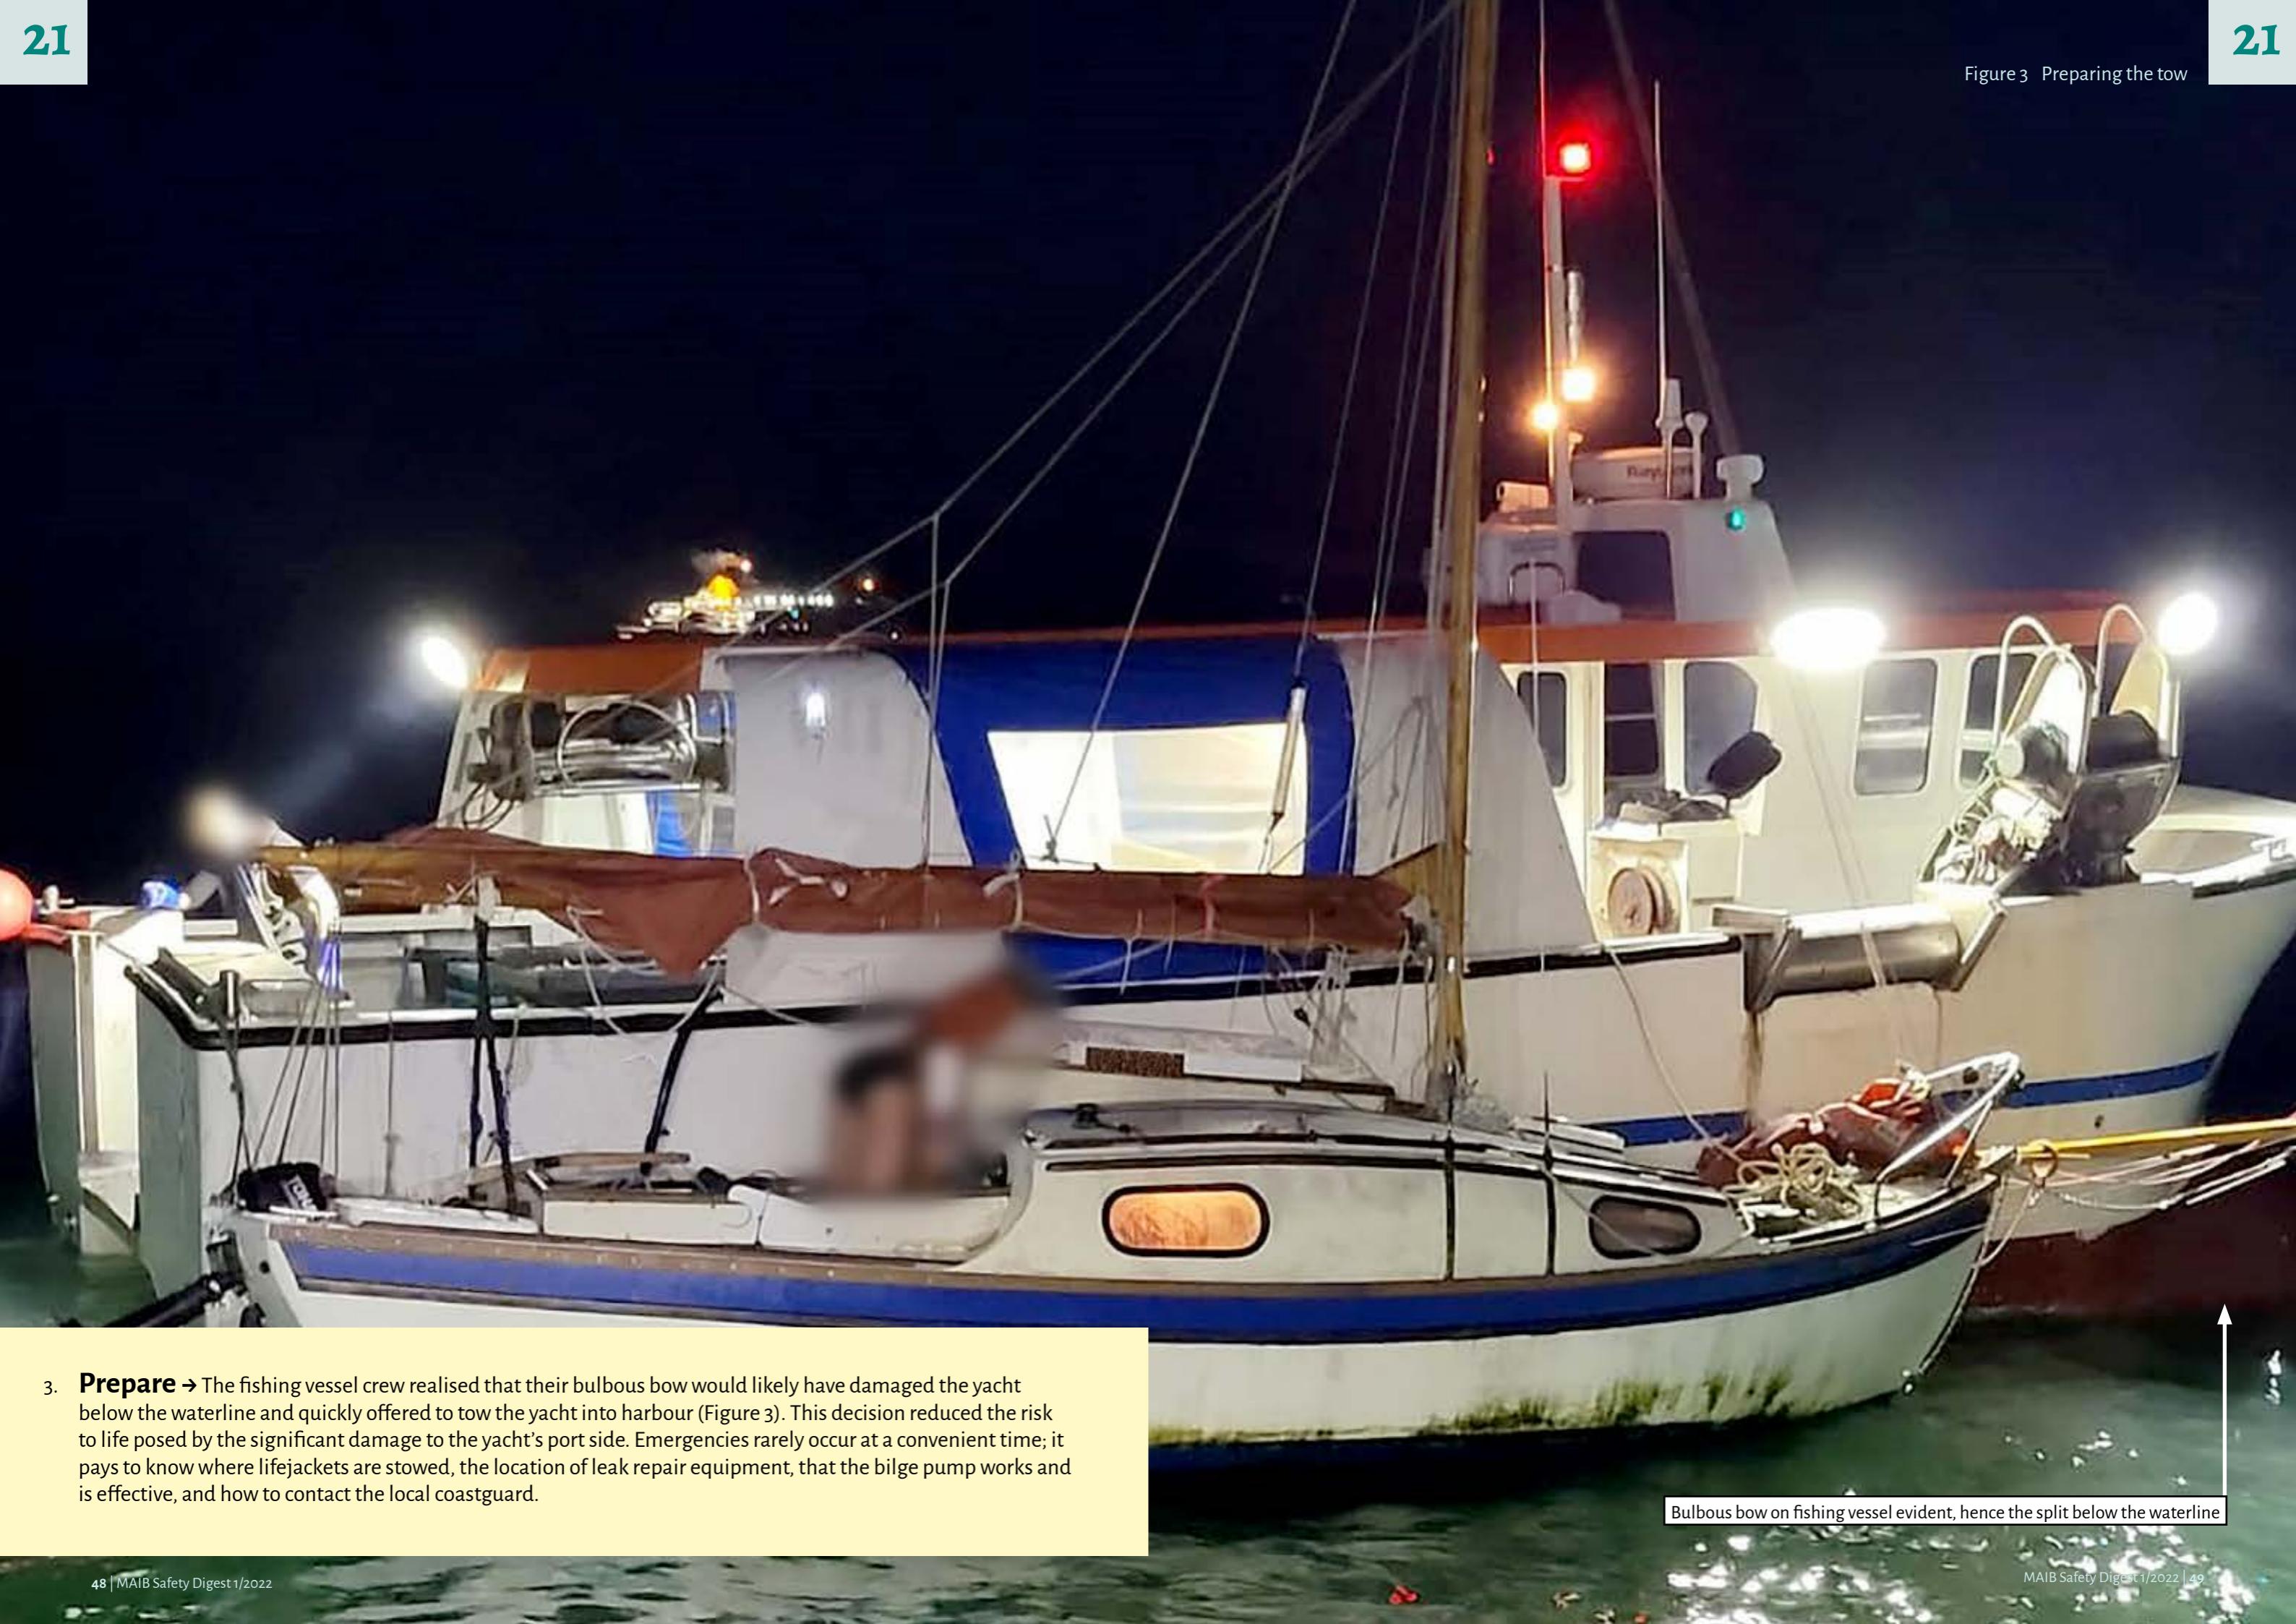
Figure 3 Preparing the tow

3. **Prepare** → The fishing vessel crew realised that their bulbous bow would likely have damaged the yacht below the waterline and quickly offered to tow the yacht into harbour (Figure 3). This decision reduced the risk to life posed by the significant damage to the yacht's port side. Emergencies rarely occur at a convenient time; it pays to know where lifejackets are stowed, the location of leak repair equipment, that the bilge pump works and is effective, and how to contact the local coastguard.

Bulbous bow on fishing vessel evident, hence the split below the waterline
