SAFETY DIGEST

Lessons from Marine Accident Reports

1/2022

MARINE ACCIDENT INVESTIGATION BRANCH

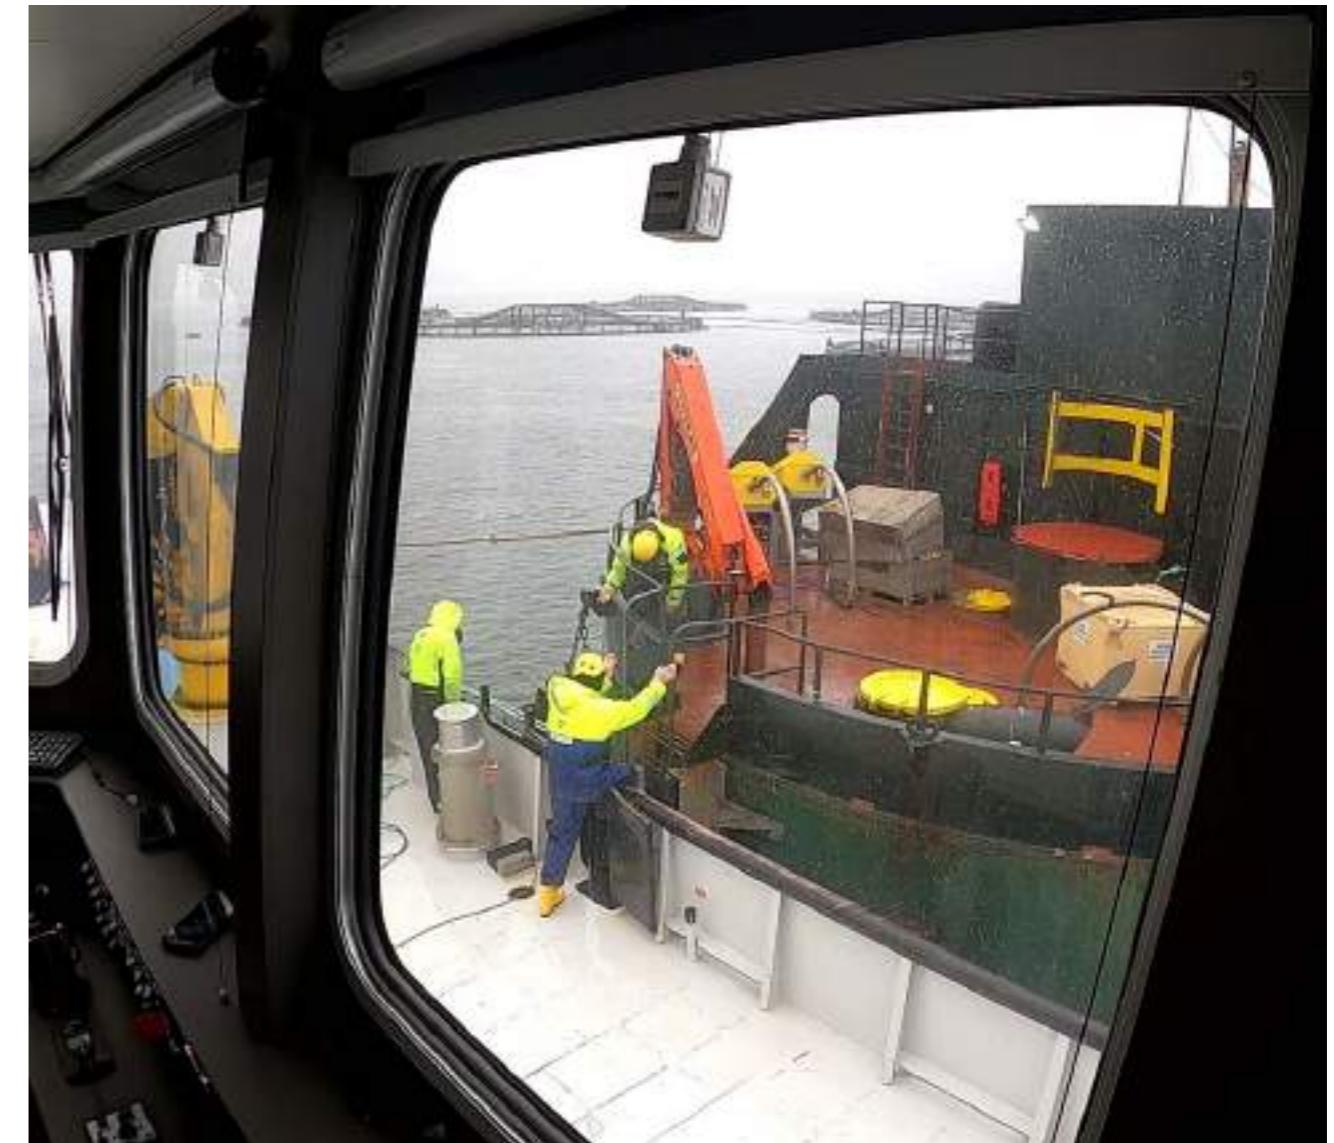
Figure: Reconstruction of the team leader stepping through the bulwark gate

- Equipment** → There is usually no warning that you will need personal protective equipment. While it is sometimes hot or uncomfortable to wear, it is designed to save lives or minimise injury. Always make sure PFDs are fitted properly and securely, and with the crotch straps fastened, so that the wearer's head remains above water if they fall overboard.
- Procedure** → Bulwark gates should be kept closed unless in use as an open gate poses an unnecessary hazard. On this occasion, keeping the gate closed until the workboat was in position and it was safe to transfer would have avoided this accident.

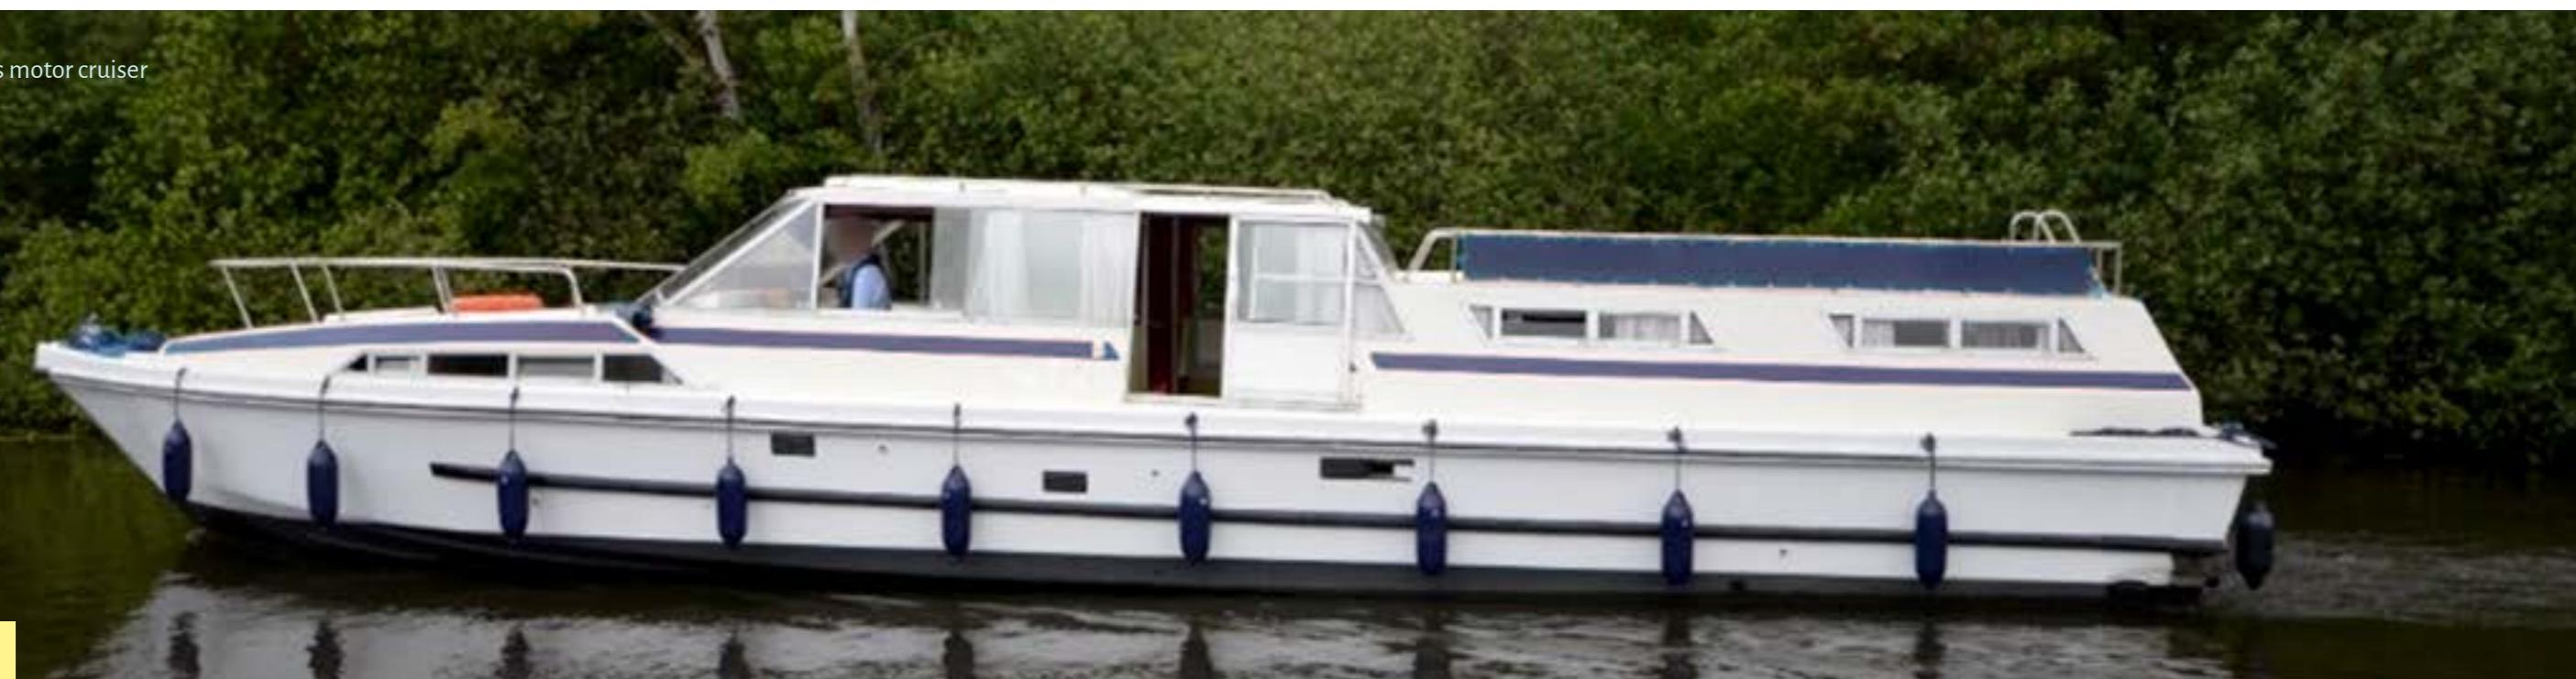
Figure: Inland waterways motor cruiser

1. **Hazard** → Whether intended, accidental or because of horseplay, entering the water close to a boat that is underway can be dangerous. In hot conditions a swim might seem appealing, but a rotating propeller presents significant hazards and should be avoided. Additionally, the local authority did not recommend swimming from boats in this area and, in this case, the motor cruiser did not have a boarding ladder.

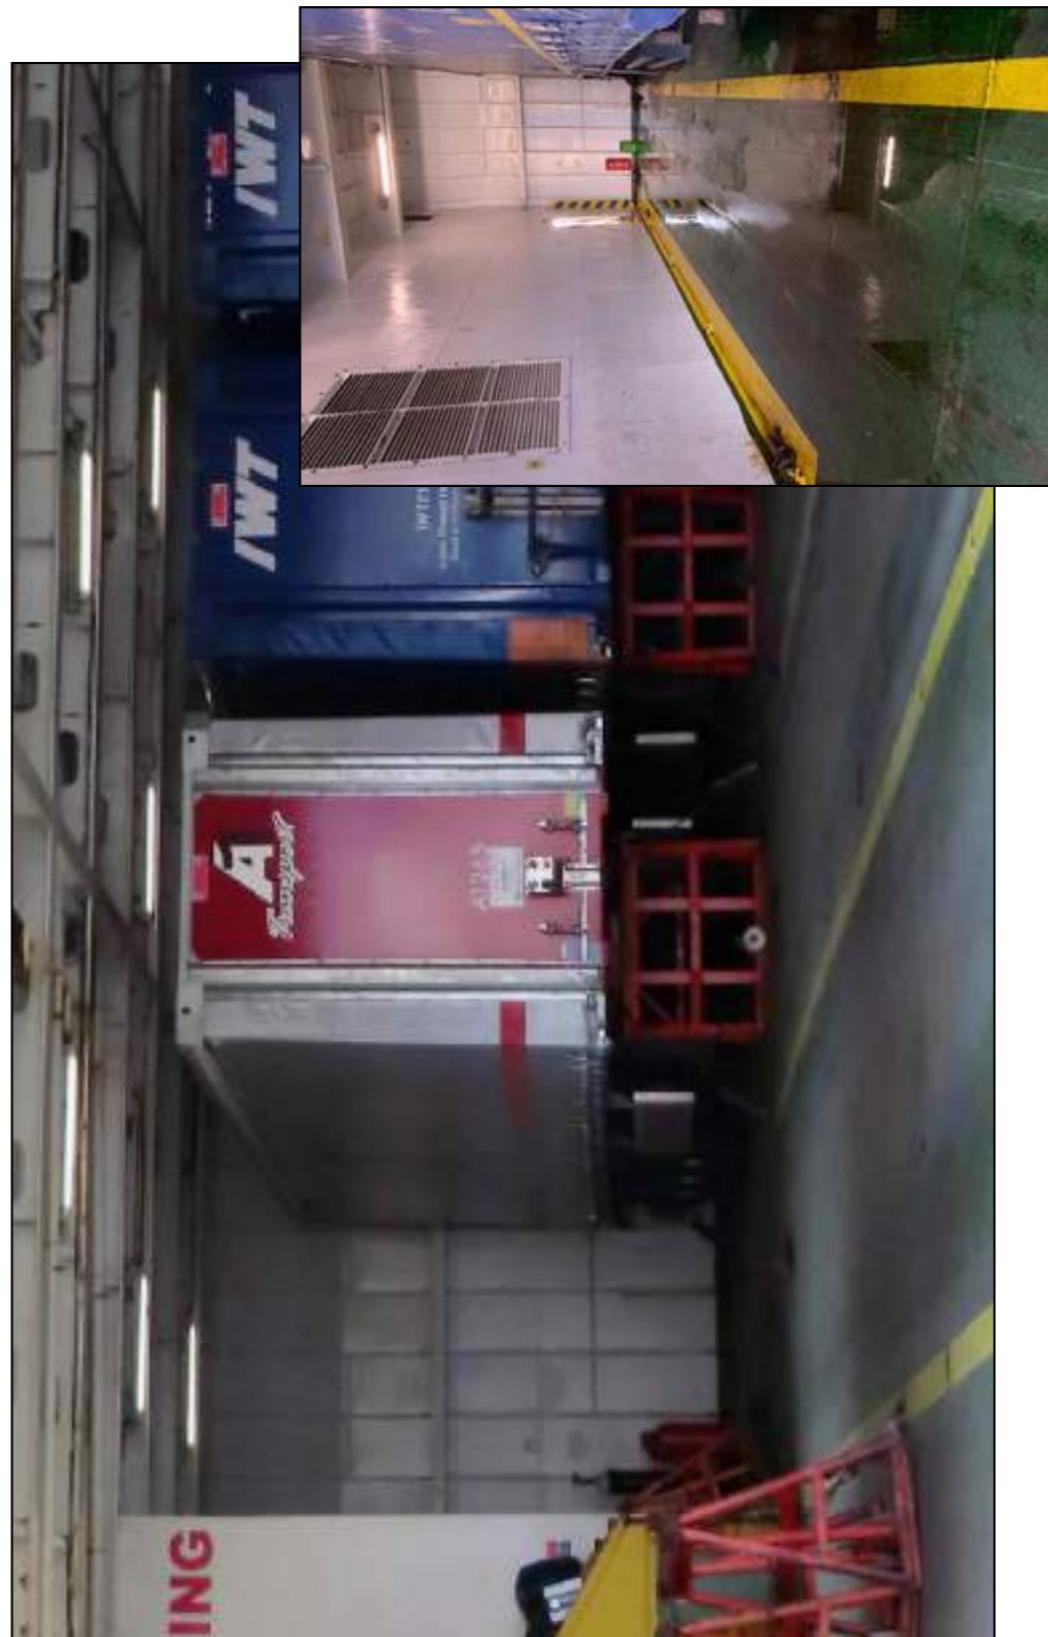
All aspects of this accident are under investigation by the MAIB and a full report explaining the causes and circumstances will be published in due course. Nevertheless, it is apparent from the initial evidence collected that there is an extreme risk of crushing injuries in stowage spaces adjacent to the vessel's structure, with limited areas to remain clear or escape.

Figure 1: Reconstruction of the semi-trailer parking arrangement, with inset view of the space (post-accident)

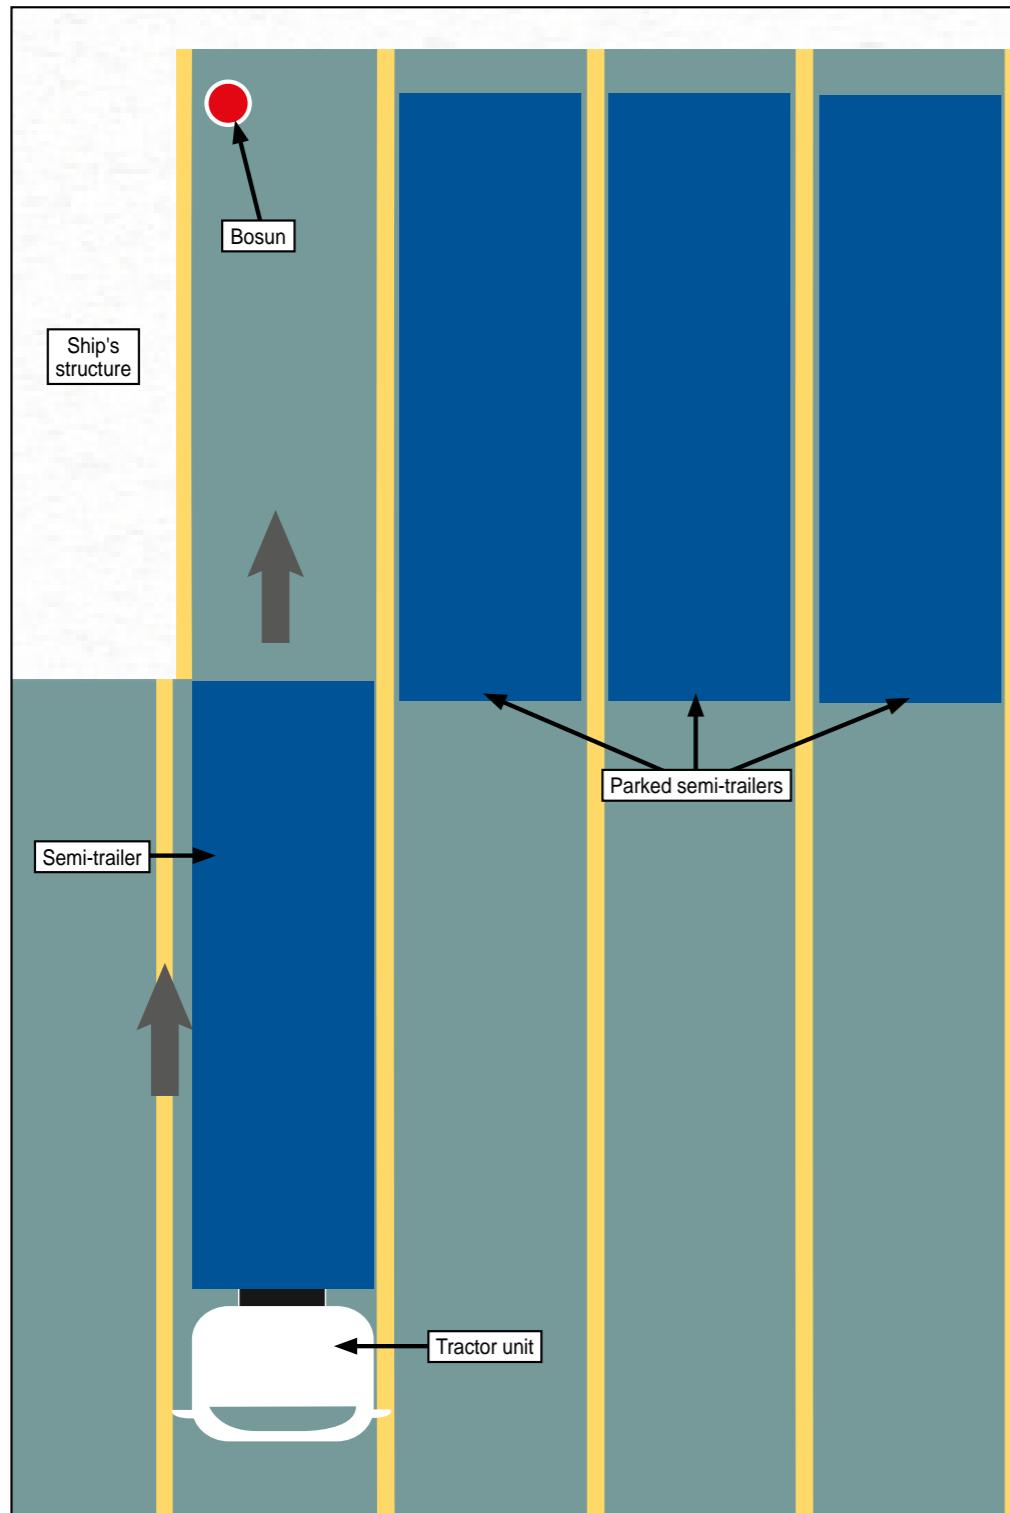
Figure 2: Graphic showing plan view of the semi-trailer's approach to the parking space

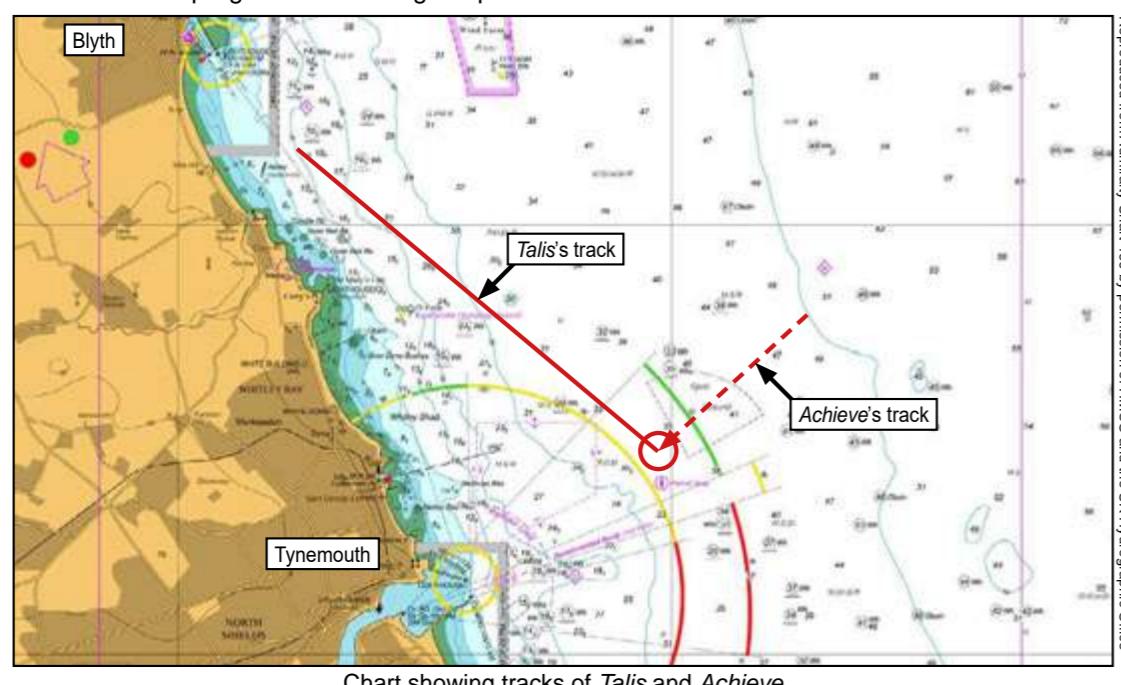
Chart showing tracks of *Talis* and *Achieve*
