Annual Digest

Reports and Insight Articles

2021

Annual Digest of Reports and Insight Articles 2021

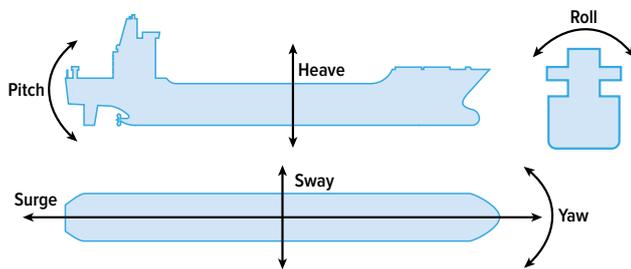
Figure 3 (image courtesy of Witherbys Publishing)

- two dissimilar vessels will each have their respective pitch, roll, heave, surge, yaw, and sway movement periods, potentially in opposition to each other at any given moment. This can put tremendous snatch loading on the mooring lines.

- all crew members of vessels involved in STS operations should be fully conversant with all aspects of the agreed standard operating procedures including any special arrangements for quick release of mooring lines if this becomes necessary. Regular emergency preparedness exercises for unmooring should be practised.

- it is important that all mooring lines in each of the three (3) groups, breast lines, spring lines, and head / stern lines are of the same size, construction, breaking strength and length to ensure equal tension on all lines. Dissimilar characteristics within a group can lead to rapid parting of mooring lines.

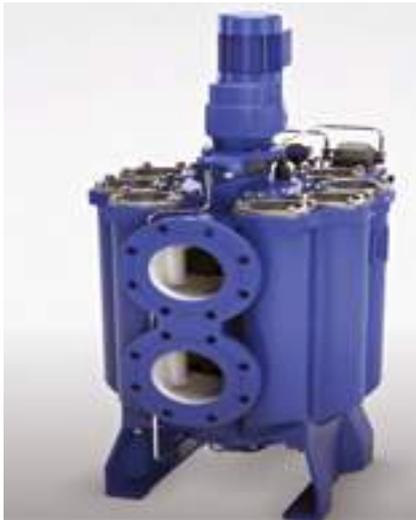
The filters were not checked for being under pressure and draining of the filter was not carried out prior to opening the cover.

The maker's safety instructions were not followed.

A Typical modern Fuel Oil Back flush filter

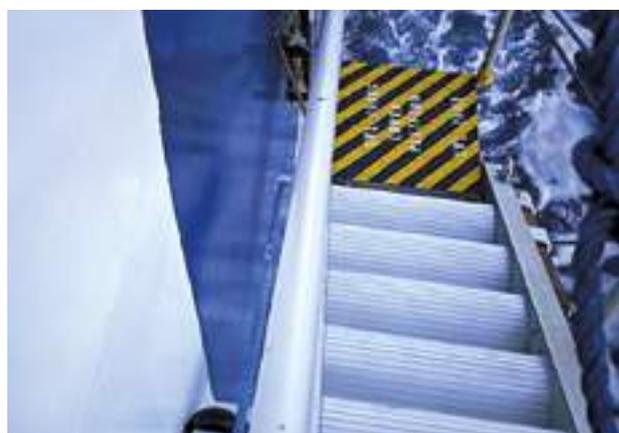
Figure 12. Compliant combination pilot boarding arrangement ready for use

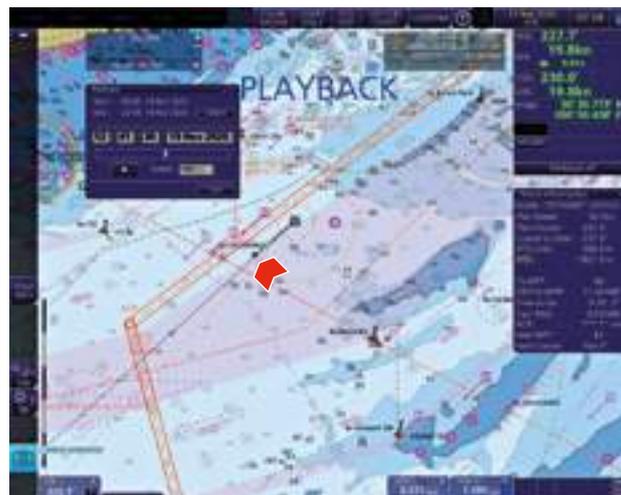
CHIRP also contacted the ISM managers for the container vessel, and details of the reported incident were passed to the DPA. Subsequently, after contacting the captain of their vessel, the DPA reverted to CHIRP with a response including a series of screen shots from the bridge of the container ship and a commentary from the captain with regards to the incident. The screen shots show that the container vessel was south of the planned route and outside the charted safety corridor in a position close to the boundary between the SW lane and the central separation zone.

Figure 4 – Screen shot from the container vessel.

Both the reporter and the captain of the container ship quoted rule 10 of the Collision Regulations to support their position that the other party was at fault.

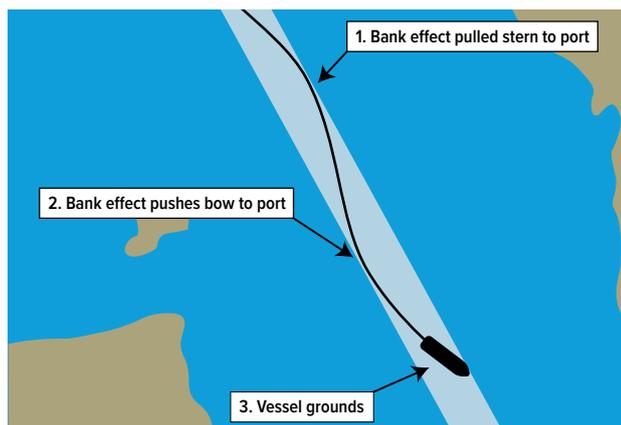
The tanker was transiting a canal with 2 pilots on the bridge in addition to the master, chief officer, helm and lookout. The pilot ordered a turn to starboard later than planned, but this was not challenged by the bridge team. As the vessel approached the channel's port side the *bank effect* pulled the stern to port just as starboard rudder was applied. In combination, these caused the vessel to cross to the channel's starboard side where bank effect pushed the bow to port. The vessel re-crossed the channel and touched bottom on her port side, breaching the water ballast tanks.

The vessel was directed to a safe anchorage for damage assessment by the company, flag state, class, insurers, and the port authorities. An investigation revealed that this type of manoeuvring incident frequently occurred in this canal.

The vessel's track at the time of the incident is shown on the ECDIS screenshot below.

The latent causes of this incident were in place long before the vessel touched bottom. During the planning stage, the available depth of water and the narrow breadth of the channel should have prompted the master and navigator to consider the possibility that *bank effect* and *squat* could affect manoeuvrability and to determine the speed at which these might take effect. If this speed was below the minimum steerage speed, then the use of tugs should have been considered. The need for tugs should have been revisited during the master/pilot exchange (see IMO Resolution A.960(23) Annex 2 for more details).

The port authorities were aware that vessels often touched the bottom in the canal, which could indicate out of date or inaccurate chart data, the need for maintenance dredging, or missing or inaccurate aids to navigation. Suitable control measures could have included the requirement for deep-draughted vessels to take tugs to control manoeuvring in the channel, or at least the provision of navigational warnings of the risk of bank effect and squat.

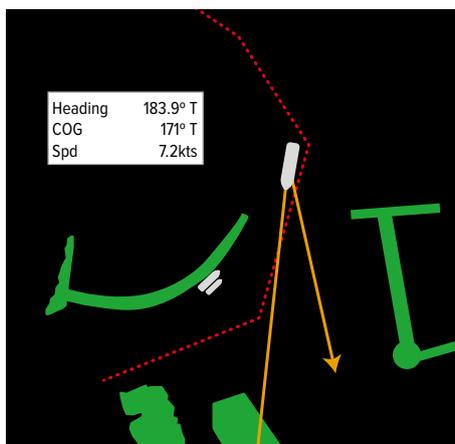
The vessel's speed was still above 5 knots, so the pilot ordered that both anchors be let go. The vessel speed had reduced to 4.5 knots when it contacted a barge that had been berthed outboard of another.

A detailed inspection was carried out by the ship's staff, followed later by an inspection by class. Non-penetrating

hull damage was identified, with significant indents and minor deformation to internal strength members that required repairs.

The investigation revealed that maintenance work conducted 6 days before on the engine control system had not been properly completed nor had it been inspected afterwards. The red locking pin (see photos below) had not been correctly secured back into position and during manoeuvring it had shaken loose due to vibration. This activated the emergency manoeuvring system which over-rode both the bridge and engine room control systems.

The investigation revealed that the direct cause of this incident was the disengagement of the emergency manoeuvring system's locking arrangement.

The root causes for this incident were found to be a lack of understanding of the risks by the engineering officers carrying out the checks, which were not overseen by a supervising officer – a procedural requirement that is stated in the SMS procedures for working on critical equipment. It is likely therefore that the engineering officers failed to appreciate the criticality and impact of the locking system.

Critical equipment defined in the company SMS must be inspected on completion of any maintenance by a supervising officer. Crucially, single points of failure must also be checked as part of routine pre-arrival and pre-departure checks.

Local Practices: Navigational risk assessments should include the risk of engine or control failures and consider whether tugs on stand-by would be an appropriate control measure. Ordering tugs as a precautionary measure is always cheaper than the cost of repairs!

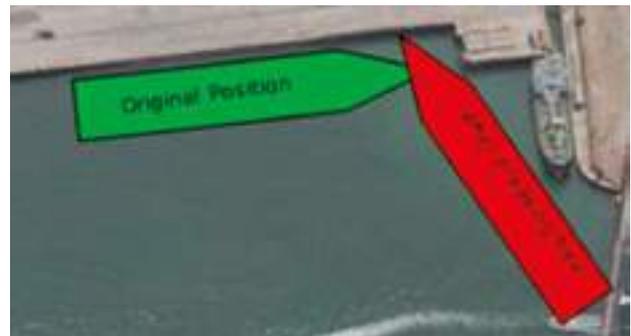
The vessel was now attached to the dock with just 2 headlines and one fore spring, and as it continued to swing it hit a berthed bunker barge and a railway bridge, sustaining damage to the starboard side amidships as well as on the starboard quarter. A piece of cargo was also discovered to be hanging over the starboard side.

Tugs were deployed and the vessel was re-secured to the dock at 0300 hrs. A memorandum of class was subsequently issued due to impact damages to the vessel and cargo. There was some minor damage to the bunker barge and the rail bridge.

An investigation revealed that the mooring bollard to which the stern lines of both vessels were attached had been pulled completely out of its foundations due to the wind loading on the side of the vessels. It also concluded that the crew could not have prevented the incident.

Placing all the stern ropes onto one bollard created a single point of failure which was aggravated when the second vessel secured to the same bollard. Either vessel could have identified this latent risk, as could the supervisor of the line-handling party. It is possible that neither the port authority nor the master understood the risk which had been created. There is no evidence of a discussion regarding the possibility of the vessel moving to an alternative berth, either before or after the strong wind warning was issued, and no additional lines were put ashore after the warning had been received. Similarly, the vessel could have brought its engine(s) to immediate notice as a prudent contingency measure.

While not an exact science, it is possible to estimate the likely forces generated by high winds on a high-sided vessel so long as the windage area is known. Many vessels keep a 'ready reckoner' on the bridge for quick reference, and some port authorities that regularly berth high-sided vessels have similarly developed a guide to assist them in calculating the likely 'pull' forces that the bollards must accommodate. The use of auto-tensioners can cause dynamic loading of lines that potentially exceed bollard holding limits so this should be considered as well.

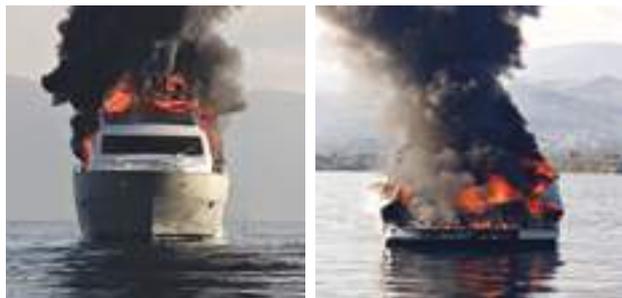
Figures 1 and 2

Shortly after weighing anchor following an overnight stop, the vessel suffered a catastrophic engine room fire which spread rapidly throughout the vessel.

The two crew abandoned the vessel using a tender and liferaft combination and were unharmed.

The vessel subsequently sank in deep water whilst a firefighting vessel was attempting to extinguish the blaze.

Although anything mechanical can fail, the risks are reduced when equipment is maintained in accordance with the manufacturer's guidance.

Voice or DSC? Both, if possible. The DSC (Digital Selective Calling) function, which would automatically have included a GPS position in the distress message, was not used as it was not user-friendly, not routinely used aboard, and the crew were unfamiliar with its use. Familiarise yourself with your safety equipment. It is better to initiate a call using DSC and back it up with voice communication. Write down your position and update it frequently before making the call so it remains available if your electronics fail.

Lifejackets are useless if not worn. They need to be distributed early in an emergency and must remain readily accessible. They should also be worn whenever there is a risk of falling overboard.
