## ACCIDENT REPORT

VERY SERIOUS MARINE CASUALTY

REPORT NO 9/2022

### Mooring deck accident on board the cargo vessel *Teal Bay* resulting in one fatality at Kavkaz South anchorage, Russia on 30 August 2021

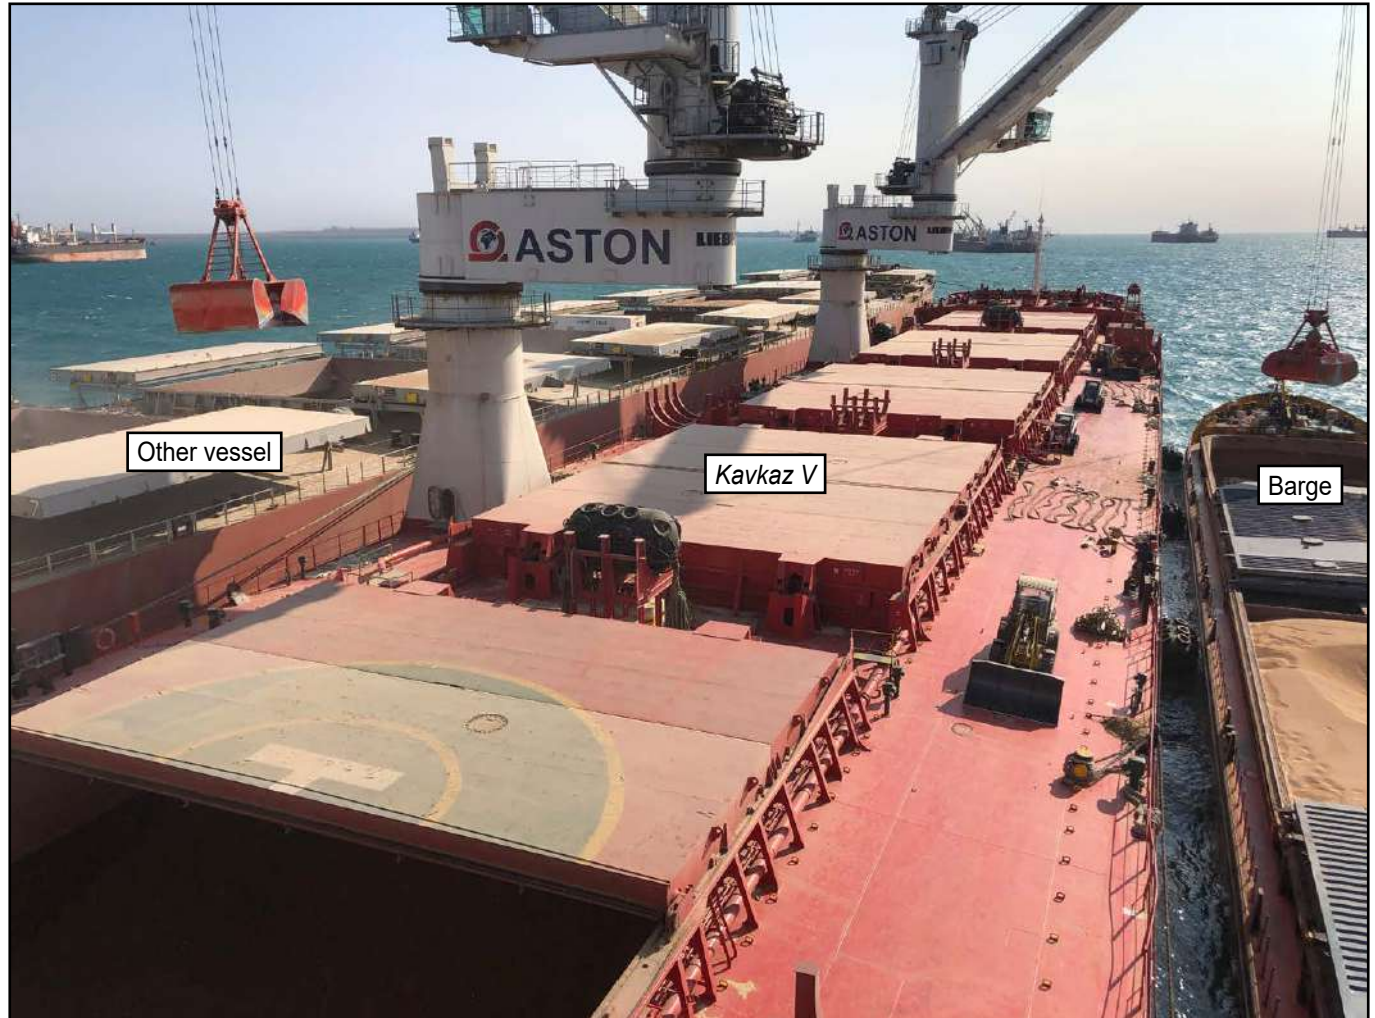
When acting as a storage vessel at anchor, *Kavkaz V*'s cargo holds were loaded with grain from river barges. The grain was then discharged into other vessels moored alongside for onward transport (**Figure 3**). *Teal Bay*'s crew had not loaded cargo in this way before and, until the pilot boarded and informed him of the loading arrangements, the master was expecting to load grain directly from barges while at anchor.

**Figure 3:** *Kavkaz V* (centre) loading grain from a barge (right) while transferring cargo to another vessel (left)
