Issued August 9, 2022

MIR-22/18

## Contact of Bulk Carrier *Ocean Princess* with Oil and Gas Production Platform SP-83A

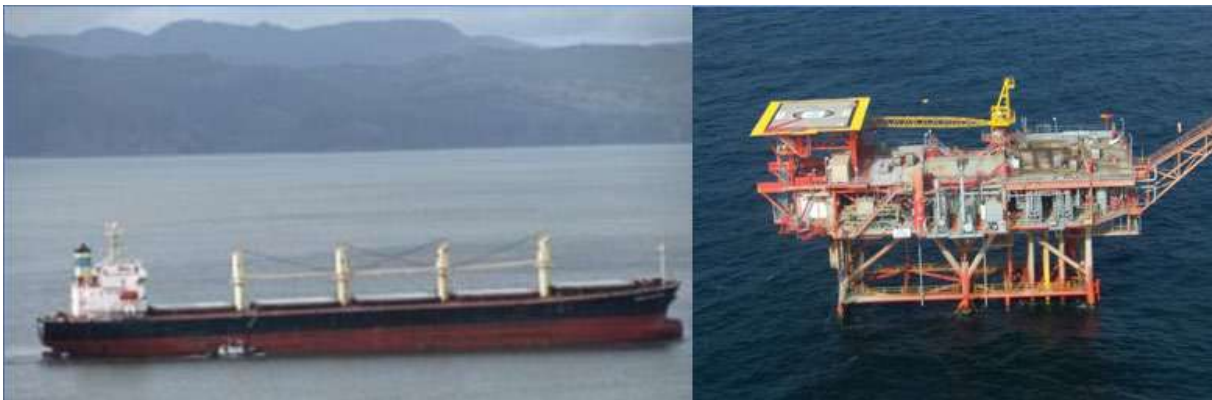
**Figure 1.** *Ocean Princess* under way before the casualty (left); SP-83A before the casualty (right). (Sources: ©Malcom Cotte MarineTraffic.com; Arena Offshore)
