Fire on board *BBC Rhonetal*

Port Hedland, Western Australia on 25 March 2021

ATSB Transport Safety Report
Marine Occurrence Investigation (Defined)
MO-2021-002
Final – 21 September 2022

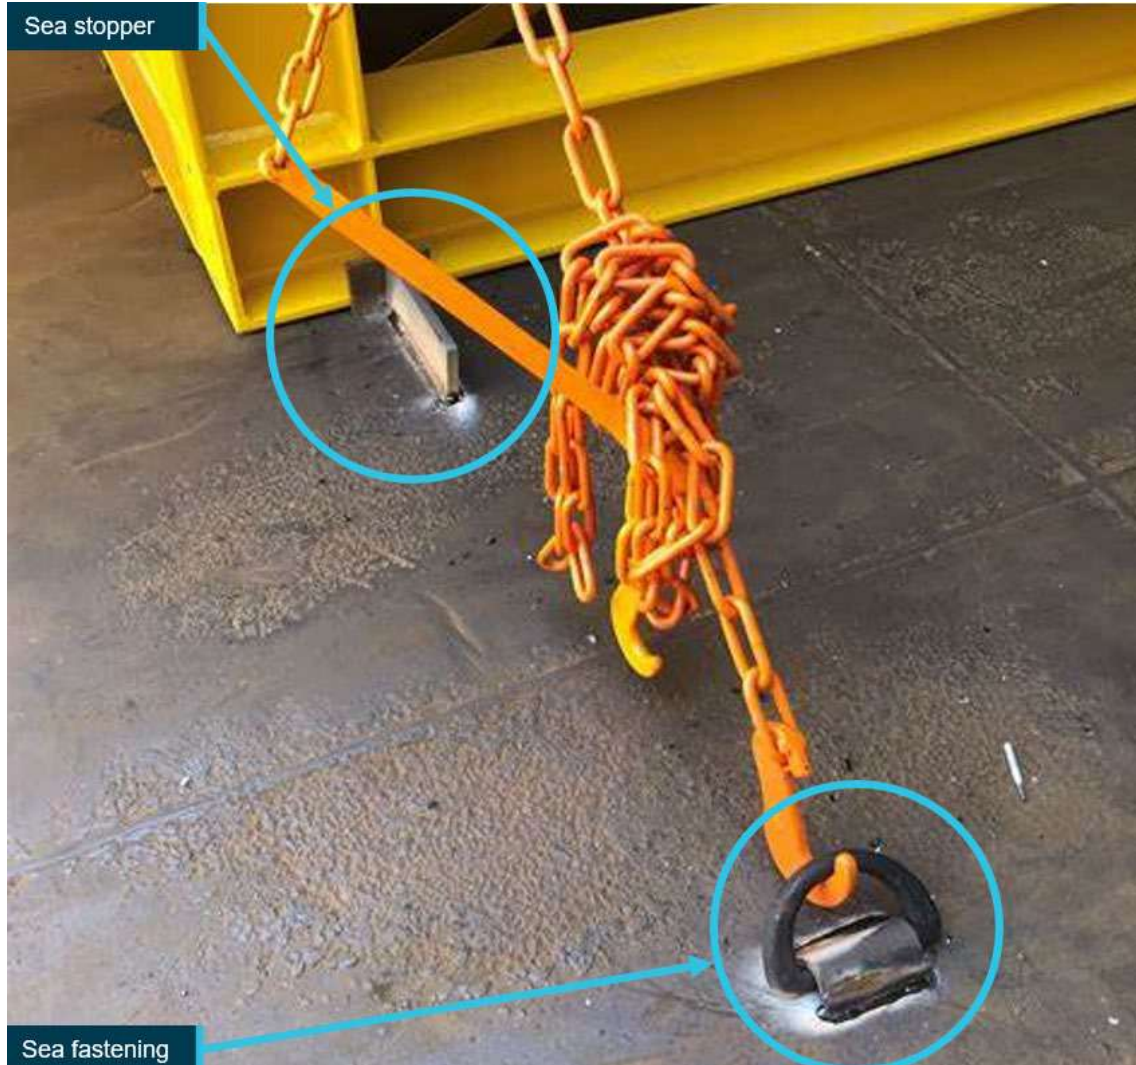
Figure 6: Example of project cargo securing

(often referred to as sea stoppers) to the deck, and directly against items of cargo, to prevent movement across the deck while at sea (Figure 6).

Since the fastenings and stoppers were welded to the deck, hot work techniques including cutting and gouging were required to remove them whenever the cargo was discharged. As a result of this type of cargo securing arrangement, hot work operations were much more frequent on this type of multi-purpose general cargo ship than on many other types of cargo ships.
