# MAERSK ESSEN

Marine accident report on loss of cargo

16 JANUARY 2021

**MARINE ACCIDENT REPORT ON MAERSK ESSEN'S  
LOSS OF CARGO ON 16 JANUARY 2021**

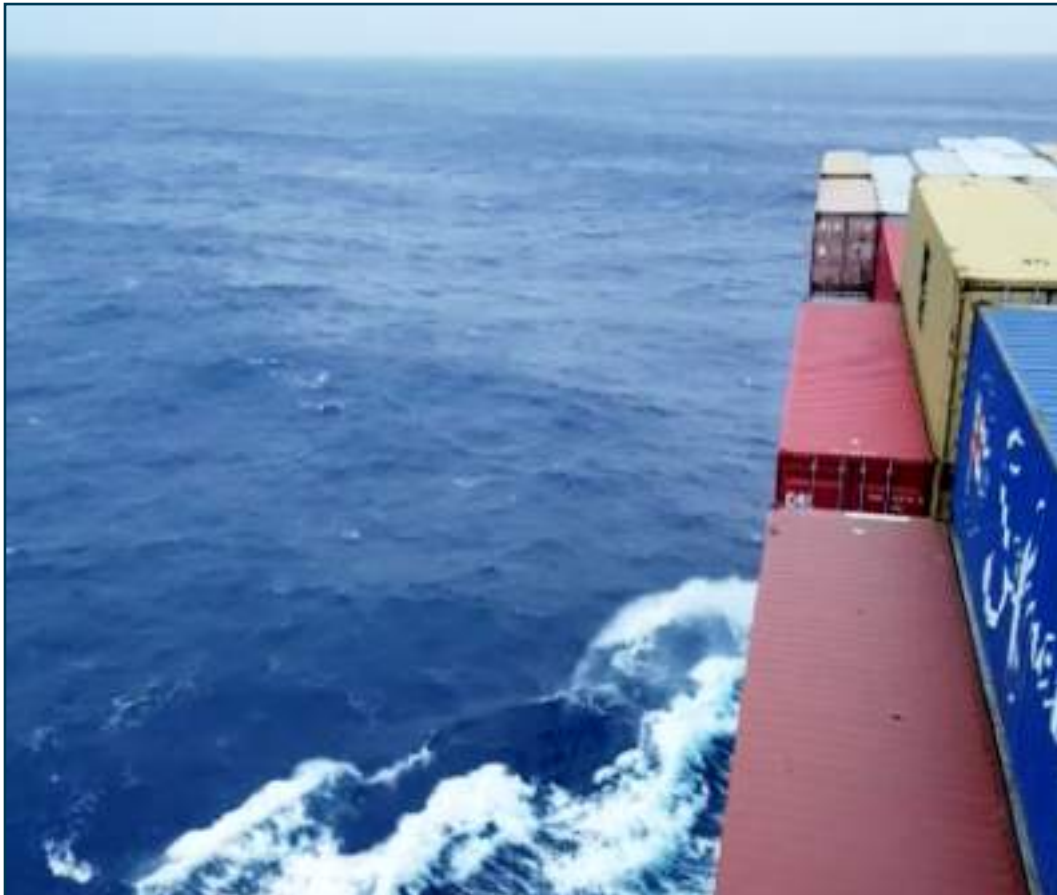
At approximately 0600, some of the crew were woken by the sound of cups and laptops sliding and falling off tables in their cabins as the ship took a few heavy, slow rolls. On the bridge, the chief officer saw from the inclinometer that the ship had rolled 15° to each side. The rolls stopped as quickly, as they had started. The chief officer observed nothing unusual out of the windows, and the sea state seemed not to have changed (Figure 5).

*Figure 5: Sea state in the morning on 16 January 2021  
Source: Private photo*

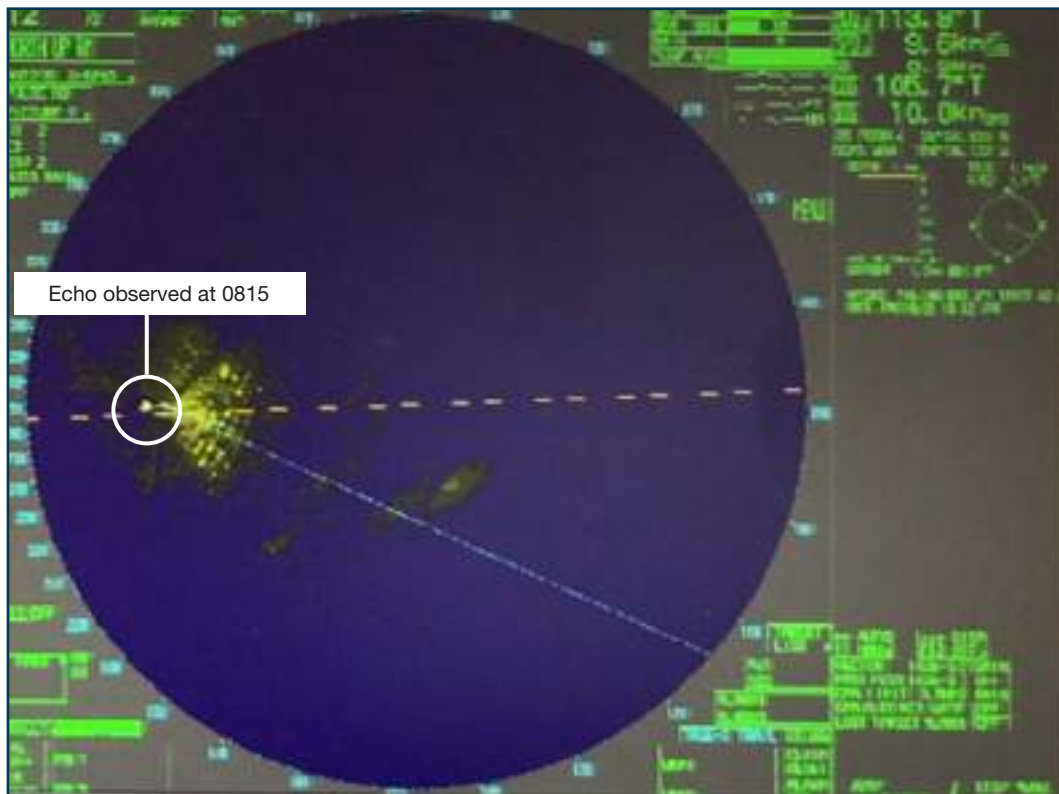
At 0815, the master detected an echo on the radar close astern of the ship (Figure 6).

Figure 6: Echo observed on the radar at 0815  
Source: Maersk A/S

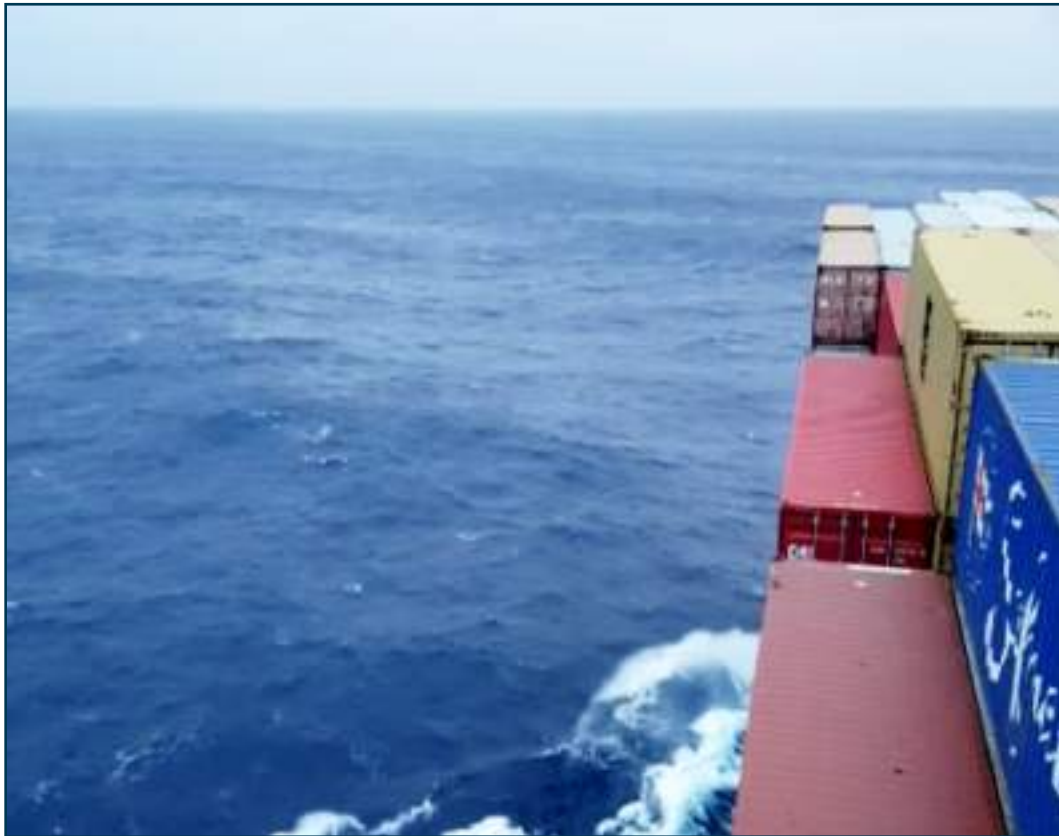
During the hours prior to the heavy rolling episodes, observations of north-north-easterly (NNE) wind of Beaufort force 6 were recorded in the bridge logbook. This corresponded to a strong breeze of 10-14 m/s and moderate wind seas of approximately 2m. The Beaufort scale only refers to wind and wave, not swell. Hence, swell height was not recorded in the logbook. According to crew statements, the swell was about 5m with a long period coming on the ship's port quarter. Photographs taken 45 minutes before and 8 minutes after the loss of containers corresponds with the crew's observations (Figures 16 and 17).

*Figure 16: Sea state 45 minutes prior to the accident. Photo taken from the bridge wing.  
Source: Maersk A/S*

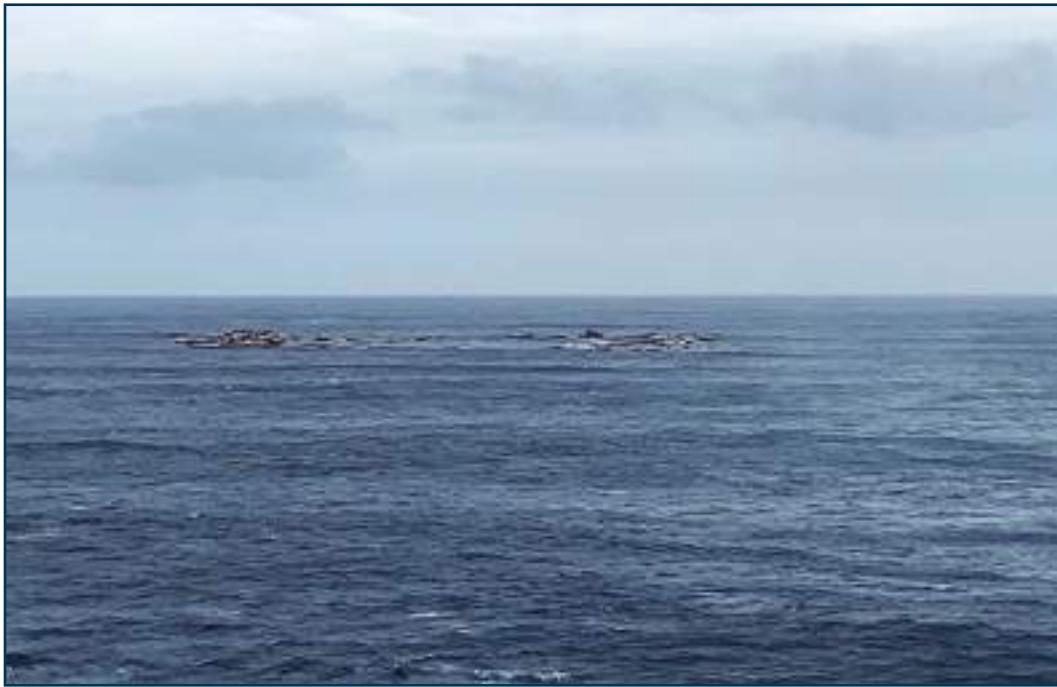
Figure 17: Sea state 8 minutes after the accident  
Source: Maersk A/S

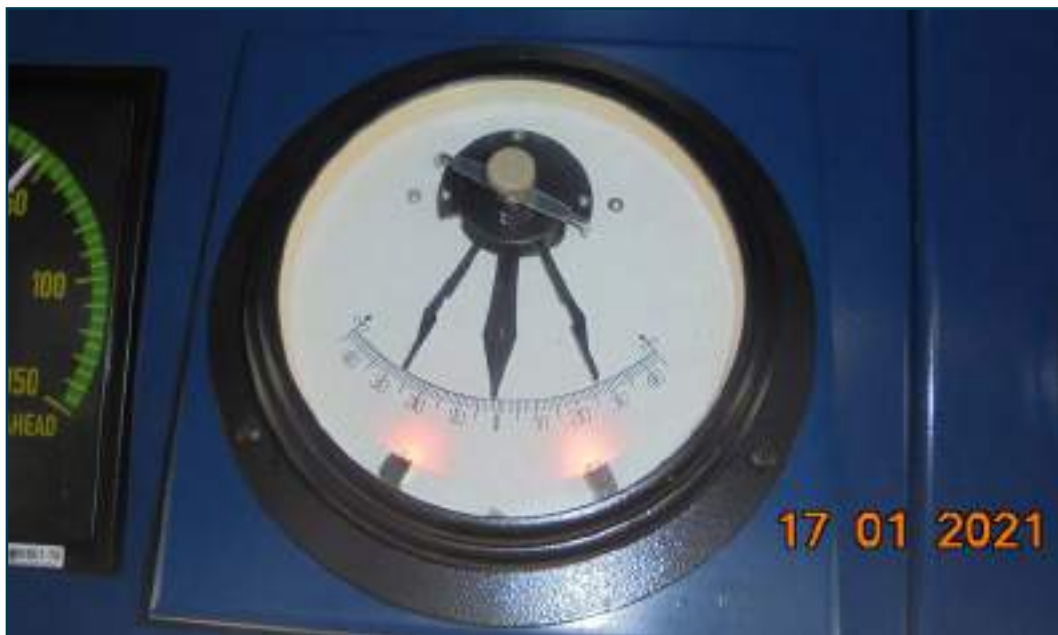
A mechanical inclinometer on the bridge indicated the ship's heel angle and recorded the maximum heel angle. Photographs of the inclinometer taken after the heavy rolling episodes (Figure 19) show that the ship reached angles of 26° to port and starboard. The inclinometer had been reset by the chief officer before the 3<sup>rd</sup> officer took over the watch, and the 26° hence reflected the heavy rolling episode between 08:04-08:10.

Figure 19: Inclinometer after the heavy rolling occurrence on 16 January 2021  
Source: Maersk A/S

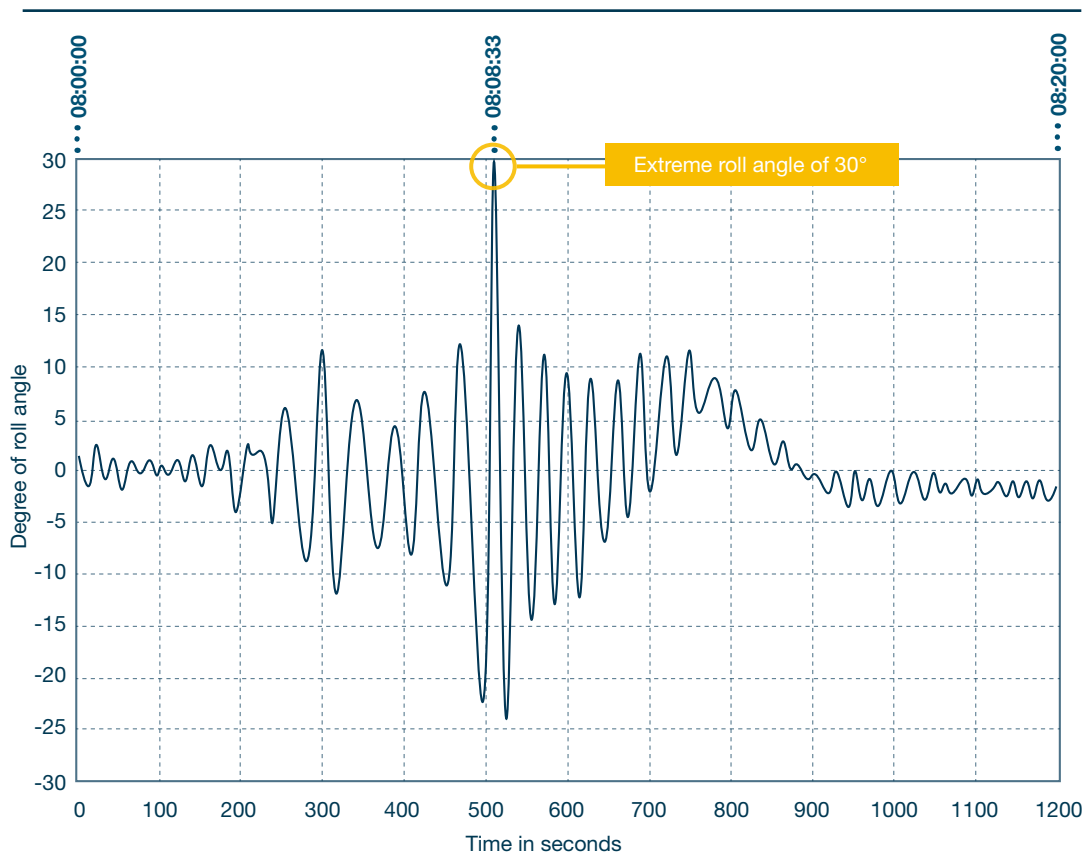
On request from Maersk A/S, an investigation into MAERSK ESSEN's cargo loss was carried out by the Institute of Ship Design and Ship Safety at Technische Universität Hamburg (TUHH). By retrieving data from the VDR on the ship's course over ground and the ship's GPS antenna location, TUHH calculated the rolling angles experienced by MAERSK ESSEN between 08:00-08:12. The calculations concluded that the ship experienced roll angles up to 30° (Figure 20). As the inclinometer reading gives a lower value than the TUHH calculations, it suggests that it was not influenced by acceleration forces resulting in higher roll angle readings.

Figure 20: Graph of TUHH's roll angle calculations, modified by DMAIB  
Source: Maersk A/S

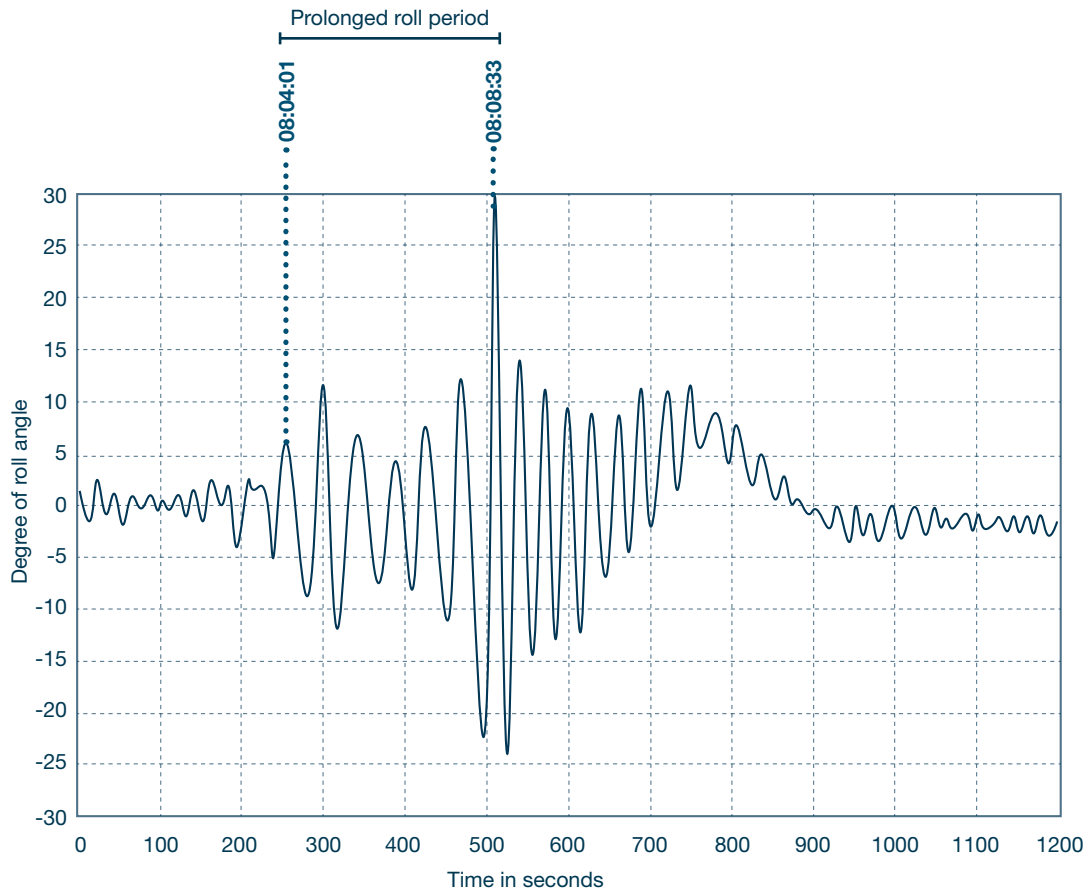
Figure 21 shows TUHH's calculations of MAERSK ESSEN's roll cycles between 08:00 and 08:20. It can be seen that the roll angles before and after the episodes of heavy rolling were between 2-3° to each side, and that the stable period experienced by the 3<sup>rd</sup> officer was not a complete return to the ship's normal roll period and angle.

Figure 21: Graph of TUHH's roll angle calculations, modified by DMAIB  
Source: Maersk A/S

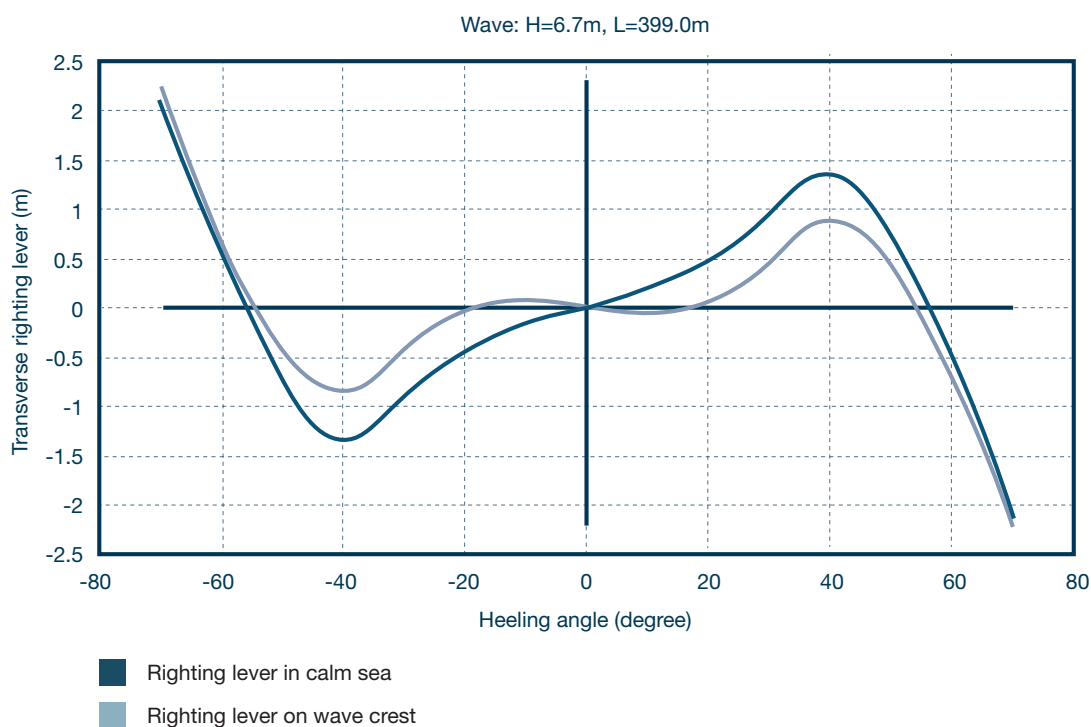
The stability calculation indicates that while the GZ curve for calm sea was positive until a heeling angle of 55°, the initial stability was negative on a wave crest and would not find a stable equilibrium until an 18° heeling angle was reached. Based on this calculation, TUHH concludes that MAERSK ESSEN was exposed to a pure loss of stability which could potentially cause the ship to capsize. However, TUHH also concludes that this scenario would not be plausible for a container vessel, as the cargo will fall overboard and improve the stability.

Figure 22: Stability graph for MAERSK ESSEN prepared by TUHH, modified by DMAIB  
Source: Maersk A/S

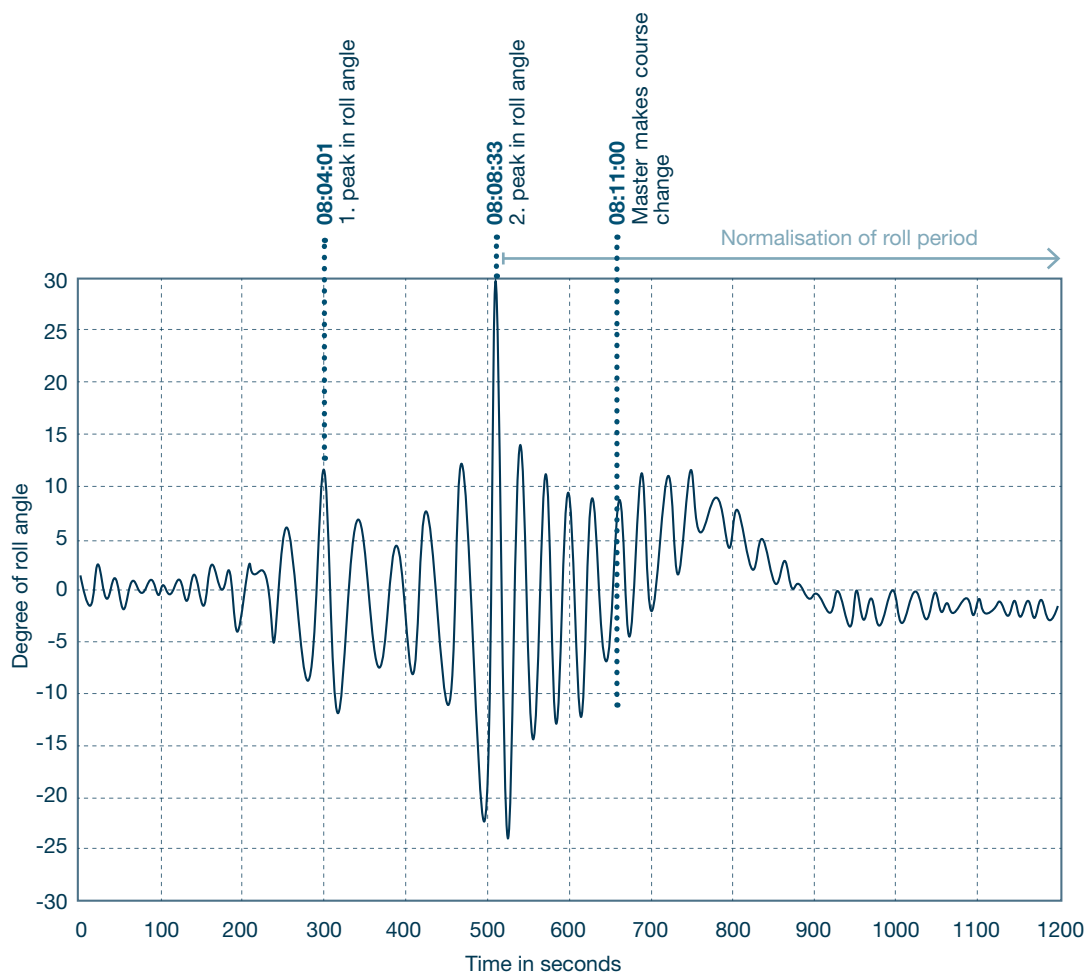
The roll angle graph prepared by TUHH for the time of the container losses reflects parametric resonance. It can be seen that there are two episodes of increasing roll angles. After the first peak in roll angle, the roll angle starts to decrease while the roll period continues to be prolonged. This indicates that the resonance conditions diminished momentarily. This might have been due to alterations in frequency coupling linked to speed or wave period. However, the resonance effect swiftly returned. After the second extreme peak in roll angle, the roll angles decreased, and the roll period normalised (Figure 26). These episodes occurred without any observed changes in the sea conditions.

During these oscillations, the ship lost containers overboard resulting in significant change in GM. Information from the ship's stability calculation software indicated that the GM increased from 0.95 m to 2.44 m, which altered the ship's natural roll period so that the frequency coupling with the wave encounter ceased.

Figure 26: Graph MAERSK ESSEN's roll angles at time of the accident.  
Source: TUHH, modified by DMAIB

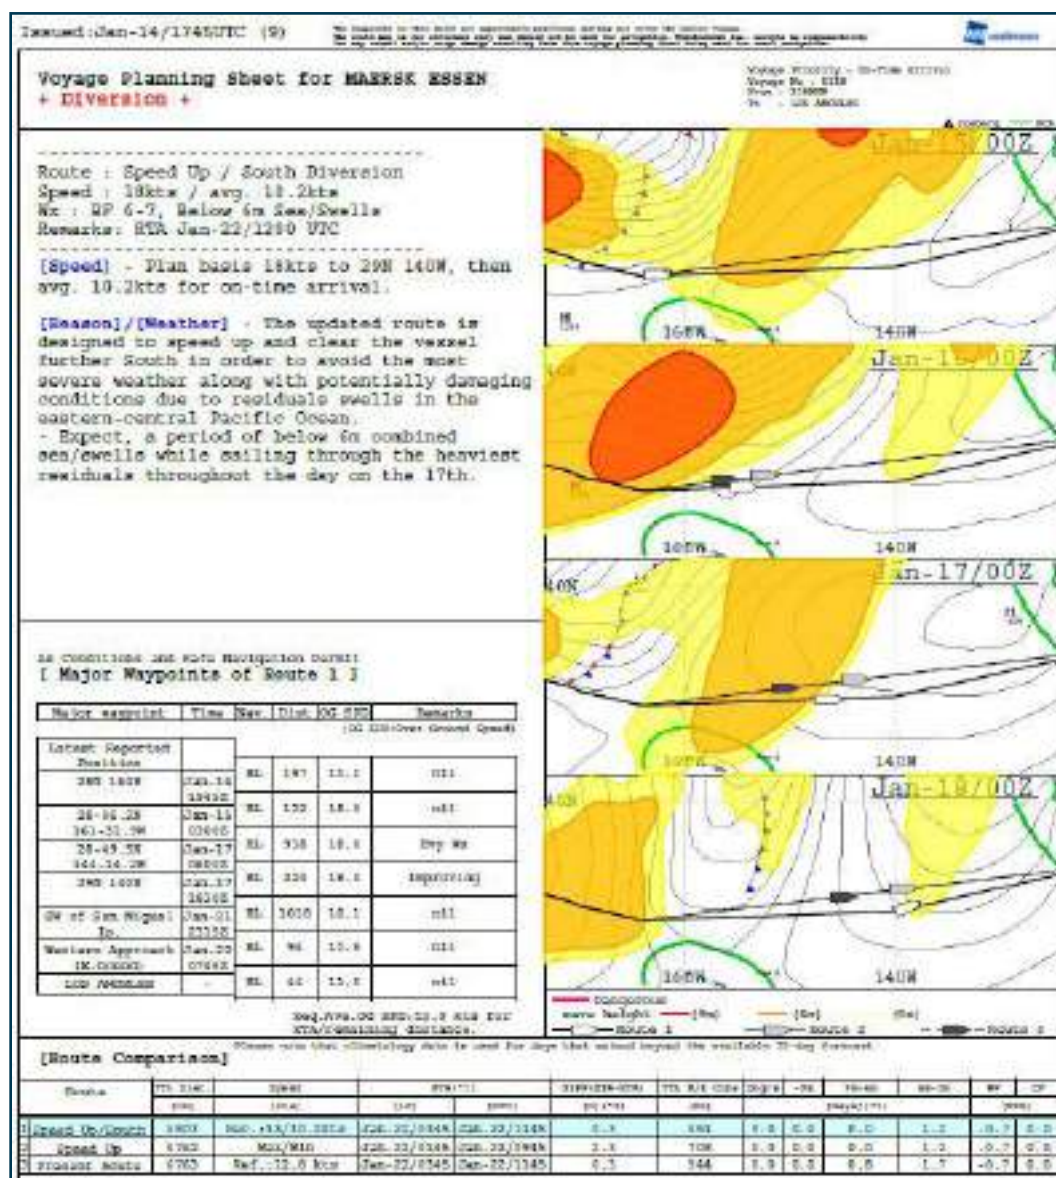
Figure 27: Voyage planning sheet issued 14 January 2021  
Source: WNI

The voyage planning sheet from WNI consisted of text with advice and reasoning for the recommended route, four pressure surface maps with wave height indications, three route choices, a waypoint overview with weather remarks and speed advice, a route comparison scheme and graphs of speed and forecasted wind and wave height until arrival (Figure 27). MAERSK ESSEN was advised to increase speed and adjust course to the south to avoid a heavy weather area with significant wave heights exceeding 6 m. The three routes marked on the surface pressure maps represented WNI's recommendation of increasing speed and altering course further south (white ship), increasing speed only (grey ship) and the current route at a speed of 12.8 knots (black ship). Both WNI's recommended routes cleared a forecasted heavy weather area on 17 January 00 Zulu (00 GMT), corresponding to 16 January 2021, 14:00, ship's time.

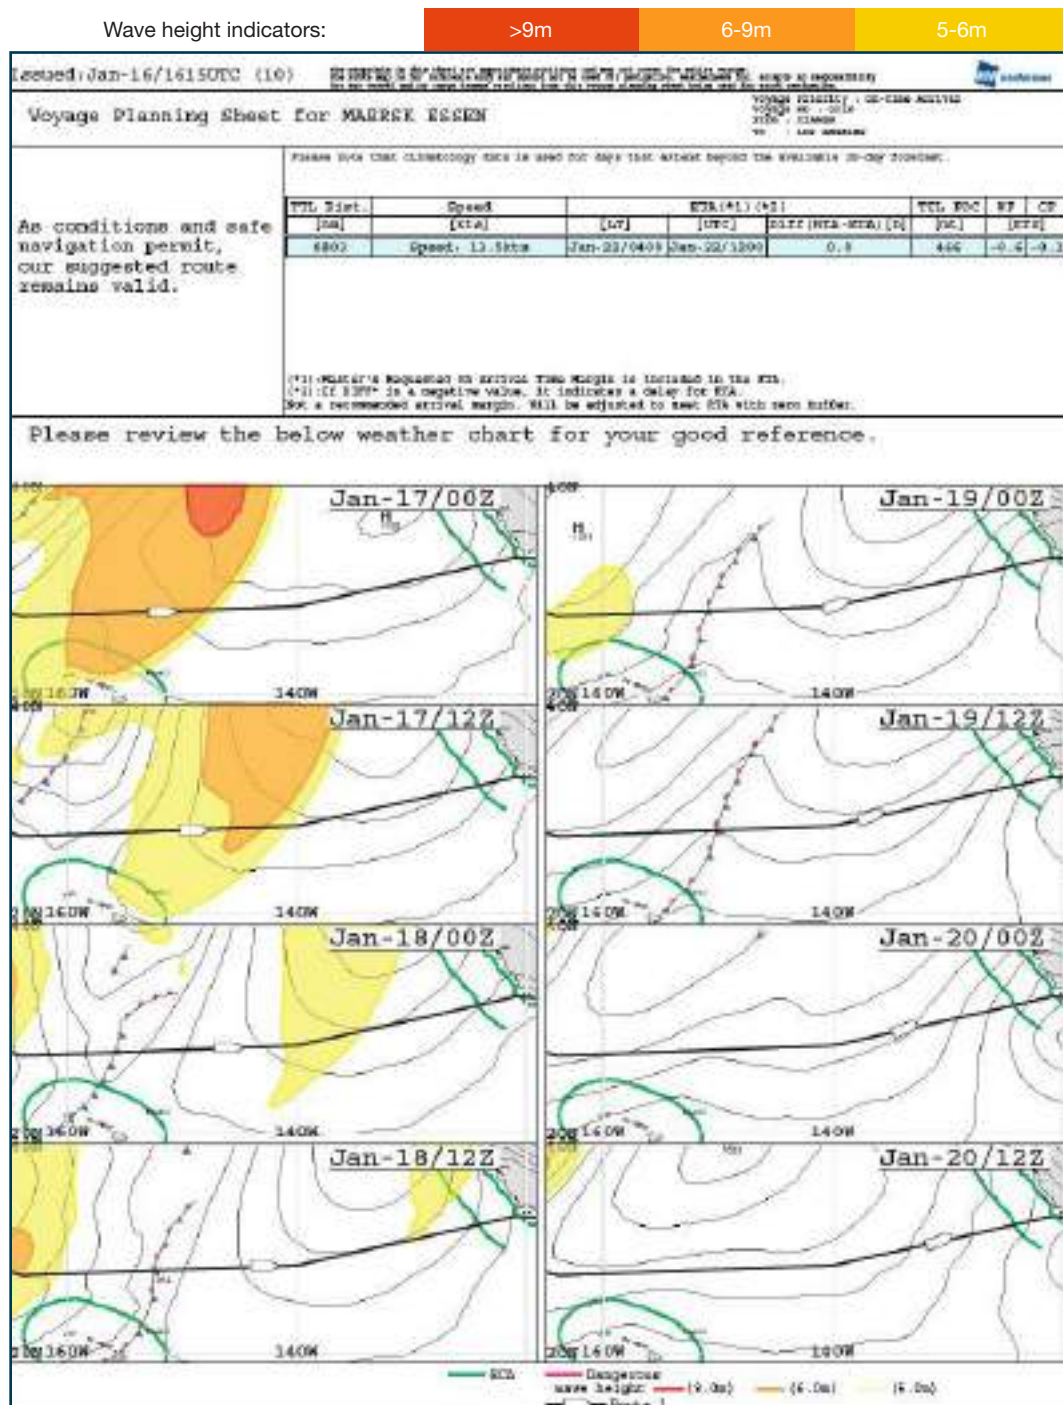
Furthermore, although WNI were informed on 14 January that the ETA in Los Angeles had been delayed until 28 January, it remained as 22 January in the voyage planning sheet. It is thus evident that the voyage planning sheet had not been updated to incorporate the latest information received from MAERSK ESSEN.

WNI's voyage planning sheet contained a four-day forecast described in eight surface pressure charts starting at 16 January at 14:00 (Jan-17/00Z) (Figure 28) which indicated improving conditions with the ship clearing an area with significant wave heights between 6-9 m on 17 January at 02:00 ship time (Jan-17/12Z). The graph of forecasted wind, sea and swell heights combined indicated significant wave heights of 7.5 m on 16 January 14:00 LT (00 Zulu) and that the wave height was reducing (Figure 29).

Figure 28: Voyage planning sheet issued on 16 January 2021  
 Source: WNI, modified by DMAIB

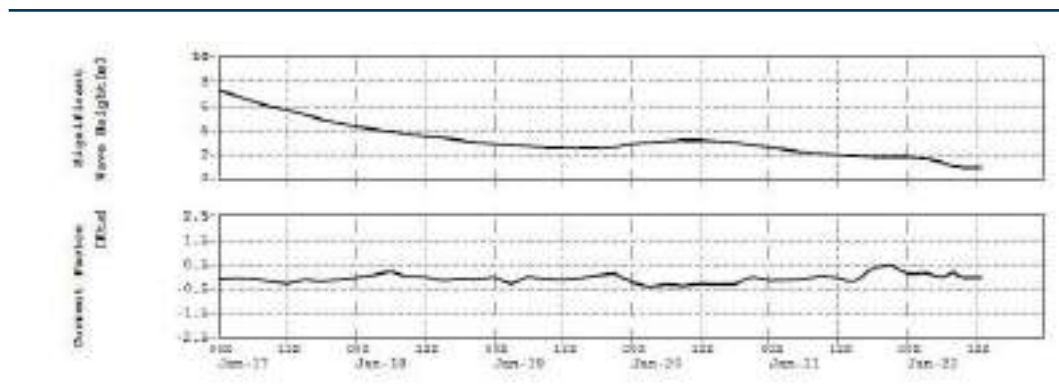
Figure 29: Voyage planning sheet issued on 16 January 2021  
Source: WNI

The gradient of the significant wave height in the damage mitigation message indicates that the wave height was improving from 17 17 Jan/00Z (Figure 29). Arguably, when the message was received at 06:45 (ship's time), it could be extrapolated from the graph that the ship was already encountering worse sea conditions than those forecast in the damage mitigation message. In these circumstances, the message was not seen to be urgent which led to the chief officer's decision not to inform the master about the message until 08:00 at the operational meeting. In addition, as the damage mitigation message did not mention parametric rolling, it did not prompt the association of the heavy rolling at 06:00 with this phenomenon. It is noted that the heavy rolling that resulted in the loss of containers occurred at 08:00 on 16 January 2021, six hours earlier than the start of the period covered by the damage mitigation message from WNI.

As the ship was most likely already situated in worse conditions than forecast in the damage mitigation message, the message provided little or no possibility for the crew to react by means of heavy weather securing or route diversion. The heavy rolling accident occurred at 08:00 on 16 January 2021, six hours earlier than the time scope of the damage mitigation message. Neither of the route diversion recommendations or damage mitigations mentioned parametric rolling.

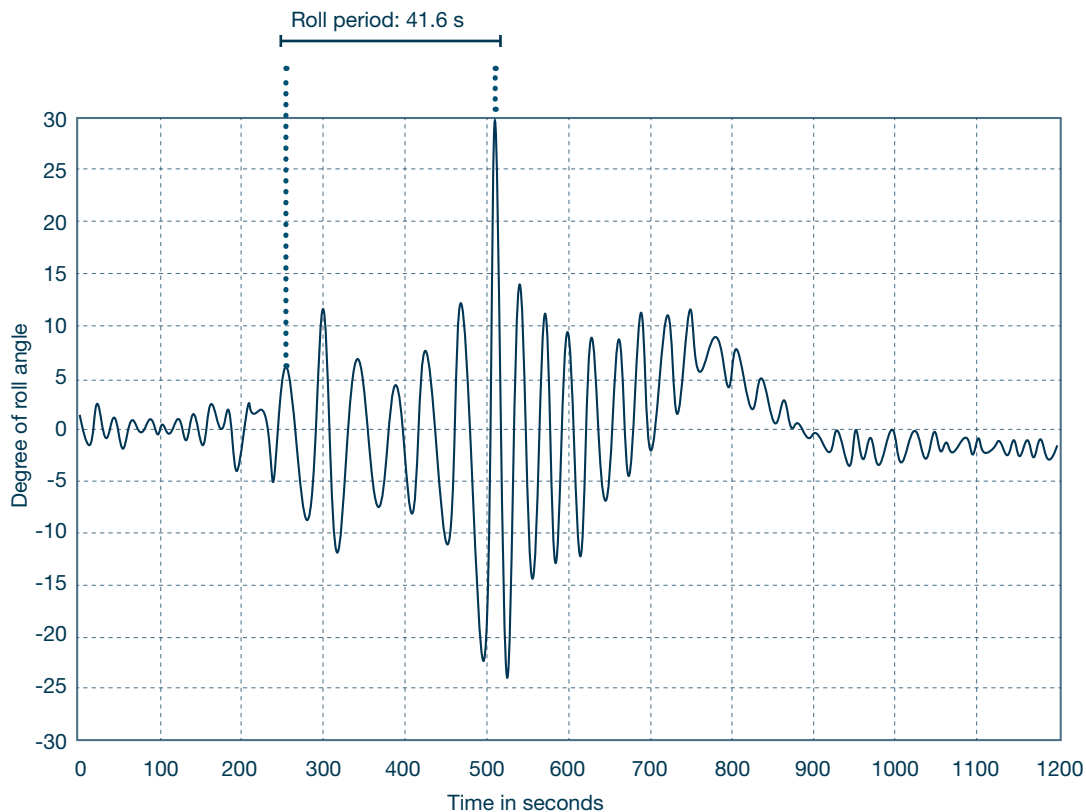
Figure 30: Graph MAERSK ESSEN's roll angles at time of the accident.  
Source: TUHH, modified by DMAIB

“Close to” is not defined by a spectrum or threshold and is hence left to masters’ discretion. Guidance is provided on how to obtain the values needed to determine the encounter period and ship’s roll period with a ship’s natural roll period being estimated by observing the rolling motion in calm sea. In practise, this is not possible as the ship will not roll in calm seas, and measuring the rolling motions in rough seas will not reflect a ship’s natural rolling motions. The variability of a ship’s roll period is demonstrated by the TUHH calculations which show that, in the case of MAERSK ESSEN, the roll period in waves before the heavy rolling episodes was considerably shorter than the natural roll period calculated by TUHH, while the roll period in waves during the parametric rolling motions is close to the calculated natural roll period (Figure 30).

The inclinometer and TUHH calculations concluded that roll angles experienced by MAERSK ESSEN during the loss of cargo was 26-30°. This is well above the ship's simulated maximum roll angle and the pre-set operational limit for the loading condition on this voyage.

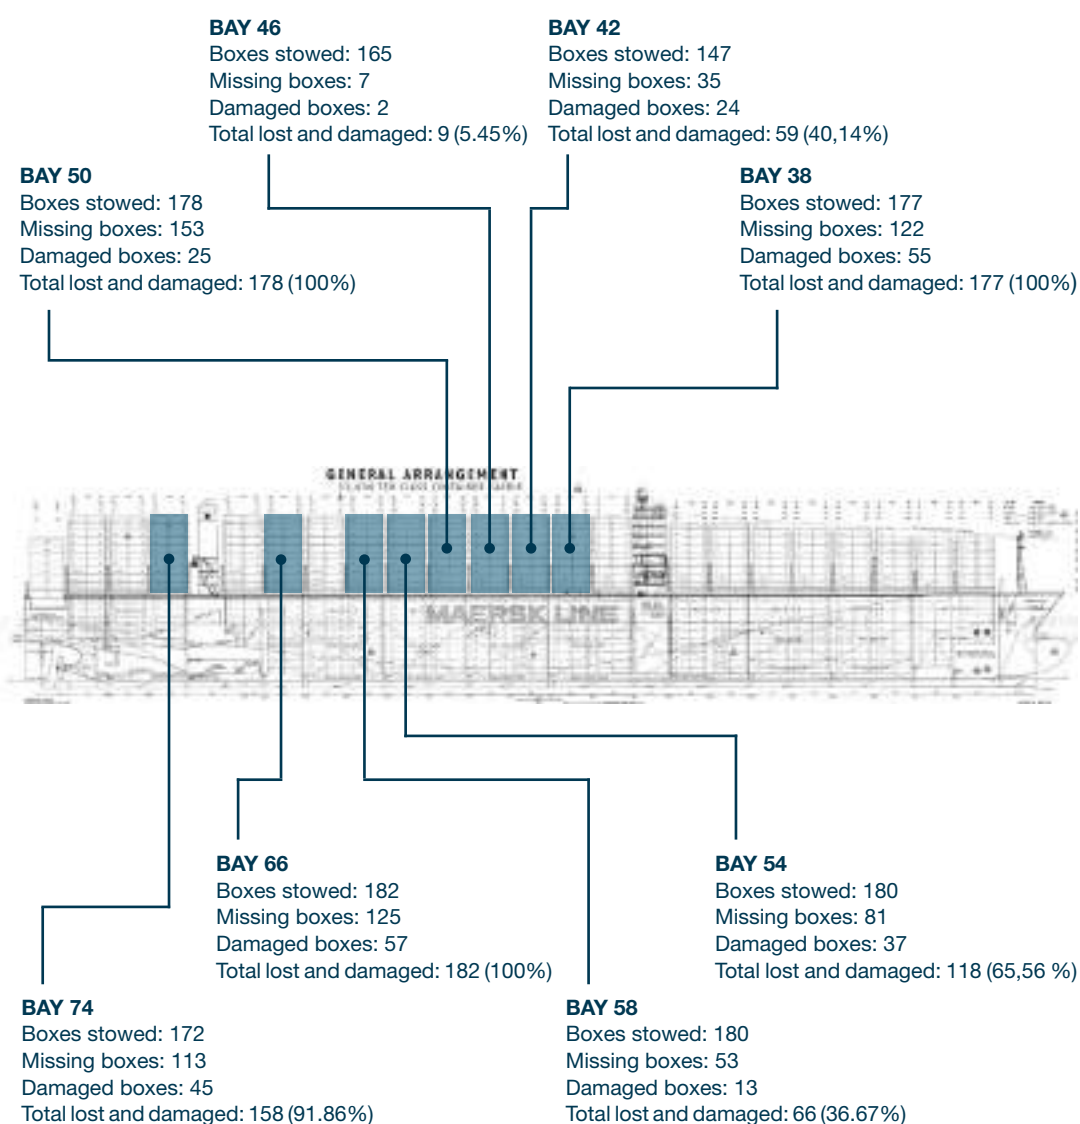
Figure 42: Overview damaged and lost containers based on Maersk info (DMAIB)  
Source: MAERSK A/S / DMAIB

After all the containers on board had been accounted for, Maersk A/S informed DMAIB that 689 containers were lost and 258 were damaged. Eight bays aft of the accommodation were affected: Bays 38, 42, 46, 50, 54, 58, 66 and 74. In Figures 42 and 43, the location and number of missing and damaged containers on the affected bays are highlighted:

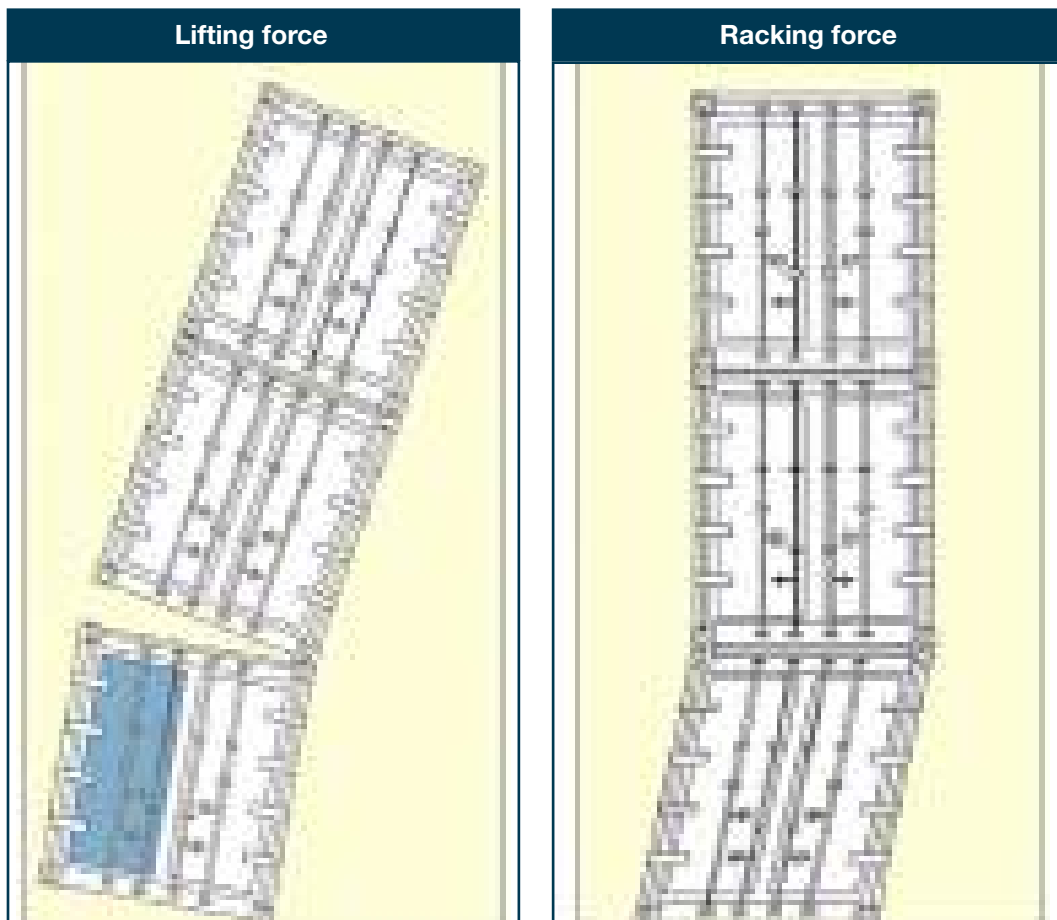
Figures 53 and 54: Racking and lifting force  
Source: UK P&I Club, modified by DMAIB

The ISO sockets, which had the lowest holding capacity, were damaged on most of the affected bays. Fractures on sockets, corner castings and base-locks often related to overload caused by lifting and separation forces induced by heavy rolling, which resulted in a tipping moment (Figure 53). However, the corner post load or lifting force might also have resulted from other dynamics within the individual stack, such as acceleration forces at the top leading to racking forces towards the middle of the stack, which then results in lifting/compression in the bottom of the stack (Figure 54). This type of dynamic will increase with stack height, especially for stacks with the tiers above the lashing bridge connected by twistlocks only. Furthermore, impact from collapsing adjacent stacks can also induce a tipping moment.
