# **Final Report**

## **FATALITY OF CREW ON BOARD NOZOMI IN BANGKA STRAIT, INDONESIA 1 APRIL 2022**

TIB/MAI/CAS.122

Transport Safety Investigation Bureau  
Ministry of Transport  
Singapore

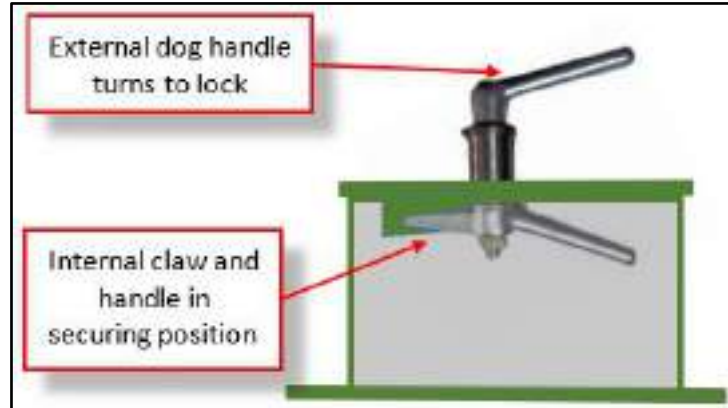
Figure 1 - Illustration of a set of dog handles securing a booby hatch (not to scale)

1.1.4 The Bosun and the three ASDs transferred the grease and tools to the forward booby hatch (for accessing No.5 cargo hold, see **figure 2**). While turning the external dog handles to open the booby hatch cover, two out of the four were found to be seized. The deck crew used a short pipe to slot into the external dog handles and managed to turn them, and thereafter were able to lift open the booby hatch cover.
