SAFETY DIGEST

Lessons from Marine Accident Reports

1/2023

MARINE ACCIDENT INVESTIGATION BRANCH

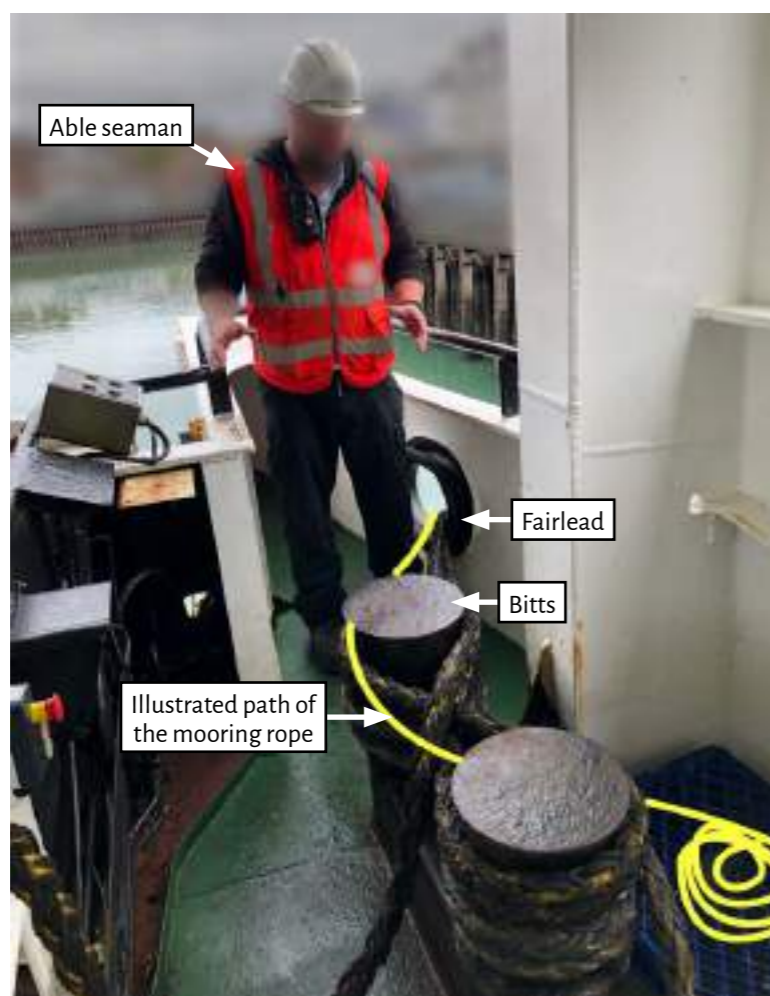
Figure 1: Reconstruction of the approximate position of the able seaman when he was struck by the mooring rope

When the mooring rope was released the heaving line, which was weighted with a sandbag, sank and was drawn into the forward propulsion unit. The mooring rope was still caught up in the heaving line and ripped free of the AB's hands and started to pay out at speed from the pallet that it was stowed on (Figure 1), at which point he tried to jump out of the way to a safe area.

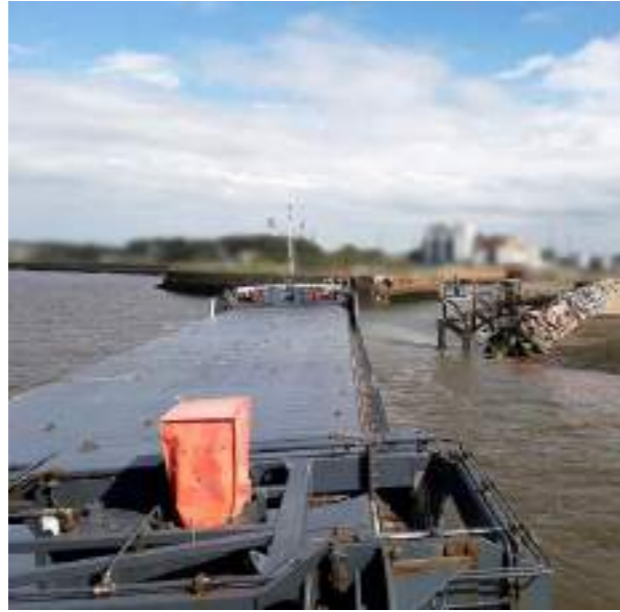
The pilot and master took rapid action to apply lots of stern power and managed to free the bulk carrier from the shoal after 20 minutes. The ship had turned back into the main channel and, with the tide falling quickly and the ebb stream strengthening, the pilot and master decided to make a second approach. However, having made a very tight turn off the harbour entrance the bulk carrier again missed the approach and grounded for a second time on the same shoal (Figure 2). The ship had to wait until the next

Figure 1: View from the starboard bridge wing towards the harbour entrance during the first grounding

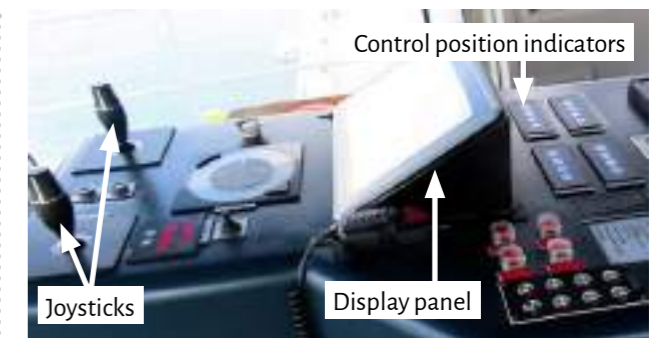
The vessel was fitted with a Voith Schneider Propeller (VSP) system that provided it with the ability to drive in any direction without the need for a rudder. The VSP could be controlled from joysticks on one of three consoles on the port, starboard or centre of the bridge. Control was exchanged by pressing a *command* button at one of the consoles and confirmed by pressing the button a second time. An audible tone would indicate when there was misalignment between the joysticks of the two consoles and the transfer would not take place. The angle of the control display panels made it difficult to see which console was in control.

The master was using the starboard console (see figure) to manoeuvre the ferry out of port on the morning of the incident. The helmsman pressed the *command* button on the centre console to request control as normal and the audible tone sounded. The master, believing control had been passed, set the starboard console's joystick to the *zero* position. However, the VSP audible tone continued.

Figure: Voith Schneider Propeller control console

This was confusing. Neither the master nor helmsman knew who was in control. The ferry slowed and swung to port, lining itself up with a man who was enjoying an early morning cup of coffee on the beach, much to his consternation. The bridge team attempted to take control at each console station and in doing so the control passed backwards and forwards many times.

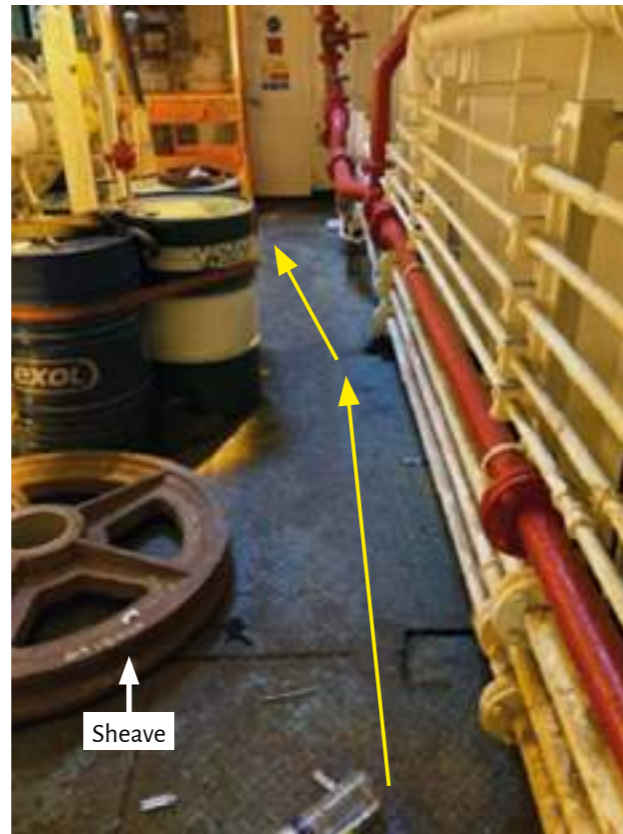
The bosun thought he had lots of time in hand so decided to prepare a 0.5t sheave, which was due to be lifted ashore from a void space. He removed the lashings that were securing the sheave vertically against some pipework and started to roll it toward the port side hatch in readiness for offload. The bosun was manoeuvring the sheave past some oil drums when he lost control and the sheave toppled over, struck his thigh and then trapped him under its weight (Figure 1).

Figure 1: Planned route to move the sheave across the void space

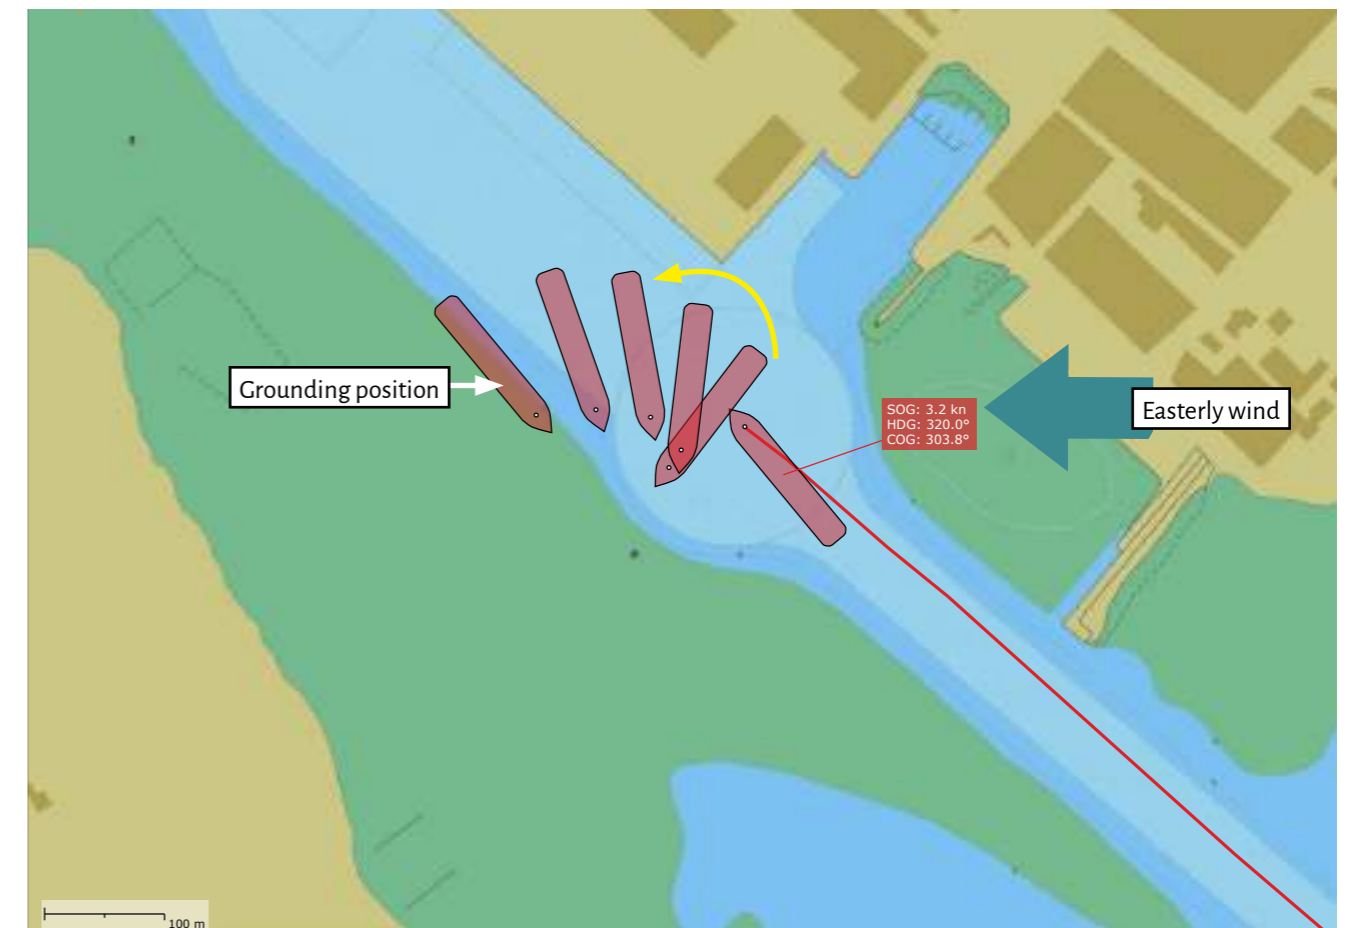
operational limits and began drifting sideways at 1.5kts toward unsafe water. The master became slightly flustered and several unclear messages were relayed to the anchor party, which needed clarification before the port anchor was eventually dropped. However, this did not stop the ferry from running aground on the western limit of the channel (see figure).

Figure: Cargo ferry's swing to port and subsequent grounding position

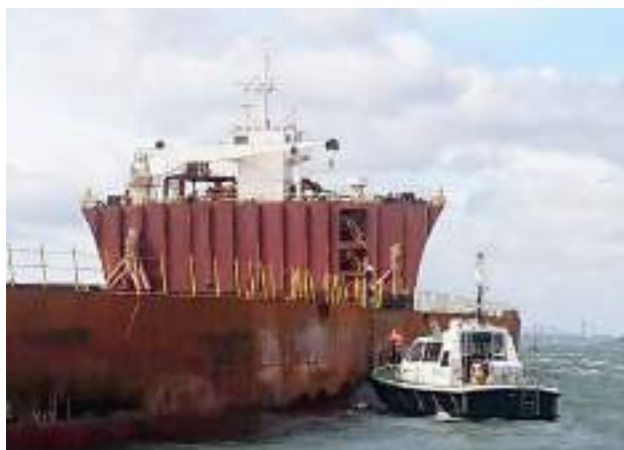
A crew transfer vessel in a northern European port had come alongside a cargo ship (Figure 1) to transfer two passengers and their luggage. The first passenger successfully climbed the pilot ladder (Figure 2) and boarded the cargo ship. The second passenger had started to ascend the ladder while the transfer vessel moved clear of it; as he continued to climb, first one foot and then the other slipped from the rung. Unable to either regain his footing or support himself, he fell from a height of 2m into the water between the two vessels.

Figure 1: The transfer vessel alongside the cargo ship

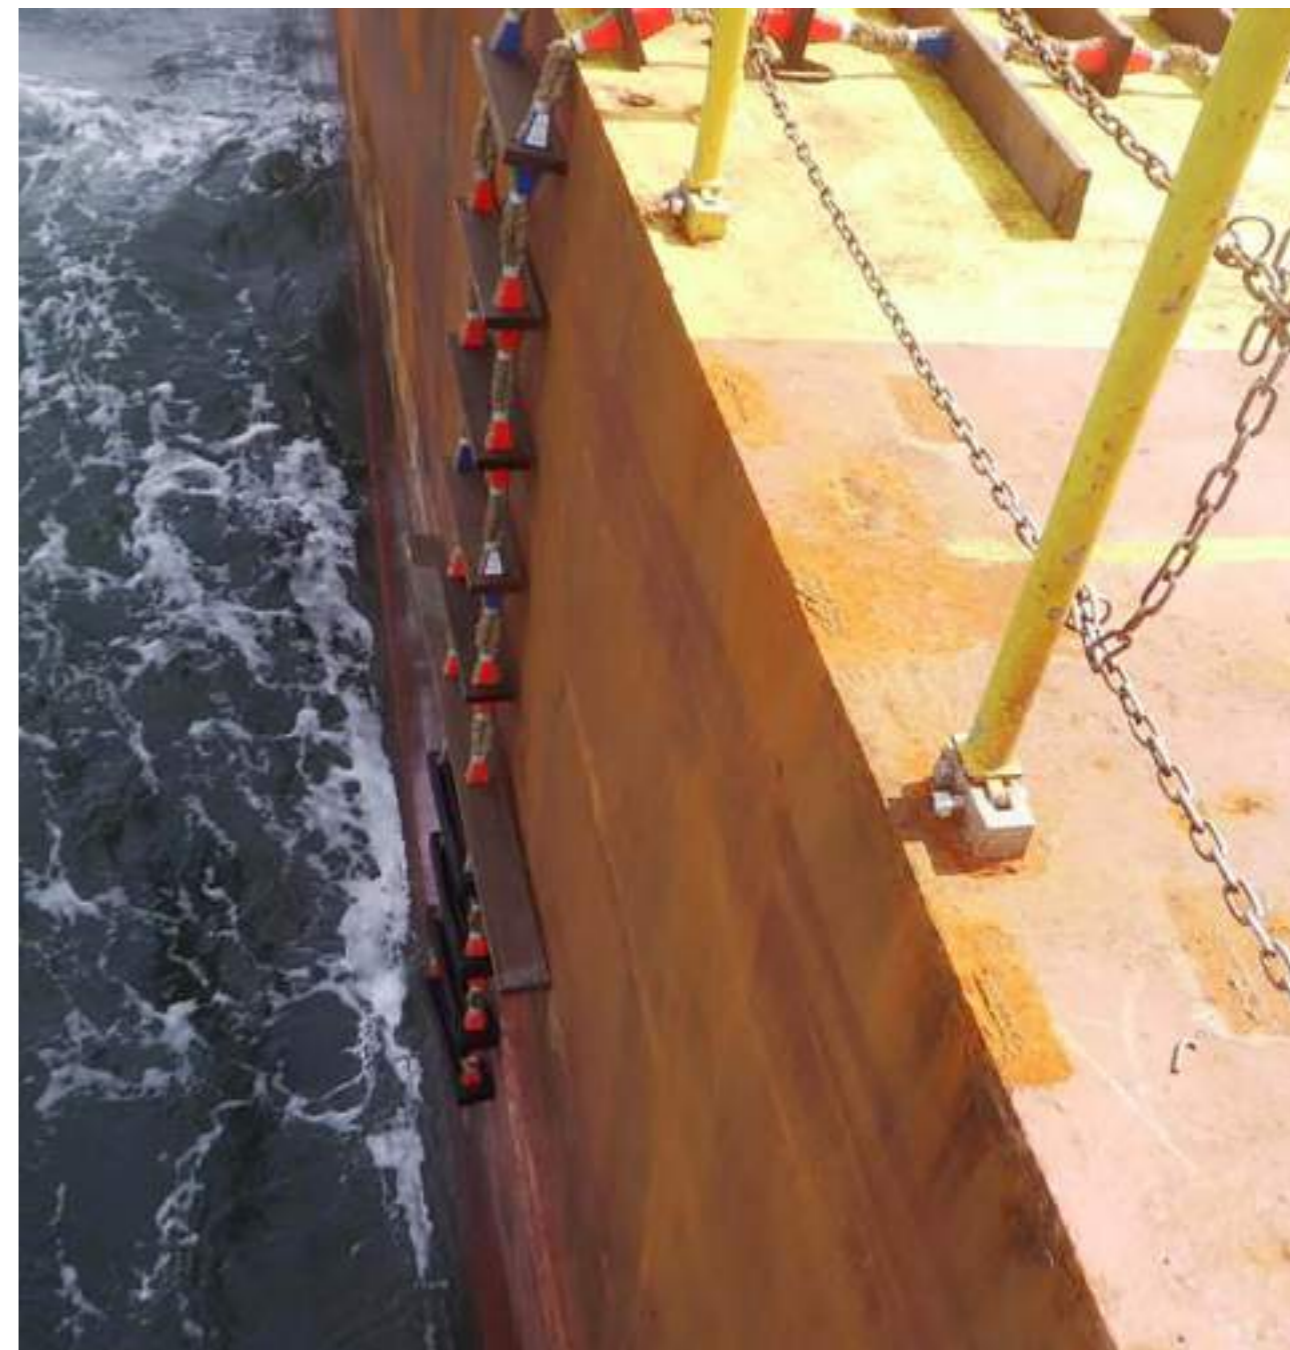
Figure 2: The cargo ship pilot ladder

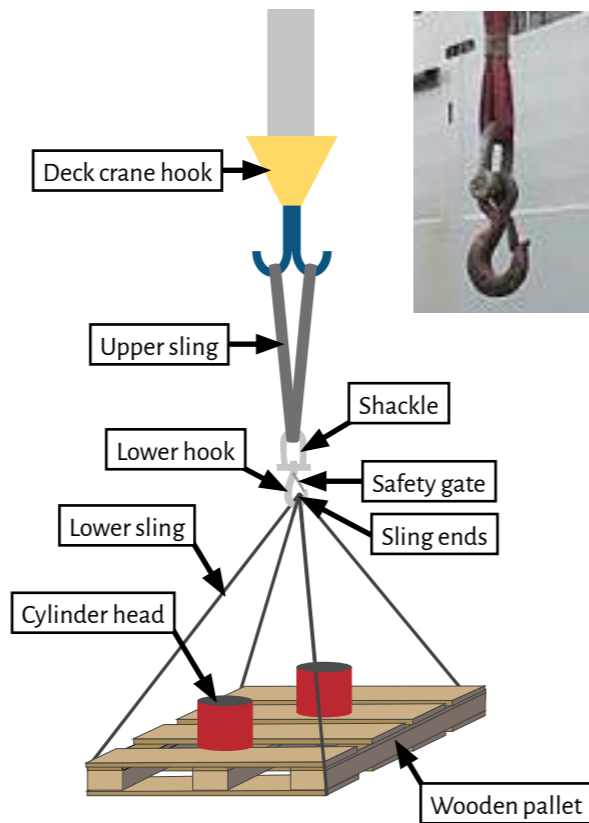
Two slings were passed through the pallet and the four ends were attached to a lower hook, which was joined to two upper slings by a shackle; these upper slings were suspended from the deck crane hook. The four sling ends rested one on top of the other in the throat of the lower hook and so it was impossible to close the safety gate (Figure 1).

The initial lift of the wooden pallet was successful but when it was about 10m above the jetty the uppermost sling end slipped from the lower hook and flipped the pallet over, causing the cylinder heads to fall. Thankfully, the lifting operation plan ensured nobody was standing below the suspended load and damage was minimal; the falling cylinder heads caused a dent in both the jetty (Figure 2) and the operator's wallet.

Figure 1: Slinging arrangement and (inset) close-up of lower hook

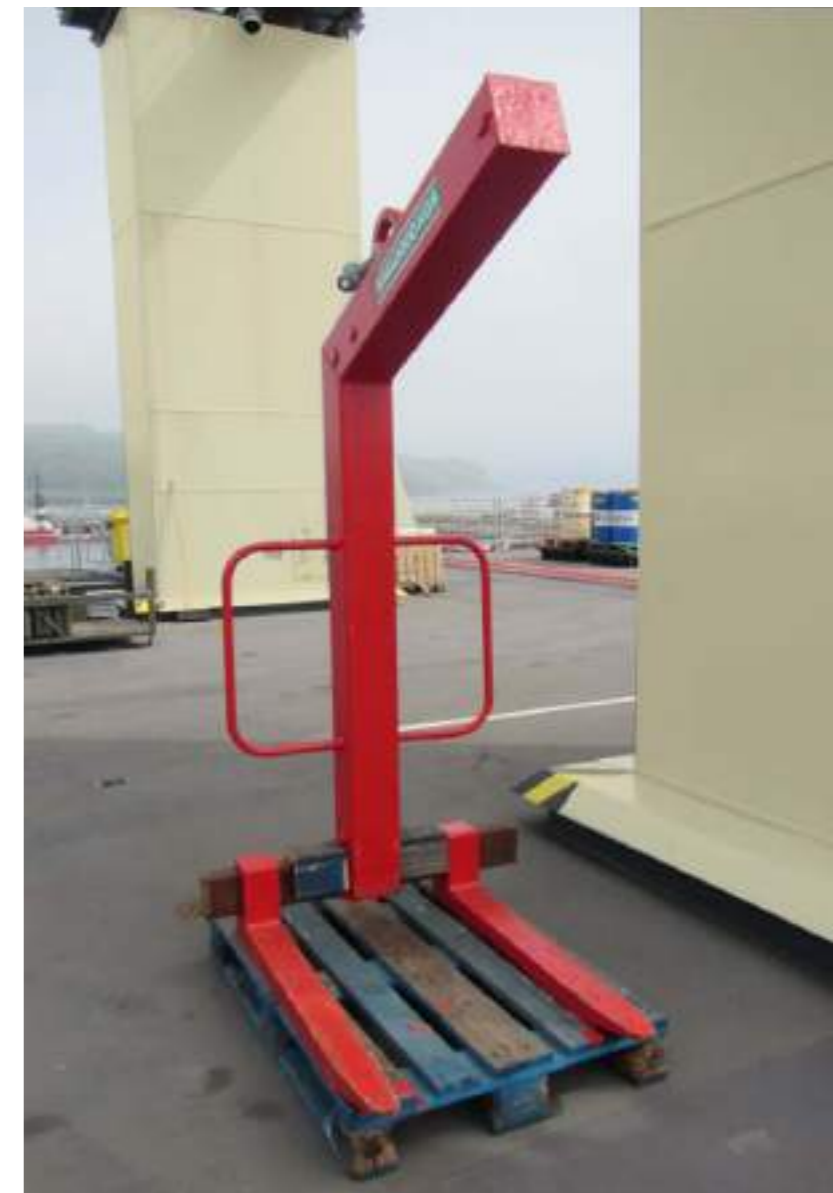
Figure 3: Wooden pallet fork-lift hook

- Procedure** → Adherence to COSWP is essential during lifting operations, particularly its instruction that loads should be lifted using *certified lifting equipment that should be appropriate for the task*. The cargo ship was equipped with a purposely designed set of forks with which to lift loaded pallets, but it was not used (Figure 3).

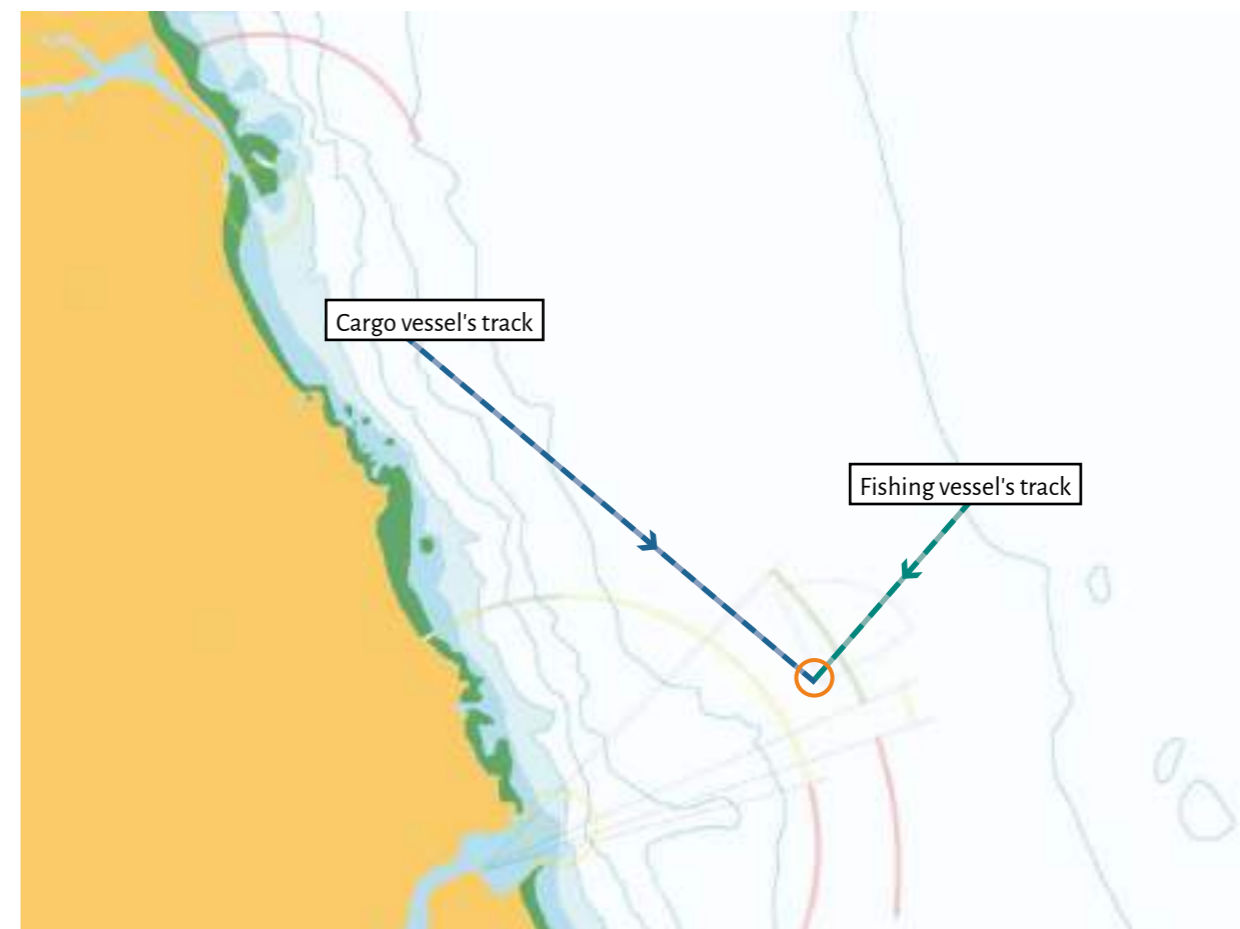
The OOW on board the cargo ship turned from his workstation and saw a small target appear on the radar, close on the port bow. He reduced the radar range scale that was in use and instructed the lookout to keep watch on the port side. The OOW picked up the binoculars and searched the foggy gloom. Suddenly, a fishing boat appeared three points to port. The OOW looked to the wheelhouse of the boat but could not see anyone. He sounded a long blast on the whistle and altered course to starboard, but it was too late to avoid a collision (see figure).

The fishing boat's bow was severely damaged and water flooded the forward space. Despite the efforts of the crew and local boats, it sank 2 hours later while being towed back into port. The crew were rescued without injury.

Figure: Tracks of both vessels up to point of collision

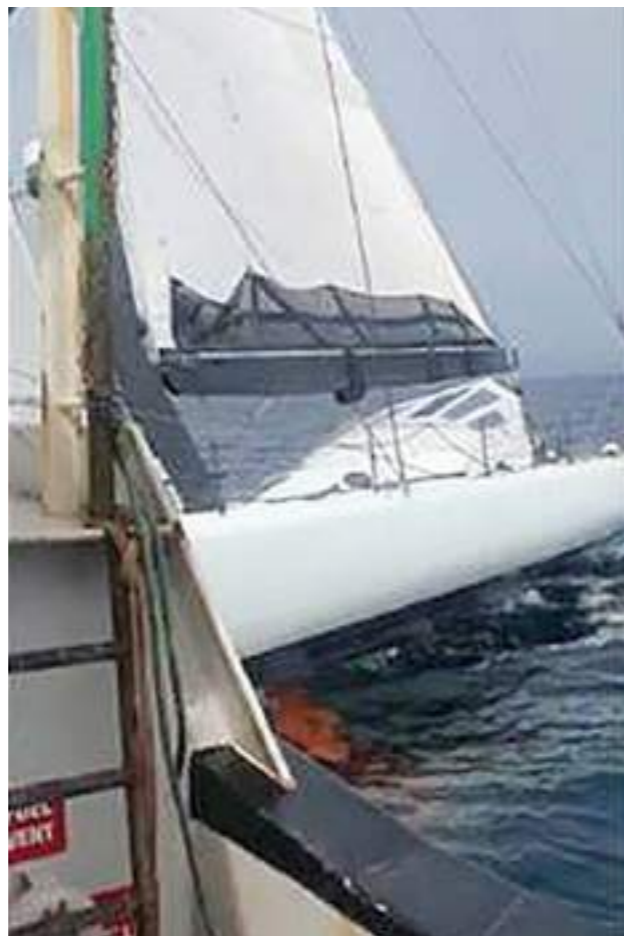
A few minutes later the 20m yacht passed about 1m ahead of the fishing vessel, travelling at about 8kts (see figure). The skipper and crew member on board the fishing vessel could see that neither the yacht's cockpit nor deck was manned as it passed them. The fishing vessel's skipper subsequently reported the incident to the coastguard.

Figure: The near miss

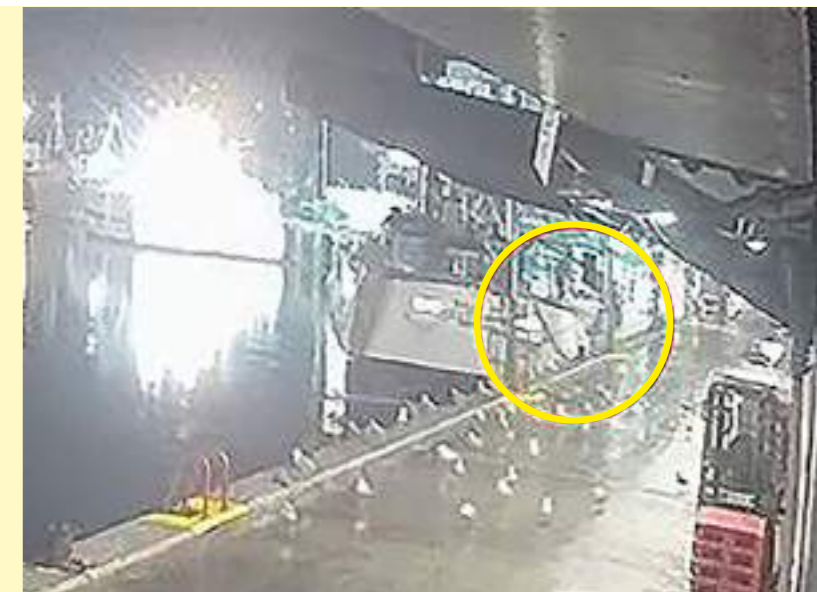
Figure 1: CCTV still of whelk trawler berthing

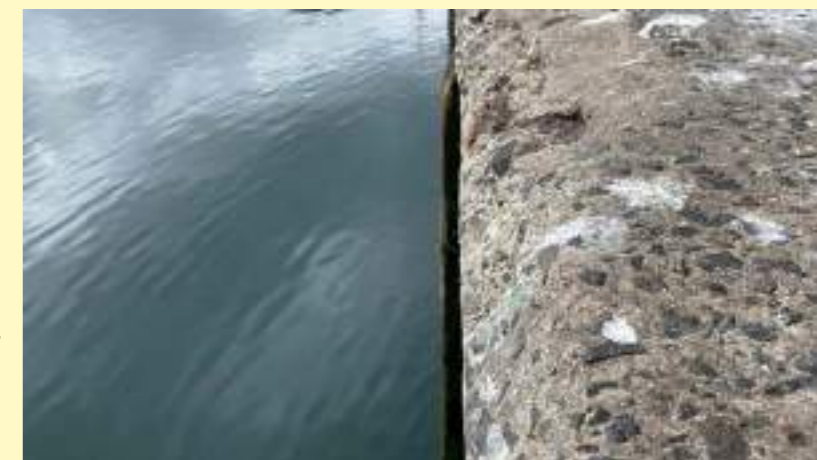
- Maintain** → The condition of the quay was not ideal. The disintegration of the concrete had resulted in a downward slope (Figure 2), increasing the likelihood of slipping when walking or stepping onto it. Regular inspection and maintenance of quaysides, ladders and railings reduces the risk of further hazards being introduced by surfaces or equipment that is designed to provide protection.

Figure 2: The sloping quayside

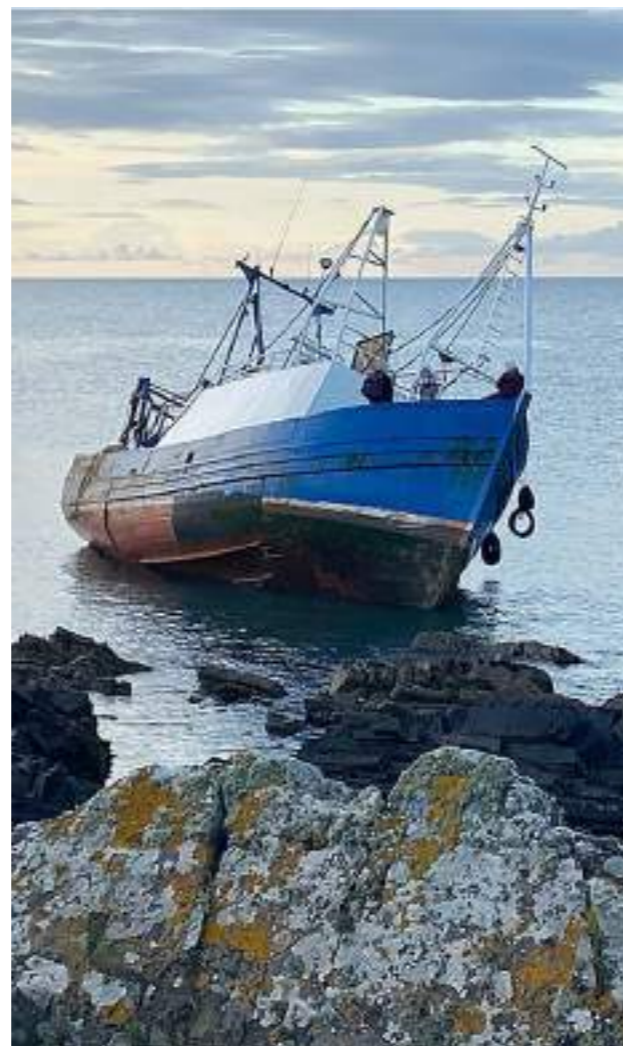
The vessel was set to autopilot, proceeding at about 8kts, and the first few hours were uneventful. However, the skipper fell asleep at just after 0300 and about an hour later he and the crew were awoken by the gill-netter grounding on a rocky shelf close to shore (see figure).

The skipper had been awake for about 20 hours at the time of the accident. Thankfully, the crew found only minor damage during an inspection of the hull and it was quickly repaired. The vessel was later refloated and returned to its home port under its own power.

Figure: The fishing vessel aground

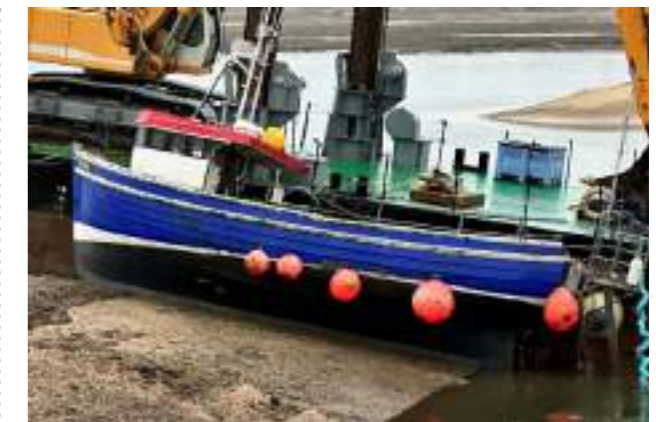
The 50-year-old vessel had been out of service due to bad weather and seasonal fishing patterns when, within 24 hours of the owner's last inspection, its watertight integrity failed and it was found submerged and resting on the seabed at a depth of 2 metres. The vessel had been checked at regular intervals while in use and when laid up; however, there had also been periods of 24 hours or longer when it was left unattended.

The wooden hull was fastened with nails, some of which the owner had identified in recent years as rusted below the waterline; these had been marked up and replaced when the vessel was lifted out of the water during its repair periods, although this had not taken place within the previous 12 months. The sunken vessel was eventually raised and the source of the leak was found to be failure of its hull due to a rusted and badly corroded nail.

Figure: The potting vessel

The vessel's electric bilge pumps were powered by its service batteries and activated by float switches. The reserve voltage held in these batteries was insufficient to power the bilge pumping system for longer than a few hours. The batteries were quickly drained of power when the water started to enter the hull during the night and the bilge pumps had stopped working before the owner arrived early the next morning.

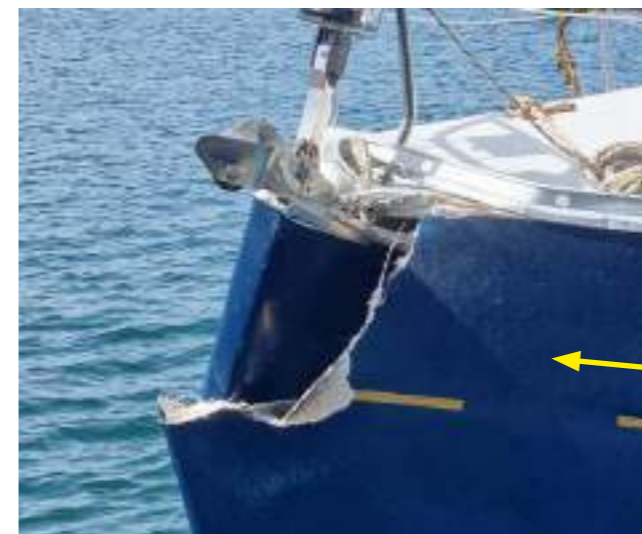
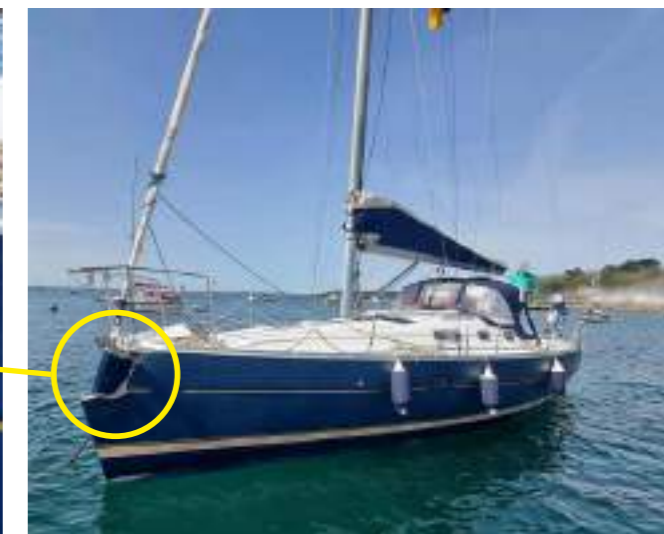
Although damaged (see figure) neither vessel was taking on water and both were able to return to port unaided to carry out necessary repairs.

Figure: The damaged fishing vessel (above) and yacht (below)

- 1. **Plan** → Skippers planning a seagoing voyage should identify areas that may require extra vigilance due to high volumes of marine traffic such as fishing vessels, ferries, workboats and pleasure craft.
- 2. **Observe** → Maintaining a proper lookout by all available means can provide early warning of the risk of collision. This includes the use of electronic equipment such as radar and AIS. Moving your position frequently can offer the best opportunity to observe approaching vessels that may be obscured by window frames, masts, sails, cockpit canopies and other on board structures.

- 3. **Equipment** → All seagoing commercial vessels should be fitted with an AIS transceiver to transmit and receive signals that can be observed by anyone on mobile phones when in areas of network coverage. Pleasure yachts are not required to be fitted with AIS transceivers; however, recreational skippers should consider the safety benefits of installing AIS equipment.
- 4. **Monitor** → It is important that all vessels at sea maintain a listening watch on both VHF channel 16 and any working local port frequency to ensure the reception of important safety information and remain contactable.

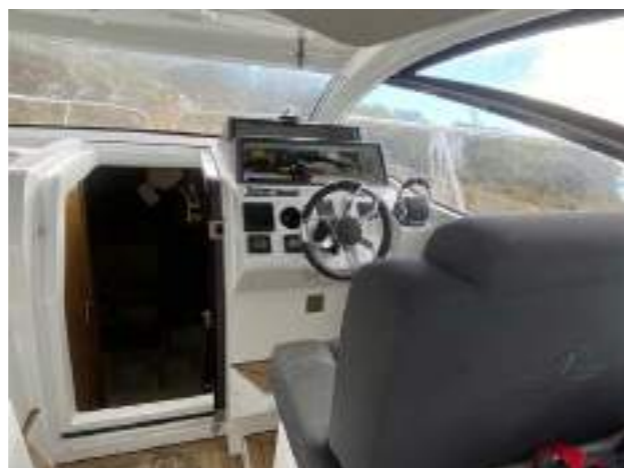
The mood on board was buoyant as the crew discussed their day. One crew member went to find a jumper and in doing so switched on all the lights in the forward cabin (Figure 1) and along the passageway. The skipper's night vision was compromised by a combination of the glare created by the bright cabin lights and spray on

Figure 1: View from inside main cabin

the windscreen. Suddenly, and before he could appraise the situation, a cliff appeared from nowhere ahead of him. The motor cruiser hit the shore at full speed and came to a crashing halt, the sudden jolt propelling the crew forward (Figure 2).

- Hazard** → The glare of your own lights can significantly impact your ability to keep a good lookout at night. Everyone on board should make sure that the watchkeeper is given the best opportunity to see hazards. White light can seriously affect night vision and the glare on windscreens can make it almost impossible to see out effectively. Use torches or red lighting to move about or keep doors, curtains and scuttle covers closed.

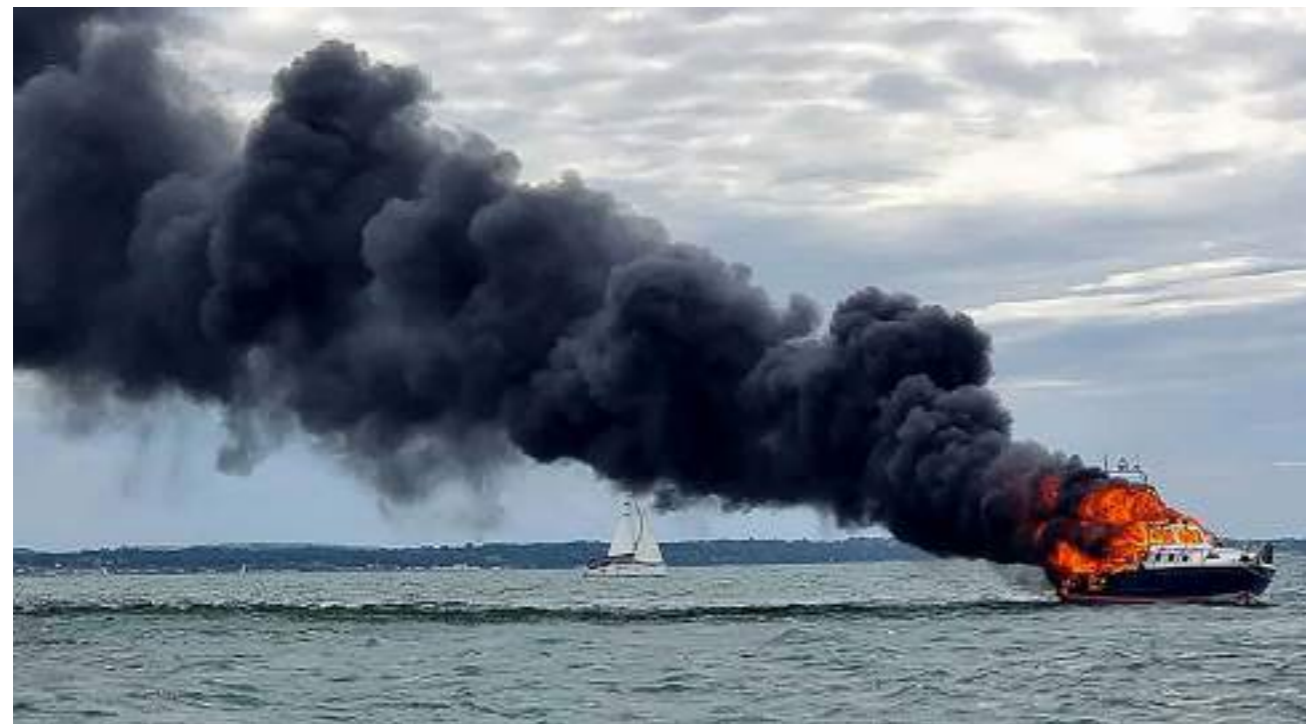
As they were returning to port after their excursion, the couple noted that smoke was emanating from the starboard engine and into

Because the vessel was in a busy shipping channel approaching a port, a second lifeboat was tasked to tow the burning vessel to a place of safety. The lifeboat crew attached a line to the motor cruiser and towed it out of the channel before using the

Figure 1: Motor cruiser after crew abandoned it

2. **Maintain** → A fixed firefighting system is no use if, as in this case, it fails to suppress the fire and contributes to its uncontrollable spread. Fixed firefighting equipment is not required on board private pleasure and recreational craft; however, where such a system is installed it should be inspected and serviced regularly to ensure it works in an emergency.
3. **Equipment** → Stowed lifesaving appliances should be accessible in an emergency. When deciding what storage locations are suitable, apply various scenarios to each type of essential survival equipment and consider how easy it would be to retrieve the item in an urgent situation.

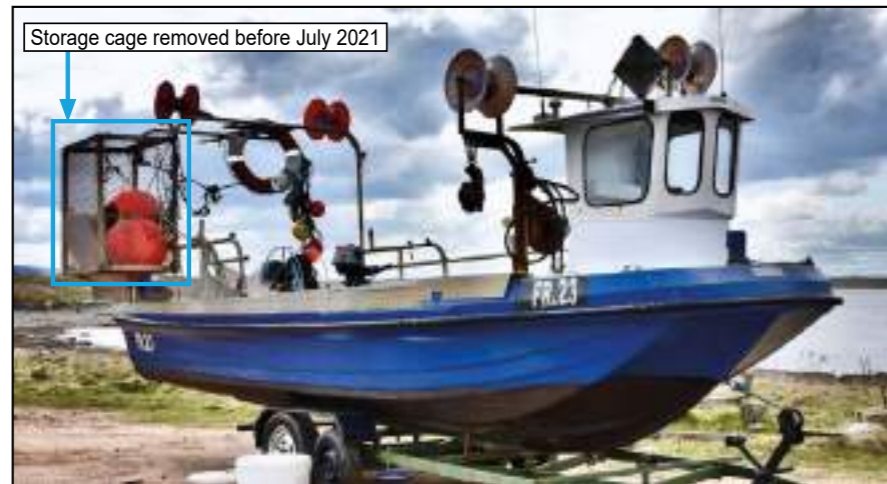
Figure 1: *Goodway*

At 1140 on 16 October 2021, the 6.85m creel fishing vessel *Goodway* (Figure 1) left Cairnbulg harbour, Scotland, to work creels locally. The owner was the only person on board. At 1340, the owner's mobile phone suddenly disconnected from the network and it is highly likely that *Goodway* capsized at that time, while the owner attempted to free creels that had become fast to rocks on the seabed. At 2018, a concerned family member alerted the coastguard that the vessel was overdue and the RNLI and coastguard helicopter assets were immediately tasked to search for both *Goodway* and its owner. At 2233, a coastguard helicopter found *Goodway's* upturned hull anchored to rocks by a snagged fleet of creels that were attached to a cleat on the starboard side of the vessel. The hull was briefly inspected before being freed from the rocks by the tide and washed ashore, where it was turned over and thoroughly examined (Figure 2).

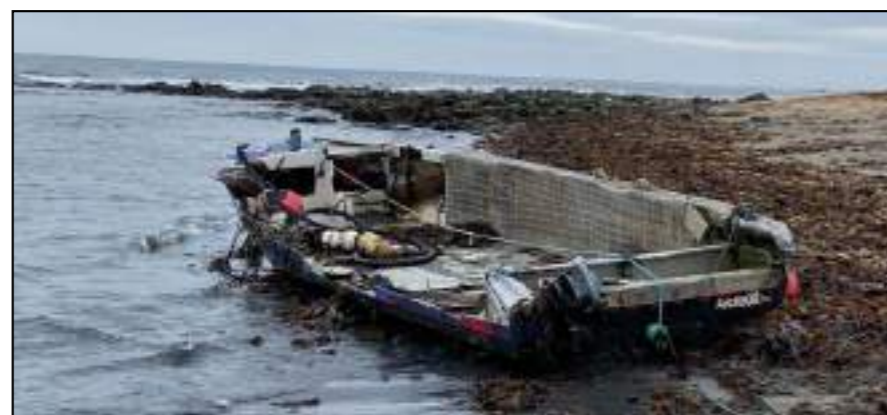
Figure 2: The wreck of *Goodway* washed ashore on Cairnbulg Point

The evidence indicated that the owner had attached the back rope of the snagged fleet of creels to the cleat on the starboard side of his vessel. It is likely that *Goodway* capsized when the owner used the outboard engine, which was offset to port, to drive the vessel forward in an attempt to free the fleet. It is presumed that the skipper fell overboard when *Goodway* capsized and he was unable to board the upturned hull or send a distress alert. It is unknown if the owner was wearing a personal flotation device (PFD) or carrying his recently purchased automatic personal locator beacon (PLB) at the time of the accident, as he has not been found and no alert was received from his PLB. *Goodway* was not fitted with a float free Emergency Position Indicating Radio Beacon (EPIRB) and the PLB purchased by the owner did not operate on the 406 megahertz (MHz) frequency required to transmit a distress alert to the coastguard.
